Visual Site Inspection Report

Project Name	H-600 Pipeline Spread G	AFE	124300137	Spread	H-600 Pipeline Spread G
Contractor	Precision			Report #	7119
Inspector	Garrett Barclay			Date/Time	1/6/2020 7:00 AM
Permit #	TBD	Inspection Type	VA SWPP	Station Begin	11250+00
State	VA	Inspection Area	Partial	Station End	11140+00
County	Giles	Ground	Dry	Temperature (°F)	38.00
Municipality	N/A	Weather	Below Freezing Temp	Rain Gauge (in)	0.20
				Rain Accumulation Time (days)	1.00

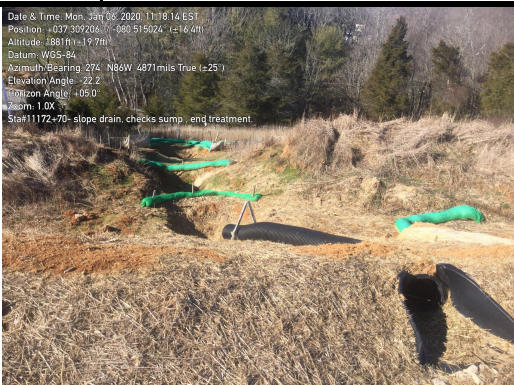
Pic 5 Desc.	Slope drain, checks, sump, end treatment are in acceptable condition.	Pic 6 Desc.	Kow Camp rain gauge reading-0.40"

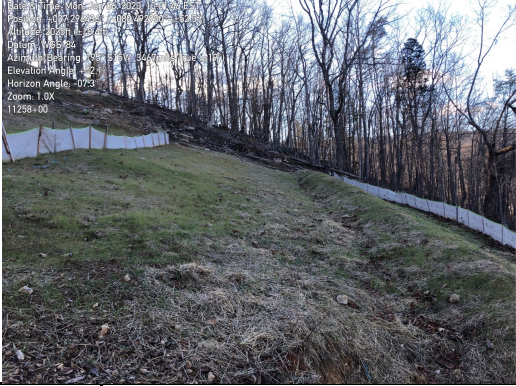
GPS Location	1	GPS Location	2		
Field Station#	11258+00	Field Station#	11265+00		
Pic 1 Desc.	Temporary vegetation sufficient.	Pic 2 Desc.	P-1 silt fence perimeter control functional.

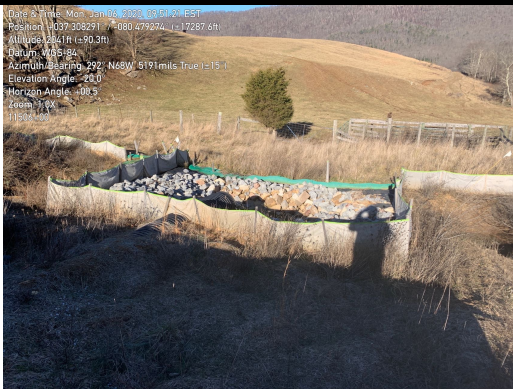
GPS Location		See photo for GPS location.		GPS Location	
Field Station#		11506+00		Field Station#	
Pic 1 Desc.		Clean water diversion pipe and plunge pool in place.		Pic 2 Desc.

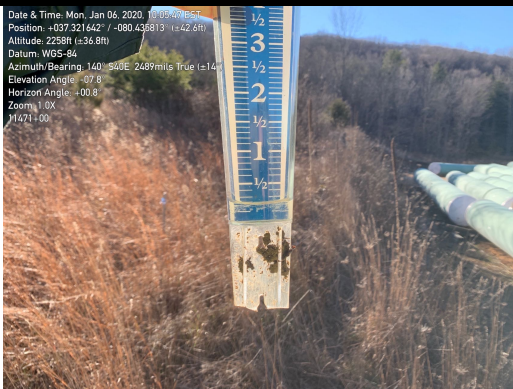
GPS Location		See photo for GPS location.		GPS Location	
Field Station#		11471+00		Field Station#	
Pic 3 Desc.		Rain gauge at Steele Acres Road reads 0.3 inches.		Pic 4 Desc.

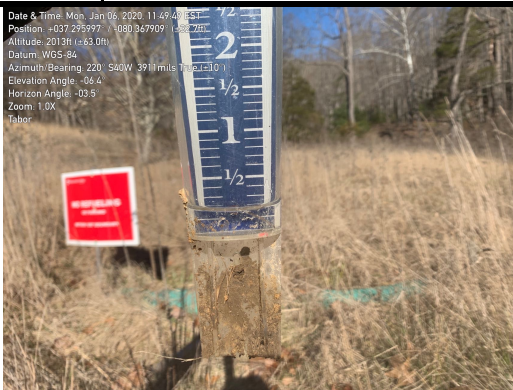
GPS Location		See photo for GPS location.		GPS Location	
Field Station#		11767+00		Field Station#	
Pic 5 Desc.		Rain gauge at Mount Tabor Road reads 0.2 inches.		Pic 6 Desc.

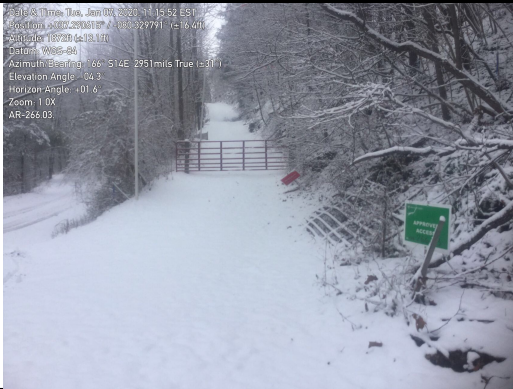
GPS Location	See photo GPS		GPS Location	See photo GPS	
Field Station#	11900+00		Field Station#	11989+00	
Pic 1 Desc.	AR-266.03- Access road is snow covered & slippery.		Pic 2 Desc.	P1 silt fence filtering water from culvert crossing AR-266.00

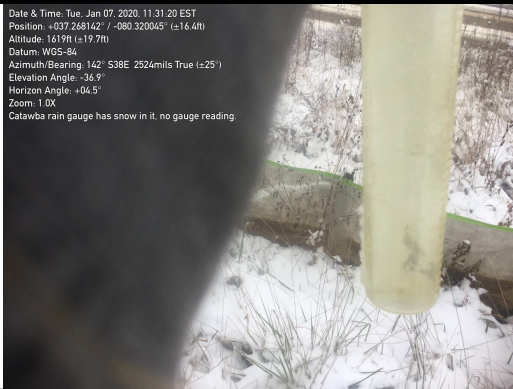
GPS Location	See photo GPS		GPS Location	See photo GPS	
Field Station#	11989+00		Field Station#	11989+00	
Pic 3 Desc.	Catawba rain gauge full of snow, no gauge reading.		Pic 4 Desc.	AR-266.00- Culvert crossing access road, inlet & outlet are open, culvert is functional.

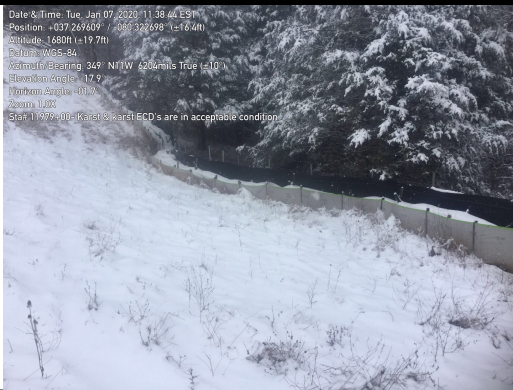
GPS Location	See photo GPS		GPS Location	See photo GPS	
Field Station#	11979+00		Field Station#	11970+00	
Pic 5 Desc.	Karst and Karst ECD's are in acceptable condition.		Pic 6 Desc.	Row is snow covered but in stable condition.

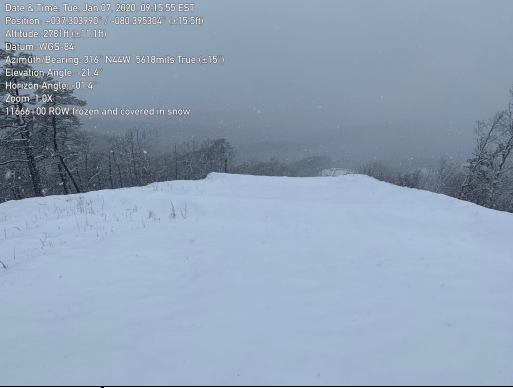
<p>Date & Time: Tue Jan 07, 2020 09:15:55 EST Position: +37.133333° / -80.133333° (±113.9ft) Altitude: 2261ft (±111.9ft) Datum: WGS 84 Azimuth Bearing: 316° N46W 5618mils True (±15°) Elevation Angle: 21.4° Horizon Angle: 01.4° Zoom: 1.0X Brush Min: ROW frozen and covered in snow</p>	
GPS Location	On photo	GPS Location	On photo
Field Station#	11668+00	Field Station#	11666+00
Pic 1 Desc.	Unable to completely inspect ECDs due to conditions	Pic 2 Desc.	ROW frozen with 3 to 4 inches of snow

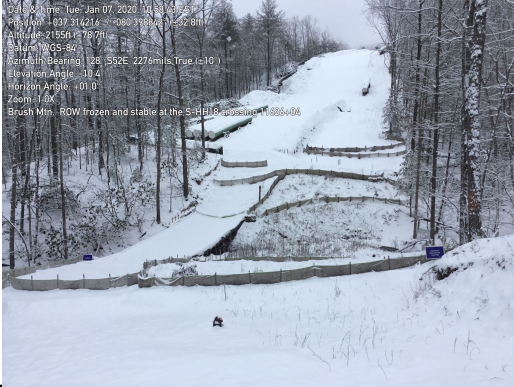
<p>Date & Time: Tue Jan 07, 2020 10:50:12 EST Position: +37.142214° / -80.133333° (±122.0ft) Altitude: 2155ft (±76.7ft) Datum: WGS 84 Azimuth Bearing: 105° S52E 2276mils True (±10°) Elevation Angle: 10.4° Horizon Angle: 101.0° Zoom: 1.0X Brush Min: ROW frozen and stable at the S-HH18 crossing</p>

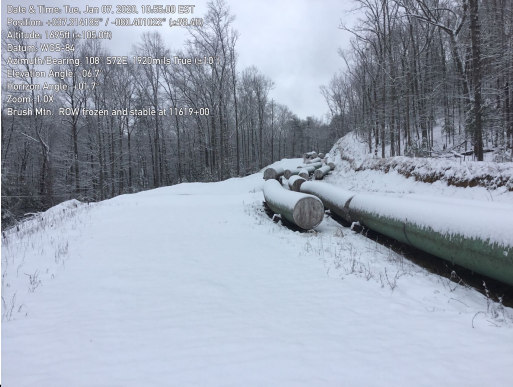
<p>Date & Time: Tue Jan 07, 2020 10:50:40 EST Position: +37.141022° / -80.141022° (±101.4ft) Altitude: 1339ft (±41.0ft) Datum: WGS 84 Azimuth Bearing: 100° S72E 1026mils True (±10°) Elevation Angle: 12.4° Horizon Angle: 101.7° Zoom: 1.0X Brush Min: ROW frozen and stable at 11619+00</p>

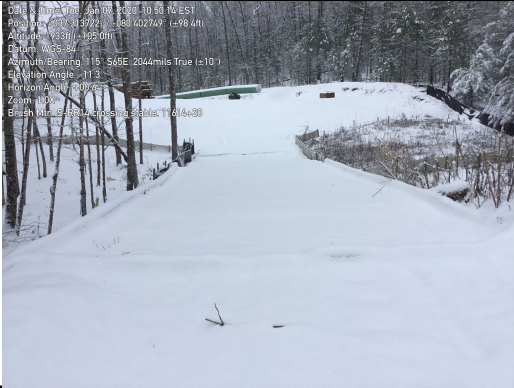
<p>Date & Time: Tue Jan 07, 2020 10:50:12 EST Position: +37.142214° / -80.133333° (±122.0ft) Altitude: 2155ft (±76.7ft) Datum: WGS 84 Azimuth Bearing: 115° S45E 2044mils True (±10°) Elevation Angle: 11.3° Horizon Angle: 101.3° Zoom: 1.0X Brush Min: ROW frozen and stable at the S-RR14 crossing</p>

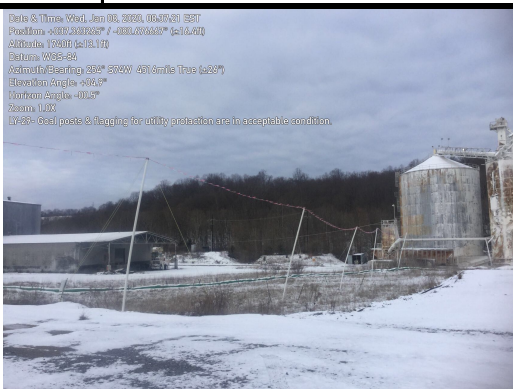
GPS Location				See photo GPS				GPS Location			
Field Station#				12005+00				Field Station#			
Pic 5 Desc.				LY-29- Goal posts and flagging for utility protection are in acceptable condition.				Pic 6 Desc.			
								Road culvert and drainage feature are in acceptable condition.			
<p>Date & Time: Wed, Jan 08, 2020, 08:42:40 EST Position: +017.063158° / -080.676680° (+16.4ft) Altitude: 170ft (+12.7ft) Datum: WGS-84 Azimuth/Bearing: 151° 52'W 268mils True (+20°) Elevation Angle: -01.6° Horizon Angle: -01.5° Zoom: 1.0X LY-29- Road culvert & drainage feature are in good condition.</p>

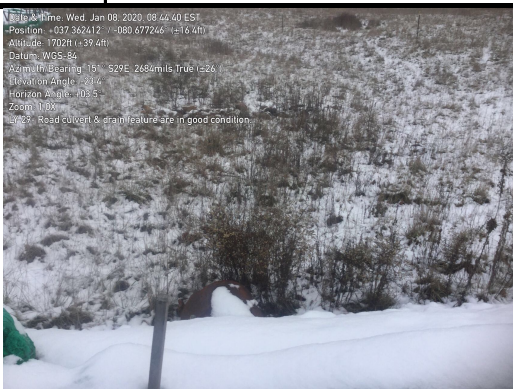
GPS Location				See photo GPS				GPS Location			
Field Station#				12005+00				Field Station#			
Pic 6 Desc.				Road culvert and drainage feature are in acceptable condition.

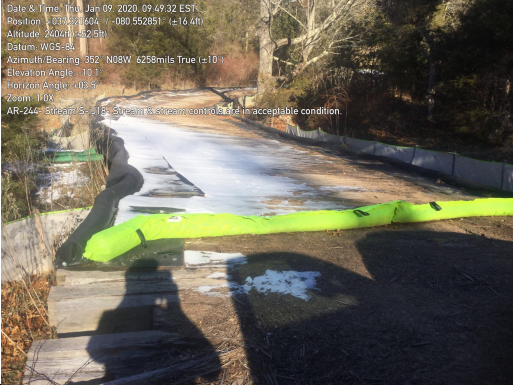
<p>Date & Time: Thu Jan 09, 2020, 09:49:32 EST Position: +037 318001 / +080 552851 (+16.4ft) Altitude: 2200ft (+20.8ft) Datum: WGS-84 Azimuth/Bearing: 352° N08W 6258mils True (+10°) Elevation Angle: -10.1° Horizon Angle: +00.5° Zoom: 1.0X AR-244 Stream S-IJ18 Stream & stream controls are in acceptable condition.</p>			
GPS Location	See photo GPS		GPS Location	See photo GPS	
Field Station#	11024+00		Field Station#	11024+00	
Pic 1 Desc.	AR-244 rain gauge reading- .20"		Pic 2 Desc.	Stream S-IJ18 Environmental controls are in acceptable condition.

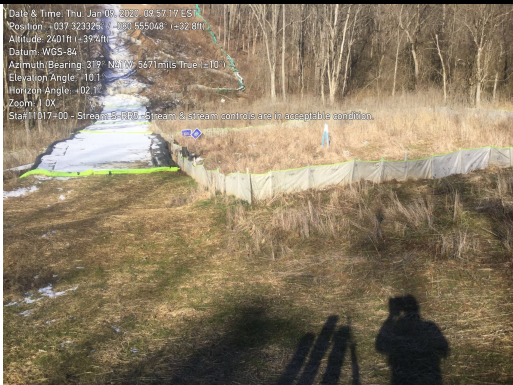
<p>Date & Time: Thu Jan 09, 2020, 09:57:17 EST Position: +037 323326 / +080 555048 (+32.8ft) Altitude: 2601ft (+39.9ft) Datum: WGS-84 Azimuth/Bearing: 319° N45W 3671mils True (+10°) Elevation Angle: +02.1° Horizon Angle: +02.1° Zoom: 1.0X Start 11017+00 - Stream S-RR5 Stream & stream controls are in acceptable condition.</p>

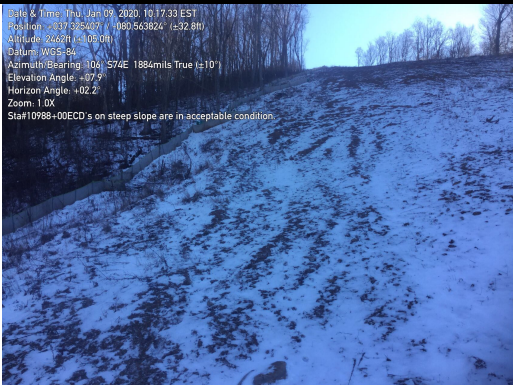
<p>Date & Time: Thu Jan 09, 2020, 10:17:33 EST Position: +037 325027 / +080 563826 (+32.8ft) Altitude: 2262ft (+30.0ft) Datum: WGS-84 Azimuth/Bearing: 106° S74E 1884mils True (+10°) Elevation Angle: +07.9° Horizon Angle: +02.2° Zoom: 1.0X Start 10988+00 ECD's on steep slope are in acceptable condition.</p>

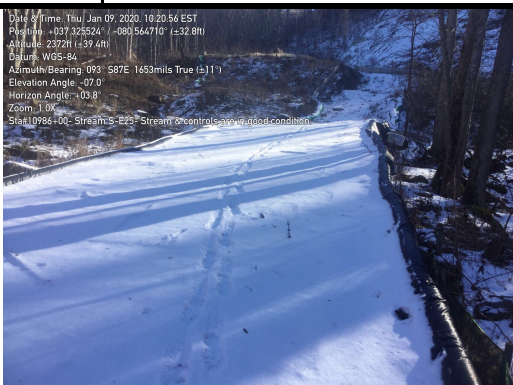
<p>Date & Time: Thu Jan 09, 2020, 10:20:56 EST Position: +037 325524 / +080 564710 (+32.8ft) Altitude: 2372ft (+39.4ft) Datum: WGS-84 Azimuth/Bearing: 093° S87E 1653mils True (+11°) Elevation Angle: -07.0° Horizon Angle: +03.8° Zoom: 1.0X Start 10986+00 Stream S-E25 Stream & stream controls are in good condition.</p>

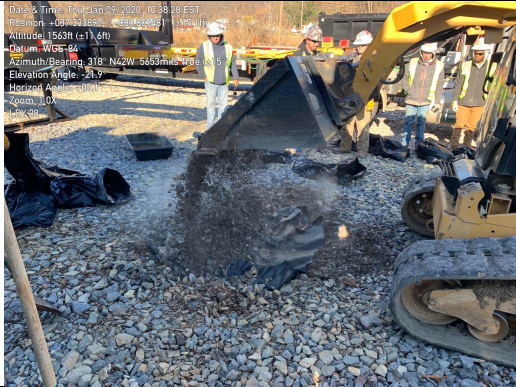
<p>Date & Time: Thu Jan 09 2020 10:38:28 EST Position: +037.33935 / +080.64753 (-148.0ft) Altitude: 1563ft (+11.6ft) Datum: WGS-84 Azimuth/Bearing: 318° N42W 568/mils True Elevation Angle: -21.9° Horizon Angle: +04.6° Zoom: 1.0x 10710+00</p>			
GPS Location	See photo for GPS location.		GPS Location	See photo for GPS location.	
Field Station#	12005+00		Field Station#	12005+00	
Pic 1 Desc.	Environmental crew cleaning hydraulic fluid release at LDY 28.		Pic 2 Desc.	Environmental crew replacing geotextile fabric and rock removed during clean up.
