# Visual Site Inspection Report

<b>Project Name</b>	H-600 Pipeline Spread G	<b>AFE</b>	124300137	<b>Spread</b>	H-600 Pipeline Spread G
<b>Contractor</b>	Precision			<b>Report #</b>	6859
<b>Inspector</b>	Brian Shields			<b>Date/Time</b>	12/23/2019 7:51 AM
<b>Permit #</b>	TBD	<b>Inspection Type</b>	VA SWPP	<b>Station Begin</b>	11670+00
<b>State</b>	VA	<b>Inspection Area</b>	Partial	<b>Station End</b>	11599+91
<b>County</b>	Montgomery	<b>Ground</b>	Damp	<b>Temperature (°F)</b>	50.00
<b>Municipality</b>	N/A	<b>Weather</b>	Sunny	<b>Rain Gauge (in)</b>	0.00
				<b>Rain Accumulation Time (days)</b>	1.00

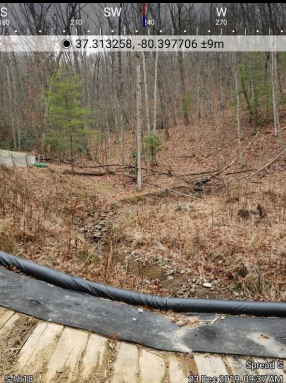
<b>GPS Location</b>	see photo		<b>GPS Location</b>	see photo	
<b>Field Station#</b>	11656+00		<b>Field Station#</b>	11630+00	
<b>Pic 3 Desc.</b>	installed super silt fence		<b>Pic 4 Desc.</b>	waterbar and end treatment

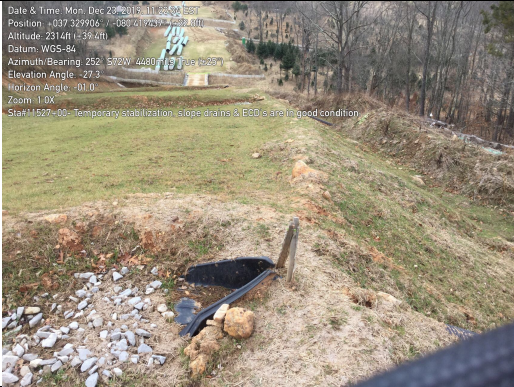
<b>A/E</b>	124300137	<b>Date/Time</b>	12/23/2019 2:22 PM	<b>Report #</b>	
<b>Pictures</b>					
<p>Date &amp; Time: Mon, Dec 23, 2019, 11:55:49 EST  Position: -037.329705 / -080.415275 (-32.9705, -80.415275)  Altitude: 214ft (-65.0m)  Datum: WGS-84  Azimuth/Bearing: 252.520W, 4280mils True (-25.25)  Elevation Angle: -27.3  Horizon Angle: -01.0  Zoom: 1.0x  Sta#11527+00- Temporary stabilization, slope drains &amp; ECD's are in good condition</p>

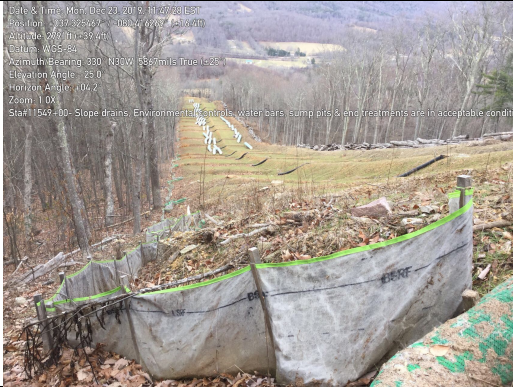
<p>Date &amp; Time: Mon, Dec 23, 2019, 11:57:00 EST  Position: -037.329705 / -080.415275 (-32.9705, -80.415275)  Altitude: 214ft (-65.0m)  Datum: WGS-84  Azimuth/Bearing: 330.180W, 4820mils True (-30.18)  Elevation Angle: -25.0  Horizon Angle: -00.2  Zoom: 1.0x  Sta#11549+00- Slope drains, Environmental controls, water bars, sump pits &amp; end treatments are in acceptable condition</p>

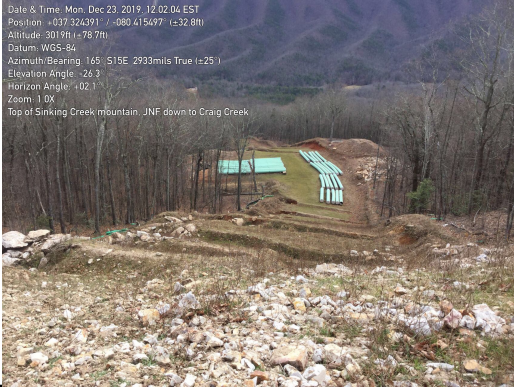
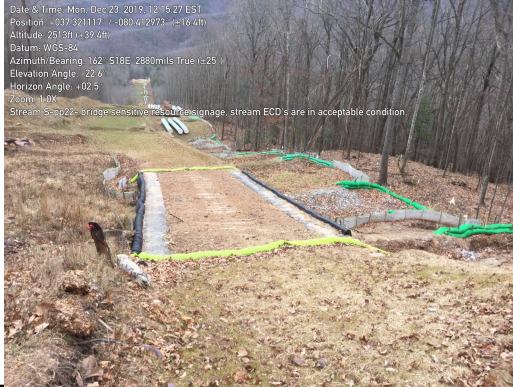
<b>GPS Location</b>	See photo GPS		<b>GPS Location</b>	See photo GPS	
<b>Field Station#</b>	11558+00		<b>Field Station#</b>	11668+00	
<b>Pic 3 Desc.</b>	Top of Sinking Creek mountain, JNF, looking towards Craig Creek.		<b>Pic 4 Desc.</b>	Stream S-PP22- Stream bridge, ECD's, sensitive resource signage, buffers are in acceptable condition.	
<p>Date &amp; Time: Mon, Dec 23, 2019, 12:29:09 EST  Position: -037.317865 / -080.409376 (-32.9841, -80.409376)  Altitude: 2064ft (-629.0m)  Datum: WGS-84  Azimuth/Bearing: 160.520E, 2844mils True (-25.15)  Elevation Angle: -18.0  Horizon Angle: -04.7  Zoom: 1.0x  Stream S-PP21 - Sta#11585 bridge sensitive resource signage, stream ECD's are in acceptable condition</p>

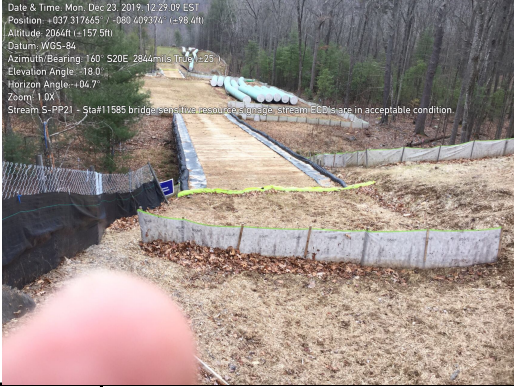
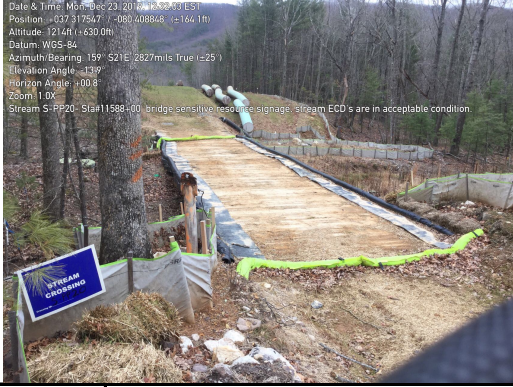
<b>GPS Location</b>	See photo GPS		<b>GPS Location</b>	See photo GPS	
<b>Field Station#</b>	11585+00		<b>Field Station#</b>	11588+00	
<b>Pic 5 Desc.</b>	Stream S-PP21- Bridge, sensitive resource signage, buffers, stream ECD's are in acceptable condition.		<b>Pic 6 Desc.</b>	Stream S-PP20- Equipment bridge, buffers, ECD's, sensitive resource signage are in acceptable condition.

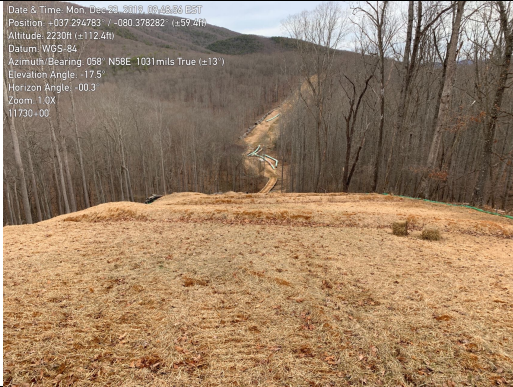
<p>Date &amp; Time: Mon, Dec 23, 2019, 11:25:00 EST Position: +037.294933° / -080.378282° (±139.4ft) Altitude: 2230ft (±12.4ft) Datum: WGS-84 Azimuth/Bearing: 058° N58E 1031mils True (±13°) Elevation Angle: -17.5° Horizon Angle: -00.3° Zoom: 1.0X 11730+00</p>			
<b>GPS Location</b>	See photo for GPS location.		<b>GPS Location</b>	See photo for GPS location.	
<b>Field Station#</b>	11687+40		<b>Field Station#</b>	11730+00	
<b>Pic 1 Desc.</b>	Sensitive resource buffer in place at stream S-MN21		<b>Pic 2 Desc.</b>	Waterbar in place and ROW is stabilized with seed and mulch.

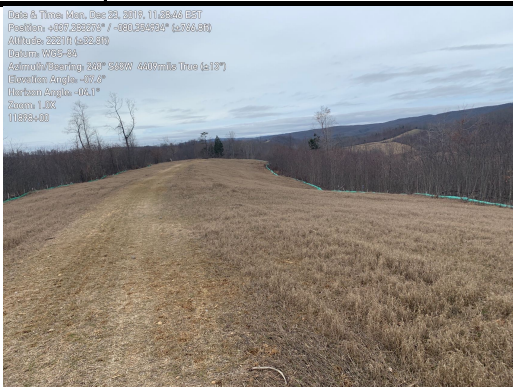
<b>GPS Location</b>	See photo for GPS location.		<b>GPS Location</b>	See photo for GPS location.	
<b>Field Station#</b>	11774+00		<b>Field Station#</b>	11898+00	
<b>Pic 5 Desc.</b>	Clean water diversion pipe and plunge pool in place.		<b>Pic 6 Desc.</b>	ROW has been restored to original grade and permanent vegetation growth present.

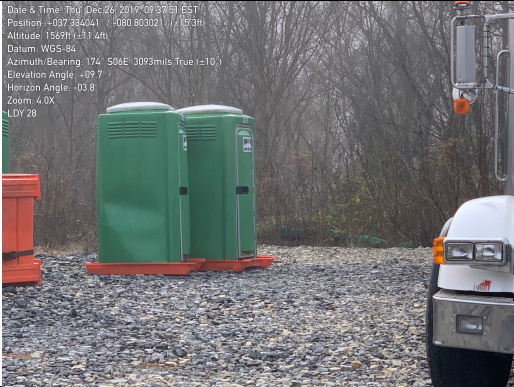
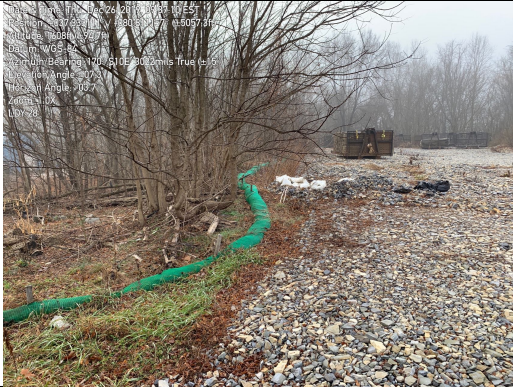
<p>Date &amp; Time: Thu, Dec 26, 2019, 09:41:19 EST Position: +49° 23' 42.1" / -80° 50' 32.1" (±10.3m) Altitude: 1555ft (±11.4m) Datum: WGS-84 Azimuth/Bearing: 174.506E 3093mils True (±10°) Elevation Angle: +09.7° Horizon Angle: -03.8° Zoom: 4.0X LDY 28</p>			
<b>GPS Location</b>	See photo for GPS location.		<b>GPS Location</b>	See photo for GPS location.	
<b>Field Station#</b>	12005+00		<b>Field Station#</b>	12005+00	
<b>Pic 1 Desc.</b>	Port-a-potties in secondary containment.		<b>Pic 2 Desc.</b>	CFS along LOD.

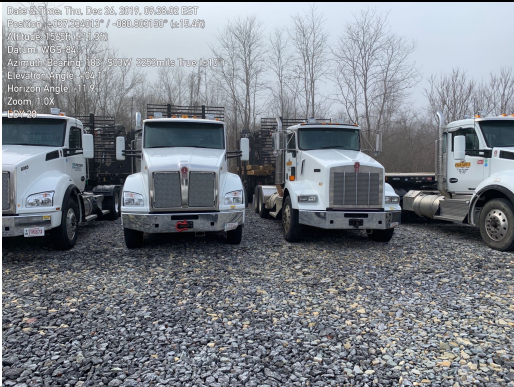
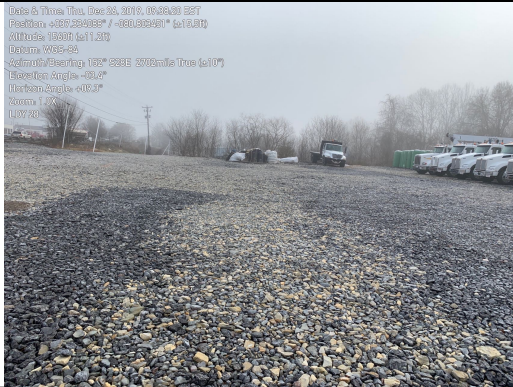
<b>GPS Location</b>	See photo for GPS location.		<b>GPS Location</b>	See photo for GPS location.	
<b>Field Station#</b>	12005+00		<b>Field Station#</b>	12005+00	
<b>Pic 3 Desc.</b>	No leaks under staged vehicles.		<b>Pic 4 Desc.</b>	Yard covered with geotextile fabric and stone.

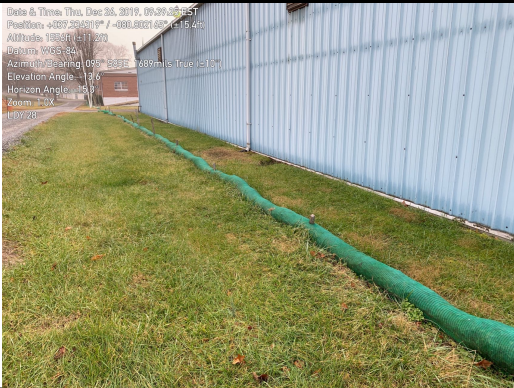
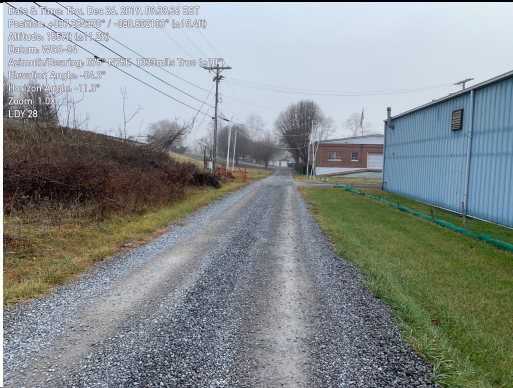
<b>Field Station#</b>	12005+00		<b>Field Station#</b>	12005+00	
<b>Pic 5 Desc.</b>	CFS along LOD.		<b>Pic 6 Desc.</b>	Access road to LDY has is covered in stone.

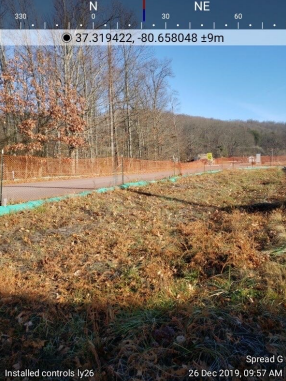
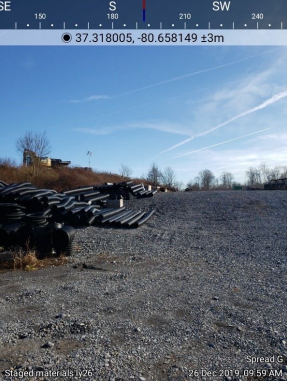
<b>GPS Location</b>	See photo		<b>GPS Location</b>	See photo	
<b>Field Station#</b>	12005+00		<b>Field Station#</b>	12005+00	
<b>Pic 1 Desc.</b>	Installed perimeter controls		<b>Pic 2 Desc.</b>	Staged materials

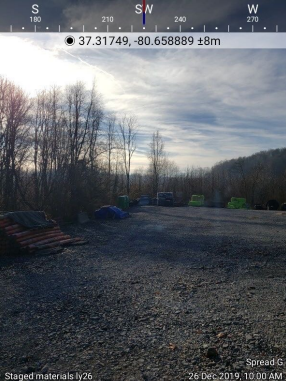
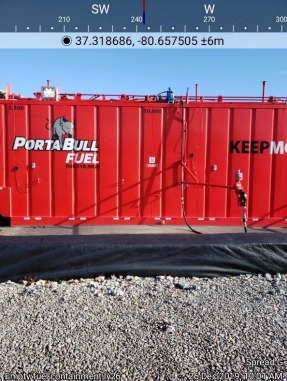
<b>GPS Location</b>	See photo		<b>GPS Location</b>	See photo	
<b>Field Station#</b>	12005+00		<b>Field Station#</b>	12005+00	
<b>Pic 3 Desc.</b>	Staged materials		<b>Pic 4 Desc.</b>	Fuel tank secondary containment

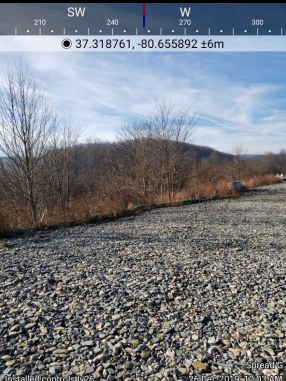
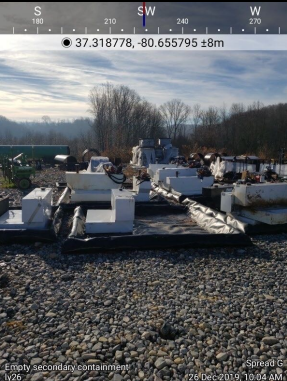
<b>GPS Location</b>	See photo		<b>GPS Location</b>	See photo	
<b>Field Station#</b>	12005+00		<b>Field Station#</b>	12005+00	
<b>Pic 5 Desc.</b>	Installed perimeter controls		<b>Pic 6 Desc.</b>	Fuel tank secondary containment. Tanks are empty

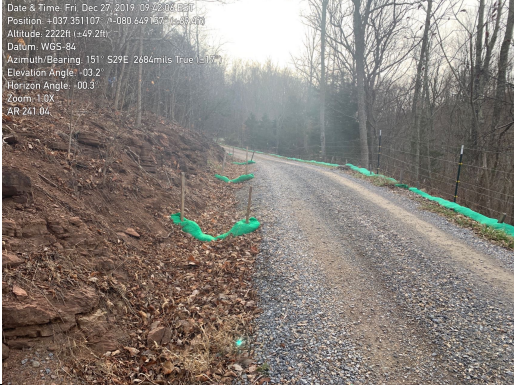
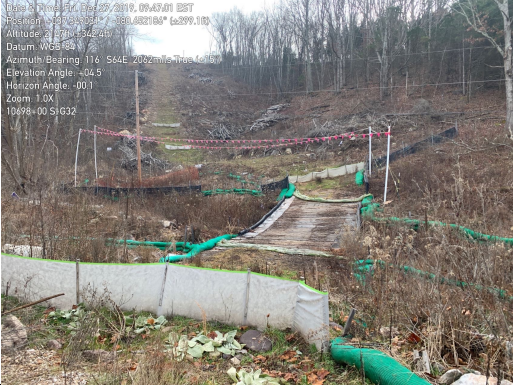
<b>GPS Location</b>	See photo for GPS location.		<b>GPS Location</b>	See photo for GPS location.	
<b>Field Station#</b>	12005+00		<b>Field Station#</b>	10698+00	
<b>Pic 1 Desc.</b>	CFS checks in place along access road 241.04 in bar ditch.		<b>Pic 2 Desc.</b>	Sensitive resource buffer in place at stream S-G32.

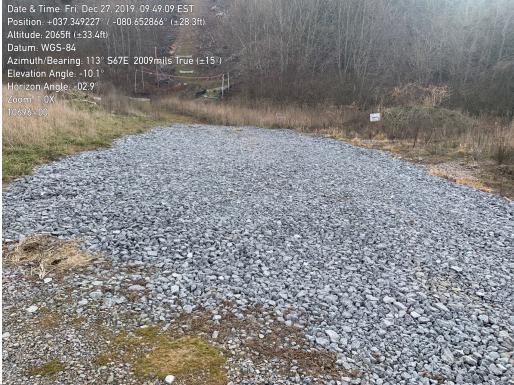
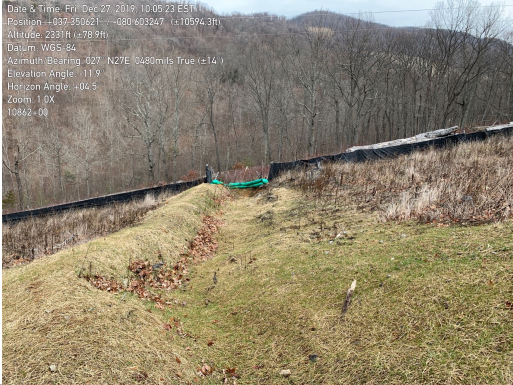
<b>GPS Location</b>	See photo for GPS location.		<b>GPS Location</b>	See photo for GPS location.	
<b>Field Station#</b>	10696+00		<b>Field Station#</b>	10862+00	
<b>Pic 3 Desc.</b>	RCE in place at Buffalo Anklets Road.		<b>Pic 4 Desc.</b>	Waterbar, sump pit, and waterbar end treatment in place.

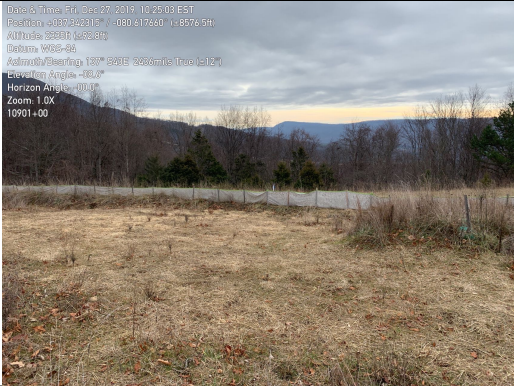
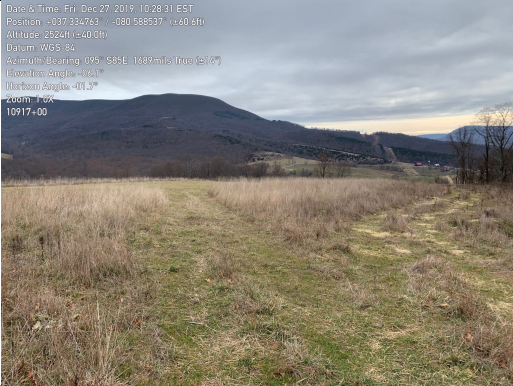
<b>GPS Location</b>	See photo for GPS location.		<b>GPS Location</b>	See photo for GPS location.	
<b>Field Station#</b>	10901+00		<b>Field Station#</b>	10917+00	
<b>Pic 5 Desc.</b>	Priority one silt fence in place along LOD.		<b>Pic 6 Desc.</b>	ROW stabilized with seed, mulch, and natural vegetation.
