Visual Site Inspection Report

Project Name	H-600 Pipeline Spread G	AFE	124300137	Spread	H-600 Pipeline Spread G
Contractor	Precision			Report #	8130
Inspector	Chris Burns			Date/Time	2/10/2020 12:50 PM
Permit #	TBD	Inspection Type	VA SWPP	Station Begin	11788+52
State	VA	Inspection Area	Partial	Station End	11899+99
County	Montgomery	Ground	Wet	Temperature (°F)	48.00
Municipality	N/A	Weather	Light Rain	Rain Gauge (in)	0.00
				Rain Accumulation Time (days)	1.00

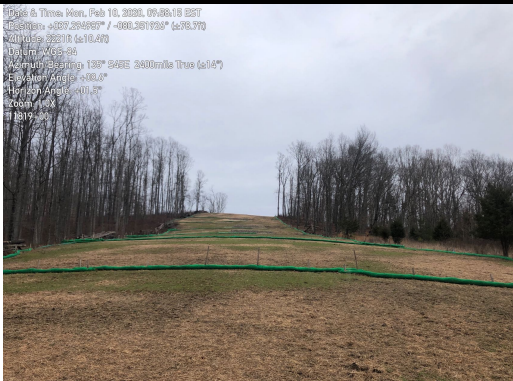
GPS Location	3	GPS Location	4		
Field Station#	11819+00	Field Station#	11863+65		
Pic 3 Desc.	Restored section of RoW conditions and controls.	Pic 4 Desc.	P-KL2.		
<div><div><div>Date & Time Mon, Feb 10, 2020, 10:22:11 EST Position: +087.297971° / -400.34979° (+213.37) Altitude: 21421 (+22.57) Datum: WGS-84 Azimuth/Bearing: 334° 24'55" 3000m True (+14°) Elevation Angle: +62.2° Horizon Angle: +62.2° Zoom: 1.0X 11878+00</div>

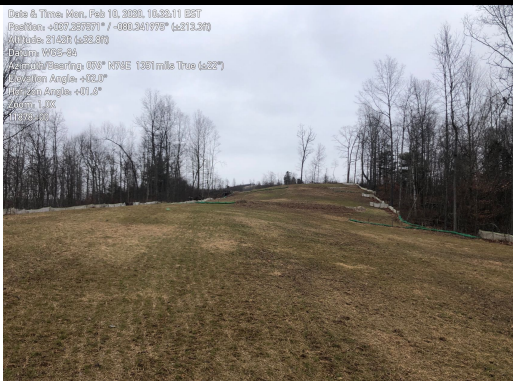
</div></div>			
GPS Location	5	GPS Location	6		
Field Station#	11878+00	Field Station#	11890+00		
Pic 5 Desc.	Restored section of RoW and controls.	Pic 6 Desc.	Restored section of RoW and controls.

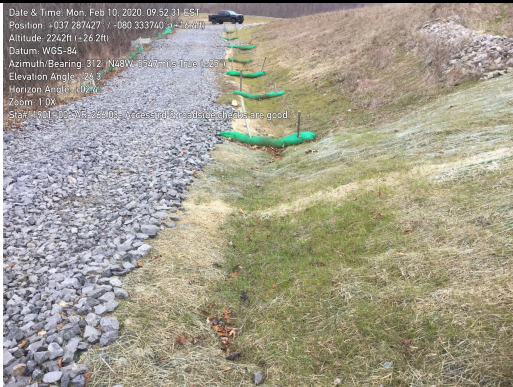
GPS Location		See photo GPS				GPS Location		See photo GPS			
Field Station#		11901+00				Field Station#		11942+00			
Pic 1 Desc.		AR-266.03- Access road and checks in bar ditch are in acceptable condition.				Pic 2 Desc.		Karst and Karst ECD's are in acceptable condition.

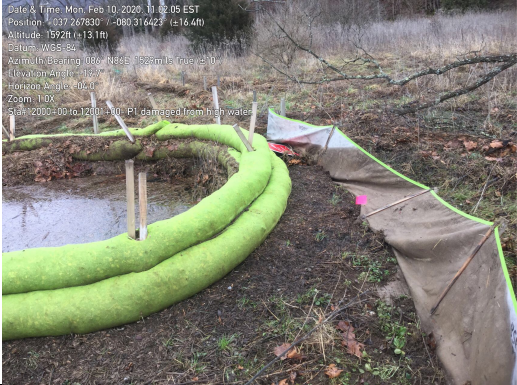
<p>Insert image here</p>			
GPS Location	See photo GPS	GPS Location			
Field Station#	12000+50	Field Station#			
Pic 7 Desc.	Wetland ECD's damaged during rain event.	Pic 8 Desc.			
<p>Insert image here</p>		<p>Insert image here</p>			
GPS Location		GPS Location			
Field Station#		Field Station#			
Pic 9 Desc.		Pic 10 Desc.			
<p>Insert image here</p>		<p>Insert image here</p>			
GPS Location		GPS Location			
Field Station#		Field Station#			
Pic 11 Desc.		Pic 12 Desc.

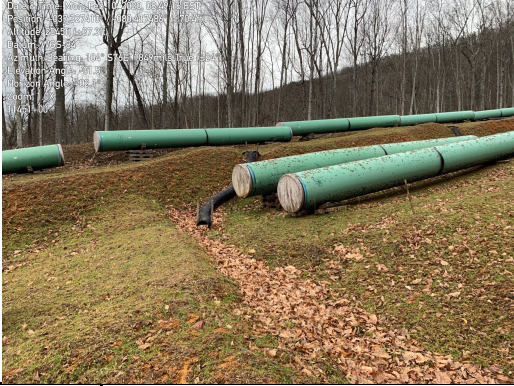
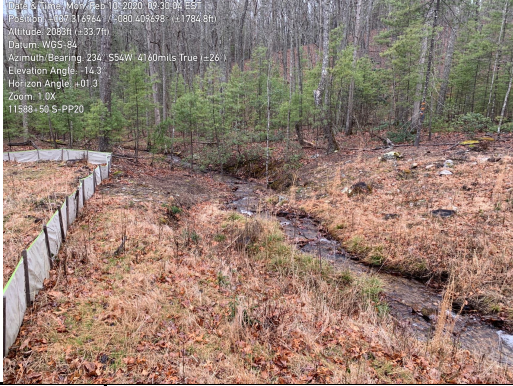
GPS Location	See photo for GPS location.		GPS Location	See photo for GPS location.	
Field Station#	11451+00		Field Station#	11588+50	
Pic 1 Desc.	Slope drain in place over two-tone and waterbar in place.		Pic 2 Desc.	Stream S-PP20 with priority one silt fence in place at stream bank buffer.

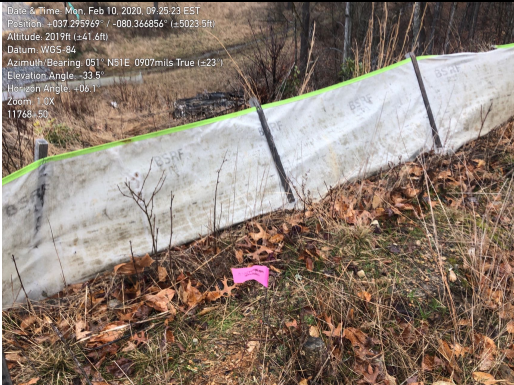
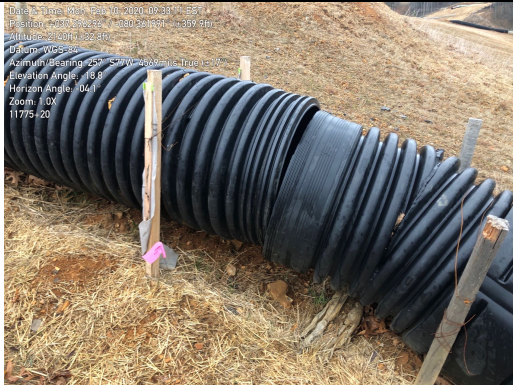
GPS Location	See photo for GPS location.		GPS Location	See photo for GPS location.	
Field Station#	11768+50		Field Station#	11775+00	
Pic 3 Desc.	Broken priority one silt fence stakes.		Pic 4 Desc.	Clean water diversion pipe disconnected.

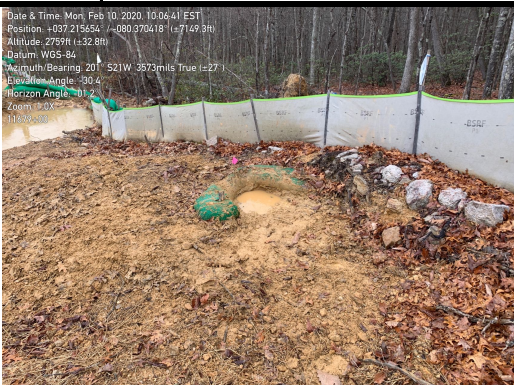
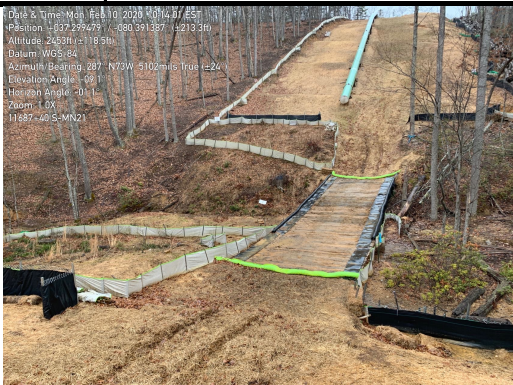
GPS Location	See photo for GPS location.		GPS Location	See photo for GPS location.	
Field Station#	11679+00		Field Station#	11687+40	
Pic 5 Desc.	Compost filter sock check cleaned out after large rain event.		Pic 6 Desc.	Sensitive resource buffer in place at stream S-MN21.

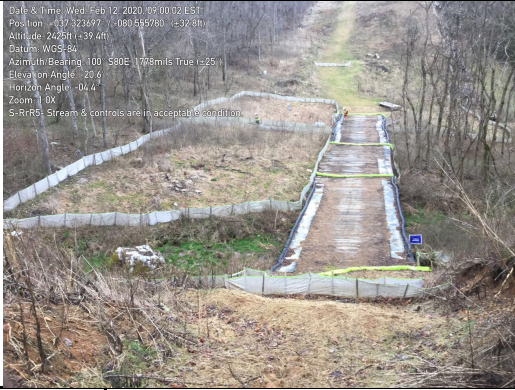
<p>Date & Time: Wed Feb 12 2020 08:00:02 EST Position: +037.3224971 / -080.6459780 / +32.60ft Altitude: 2425ft (+39.6m) Datum: WGS-84 Azimuth/Bearing: 100.590E 1778mils True (+25) Elevation Angle: -29.6 Horizon Angle: -04.4 Zoom: 1.0X S-RR5- Stream & controls are in acceptable condition.</p>

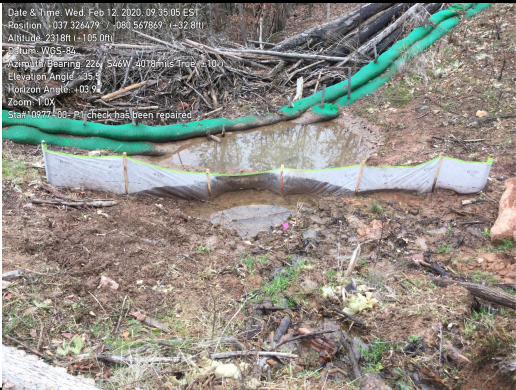
Field Station#	10977+00	Field Station#	10965+00		
Pic 5 Desc.	P1 check has been replaced.	Pic 6 Desc.	Karst and Karst ECD's are in acceptable condition.

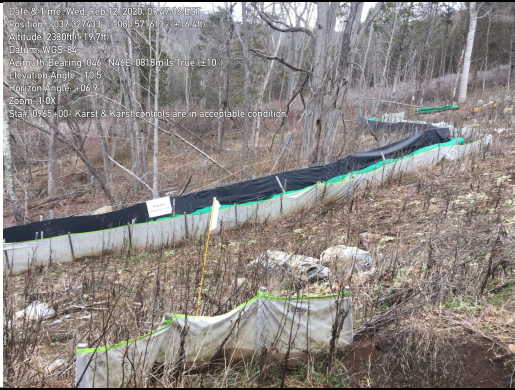
<p>Date & Time: Wed Feb 12 2020 09:37:00 EST Position: +037.3238011 / -080.5716137 / +32.60ft Altitude: 2330ft (+107.0m) Datum: WGS-84 Azimuth/Bearing: 066.544E 0818mils True (+25) Elevation Angle: -10.8 Horizon Angle: -06.1 Zoom: 1.0X Sta 10965+00- Karst & Karst ECD's are in acceptable condition.</p>

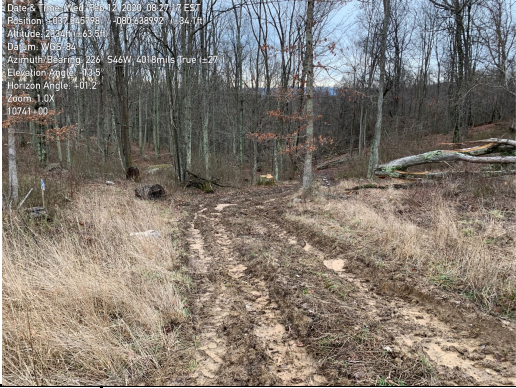
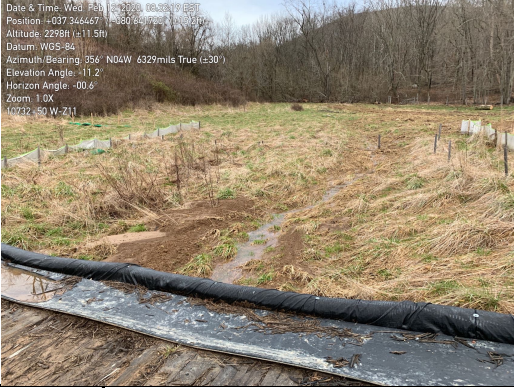
GPS Location	See photo for GPS location.		GPS Location	See photo for GPS location.	
Field Station#	10741+00		Field Station#	10732+50	
Pic 1 Desc.	Rutting from land owner logging.		Pic 2 Desc.	Sediment in wetland W-Z11. ECDs in place.

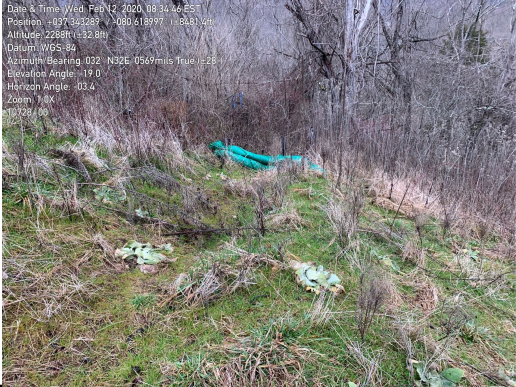
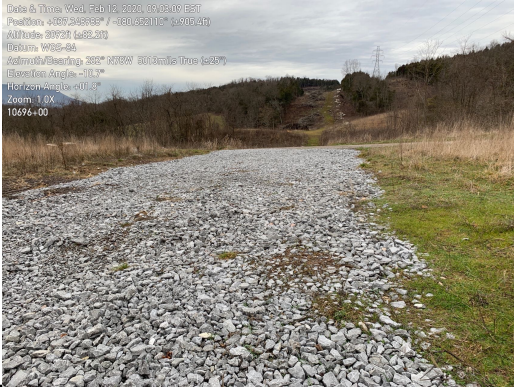
GPS Location	See photo for GPS location.		GPS Location	See photo for GPS location.	
Field Station#	10728+00		Field Station#	10696+00	
Pic 3 Desc.	Waterbar across travel lane with triple stack CFS in place.		Pic 4 Desc.	RCE in place at Buffalo Anklets Road.

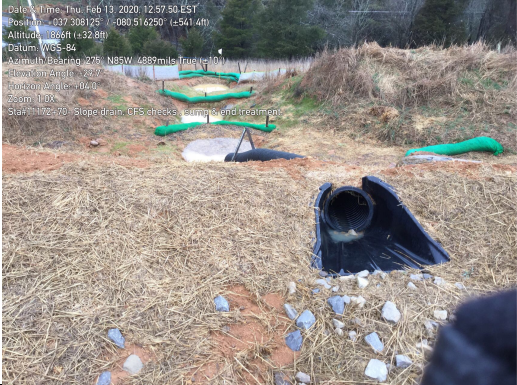
<p>Insert image here</p>	
GPS Location	See photo GPS	GPS Location			
Field Station#	11172+70	Field Station#			
Pic 7 Desc.	Slope drain, CFS checks, sump & end treatment are in acceptable condition.	Pic 8 Desc.			
<p>Insert image here</p>		<p>Insert image here</p>			
GPS Location		GPS Location			
Field Station#		Field Station#			
Pic 9 Desc.		Pic 10 Desc.			
<p>Insert image here</p>		<p>Insert image here</p>			
GPS Location		GPS Location			
Field Station#		Field Station#			
Pic 11 Desc.		Pic 12 Desc.

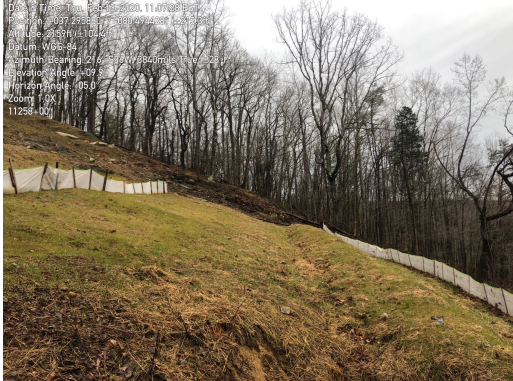
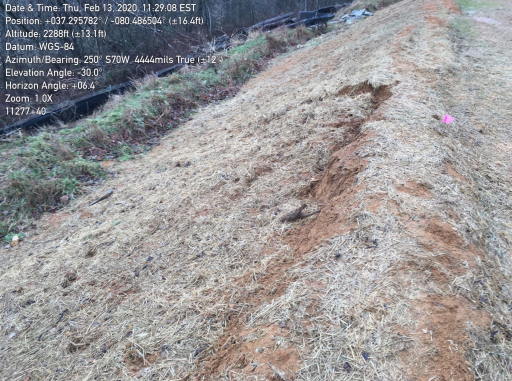
GPS Location	1		GPS Location	2	
Field Station#	11258+00		Field Station#	11277+40	
Pic 1 Desc.	Stabilization and controls.		Pic 2 Desc.	Sluffing/movement on side slope.

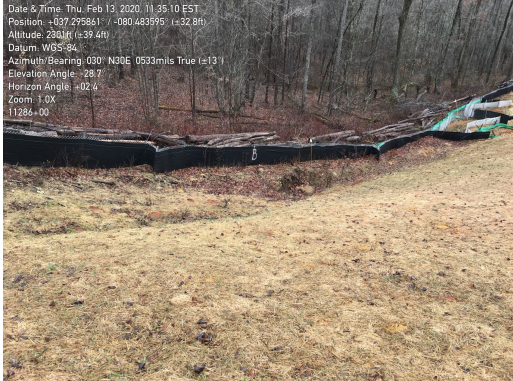
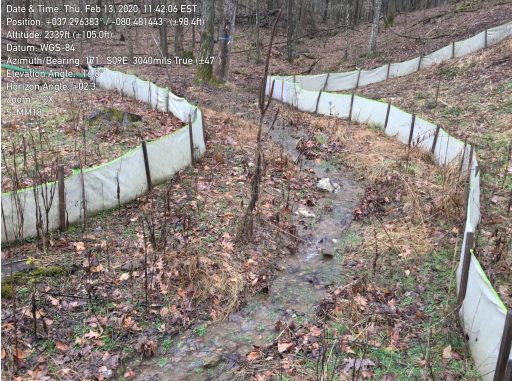
GPS Location	3		GPS Location	4	
Field Station#	11286+00		Field Station#	11292+80	
Pic 3 Desc.	Stabilized side slope and perimeter controls.		Pic 4 Desc.	S-MM18.

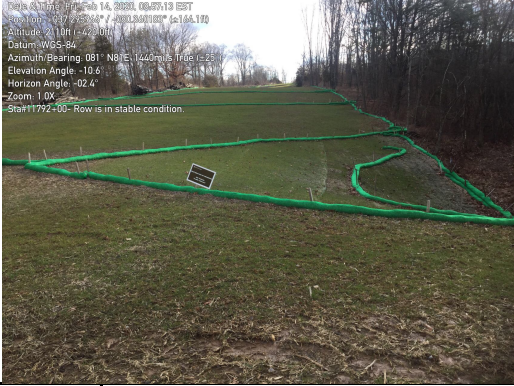
GPS Location	See photo GPS		GPS Location	See photo GPS	
Field Station#	11792+00		Field Station#	11830+00	
Pic 1 Desc.	Row in this area is in good condition.		Pic 2 Desc.	Level spreaders and controls are in acceptable condition.

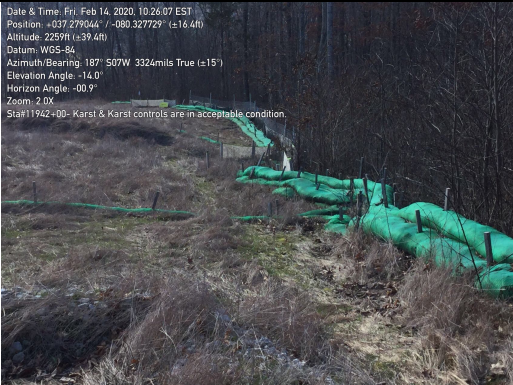
GPS Location	See photo GPS		GPS Location	See photo GPS	
Field Station#	11900+00		Field Station#	11942+00	
Pic 3 Desc.	AR-266.03- Access road and controls.		Pic 4 Desc.	Karst and Karst ECD's are in acceptable condition.	
<p>Date & Time: Fri, Feb 14, 2020, 10:33:05 EST Position: +037 227029° / -080 326176° (±32.8ft) Altitude: 2665ft (±39.4ft) Datum: WGS-84 Azimuth/Bearing: 131° S49E 2329mils True (±10°) Elevation Angle: -19.6° Horizon Angle: -10.4° Zoom: 2.0x Star#11950+00- Controls protecting Karst</p>

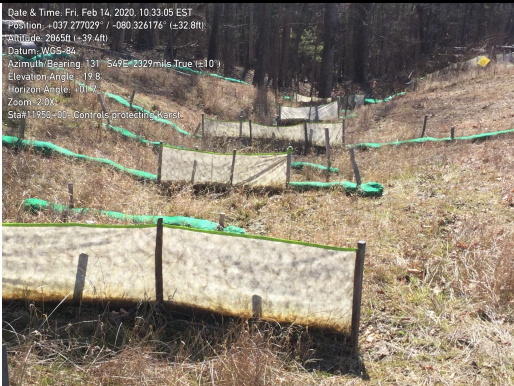
GPS Location	See photo GPS		GPS Location	See photo GPS	
Field Station#	11950+00		Field Station#	11976+94	
Pic 5 Desc.	Controls protecting Karst are in acceptable condition		Pic 6 Desc.	Karst and Karst ECD's are in acceptable condition.

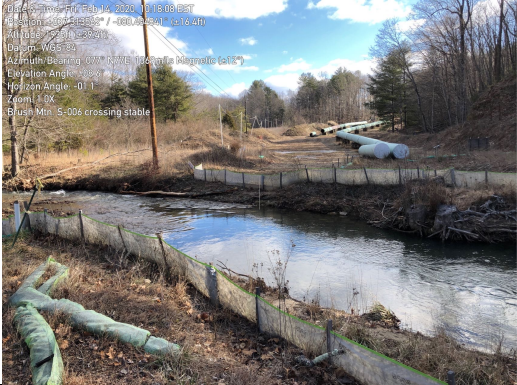
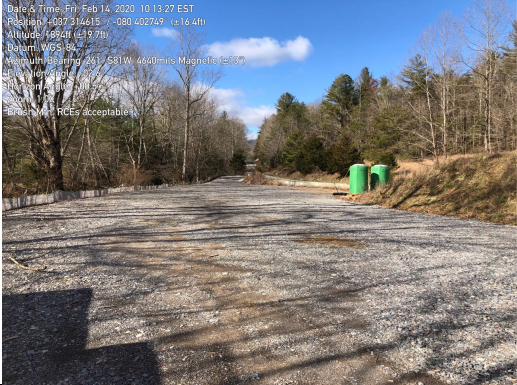
GPS Location	On photo	GPS Location	On photo		
Field Station#	11607+81	Field Station#	11613+69		
Pic 7 Desc.	Resource S-006 is stable and shows no impact	Pic 8 Desc.	RCEs are free from trash and spills		
Insert image here		Insert image here			
GPS Location		GPS Location			
Field Station#		Field Station#			
Pic 9 Desc.		Pic 10 Desc.			
Insert image here		Insert image here			
GPS Location		GPS Location			
Field Station#		Field Station#			
Pic 11 Desc.		Pic 12 Desc.
