Visual Site Inspection Report

Project Name	H-600 Pipeline Spread G	AFE	124300137	Spread	H-600 Pipeline Spread G
Contractor	Precision			Report #	8344
Inspector	Len Kruizenga			Date/Time	2/17/2020 8:21 AM
Permit #	TBD	Inspection Type	VA SWPP	Station Begin	12005+00
State	VA	Inspection Area	Full	Station End	12005+00
County	Giles	Ground	Wet	Temperature (°F)	32.00
Municipality	N/A	Weather	Sunny	Rain Gauge (in)	0.00
				Rain Accumulation Time (days)	2.00

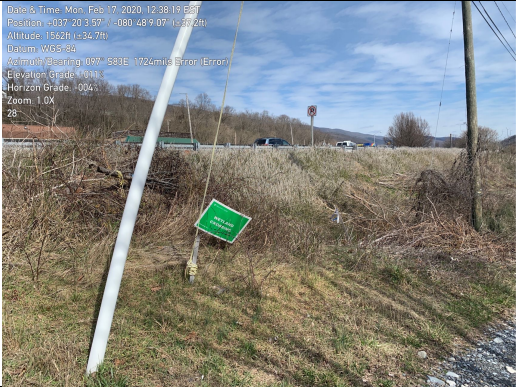
GPS Location	See picture above for GPS coordinates		GPS Location	See picture above for GPS coordinates	
Field Station#	12005+00		Field Station#	12005+00	
Pic 1 Desc.	ECD's and row conditions		Pic 2 Desc.	ECD's and row conditions

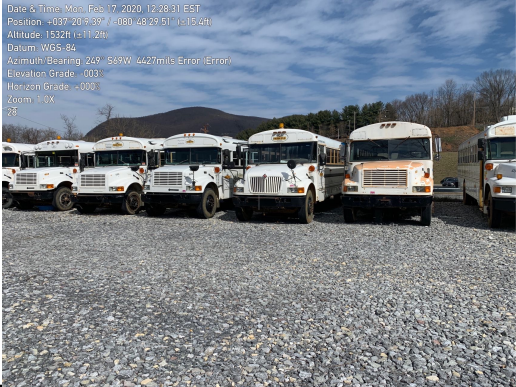
GPS Location	See picture above for GPS coordinates		GPS Location	See picture above for GPS coordinates	
Field Station#	12005+00		Field Station#	12005+00	
Pic 3 Desc.	Secondary containment @ LDY 28		Pic 4 Desc.	ECD's and row conditions

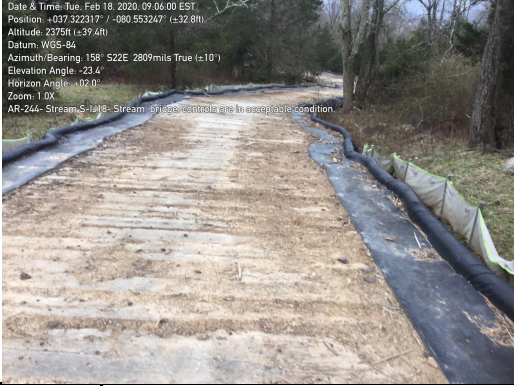
GPS Location	See photo GPS		GPS Location	See photo GPS	
Field Station#	11023+80		Field Station#	11017+00	
Pic 1 Desc.	Stream S-IJ18- Equipment bridge		Pic 2 Desc.	Stream S-RR5- Bridge & controls.

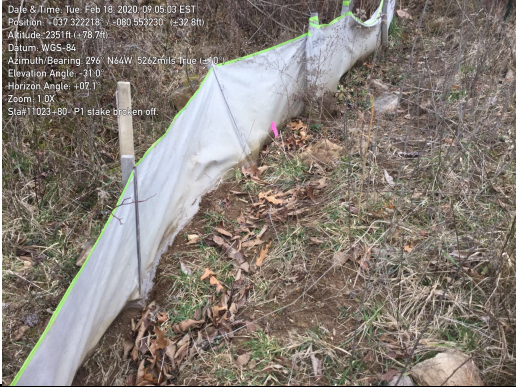
<p>Insert image here</p>			
GPS Location	See photo GPS	GPS Location			
Field Station#	11023+80	Field Station#			
Pic 7 Desc.	P1 stake at sta#11023+80 was broken, Contractor has already repaired issue.	Pic 8 Desc.			
<p>Insert image here</p>		<p>Insert image here</p>			
GPS Location		GPS Location			
Field Station#		Field Station#			
Pic 9 Desc.		Pic 10 Desc.			
<p>Insert image here</p>		<p>Insert image here</p>			
GPS Location		GPS Location			
Field Station#		Field Station#			
Pic 11 Desc.		Pic 12 Desc.

7. Identify all remedial measures that have been taken since the previous inspection was conducted.					
Comments (Reference above questions as appropriate.)					
Attended inspection meeting at the work trailer. SWPPP inspection: Sta#11023+89 to 10930+00 Weather today was cloudy with occasional sprinkles, more rain in the forecast. The row has dried since the last inspection of this area and is in stable condition. The perimeter controls, Silt fence, CFS, and SSF are in acceptable condition. Water bars are in acceptable condition. Sump pits are in acceptable condition. Water bar end treatments are in acceptable condition. Karst and Karst ECD's are in acceptable condition. Streams S-IJ18, S-RR5, S-E24, S-E25 - The Equipment bridges, buffers. Sensitive resource signage, stream ECD's are in acceptable condition. AR-244.00 and Doe Creek RCE are in good condition. Sta#11023+80- There were three P1 issues that the contractor has already repaired.

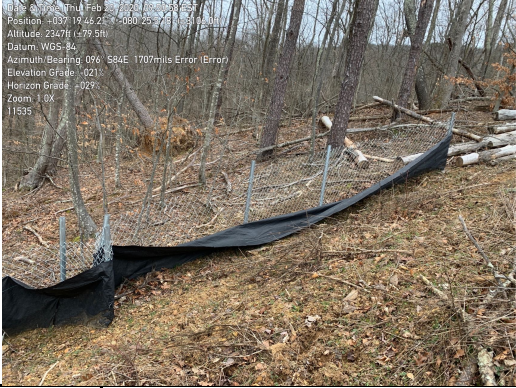
GPS Location	See picture above for GPS coordinates		GPS Location	See picture above for GPS coordinates	
Field Station#	11535+00		Field Station#	11551+00	
Pic 1 Desc.	Damaged SSF		Pic 2 Desc.	ECD's and row conditions

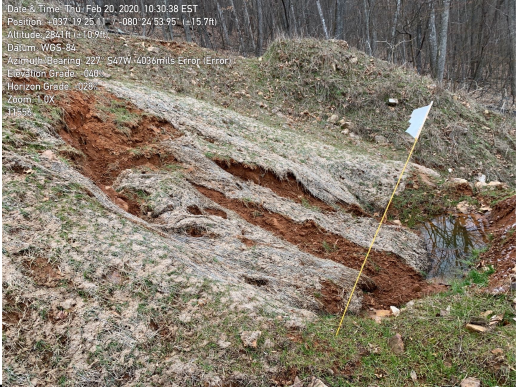
GPS Location	See picture above for GPS coordinates		GPS Location	See picture above for GPS coordinates	
Field Station#	11556+00		Field Station#	11572+00	
Pic 3 Desc.	Damaged curlex		Pic 4 Desc.	ECD's and row conditions

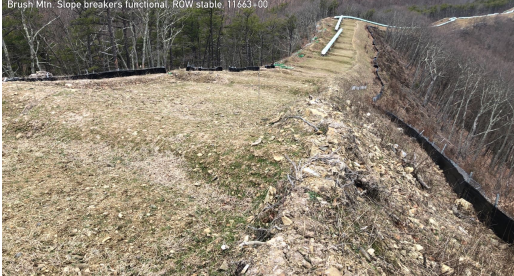
<p>Date & Time: Thu Feb 20, 2020 10:35:14 EST Position: +037.334552 / +080.395911 (+32.8ft) Altitude: 2928ft (+105.0ft) Datum: WGS-84 Azimuth/Bearing: 146° S34E 2560mils Magnetic (+13°) Elevation Angle: +04.5° Horizon Angle: -01.4° Zoom: 1.0X Brush Min. Perimeter controls in place and functional. 11654+50</p>

GPS Location	On photo	GPS Location	On photo		
Field Station#	11663+00	Field Station#	11656+50		
Pic 1 Desc.	ROW stable. Environmental controls in place and effective.	Pic 2 Desc.	End treatments and perimeter controls functional.

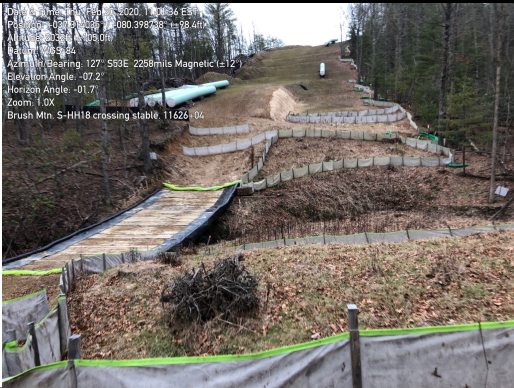
<p>Date & Time: Thu Feb 20, 2020 11:12:32 EST Position: +037.334552 / +080.402322 (+105.0ft) Altitude: 1932ft (+105.0ft) Datum: WGS-84 Azimuth/Bearing: 092° S88E 1636mils Magnetic (+14°) Elevation Angle: -10.6° Horizon Angle: +00.9° Zoom: 1.0X Brush Min. S-RR14 crossing stable</p>

GPS Location	On photo	GPS Location	On photo		
Field Station#	11626+04	Field Station#	11614+20		
Pic 5 Desc.	S-HH18 crossing stable.	Pic 6 Desc.	S-RR14 crossing stable.

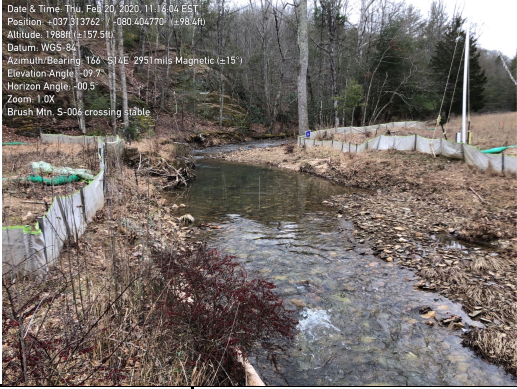
Insert image here			
GPS Location	On photo	GPS Location			
Field Station#	11608+17	Field Station#			
Pic 7 Desc.	S-006 crossing stable.	Pic 8 Desc.			
Insert image here		Insert image here			
GPS Location		GPS Location			
Field Station#		Field Station#			
Pic 9 Desc.		Pic 10 Desc.			
Insert image here		Insert image here			
GPS Location		GPS Location			
Field Station#		Field Station#			
Pic 11 Desc.		Pic 12 Desc.

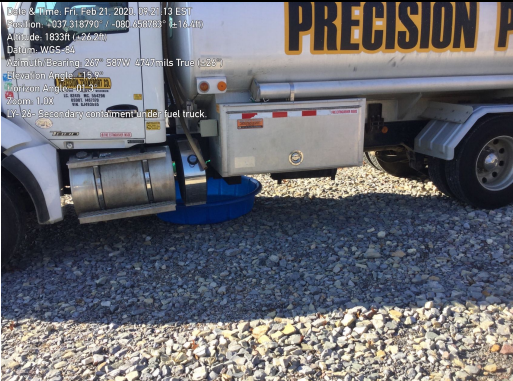
<p>Date & Time: Fri Feb 21, 2020 09:05:50 EST Position: -80.1319213 / -30.0349723 (-25.3 mi) Altitude: 19920 ft (7289 ft) Datum: WGS-84 Azimuth Bearing: 306° 00' 00" W 540 mls True (±25°) Elevation Angle: -12.6° Horizon Angle: -03.6° Zoom: 1.0X LY26- Secondary containment under fuel truck</p>
