Visual Site Inspection Report

Project Name	H-600 Pipeline Spread G	AFE	124300137	Spread	H-600 Pipeline Spread G
Contractor	Precision			Report #	9426
Inspector	Garrett Barclay			Date/Time	3/23/2020 3:22 PM
Permit #	TBD	Inspection Type	VA SWPP	Station Begin	10850+00
State	VA	Inspection Area	Partial	Station End	10929+00
County	Giles	Ground	Wet	Temperature (°F)	47.00
Municipality	N/A	Weather	Cloudy	Rain Gauge (in)	0.70
				Rain Accumulation Time (days)	1.00

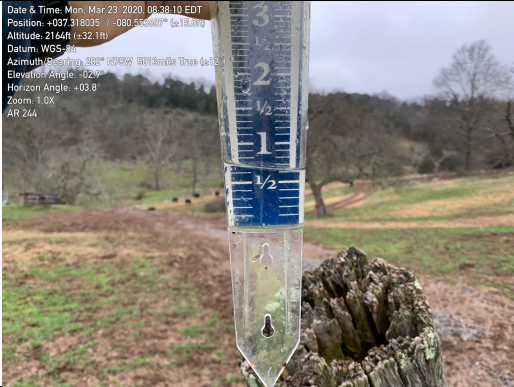
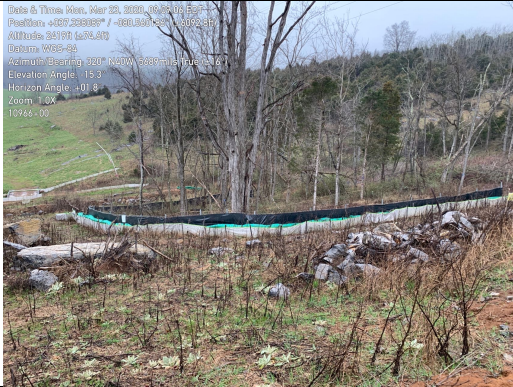
GPS Location	See photo for GPS location.		GPS Location	See photo for GPS location.	
Field Station#	11025+00		Field Station#	10966+00	
Pic 1 Desc.	Rain gauge at Access Road 244 reads 0.7 inches.		Pic 2 Desc.	Triple barrier ECDs in place at open throat karst feature.

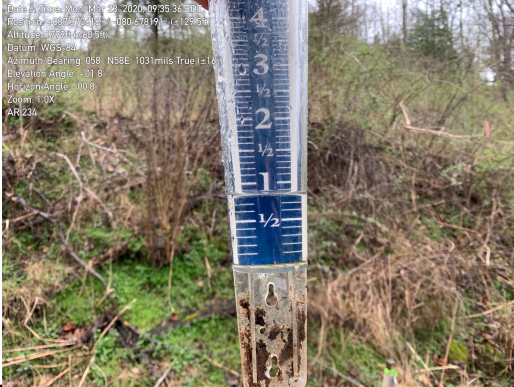
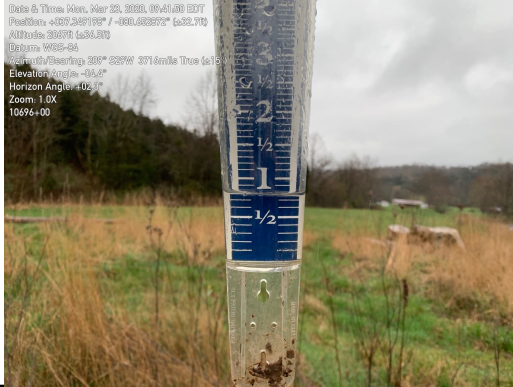
GPS Location	See photo for GPS location.		GPS Location	See photo for GPS location.	
Field Station#	12005+00		Field Station#	10696+00	
Pic 3 Desc.	Rain gauge at Access Road 234 reads 0.9 inches.		Pic 4 Desc.	Rain gauge at Buffalo Anklets Road reads 0.8 inches.

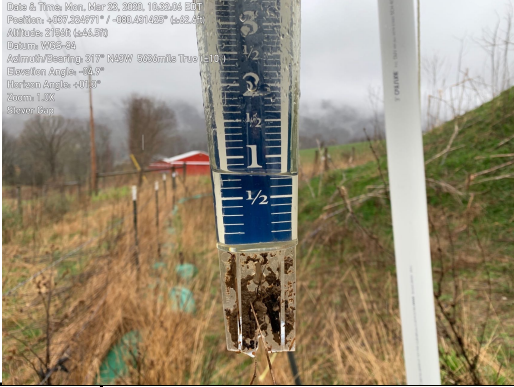
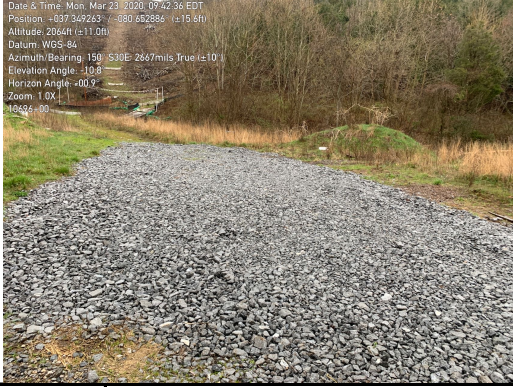
GPS Location	See photo for GPS location.		GPS Location	See photo for GPS location.	
Field Station#	11489+00		Field Station#	10696+00	
Pic 5 Desc.	Rain gauge at Stevers Gap Road reads 0.8 inches.		Pic 6 Desc.	RCE in place at Buffalo Anklets Road.

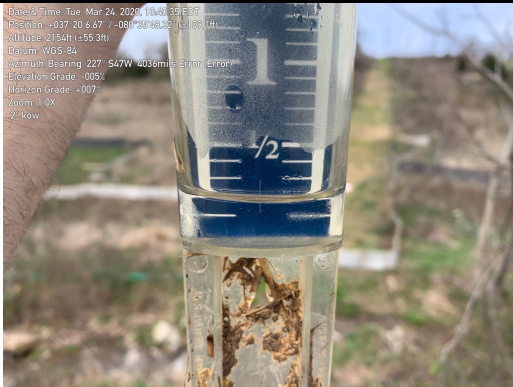
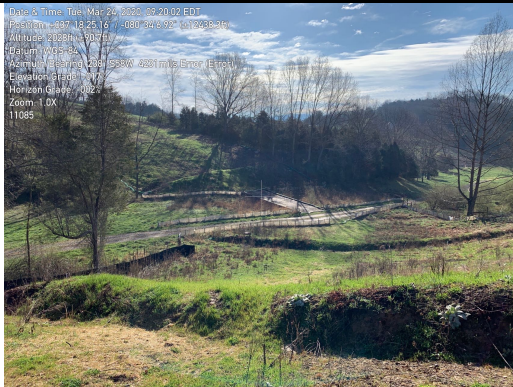
GPS Location				See picture above for GPS coordinates				GPS Location				See picture above for GPS coordinates			
Field Station#				+1				Field Station#				11085+00			
Pic 1 Desc.				.2" of rain recorded @ Kow Camp				Pic 2 Desc.				ECD's and row conditions

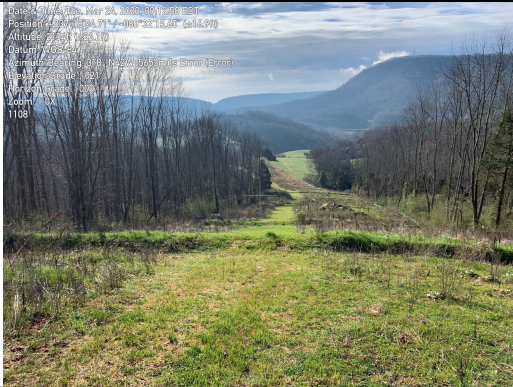
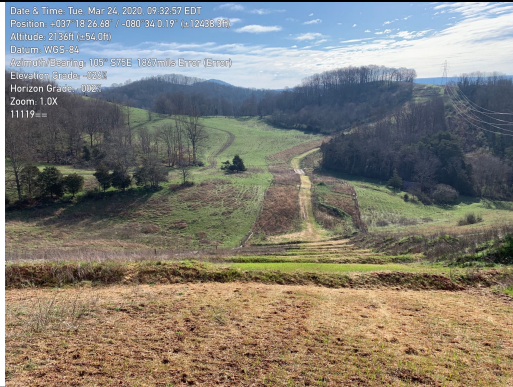
GPS Location				See picture above for GPS coordinates				GPS Location				See picture above for GPS coordinates			
Field Station#				11086+00				Field Station#				11119+00			
Pic 3 Desc.				ECD's and row conditions				Pic 4 Desc.				ECD's and row conditions

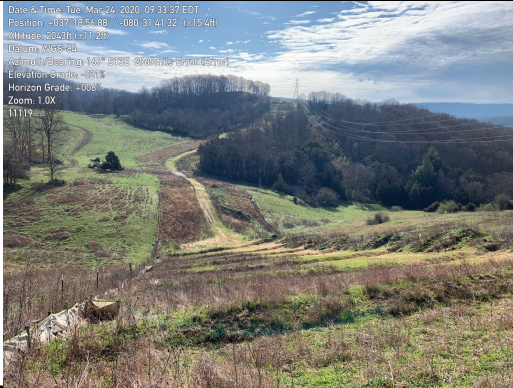
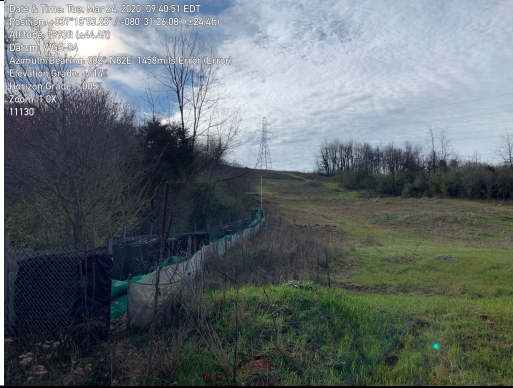
GPS Location				See picture above for GPS coordinates				GPS Location				See picture above for GPS coordinates			
Field Station#				11119+00				Field Station#				11130+00			
Pic 5 Desc.				ECD's and row conditions				Pic 6 Desc.				ECD's and row conditions

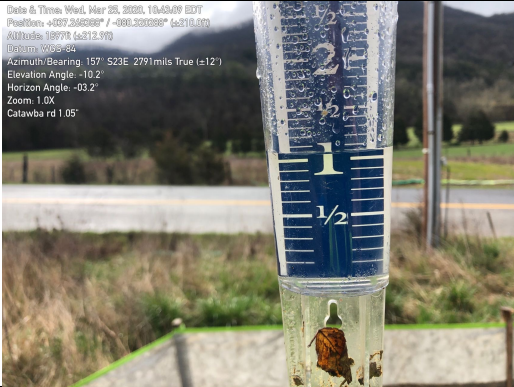
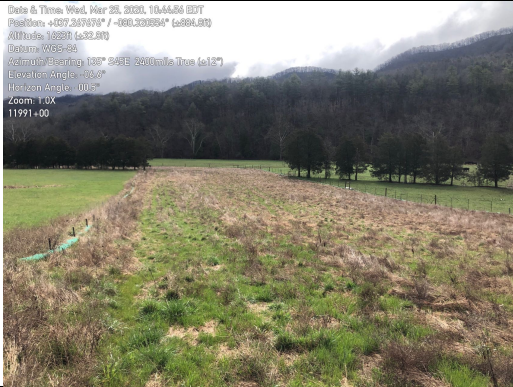
GPS Location	1	GPS Location	2		
Field Station#	11989+00	Field Station#	11991+00		
Pic 1 Desc.	Rain gauge from Catawba rd indicating 1.05" of accumulation.		Pic 2 Desc.	Section of restored RoW and controls.	
<p>Date & Time: Wed, Mar 25, 2020, 11:43:59 EDT Position: +487.247670° / -900.326594° (+312.87) Altitude: 2312ft (+45.94) Datum: WGS-84 Azimuth/Bearing: 135° S13W 2493mils True (±11°) Elevation Angle: -12.0° Horizon Angle: -00.2° Zoom: 1.0X 11993+00</p>

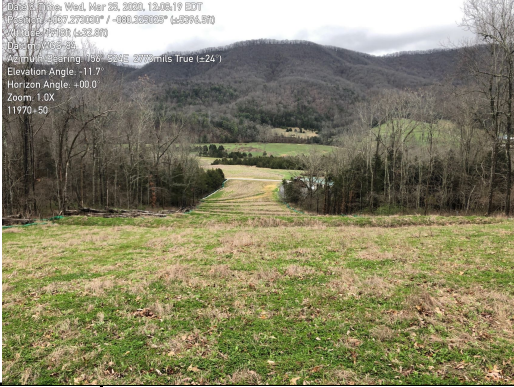
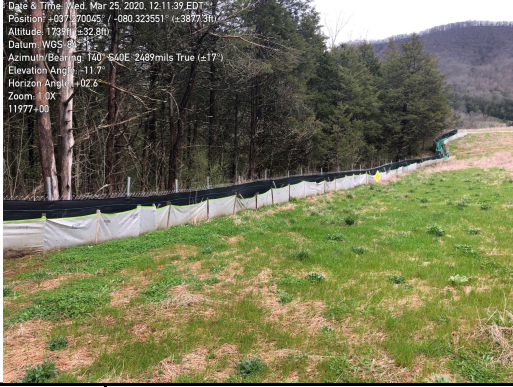
GPS Location	5	GPS Location	6		
Field Station#	11970+50	Field Station#	11977+00		
Pic 5 Desc.	Section of semi restored RoW and controls.		Pic 6 Desc.	Karst controls functional.

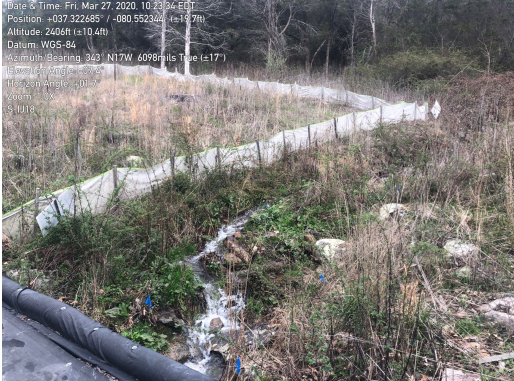
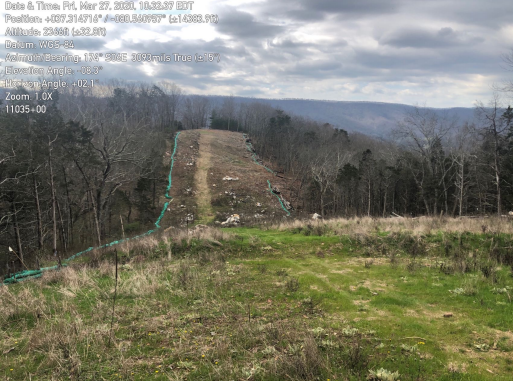
GPS Location	1	GPS Location	2		
Field Station#	11025+50	Field Station#	11035+00		
Pic 1 Desc.	S-IJ18.	Pic 2 Desc.	RoW conditions and controls.

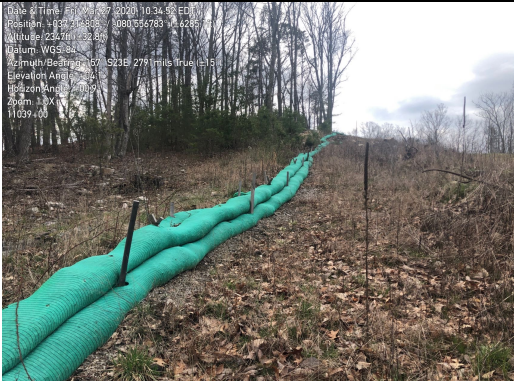
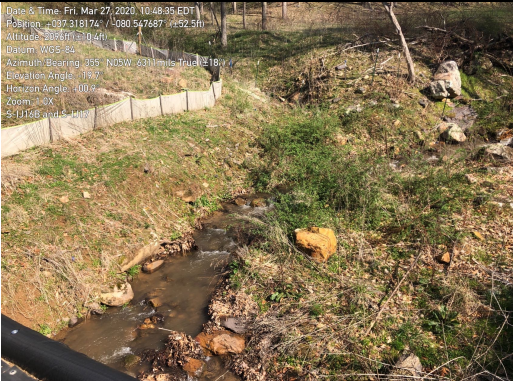
GPS Location	3	GPS Location	4		
Field Station#	11039+00	Field Station#	11050+10		
Pic 3 Desc.	Perimeter controls functional.	Pic 4 Desc.	S-IJ16B and S-IJ17.

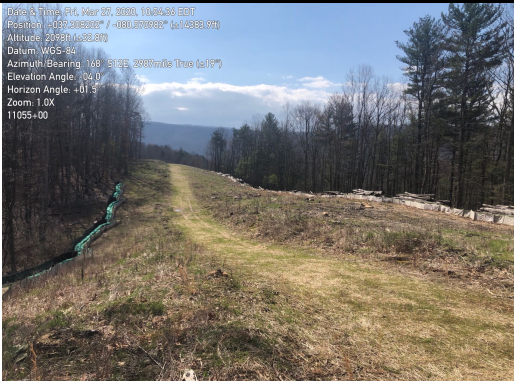
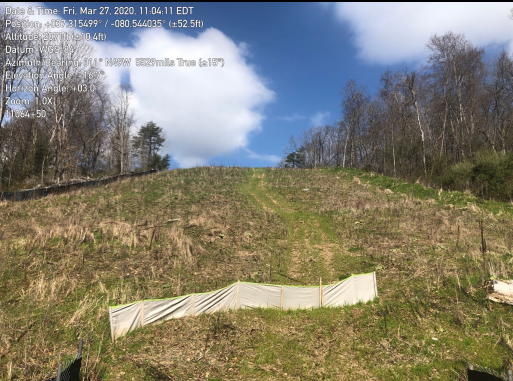
GPS Location	5	GPS Location	6		
Field Station#	11055+00	Field Station#	11064+50		
Pic 5 Desc.	RoW conditions and controls.	Pic 6 Desc.	RoW conditions and controls.

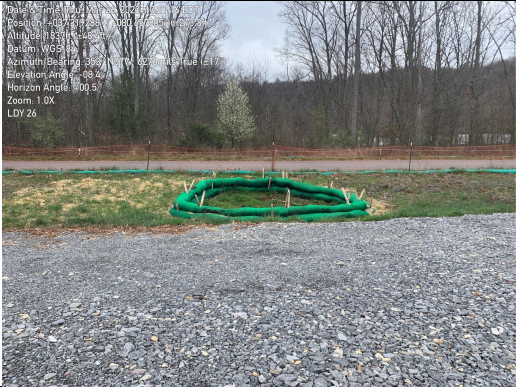
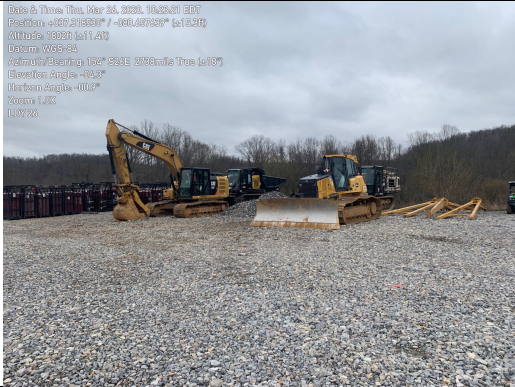
GPS Location	See photo for GPS location.		GPS Location	See photo for GPS location.	
Field Station#	12005+00		Field Station#	12005+00	
Pic 1 Desc.	Triple stack compost filter sock in place around drainage.		Pic 2 Desc.	Checked staged equipment for leaks.

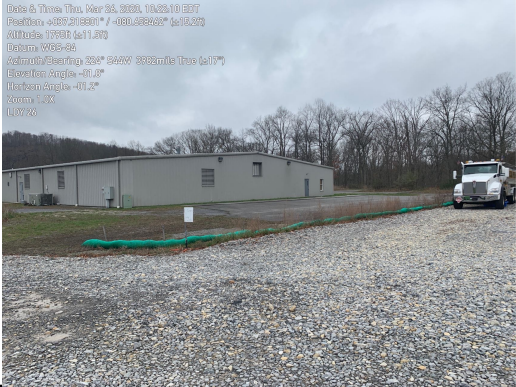
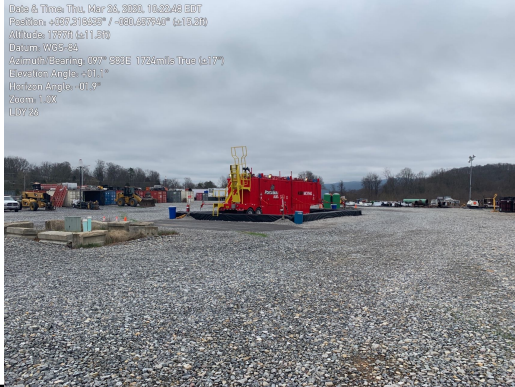
GPS Location	See photo for GPS location.		GPS Location	See photo for GPS location.	
Field Station#	12005+00		Field Station#	12005+00	
Pic 3 Desc.	18 inch compost filter sock in place along LOD of LDY.		Pic 4 Desc.	Secondary containment in place under fuel cell.

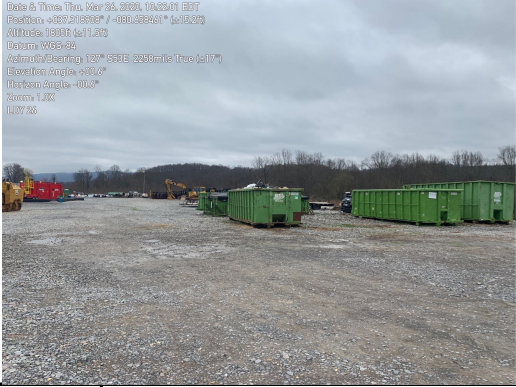
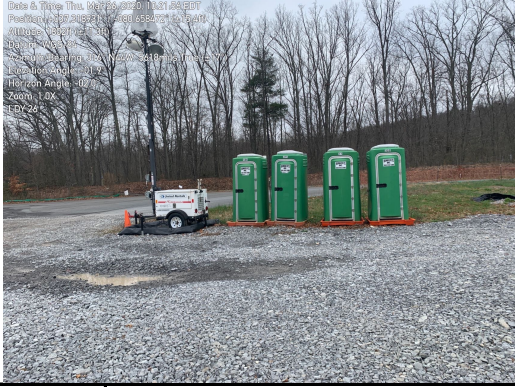
GPS Location	See photo for GPS location.		GPS Location	See photo for GPS location.	
Field Station#	12005+00		Field Station#	12005+00	
Pic 5 Desc.	Dumpsters being utilized for trash management.		Pic 6 Desc.	Port-a-potties and light plant in secondary containment.

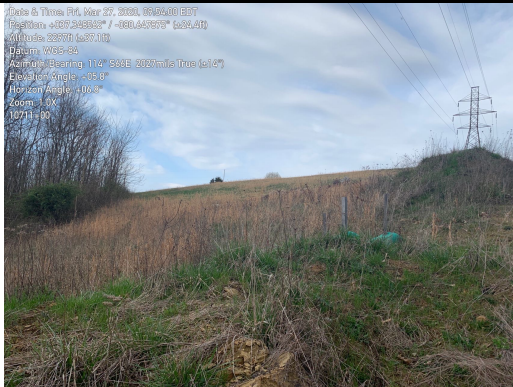
GPS Location		See photo for GPS location.						GPS Location		See photo for GPS location.	
Field Station#		10712+50						Field Station#		10711+00	
Pic 1 Desc.		Sensitive resource buffer in place at stream S-G33.						Pic 2 Desc.		ROW stabilized with natural vegetation.

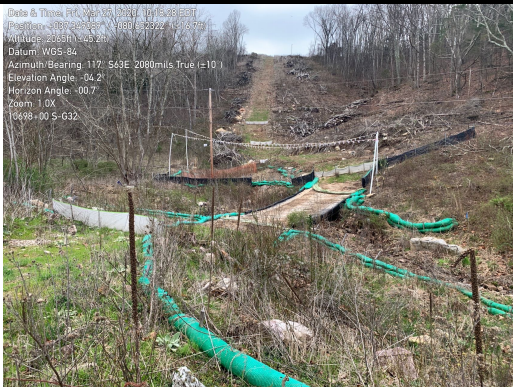
GPS Location		See photo for GPS location.						GPS Location		See photo for GPS location.	
Field Station#		10698+00						Field Station#		10696+00	
Pic 3 Desc.		Sensitive resource buffer in place at stream S-G32.						Pic 4 Desc.		RCE in place at Buffalo Anklets Road.

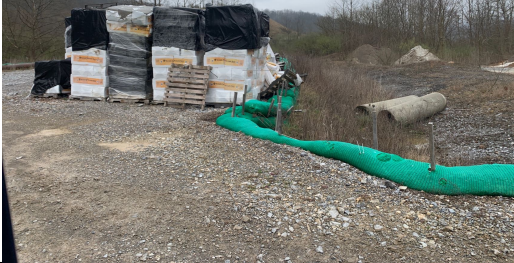
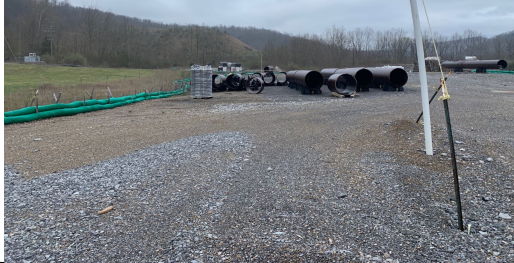
GPS Location	See picture above for GPS coordinates		GPS Location	See picture above for GPS coordinates	
Field Station#	+29		Field Station#	+29	
Pic 1 Desc.	ECD's and row conditions		Pic 2 Desc.	ECD's and row conditions	
<p>Date & Time Thu, Mar 26, 2020, 09:03:09 EDT Position: +39°52'02.45" / -85°48'10.72" (+15.6m) Altitude: 1630 ft (+50.0m) Datum: WGS-84 Azimuth/Bearing: 120° 55'48" 500m Error (Error) Elevation Grade: -00% Horizon Grade: -00% Zoom: 1.0X 28</p>

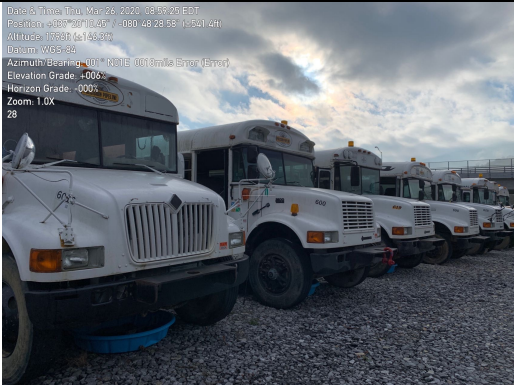
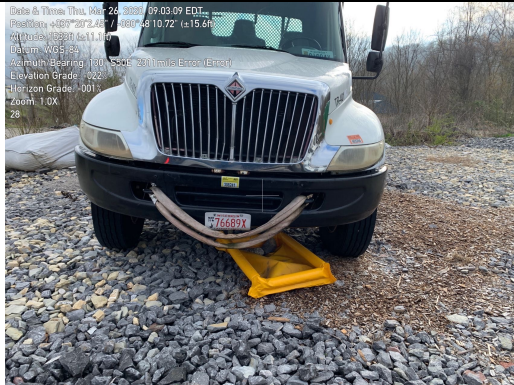
GPS Location	See picture above for GPS coordinates		GPS Location	See picture above for GPS coordinates	
Field Station#	+28		Field Station#	+28	
Pic 3 Desc.	ECD's and row conditions		Pic 4 Desc.	ECD's and row conditions	
<p>Date & Time Thu, Mar 26, 2020, 09:03:26 EDT Position: +39°52'02.45" / -85°48'11.12" (+15.6m) Altitude: 1630 ft (+50.0m) Datum: WGS-84 Azimuth/Bearing: 273° 14'57" 500m Error (Error) Elevation Grade: -010% Horizon Grade: -001% Zoom: 1.0X 28</p>

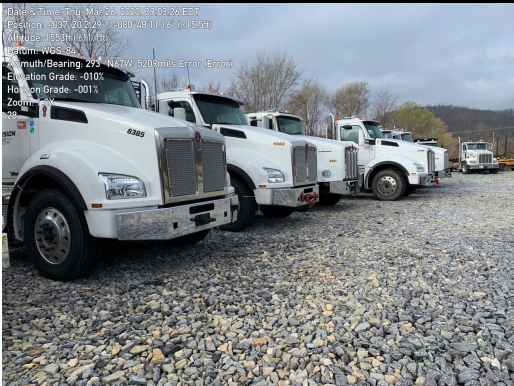
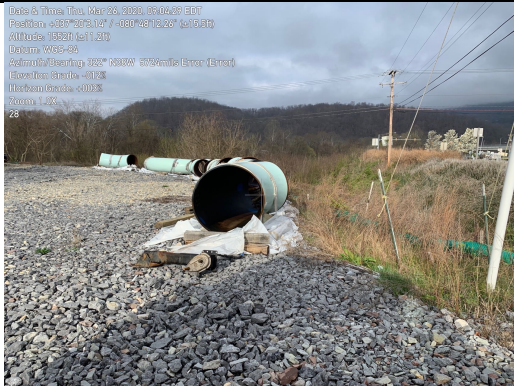
GPS Location	See picture above for GPS coordinates		GPS Location	See picture above for GPS coordinates	
Field Station#	+28		Field Station#	+28	
Pic 5 Desc.	ECD's and row conditions		Pic 6 Desc.	ECD's and row conditions

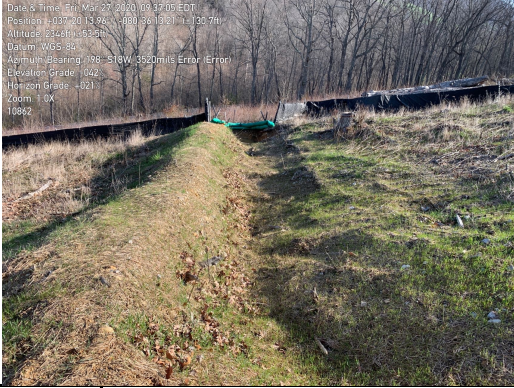
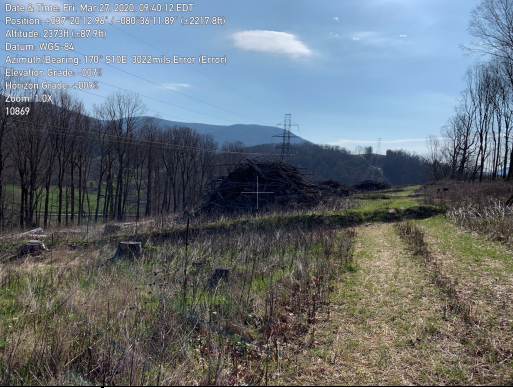
GPS Location	See picture above for GPS coordinates		GPS Location	See picture above for GPS coordinates	
Field Station#	10862+00		Field Station#	10869+00	
Pic 1 Desc.	ECD's and row conditions		Pic 2 Desc.	ECD's and row conditions

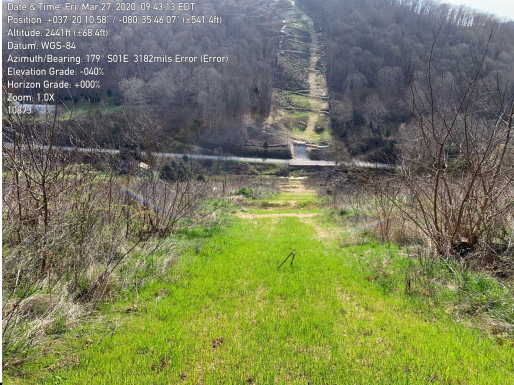
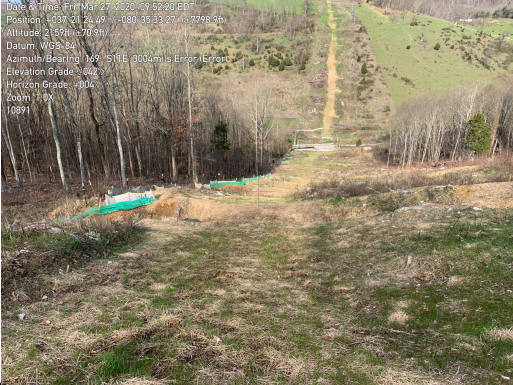
GPS Location	See picture above for GPS coordinates		GPS Location	See picture above for GPS coordinates	
Field Station#	10873+00		Field Station#	10891+00	
Pic 3 Desc.	ECD's and row conditions		Pic 4 Desc.	ECD's and row conditions

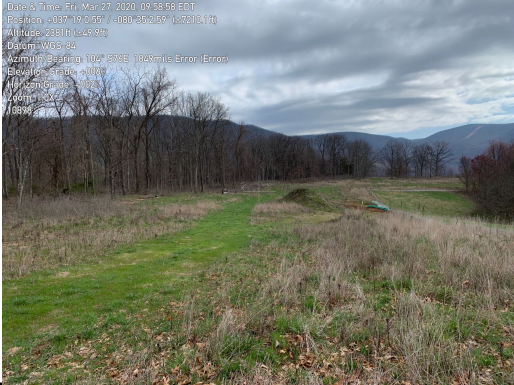
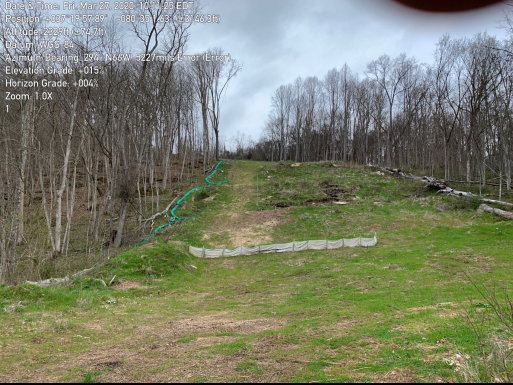
GPS Location	See picture above for GPS coordinates		GPS Location	See picture above for GPS coordinates	
Field Station#	10898+00		Field Station#	10915+00	
Pic 5 Desc.	ECD's and row conditions		Pic 6 Desc.	ECD's and row conditions
