# Visual Site Inspection Report

<b>Project Name</b>	H-600 Pipeline Spread G	<b>AFE</b>	124300137	<b>Spread</b>	H-600 Pipeline Spread G
<b>Contractor</b>	Precision			<b>Report #</b>	10224
<b>Inspector</b>	Len Kruizenga			<b>Date/Time</b>	4/20/2020 8:13 AM
<b>Permit #</b>	TBD	<b>Inspection Type</b>	VA SWPP	<b>Station Begin</b>	11024+00
<b>State</b>	VA	<b>Inspection Area</b>	Full	<b>Station End</b>	10930+00
<b>County</b>	Giles	<b>Ground</b>	Muddy	<b>Temperature (°F)</b>	51.00
<b>Municipality</b>	N/A	<b>Weather</b>	Light Rain	<b>Rain Gauge (in)</b>	0.60
				<b>Rain Accumulation Time (days)</b>	1.00

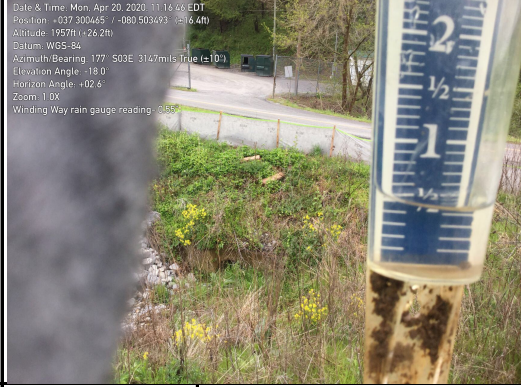
<b>GPS Location</b>	See photo GPS	<b>GPS Location</b>	See photo GPS		
<b>Field Station#</b>	11024+00	<b>Field Station#</b>	11227+00		
<b>Pic 7 Desc.</b>	AR-244 rain gauge reading- 0.60"	<b>Pic 8 Desc.</b>	Winding Way rain gauge reading - 0.55"

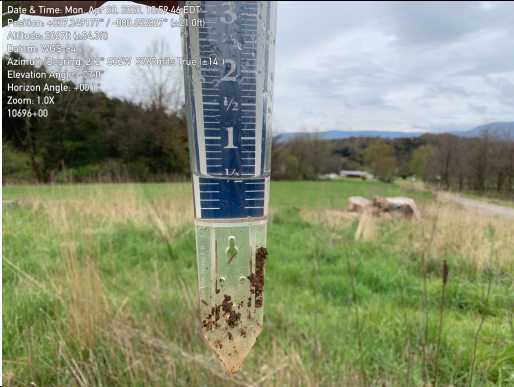
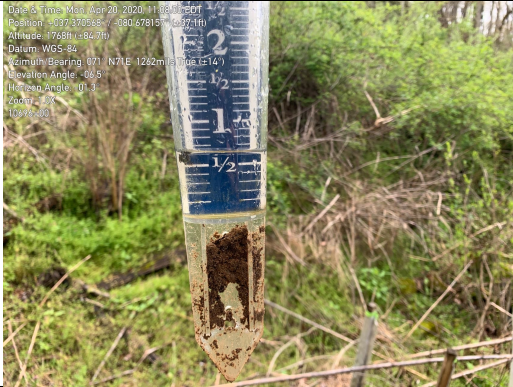
<b>GPS Location</b>	See photo for GPS location.		<b>GPS Location</b>	See photo for GPS location.	
<b>Field Station#</b>	10696+00		<b>Field Station#</b>	12005+00	
<b>Pic 1 Desc.</b>	Rain gauge at Buffalo Anklets Road reads 0.5 inches.		<b>Pic 2 Desc.</b>	Rain gauge at Access Road 234 reads 0.6 inches.

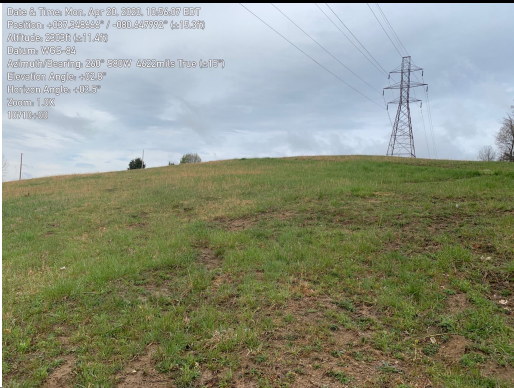
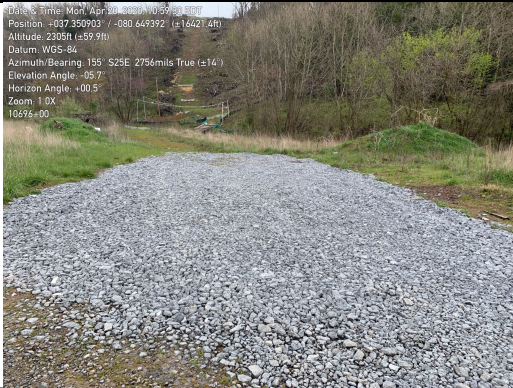
<b>GPS Location</b>	See photo for GPS location.		<b>GPS Location</b>	See photo for GPS location.	
<b>Field Station#</b>	10710+00		<b>Field Station#</b>	10696+00	
<b>Pic 5 Desc.</b>	ROW stabilized with natural vegetation growth.		<b>Pic 6 Desc.</b>	RCE in place at Buffalo Anklets Road.

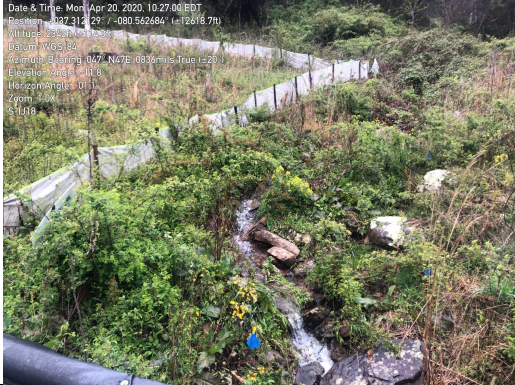
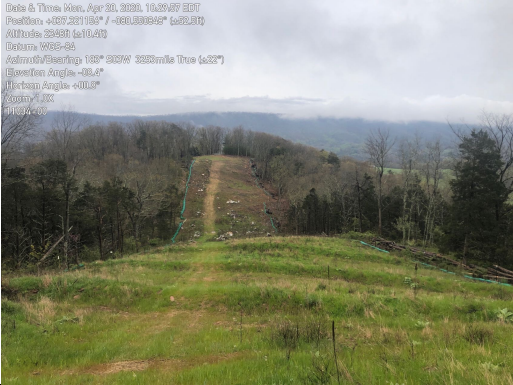
Field Station#		11025+50		11034+00	
Pic 1 Desc.		S-IJ18 and controls.		Pic 2 Desc.	
Pic 2 Desc.		RoW conditions and controls.			
<div><div><div>Date &amp; Time: Mon, Apr 20, 2020, 10:31:00 EDT</div><div>Position: +037.31523° / -80.54595° (±28.1m)</div><div>Altitude: 2295ft (±10.4m)</div><div>Datum: WGS-84</div><div>Azimuth/Bearing: 360° 000° 640mils True (±25°)</div><div>Elevation Angle: -39.6°</div><div>Horizon Angle: -0.7°</div><div>Zoom: 1.0x</div><div>S-IJ16B and S-IJ17</div></div><div>

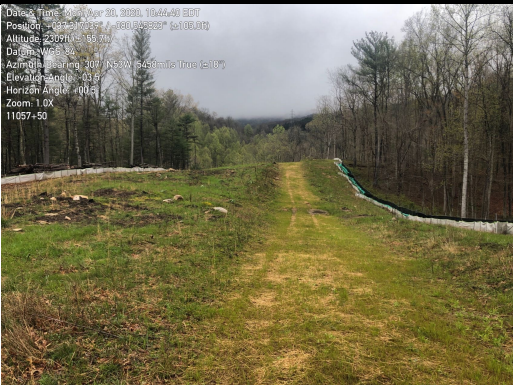
GPS Location		5		GPS Location	
Field Station#		11050+10		6	
Field Station#		11050+10		Field Station#	
Field Station#		11050+10		11057+50	
Pic 5 Desc.		S-IJ16B and S-IJ17.		Pic 6 Desc.	
Pic 6 Desc.		RoW conditions and controls.

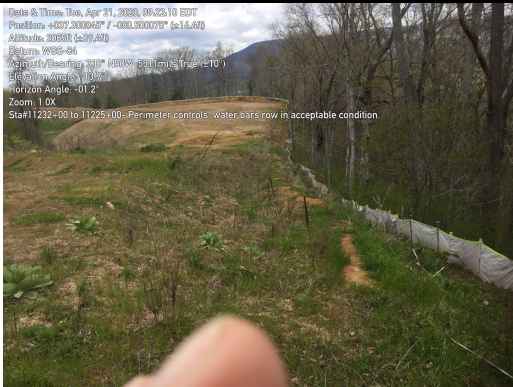
AFE	124300137	Date/Time	4/21/2020 8:47 AM	Report #	
Pictures					
<div><div><div>Date &amp; Time: Tue, Apr 21, 2020, 08:45:10 EDT Position: +037.3003487° N +000.0000797° W (+16.400) Altitude: 2067ft (+59.400) Datum: WGS-84 Azimuth/Bearing: 330° S10W 3378mils True (±10°) Elevation Angle: +15.0° Horizon Angle: +01.2° Zoom: 1.0x Sta#11232+00 to 11225+00- Perimeter controls, water bars row in acceptable condition.</div>

Pic 1 Desc.	Perimeter controls, water bars, row in acceptable condition.		Pic 2 Desc.	Slope drain, end treatment, rock channel are in acceptable condition.	
<div><div><div>Date &amp; Time: Tue, Apr 21, 2020, 09:45:14 EDT Position: +037.308012° N +000.500902° W (+105.8m) Altitude: 2021ft (+61.8m) Datum: WGS-84 Azimuth/Bearing: 169° S11E 3004mils True (±10°) Elevation Angle: +19.2° Horizon Angle: +00.9° Zoom: 1.0x Sta#11200+00 to 11204+00- Water bars on steep slope are in stable condition.</div>

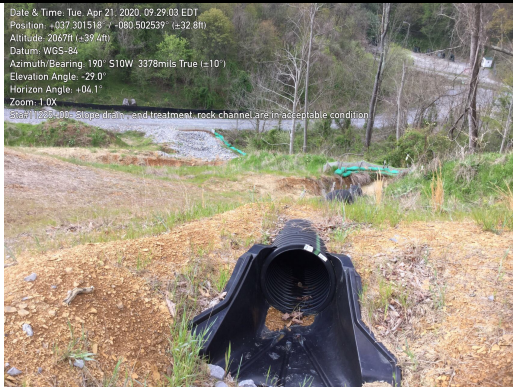
</div></div>		<div><div><div>Date &amp; Time: Tue, Apr 21, 2020, 09:29:03 EDT Position: +037.301518° N +000.002539° W (+32.8m) Altitude: 2067ft (+59.6m) Datum: WGS-84 Azimuth/Bearing: 190° S10W 3378mils True (±10°) Elevation Angle: +29.0° Horizon Angle: +06.1° Zoom: 1.0x Sta#11225+00 to 11222+00- Sloped drain, end treatment, rock channel are in acceptable condition.</div>

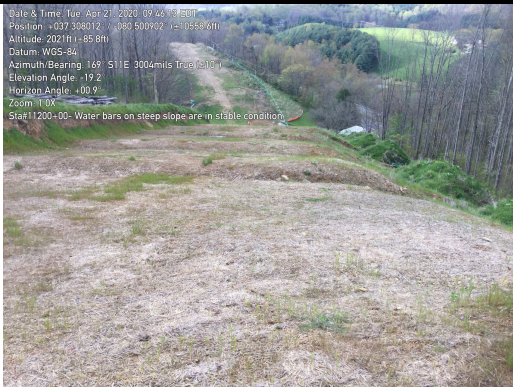
GPS Location	See photo GPS		GPS Location	See photo GPS	
Field Station#	11200+00		Field Station#	11200+00	
Pic 3 Desc.	Water bars on steep slope are stable.		Pic 4 Desc.	CFS perimeter controls and CFS triple stack end treatment's are in acceptable condition.	
<div><div><div>Date &amp; Time: Tue, Apr 21, 2020, 09:55:08 EDT Position: +037.305192° N +000.508203° W (+141.4m) Altitude: 2020ft (+61.8m) Datum: WGS-84 Azimuth/Bearing: 233° N45W 3244mils True (±10°) Elevation Angle: +23.0° Horizon Angle: +07.0° Zoom: 1.0x Sta#11195+00 to 11191+00- SSF &amp; CFS perimeter controls are in acceptable condition.</div>

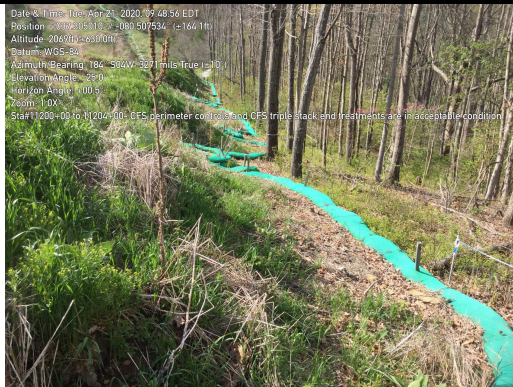
</div></div>		<div><div><div>Date &amp; Time: Tue, Apr 21, 2020, 09:48:56 EDT Position: +037.305110° N +000.507534° W (+164.1m) Altitude: 2060ft (+63.0m) Datum: WGS-84 Azimuth/Bearing: 184° S06W 3671mils True (±10°) Elevation Angle: +25.0° Horizon Angle: +00.5° Zoom: 1.0x Sta#11200+00 to 11204+00- CFS perimeter controls and CFS triple stack and treatments are in acceptable condition.</div>

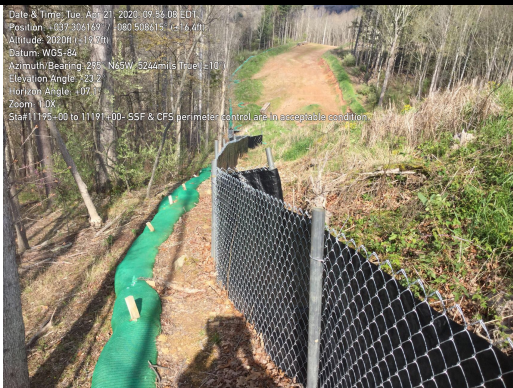
GPS Location	See photo GPS		GPS Location	See photo GPS	
Field Station#	11195+00		Field Station#	11191+00	
Pic 5 Desc.	SSF & CFS perimeter controls are in acceptable condition.		Pic 6 Desc.	Sensitive resource, drainage feature, ECD's are in acceptable condition.

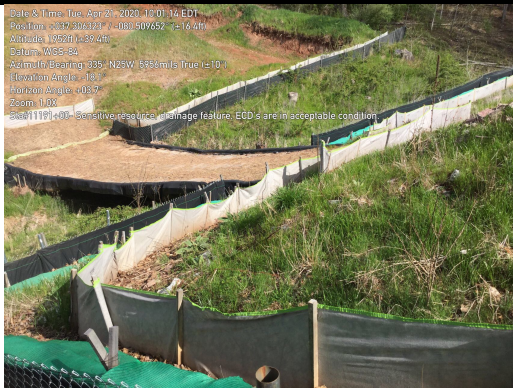
</div></div>		<div><div><div>Date &amp; Time: Tue, Apr 21, 2020, 10:01:14 EDT Position: +037.305192° N +000.509652° W (+16.0m) Altitude: 1950ft (+59.4m) Datum: WGS-84 Azimuth/Bearing: 035° N45W 5583mils True (±10°) Elevation Angle: +1.0° Horizon Angle: +05.4° Zoom: 1.0x Sta#11191+00- Sensitive resource, drainage feature, ECD's are in acceptable condition.</div>

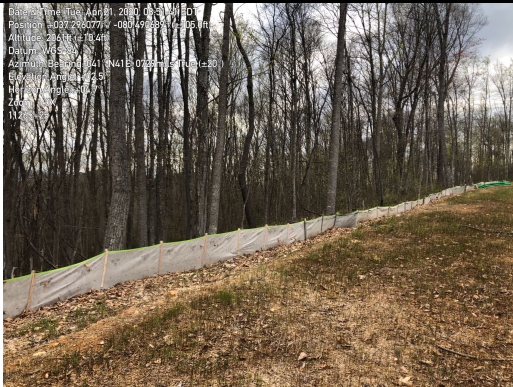
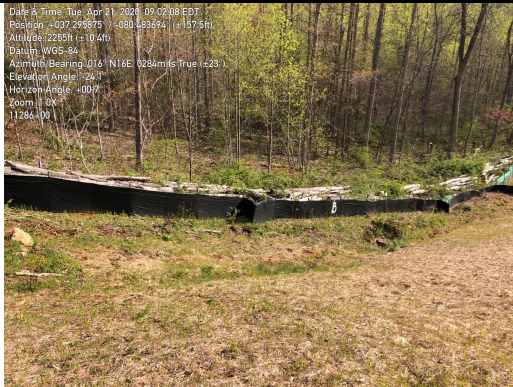
GPS Location				1				GPS Location				2			
Field Station#				11265+25				Field Station#				11286+00			
Pic 1 Desc.				Perimeter controls functional.				Pic 2 Desc.				Perimeter controls functional.

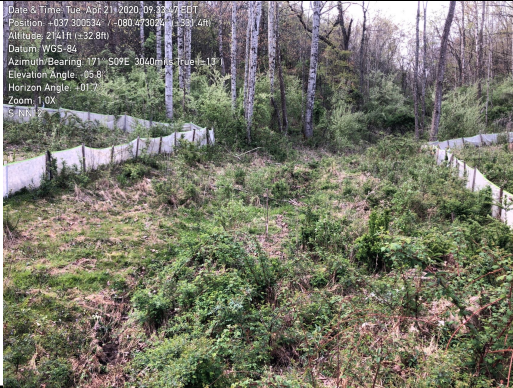
GPS Location				5				GPS Location				6			
Field Station#				11327+85				Field Station#				11352+97			
Pic 5 Desc.				S-NN12 and controls.				Pic 6 Desc.				S-NN11 and controls.

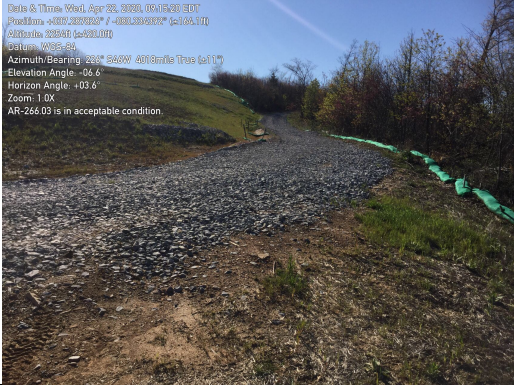
<p>Date &amp; Time: Wed, Apr 22, 2020, 09:14:30 EDT Position: +037.282827° N +080.325511° W (+90.40) Altitude: 2357ft (+37.4m) Datum: WGS-84 Azimuth/Bearing: 227° SSW 410mils True (+10°) Elevation Angle: -05.6° Horizon Angle: +03.6° Zoom: 1.0x AR-266.03 is in acceptable condition.</p>

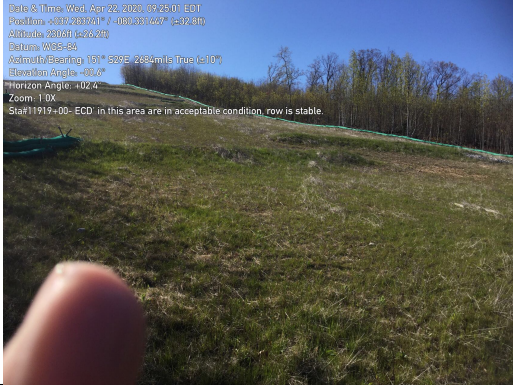
<p>Date &amp; Time: Wed, Apr 22, 2020, 09:25:01 EDT Position: +037.282827° N +080.325511° W (+90.40) Altitude: 2357ft (+37.4m) Datum: WGS-84 Azimuth/Bearing: 101° SWS 283mils True (+10°) Elevation Angle: -05.6° Horizon Angle: +02.4° Zoom: 1.0x Sta#11919+00- ECD in this area is in acceptable condition. row is stable.</p>			
<b>GPS Location</b>	See photo GPS		<b>GPS Location</b>	See photo GPS	
<b>Field Station#</b>	11900+00		<b>Field Station#</b>	11919+00	
<b>Pic 1 Desc.</b>	AR-266.03 is in acceptable condition		<b>Pic 2 Desc.</b>	Row stable, ECD's in acceptable condition.

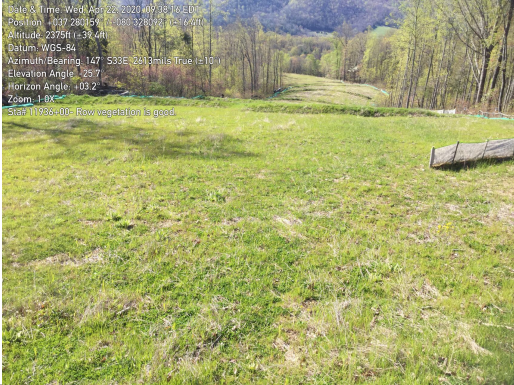
<p>Date &amp; Time: Wed, Apr 22, 2020, 09:36:00 EDT Position: +037.282827° N +080.325511° W (+90.40) Altitude: 2375ft (+37.4m) Datum: WGS-84 Azimuth/Bearing: 147° SSW 330mils True (+10°) Elevation Angle: -23.7° Horizon Angle: +03.2° Zoom: 1.0x Sta#11936+00- Row vegetation is good.</p>

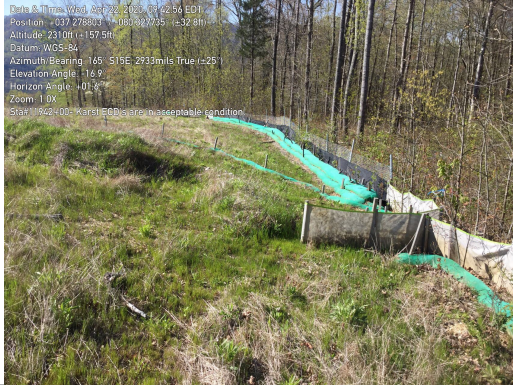
<p>Date &amp; Time: Wed, Apr 22, 2020, 09:42:54 EDT Position: +037.278803° N +080.327235° W (+90.40) Altitude: 2310ft (+37.5m) Datum: WGS-84 Azimuth/Bearing: 165° SWS 293mils True (+25°) Elevation Angle: -16.9° Horizon Angle: +01.3° Zoom: 1.0x Sta#11942+00- Karst ECD's are in acceptable condition.</p>			
<b>GPS Location</b>	See photo GPS		<b>GPS Location</b>	See photo GPS	
<b>Field Station#</b>	11936+00		<b>Field Station#</b>	11942+00	
<b>Pic 3 Desc.</b>	Row vegetation looks good.		<b>Pic 4 Desc.</b>	Karst and Karst ECD's are in acceptable condition.

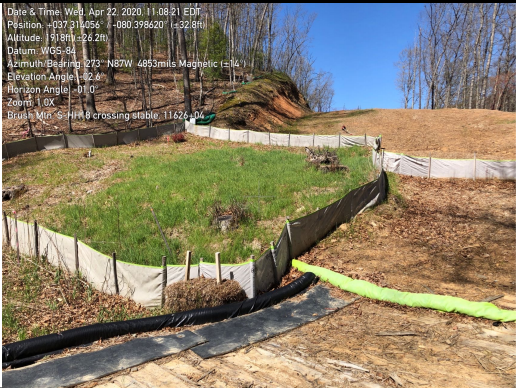
<p>Date &amp; Time: Wed Apr 22, 2020, 11:32:16 EDT  Position: +037.313626 / -080.398620 (-32.81n)  Altitude: 1940ft (-32.5n)  Datum: WGS-84  Azimuth/Bearing: 179° S01E 3182mils Magnetic (-12.6)  Elevation Angle: -06.6  Horizon Angle: -00.6  Zoom: 2.0X  Brush Min. S-006 crossing stable m.</p>

<b>GPS Location</b>	On photo	<b>GPS Location</b>	On photo		
<b>Field Station#</b>	11626+04	<b>Field Station#</b>	11607+81		
<b>Pic 5 Desc.</b>	Buffers at S-HH18 crossing stable with ECDs in place.	<b>Pic 6 Desc.</b>	S-006 crossing is stable.

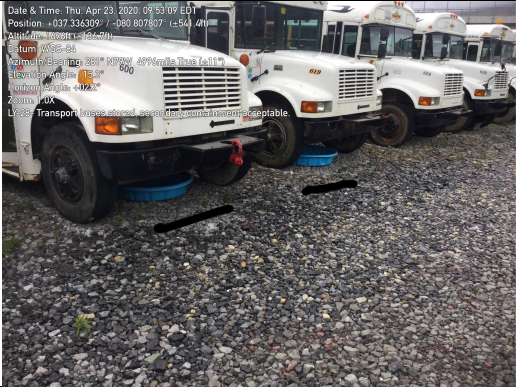
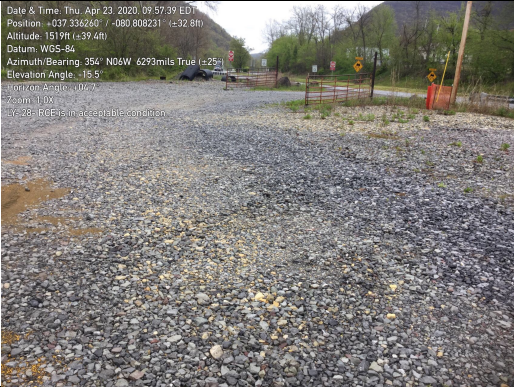
<b>GPS Location</b>	See photo GPS		<b>GPS Location</b>	See photo GPS	
<b>Field Station#</b>	12005+00		<b>Field Station#</b>	12005+00	
<b>Pic 1 Desc.</b>	LY-28- Transport buses stored, secondary containment is acceptable.		<b>Pic 2 Desc.</b>	LY-28 - RCE is maintained in acceptable condition.

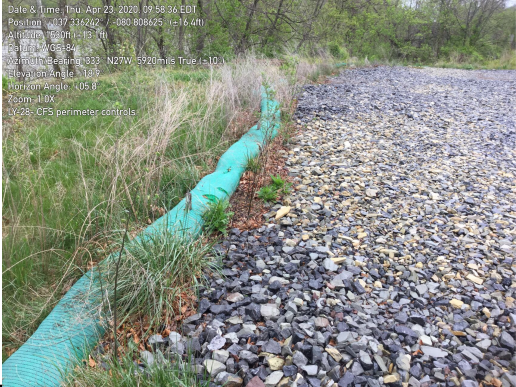
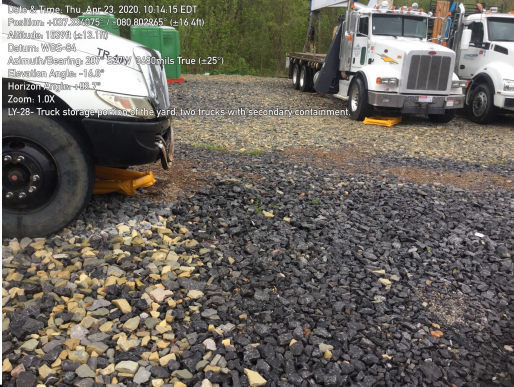
<b>GPS Location</b>	See photo GPS		<b>GPS Location</b>	See photo GPS	
<b>Field Station#</b>	12005+00		<b>Field Station#</b>	12005+00	
<b>Pic 3 Desc.</b>	LY-28- CFS perimeter controls.		<b>Pic 4 Desc.</b>	LY-28- Truck storage, containment under trucks.

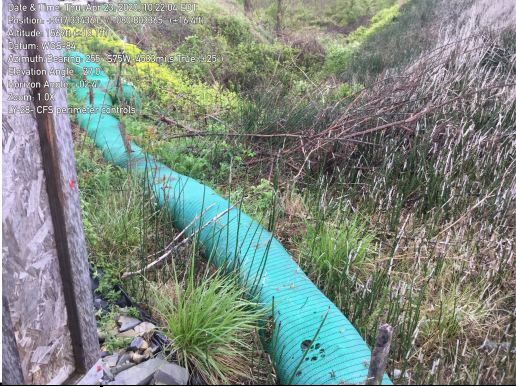
<b>GPS Location</b>	See photo GPS		<b>GPS Location</b>	See photo GPS	
<b>Field Station#</b>	12005+00		<b>Field Station#</b>	12005+00	
<b>Pic 5 Desc.</b>	CFS perimeter controls, LY28		<b>Pic 6 Desc.</b>	LY-28- Pipe fittings stored in the yard.

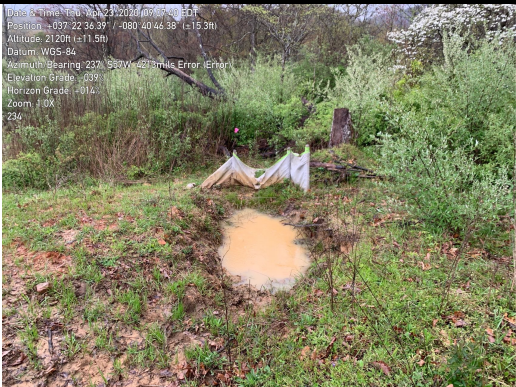
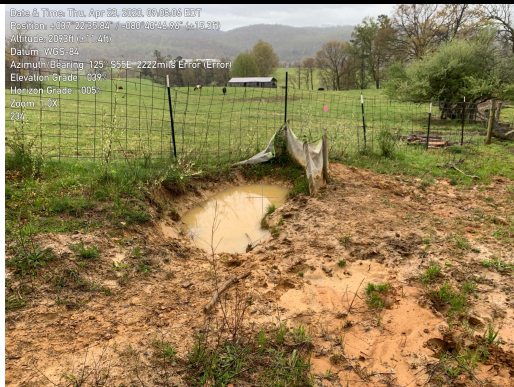
GPS Location	See picture above for GPS coordinates		GPS Location	See picture above for GPS coordinates	
Field Station#	2+34		Field Station#	2+34	
Pic 3 Desc.	Damaged P1		Pic 4 Desc.	Damaged P1	
		<p>Date &amp; Time: Thu Apr 23 2020 09:45:00 EDT  Position: -037°21'42.88" / -080°40'39.44" (-15.9M)  Altitude: 1630ft (-11.1M)  Datum: WGS-84  Azimuth: Bearing: 082° N28E 1434mils Error: Error  Elevation Grade: -000%  Horizon Grade: -000%  Zoom: 1.00X  234</p>

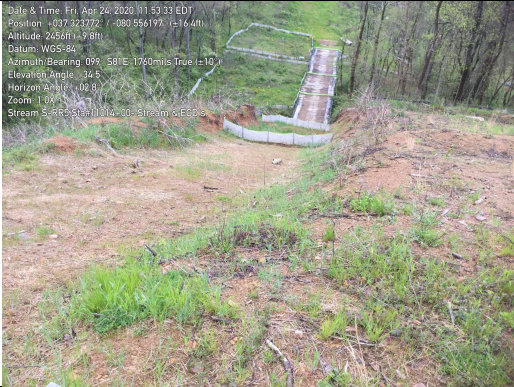
<p>Date &amp; Time: Fri, Apr 24, 2020 11:53:33 EDT Position: +037 23272° / -080 56619° (±16.4ft) Altitude: 2265ft (±39.6ft) Datum: WGS-84 Azimuth/Bearing: 099° S81E 1760mils True (±10°) Elevation Angle: -34.5° Horizon Angle: -109.8° Zoom: 1.0X Stream S-RR-5 Sta#11016+00 - Stream &amp; controls are in acceptable condition.</p>

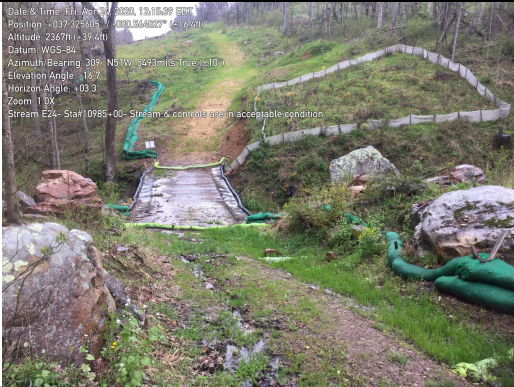
<p>Date &amp; Time: Fri, Apr 24, 2020 12:15:39 EDT Position: +037 232505° / -080 554822° (±16.4ft) Altitude: 2267ft (±39.6ft) Datum: WGS-84 Azimuth/Bearing: 308° N51W 563mils True (±10°) Elevation Angle: -15.7° Horizon Angle: -103.3° Zoom: 1.0X Stream E24 - Sta#10985+00 - Stream &amp; controls are in acceptable condition.</p>
