Visual Site Inspection Report

Project Name	H-600 Pipeline Spread G	AFE	124300137	Spread	H-600 Pipeline Spread G
Contractor	Precision			Report #	10838
Inspector	Len Kruizenga			Date/Time	5/11/2020 8:27 AM
Permit #	TBD	Inspection Type	VA SWPP	Station Begin	12005+00
State	VA	Inspection Area	Full	Station End	12005+00
County	Giles	Ground	Dry	Temperature (°F)	44.00
Municipality	N/A	Weather	Cloudy	Rain Gauge (in)	0.30
				Rain Accumulation Time (days)	1.00

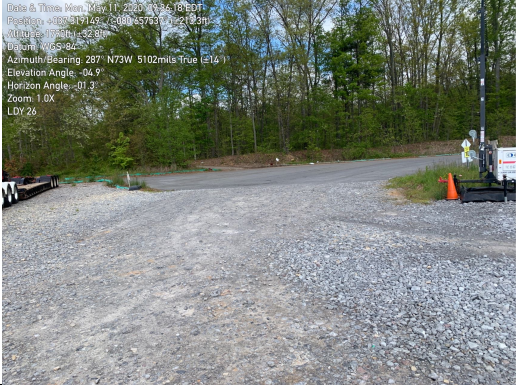
GPS Location	See photo for GPS location.		GPS Location	See photo for GPS location.	
Field Station#	12005+00		Field Station#	12005+00	
Pic 1 Desc.	RCE in place at lay down yard 26.		Pic 2 Desc.	Dumpsters being utilized for trash management.

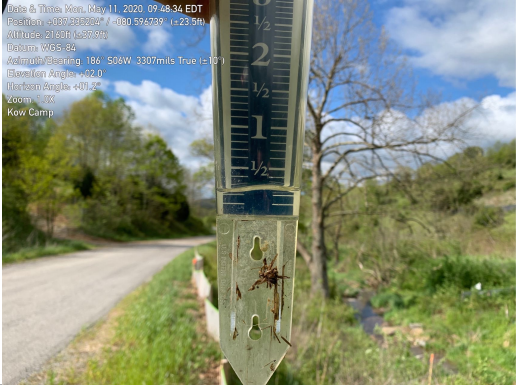
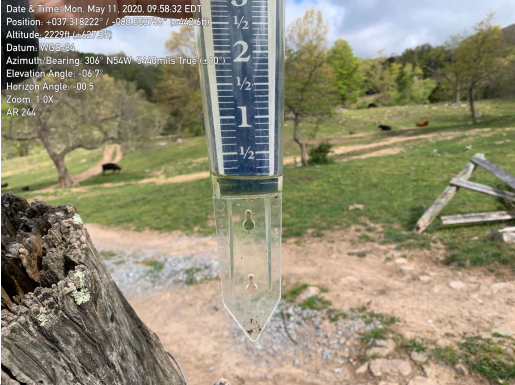
GPS Location	See photo for GPS location.		GPS Location	See photo for GPS location.	
Field Station#	10883+50		Field Station#	11025+00	
Pic 3 Desc.	Rain gauge at Kow Camp Road reads 0.3 inches.		Pic 4 Desc.	Rain gauge at Access Road 244 reads 0.2 inches.

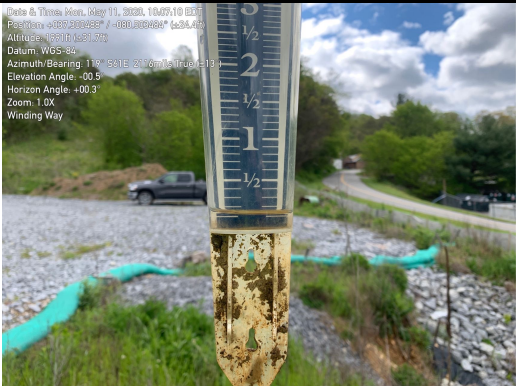
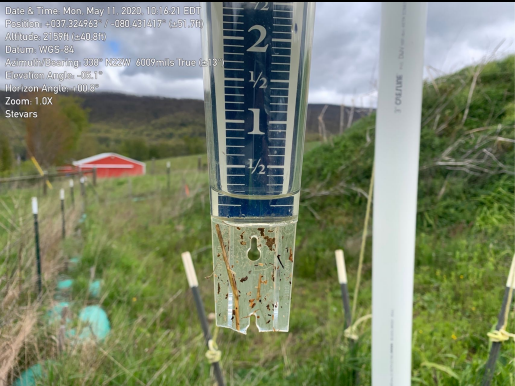
GPS Location	See photo for GPS location.		GPS Location	See photo for GPS location.	
Field Station#	11114+00		Field Station#	11487+00	
Pic 5 Desc.	Rain gauge at Winding Way Road reads 0.15 inches.		Pic 6 Desc.	Rain gauge at Stevers Gap Road reads 0.2 inches.

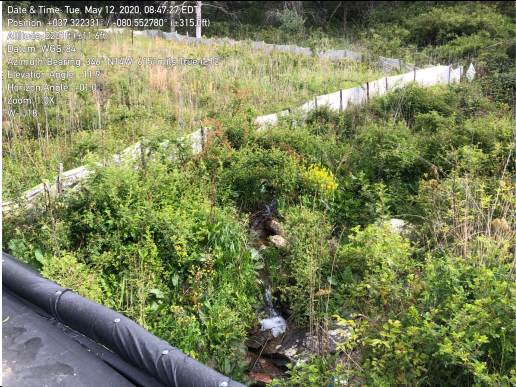
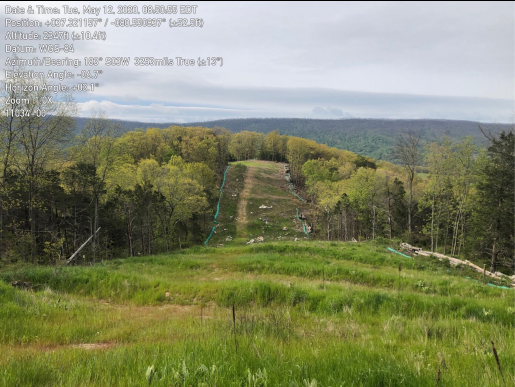
GPS Location	1	GPS Location	2		
Field Station#	11025+50	Field Station#	11034+00		
Pic 1 Desc.	S-IJ18 and controls.	Pic 2 Desc.	RoW conditions and controls.

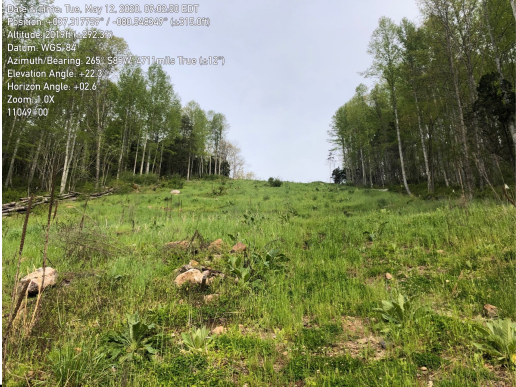
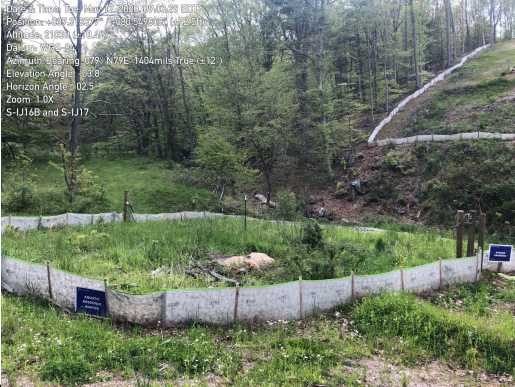
GPS Location	3	GPS Location	4		
Field Station#	11049+00	Field Station#	11050+10		
Pic 3 Desc.	RoW conditions and controls.	Pic 4 Desc.	S-IJ16B and S-IJ17 showing buffers and controls.

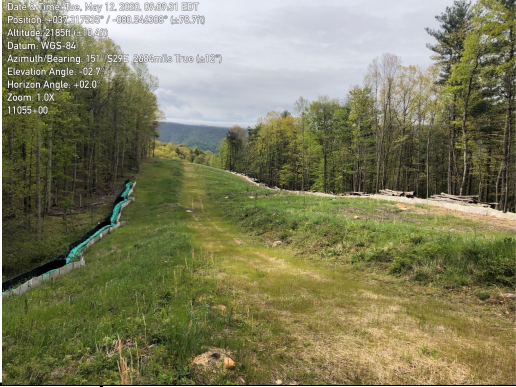
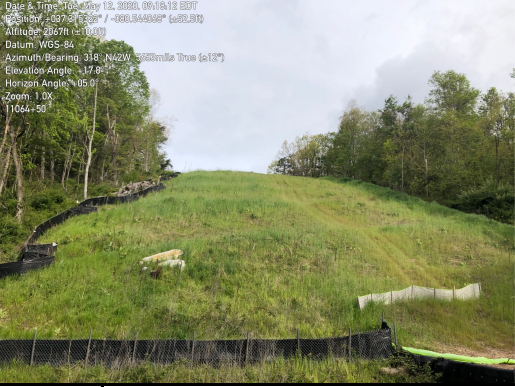
GPS Location	5	GPS Location	6		
Field Station#	11055+00	Field Station#	11064+50		
Pic 5 Desc.	RoW conditions and controls.	Pic 6 Desc.	RoW conditions and controls.

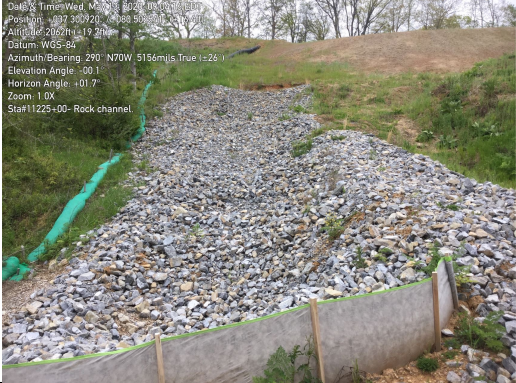
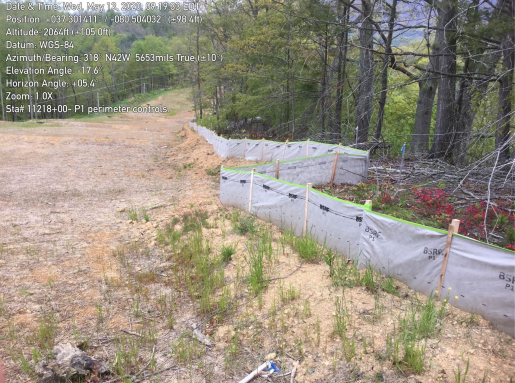
GPS Location	See photo GPS	GPS Location	See photo GPS		
Field Station#	11225+00	Field Station#	11218+00		
Pic 1 Desc.	Rock channel & controls.	Pic 2 Desc.	P1 silt fence perimeter controls

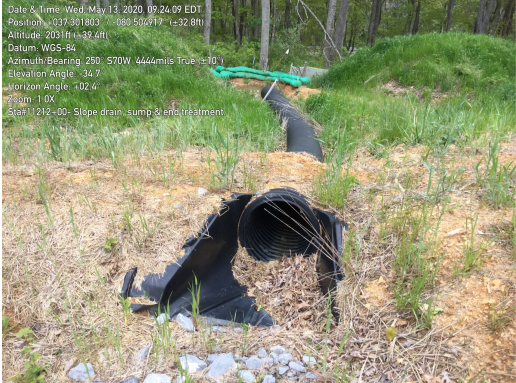
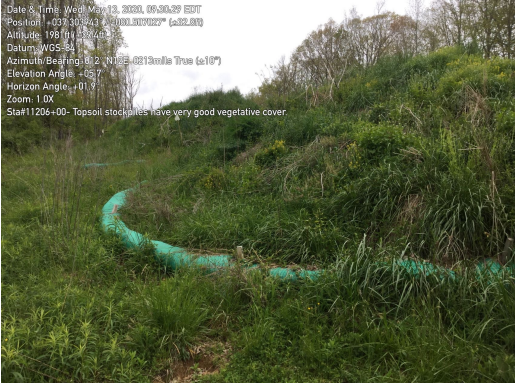
GPS Location	See photo GPS	GPS Location	See photo GPS		
Field Station#	11212+00	Field Station#	11206+00		
Pic 3 Desc.	Slope drains are in acceptable condition.	Pic 4 Desc.	Topsoil stockpiles are vegetated & stable

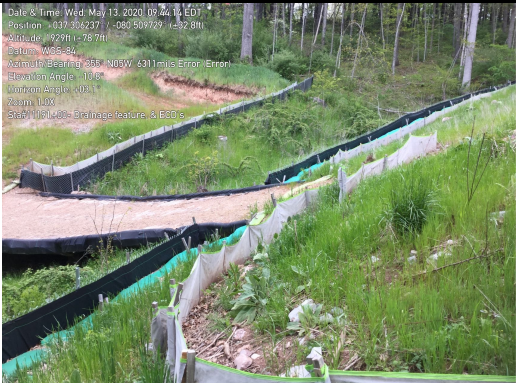
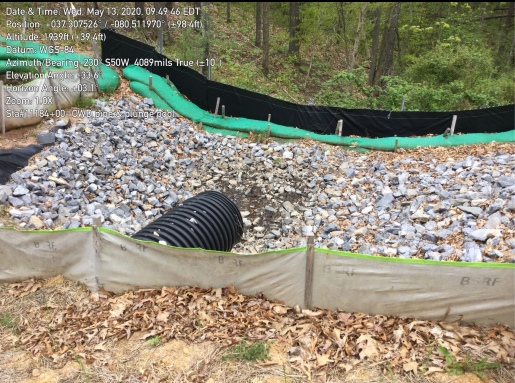
GPS Location	See photo GPS	GPS Location	See photo GPS		
Field Station#	11191+00	Field Station#	11184+00		
Pic 5 Desc.	Drainage feature & ECD's	Pic 6 Desc.	CWD pipe and plunge pool are in good condition.

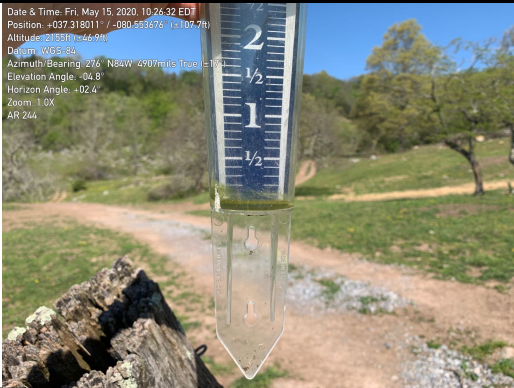
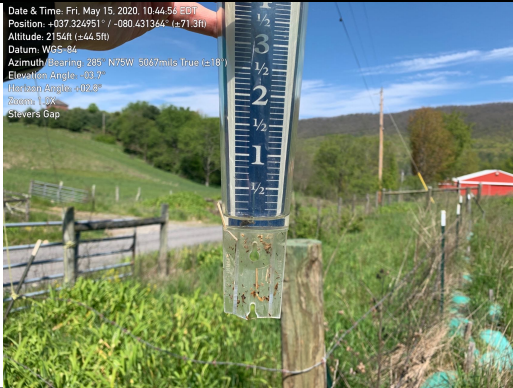
GPS Location	See photo for GPS location.		GPS Location	See photo for GPS location.	
Field Station#	11025+00		Field Station#	11489+00	
Pic 5 Desc.	Rain gauge at access road 244 reads 0.05 inches.		Pic 6 Desc.	Rain gauge at Stevens Gap Road reads 0.1 inches.

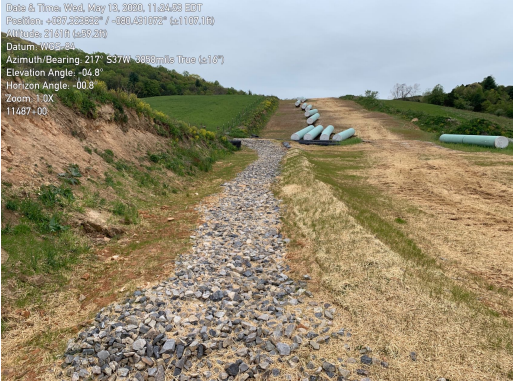
GPS Location				See photo for GPS location.				GPS Location				See photo for GPS location.			
Field Station#				11505+00				Field Station#				11487+00			
Pic 1 Desc.				Clean water diversion pipe and clean water diversion berm in place.				Pic 2 Desc.				Rock lined channel in place.

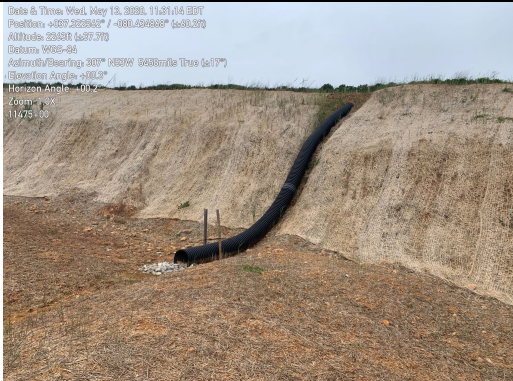
GPS Location				See photo for GPS location.				GPS Location				See photo for GPS location.			
Field Station#				11475+00				Field Station#				11471+00			
Pic 3 Desc.				Slope drain over two tone with rock outlet in place.				Pic 4 Desc.				Sock checks in place along bar ditch.

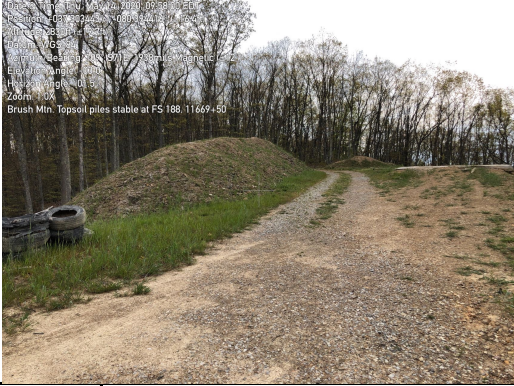
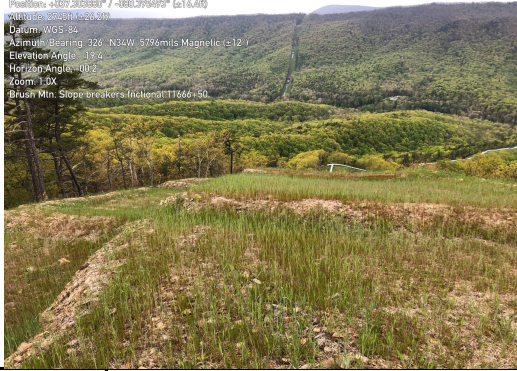
GPS Location	On photo	GPS Location	On photo		
Field Station#	11669+50	Field Station#	11666+50		
Pic 1 Desc.	Topsoil piles in the inspection area are stable. No issues identified at FS188 crossing.	Pic 2 Desc.	Slope breakers in place. Sumps and end treatments effective. Surface stable.

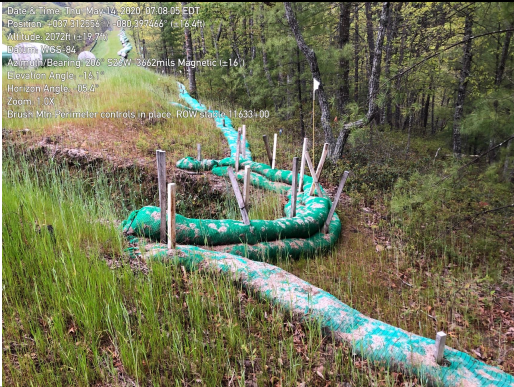
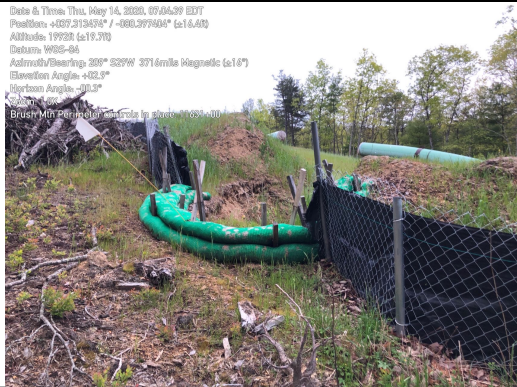
GPS Location	On photo	GPS Location	On photo		
Field Station#	11633+00	Field Station#	11631+00		
Pic 3 Desc.	End treatments are working as designed.	Pic 4 Desc.	Perimeter controls are in place and functioning.

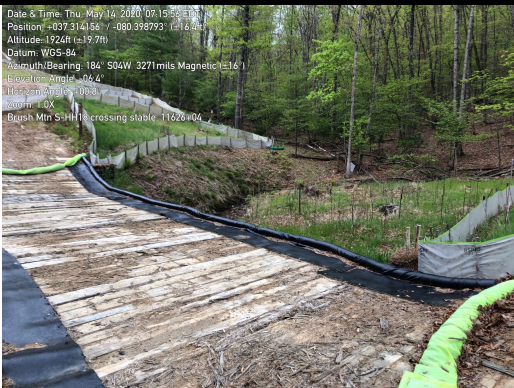
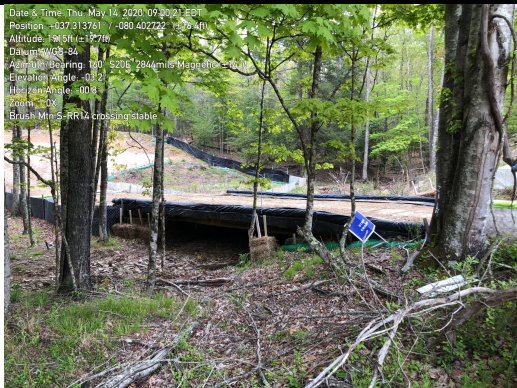
GPS Location	On photo	GPS Location	On photo		
Field Station#	11626+04	Field Station#	11614+20		
Pic 5 Desc.	S-HH18 crossing is stable.	Pic 6 Desc.	S-RR14 crossing stable with controls in place.

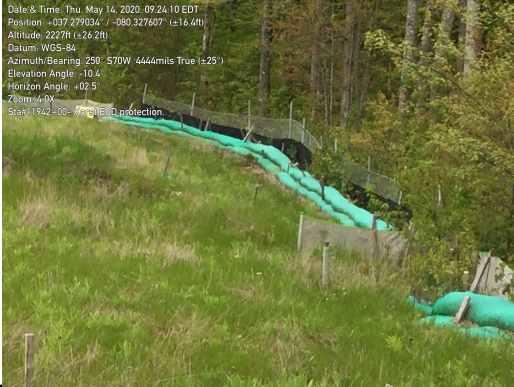
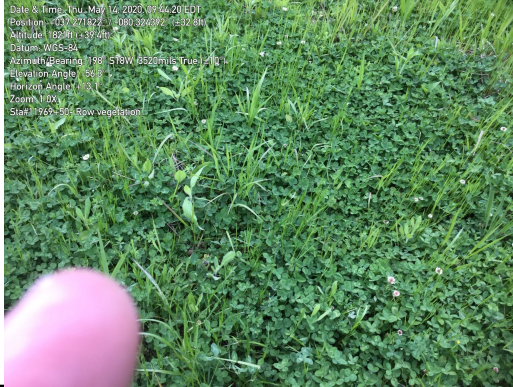
GPS Location	See photo GPS	GPS Location	See photo GPS		
Field Station#	11942+00	Field Station#	11969+50		
Pic 3 Desc.	Karst ECD's	Pic 4 Desc.	Row vegetation		
<p>Date & Time: Thu, May 14, 2020, 09:50:26 EDT Position: +037.225024° / -080.260564° (±16.6ft) Altitude: 1841ft (±88.9ft) Datum: WGS-84 Azimuth/Bearing: 148° S32E 293mils True (±10°) Elevation Angle: -15.3° Horizon Angle: +02.5° Zoom: 1.0x Sta#11977+00- Karst ECD's</p>

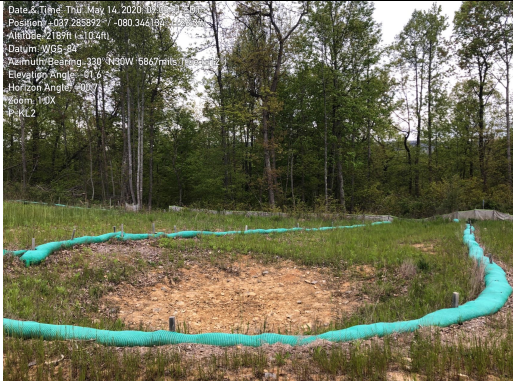
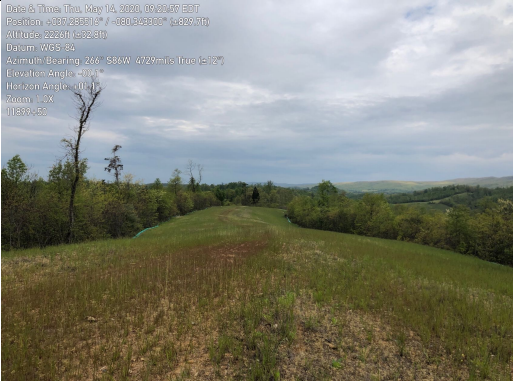
GPS Location	5		GPS Location	6	
Field Station#	11863+65		Field Station#	11899+50	
Pic 5 Desc.	P-KL2 and controls.		Pic 6 Desc.	Section of restored RoW showing conditions and controls.
