# Visual Site Inspection Report

<b>Project Name</b>	H-600 Pipeline Spread G	<b>AFE</b>	124300137	<b>Spread</b>	H-600 Pipeline Spread G
<b>Contractor</b>	Precision			<b>Report #</b>	11036
<b>Inspector</b>	Jared Saunders			<b>Date/Time</b>	5/18/2020 12:21 PM
<b>Permit #</b>	TBD	<b>Inspection Type</b>	VA SWPP	<b>Station Begin</b>	10670+00
<b>State</b>	VA	<b>Inspection Area</b>	Partial	<b>Station End</b>	10750+00
<b>County</b>	Giles	<b>Ground</b>	Damp	<b>Temperature (°F)</b>	65.00
<b>Municipality</b>	N/A	<b>Weather</b>	Cloudy	<b>Rain Gauge (in)</b>	0.00
				<b>Rain Accumulation Time (days)</b>	1.00

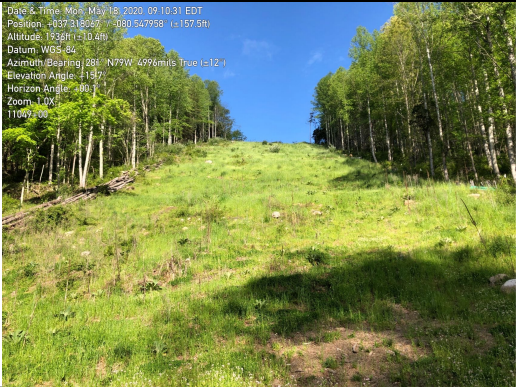
<b>GPS Location</b>	3	<b>GPS Location</b>	4		
<b>Field Station#</b>	11049+00	<b>Field Station#</b>	11050+10		
<b>Pic 3 Desc.</b>	RoW conditions and controls.	<b>Pic 4 Desc.</b>	S-IJ16B and S-IJ17 and controls.		
<p>Date &amp; Time: Mon, May 18, 2020 09:10:16 EDT  Position: +037.318070 / -080.546070 / (+105.0m)  Altitude: 2070ft (+12.3m)  Datum: WGS-84  Azimuth/Bearing: 161° S19E 262mils True (+13.4°)  Elevation Angle: -02.9°  Horizon Angle: -00.5°  Zoom: 1.0x  11055+00</p>

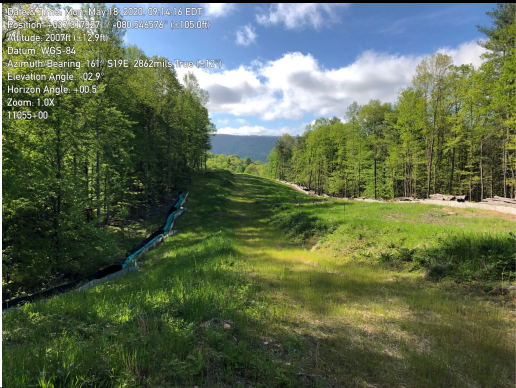
<b>GPS Location</b>	5	<b>GPS Location</b>	6		
<b>Field Station#</b>	11055+00	<b>Field Station#</b>	11064+50		
<b>Pic 5 Desc.</b>	RoW conditions and controls.	<b>Pic 6 Desc.</b>	RoW conditions and controls.

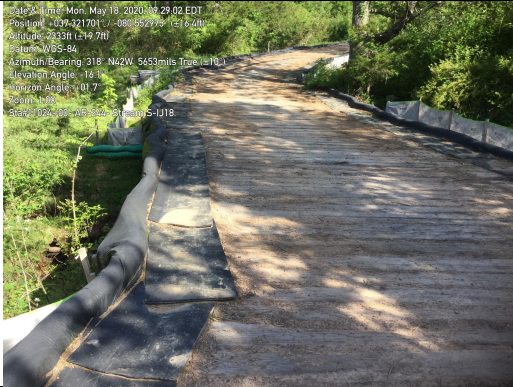
<p>Date &amp; Time: Mon, May 18, 2020 09:29:02 EDT Position: +037 32701° / -080 55279° (+16.4ft) Altitude: 2330ft (+39.2ft) Datum: WGS-84 Azimuth/Bearing: 316° N42W 5453mils True (+10°) Elevation Angle: -15° Horizon Angle: +01.7° Zoom: 1.0x Start 1024+00 - AB Slope into Stream S-IJ18</p>

<p>Date &amp; Time: Mon, May 18, 2020 09:28:19 EDT Position: +037 32721° / -080 55021° (+16.4ft) Altitude: 2330ft (+39.4ft) Datum: WGS-84 Azimuth/Bearing: 226° N42W 4900mils True (+10°) Elevation Angle: -22° Horizon Angle: +02.7° Zoom: 1.0x Start 11014+00 - Slope into stream S-RR5 is stable</p>			
GPS Location	See photo GPS		GPS Location	See photo GPS	
Field Station#	11024+00		Field Station#	11017+00	
Pic 1 Desc.	Stream S-IJ18		Pic 2 Desc.	Stream S- RR5

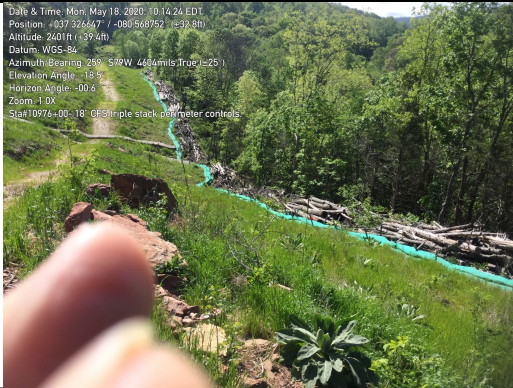
<p>Date &amp; Time: Mon, May 18, 2020 10:14:24 EDT Position: +037 32447° / -080 56052° (+16.4ft) Altitude: 2401ft (+39.4ft) Datum: WGS-84 Azimuth/Bearing: 250° N59W 4446mils True (+25°) Elevation Angle: -18.6° Horizon Angle: -00.6° Zoom: 1.0x Start 10976+00 - 18\"</p>			
GPS Location	See photo GPS		GPS Location	See photo GPS	
Field Station#	10985+00		Field Station#	10976+00	
Pic 5 Desc.	Stream S- E24		Pic 6 Desc.	18" CFS triple stack perimeter controls.

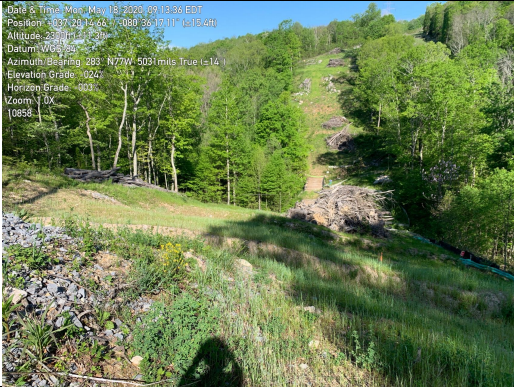
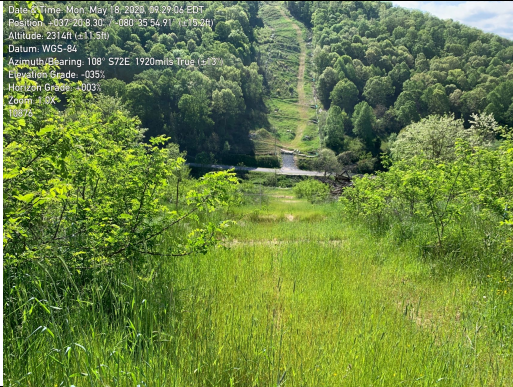
<b>GPS Location</b>	See picture above for GPS coordinates		<b>GPS Location</b>	See picture above for GPS coordinates	
<b>Field Station#</b>	10858+00		<b>Field Station#</b>	10876+00	
<b>Pic 1 Desc.</b>	ECD's and row conditions		<b>Pic 2 Desc.</b>	ECD's and row conditions

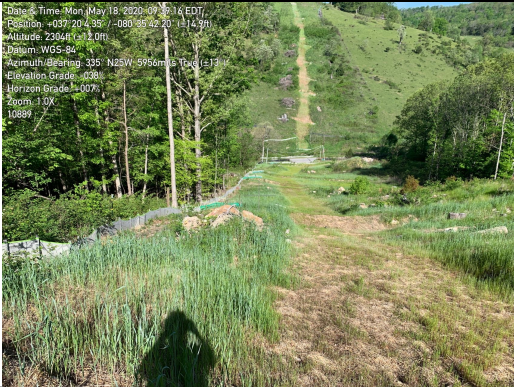
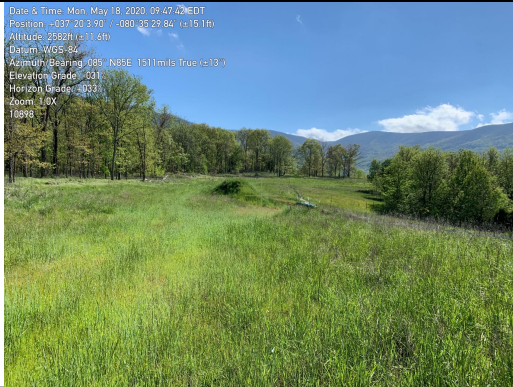
<b>GPS Location</b>	See picture above for GPS coordinates		<b>GPS Location</b>	See picture above for GPS coordinates	
<b>Field Station#</b>	10889+00		<b>Field Station#</b>	10898+00	
<b>Pic 3 Desc.</b>	ECD's and row conditions		<b>Pic 4 Desc.</b>	ECD's and row conditions

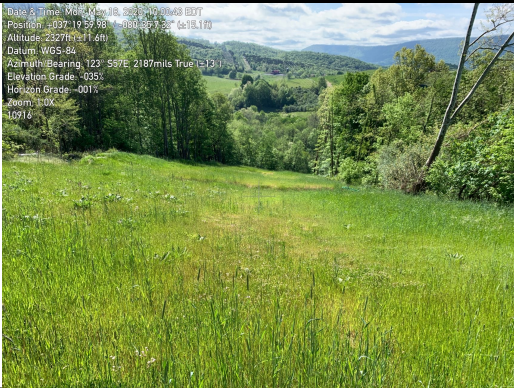
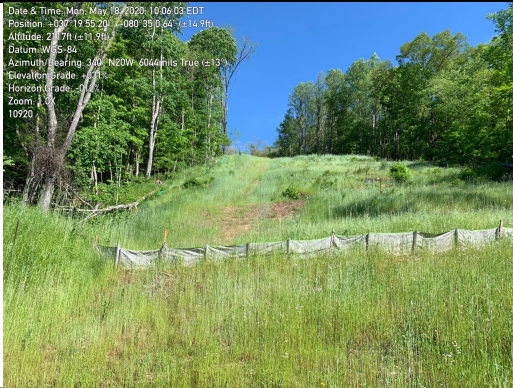
<b>GPS Location</b>	See picture above for GPS coordinates		<b>GPS Location</b>	See picture above for GPS coordinates	
<b>Field Station#</b>	10916+00		<b>Field Station#</b>	10920+00	
<b>Pic 5 Desc.</b>	ECD's and row conditions		<b>Pic 6 Desc.</b>	ECD's and row conditions

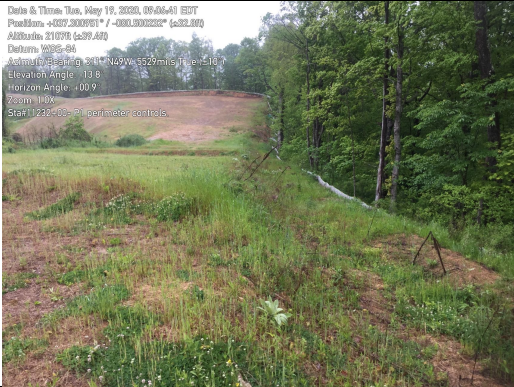
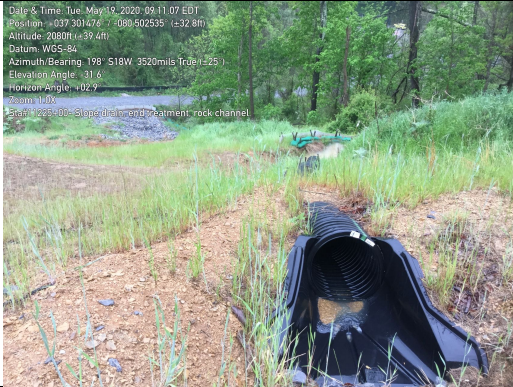
<b>GPS Location</b>	See photo GPS	<b>GPS Location</b>	See photo GPS		
<b>Field Station#</b>	11232+00	<b>Field Station#</b>	11225+00		
<b>Pic 1 Desc.</b>	P1 perimeter controls are in acceptable condition.	<b>Pic 2 Desc.</b>	Slope drain pipe, end treatment, rock channel.

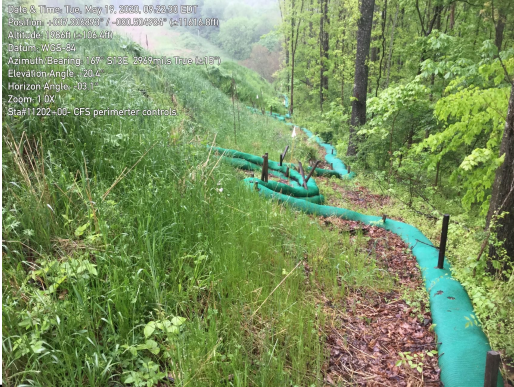
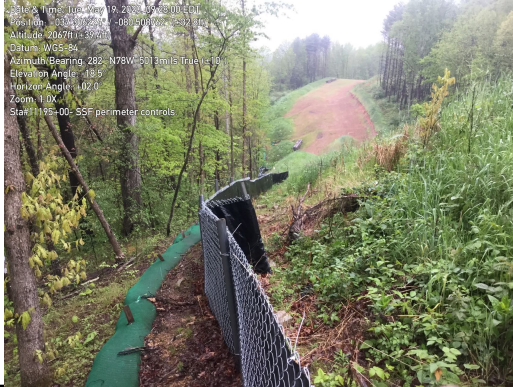
<b>GPS Location</b>	See photo GPS	<b>GPS Location</b>	See photo GPS		
<b>Field Station#</b>	11202+00	<b>Field Station#</b>	11195+00		
<b>Pic 3 Desc.</b>	CFS perimeter controls are in acceptable condition.	<b>Pic 4 Desc.</b>	SSF perimeter controls are in acceptable condition.		
<p>Date &amp; Time: Tue, May 19, 2020, 09:37:03 EDT  Position: +402.201474° N -080.902535° W (+32.80)  Altitude: 2080ft (+634.00)  Datum: WGS-84  Azimuth/Bearing: 198° S18W, 3520mils True (+25)  Elevation Angle: -11.6  Horizon Angle: +02.9  Zoom: 1.0x  Staff: 11184+00 - CWD pipe &amp; plunge pool.</p>

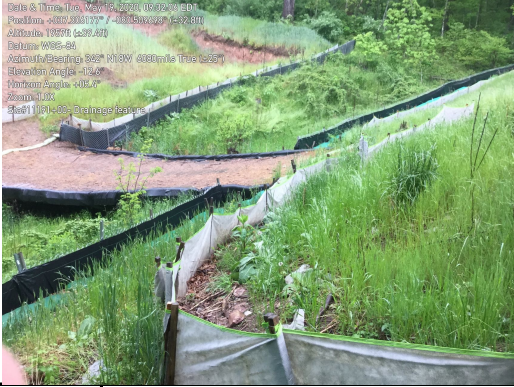
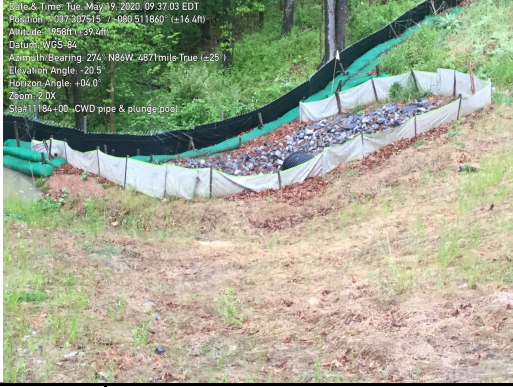
<b>GPS Location</b>	See photo GPS	<b>GPS Location</b>	See photo GPS		
<b>Field Station#</b>	11191+00	<b>Field Station#</b>	11184+00		
<b>Pic 5 Desc.</b>	Drainage feature and ECD's are in acceptable condition.	<b>Pic 6 Desc.</b>	CWD pipe and plunge pool are in good condition.

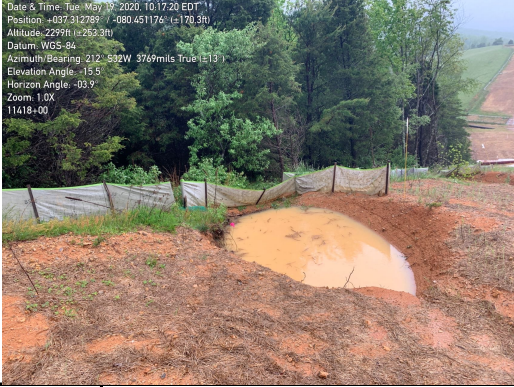
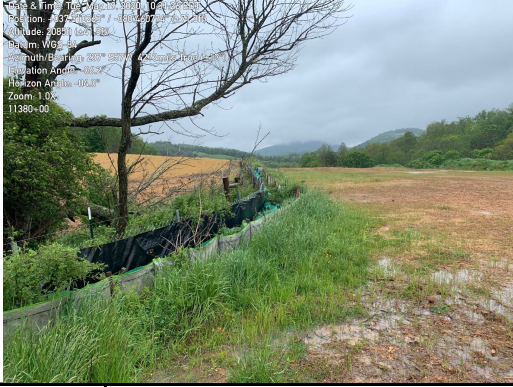
<b>GPS Location</b>	See photo for GPS location.		<b>GPS Location</b>	See photo for GPS location.	
<b>Field Station#</b>	11418+00		<b>Field Station#</b>	11380+00	
<b>Pic 5 Desc.</b>	Broken priority one silt fence stake.		<b>Pic 6 Desc.</b>	Triple barrier ECDs in place at off ROW karst feature.

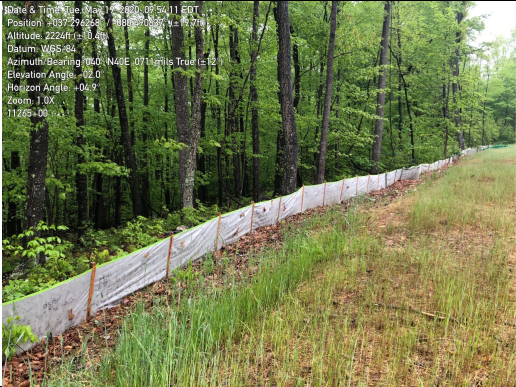
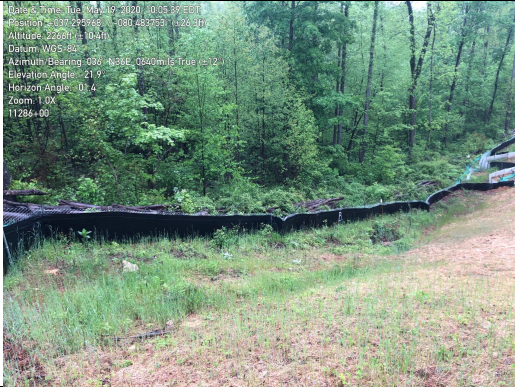
<b>GPS Location</b>	1	<b>GPS Location</b>	2		
<b>Field Station#</b>	11265+00	<b>Field Station#</b>	11286+00		
<b>Pic 1 Desc.</b>	Perimeter controls functional.	<b>Pic 2 Desc.</b>	Perimeter controls functional.

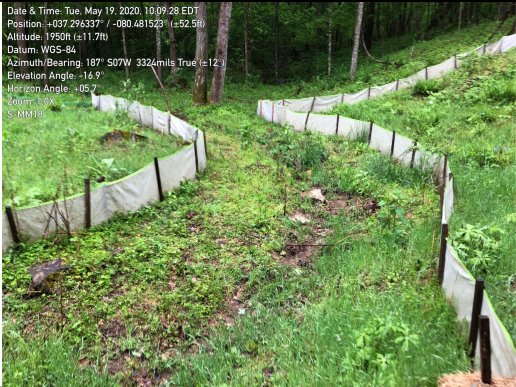
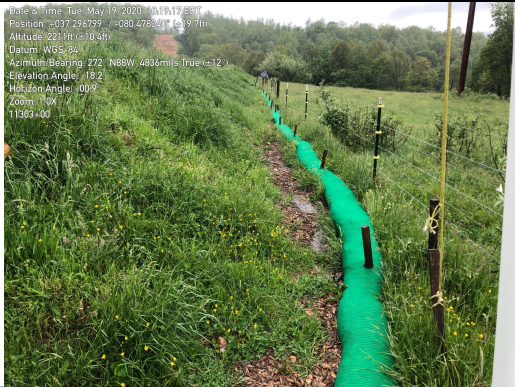
<b>GPS Location</b>	3	<b>GPS Location</b>	4		
<b>Field Station#</b>	11292+80	<b>Field Station#</b>	11303+00		
<b>Pic 3 Desc.</b>	S-MM18 and controls.	<b>Pic 4 Desc.</b>	Perimeter controls functional.

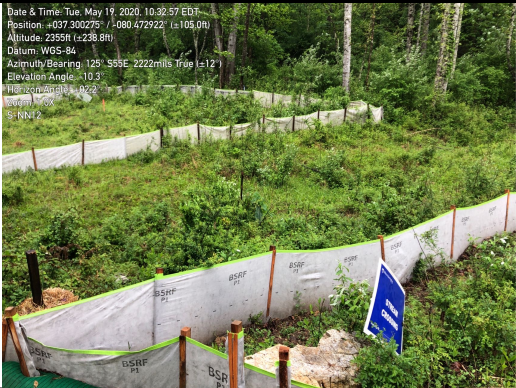
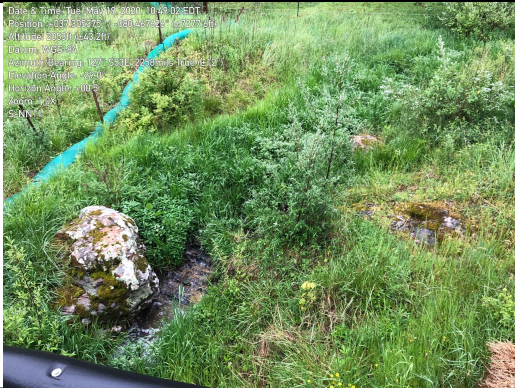
<b>GPS Location</b>	5	<b>GPS Location</b>	6		
<b>Field Station#</b>	11327+85	<b>Field Station#</b>	11352+97		
<b>Pic 5 Desc.</b>	S-NN12 and controls.	<b>Pic 6 Desc.</b>	S-NN11.

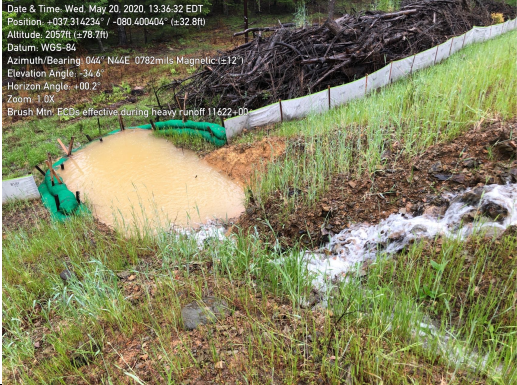
<p><small>Date &amp; Time: Wed, May 20, 2020, 13:36:32 EDT Position: +037.314234° / -080.400404° (±32.8ft) Altitude: 2057ft (±78.7ft) Datum: WGS-84 Azimuth/Bearing: 046° N44E 0782mils Magnetic (±12°) Elevation Angle: -36.0° Horizon Angle: +00.2° Zoom: 1.0X Brush Mtn. ECDs effective during heavy runoff 11622+00</small></p>

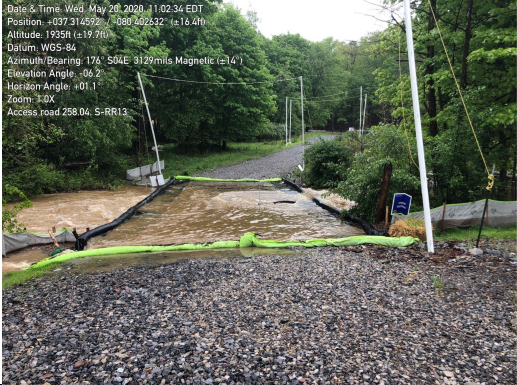
<p><small>Date &amp; Time: Wed, May 20, 2020, 11:02:34 EDT Position: +037.314552° / -080.402632° (±16.4ft) Altitude: 1935ft (±19.7ft) Datum: WGS-84 Azimuth/Bearing: 176° S04E 3129mils Magnetic (±14°) Elevation Angle: -06.2° Horizon Angle: +01.1° Zoom: 1.0X Access road 258.04 S-RR13</small></p>			
<b>GPS Location</b>	On photo	<b>GPS Location</b>	On photo		
<b>Field Station#</b>	11622+00	<b>Field Station#</b>	11613+69		
<b>Pic 7 Desc.</b>	Heavy runoff controlled by ECDs. No sediment lost from limits of disturbance.	<b>Pic 8 Desc.</b>	Craig Creek washes over equipment bridge at access road 258.04.

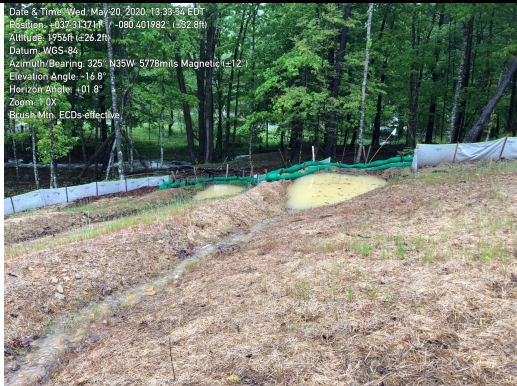
<p><small>Date &amp; Time: Wed, May 20, 2020, 13:39:54 EDT Position: +037.313214° / -080.401982° (±32.8ft) Altitude: 1926ft (±26.2ft) Datum: WGS-84 Azimuth/Bearing: 325° N35W 5778mils Magnetic (±12°) Elevation Angle: -14.8° Horizon Angle: +01.8° Zoom: 1.0X Brush Mtn. ECDs effective</small></p>

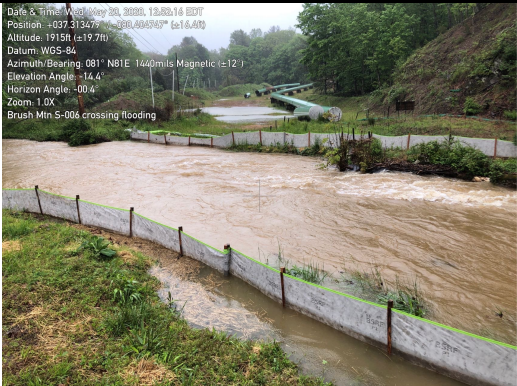
<p><small>Date &amp; Time: Wed, May 20, 2020, 13:40:16 EDT Position: +037.313475° / -080.404745° (±16.4ft) Altitude: 1918ft (±19.7ft) Datum: WGS-84 Azimuth/Bearing: 081° N81E 1440mils Magnetic (±12°) Elevation Angle: -14.4° Horizon Angle: -00.4° Zoom: 1.0X Brush Mtn S-004 crossing flooding</small></p>			
<b>GPS Location</b>	On photo	<b>GPS Location</b>	On photo		
<b>Field Station#</b>	11614+75	<b>Field Station#</b>	11607+81		
<b>Pic 9 Desc.</b>	Slope breakers, sumps and end treatments working properly.	<b>Pic 10 Desc.</b>	Craig Creek is swollen from recent rainfall. Damages to ECDs will be assessed again after water resides.

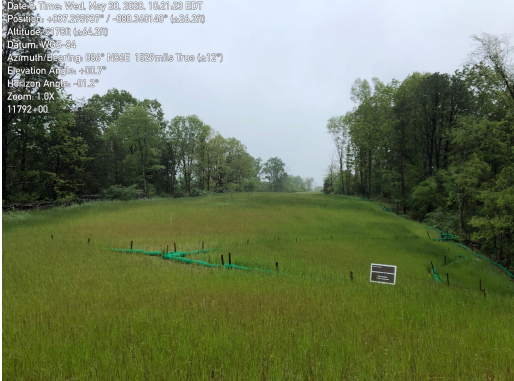
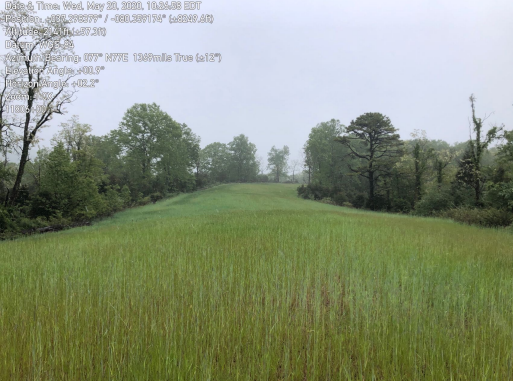
<b>GPS Location</b>	1	<b>GPS Location</b>	2		
<b>Field Station#</b>	11793+00	<b>Field Station#</b>	11806+00		
<b>Pic 1 Desc.</b>	Section of restored RoW showing conditions and controls.		<b>Pic 2 Desc.</b>	Section of restored RoW showing conditions and controls.

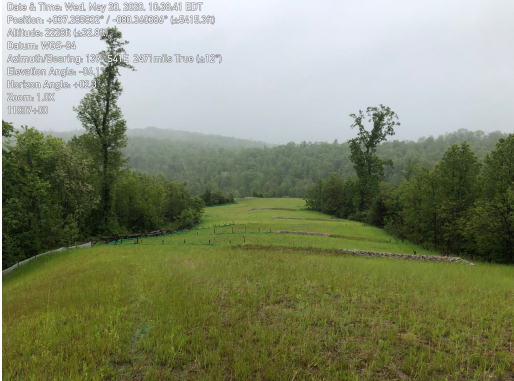
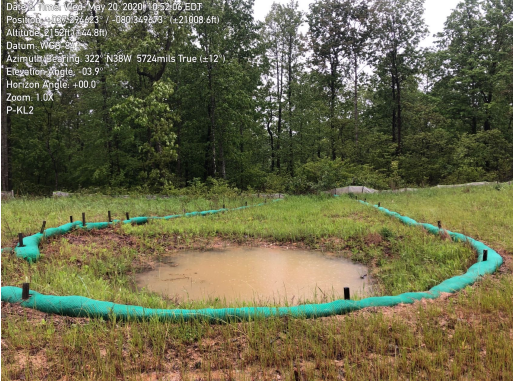
<b>GPS Location</b>	3	<b>GPS Location</b>	4		
<b>Field Station#</b>	11837+00	<b>Field Station#</b>	11863+65		
<b>Pic 3 Desc.</b>	Section of restored RoW showing conditions and controls.		<b>Pic 4 Desc.</b>	P-KL2.

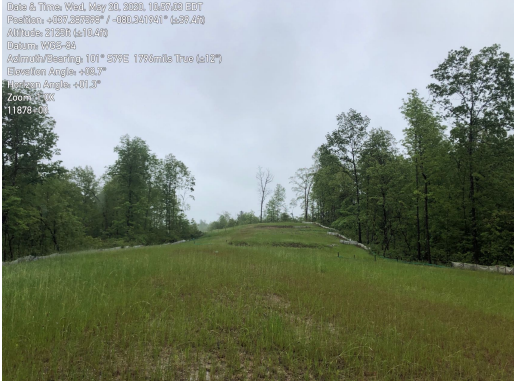
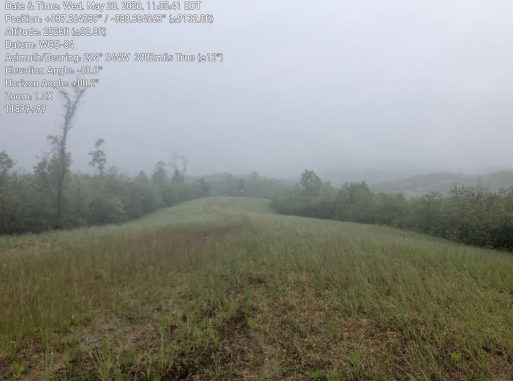
<b>GPS Location</b>	5	<b>GPS Location</b>	6		
<b>Field Station#</b>	11878+00	<b>Field Station#</b>	11899+99		
<b>Pic 5 Desc.</b>	Section of restored RoW showing conditions and controls.		<b>Pic 6 Desc.</b>	Section of restored RoW showing conditions and controls.

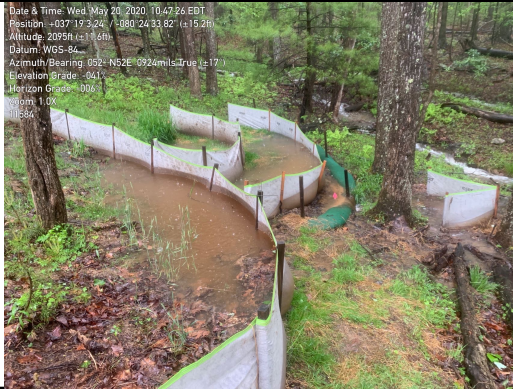
<p>Date &amp; Time: Wed, May 20, 2020, 10:40:20 EDT Position: +037 18 13.51' / -080 24 44.20' (+15.1m) Altitude: 2466ft (+751.7m) Datum: WGS-84 Azimuth/Bearing: 253° S73W 4498mils True (+19°) Elevation Grade: -054° Horizon Grade: -022° Zoom: 1.0x 11575 fpp2x</p>			
<b>GPS Location</b>	See picture above for GPS coordinates		<b>GPS Location</b>	See picture above for GPS coordinates	
<b>Field Station#</b>	11550+00		<b>Field Station#</b>	11584+00	
<b>Pic 3 Desc.</b>	ECD's and row conditions		<b>Pic 4 Desc.</b>	ECD's and row conditions
