Visual Site Inspection Report

Project Name	H-600 Pipeline Spread H	AFE	124300138	Spread	H-600 Pipeline Spread H
Contractor	Precision			Report #	7497
Inspector	Pat Davis			Date/Time	1/20/2020 4:00 PM
Permit #	TBD	Inspection Type	VA SWPP	Station Begin	+0
State	VA	Inspection Area	Partial	Station End	+0
County	Roanoke	Ground	Frozen	Temperature (°F)	34.00
Municipality	N/A	Weather	Sunny	Rain Gauge (in)	0.10
				Rain Accumulation Time (days)	0.00

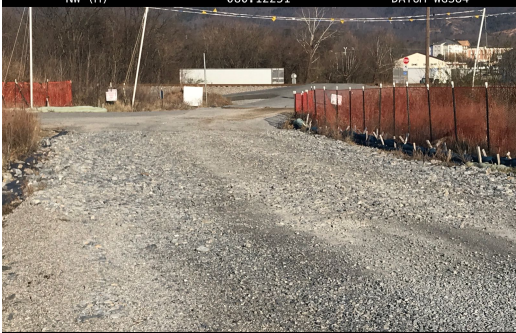
<p>DIRECTION NW (M) +37.27171° -080.12251° ACCURACY 16 ft DATUM WGS84</p> <p>MVP-LY-049_012020 Condition of rock entrance 2020-01-20 09:10:17-05:00</p>

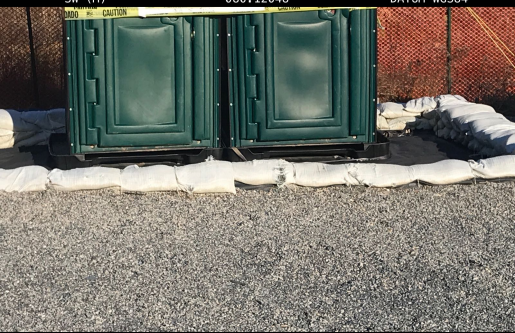
<p>DIRECTION SW (M) +37.27154° -080.12048° ACCURACY 16 ft DATUM WGS84</p> <p>MVP-LY-049_012020 Condition of trays and containment 2020-01-20 09:24:59-05:00</p>	
GPS Location	MVP-LY-049 See photo great gps data		GPS Location	MVP-LY-049 See photo great gps data	
Field Station#	+0		Field Station#	+0	
Pic 1 Desc.	Condition of rock entrance on center driveway. Looking NW.		Pic 2 Desc.	Condition of trays and containment under toilets. Looking NE.

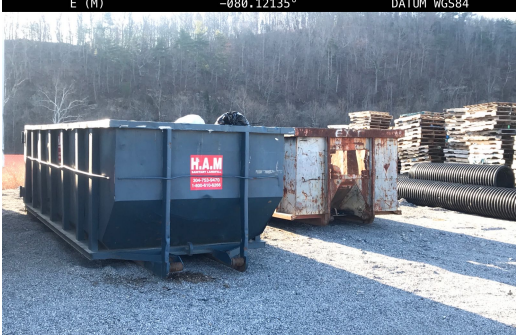
<p>DIRECTION E (M) +37.27039° -080.12135° ACCURACY 16 ft DATUM WGS84</p> <p>MVP-LY-049_012020 No loose trash around south dumpsters 2020-01-20 09:27:38-05:00</p>

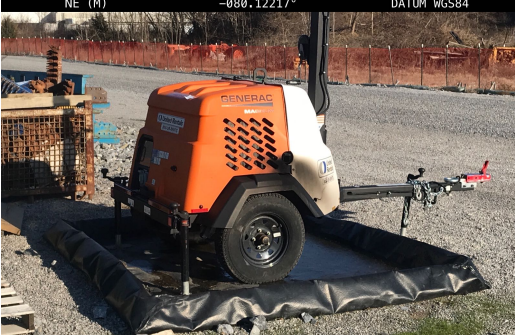
<p>DIRECTION NE (M) +37.27103° -080.12217° ACCURACY 16 ft DATUM WGS84</p> <p>MVP-LY-049_012020 Condition of containment 2020-01-20 09:28:39-05:00</p>

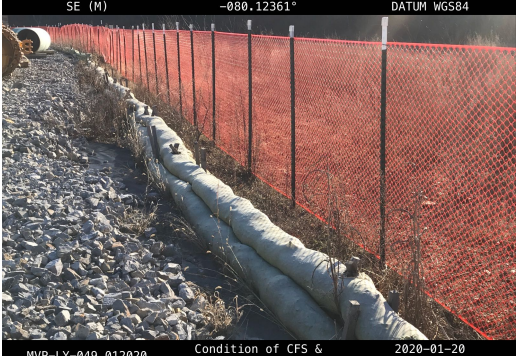
<p>DIRECTION SE (M) +37.26923° -080.12361° ACCURACY 33 ft DATUM WGS84</p> <p>MVP-LY-049_012020 Condition of CFS & safety fence 2020-01-20 09:33:57-05:00</p>

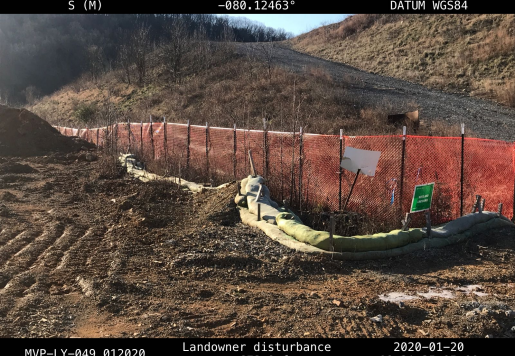
<p>DIRECTION S (M) +37.27052° -080.12463° ACCURACY 16 ft DATUM WGS84</p> <p>MVP-LY-049_012020 Landowner disturbance next to CFS & feature 2020-01-20 09:31:35-05:00</p>	
GPS Location	MVP-LY-049 See photo great gps data		GPS Location	MVP-LY-049 See photo great gps data	
Field Station#	+0		Field Station#	+0	
Pic 5 Desc.	Condition of compost filter sock and safety fence along south LOD. Looking SE.		Pic 6 Desc.	Landowner disturbance along CFS and feature. No impact. Looking S.

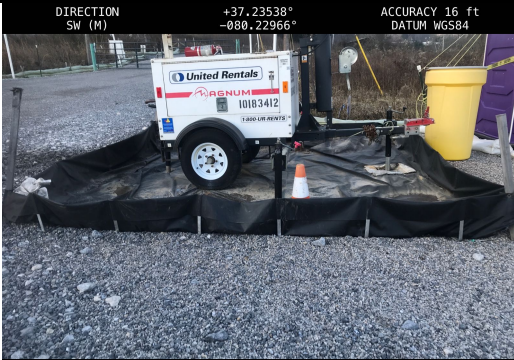
<p>DIRECTION SW (M) +37.23538° -080.22966° ACCURACY 16 ft DATUM WGS84</p> <p>MVP-PY-006_012020 Condition of containment 2020-01-20 08:14:04-05:00</p>

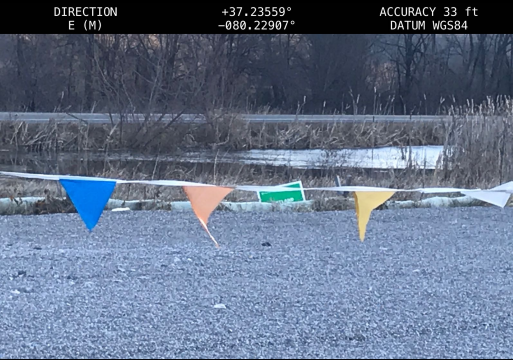
<p>DIRECTION E (M) +37.23559° -080.22907° ACCURACY 33 ft DATUM WGS84</p> <p>MVP-PY-006_012020 Signage and buffer flagging for feature 2020-01-20 08:19:21-05:00</p>			
GPS Location	MVP-PY-006 See photo for gps data		GPS Location	MVP-PY-006 See photo for gps data	
Field Station#	+0		Field Station#	+0	
Pic 1 Desc.	Condition of containment under light plant. Looking SW.		Pic 2 Desc.	Condition of signage and buffer flagging at feature. Looking NE.

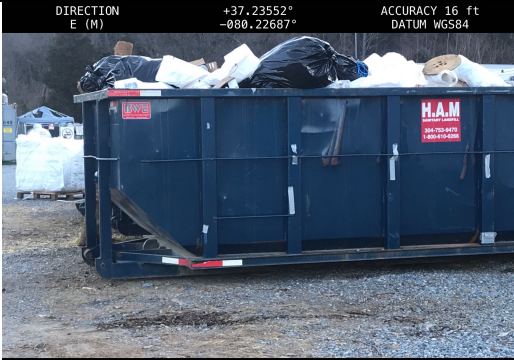
<p>DIRECTION E (M) +37.23552° -080.22687° ACCURACY 16 ft DATUM WGS84</p> <p>MVP-PY-006_012020 No loose trash around dumpsters 2020-01-20 08:21:54-05:00</p>

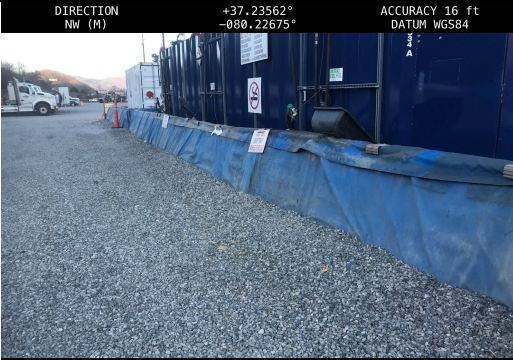
<p>DIRECTION NW (M) +37.23562° -080.22675° ACCURACY 16 ft DATUM WGS84</p> <p>MVP-PY-006_012020 No fluid deposits south of bulk tanks 2020-01-20 08:22:10-05:00</p>

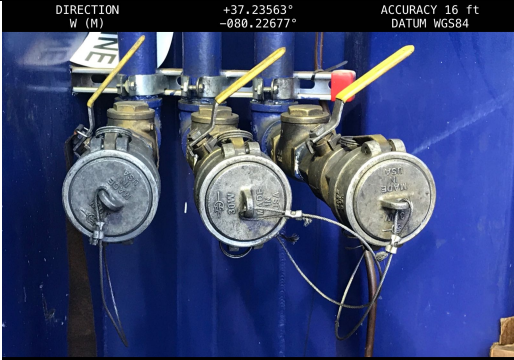
<p>DIRECTION W (M) +37.23563° -080.22677° ACCURACY 16 ft DATUM WGS84</p> <p>MVP-PY-006_012020 Blue Bulk Fuel tanks no leaky internal fi... 2020-01-20 08:22:53-05:00</p>

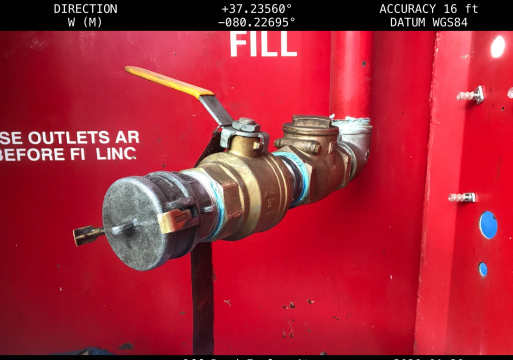
<p>DIRECTION W (M) +37.23560° -080.22695° ACCURACY 16 ft DATUM WGS84</p> <p>MVP-PY-006_012020 Off Road Fuel unit no leaky internal fitti... 2020-01-20 08:24:47-05:00</p>			
GPS Location	MVP-PY-006 See photo for gps data		GPS Location	MVP-PY-006 See photo for gps data	
Field Station#	+0		Field Station#	+0	
Pic 5 Desc.	Blue Bulk Fuel tanks no leaky internal fittings. Looking W.		Pic 6 Desc.	Off Road Fuel unit no leaky internal fittings. Looking W.

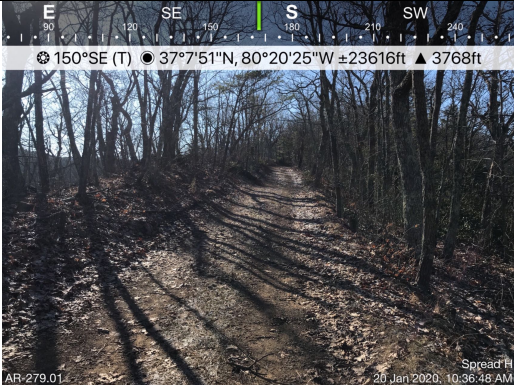
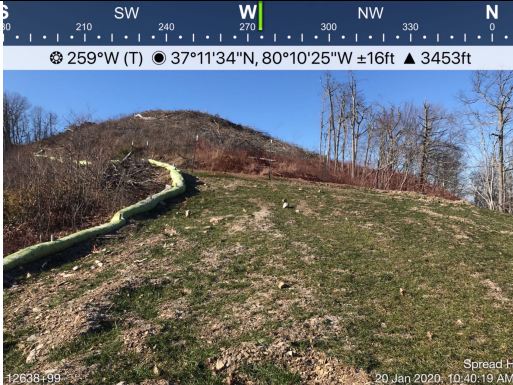
GPS Location	See photo	GPS Location	See photo		
Field Station#	279+01	Field Station#	12638+99		
Pic 1 Desc.	AR-279.01 in good condition	Pic 2 Desc.	Temporary stabilization and CFS controls in good condition.

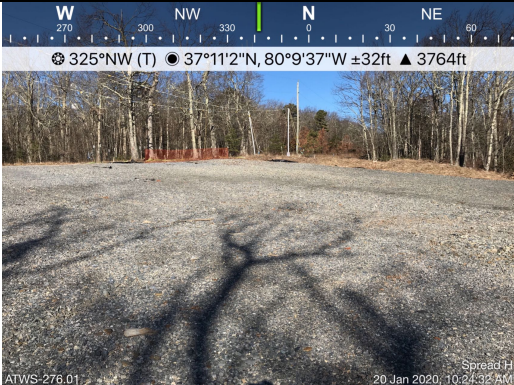
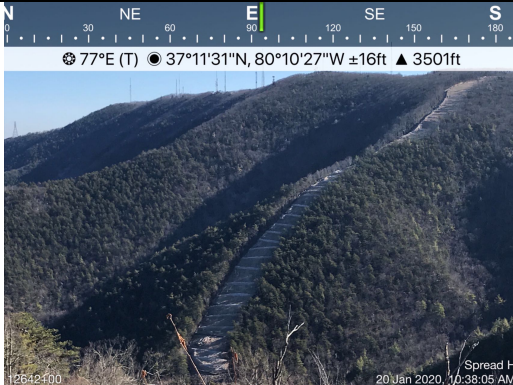
GPS Location	See photo	GPS Location	See photo		
Field Station#	2+80	Field Station#	12642+00		
Pic 3 Desc.	ATWS-280 remains inactive and controls are in acceptable condition.	Pic 4 Desc.	GAS of honeysuckle in good condition and controls appear to be functioning

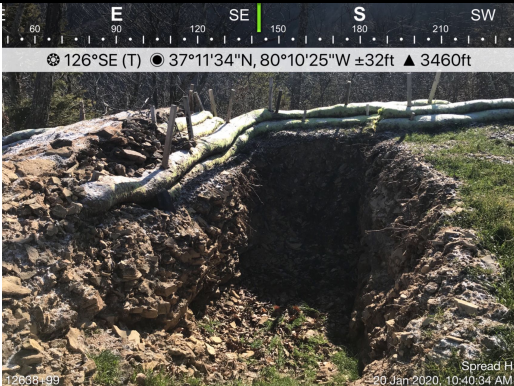
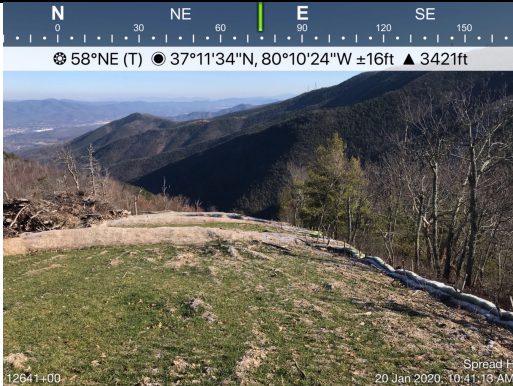
GPS Location	See photo	GPS Location	See photo		
Field Station#	12638+99	Field Station#	12641+00		
Pic 5 Desc.	End treatment in good condition	Pic 6 Desc.	Waterbars, end treatments, and other E&S controls in good condition on this slope

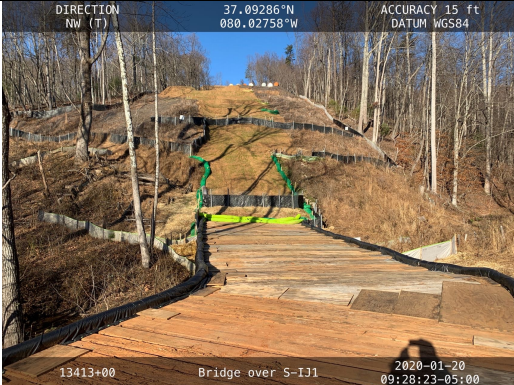
<p>DIRECTION NW (T) 37.09286°N 080.02758°W ACCURACY 15 ft DATUM WGS84</p> <p>13413+00 Bridge over S-IJ1 2020-01-20 09:28:23-05:00</p>

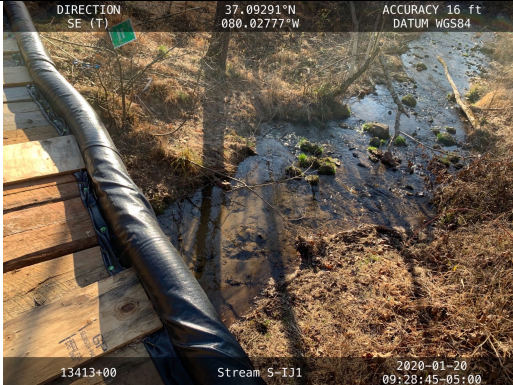
<p>DIRECTION SE (T) 37.09291°N 080.02777°W ACCURACY 16 ft DATUM WGS84</p> <p>13413+00 Stream S-IJ1 2020-01-20 09:28:45-05:00</p>			
GPS Location	See photo for gps location data.		GPS Location	See photo for gps location data.	
Field Station#	13414+00		Field Station#	13513+00	
Pic 1 Desc.	Photo shows the bridge over stream S-IJ1. No environmental issues observed.		Pic 2 Desc.	Photo shows the condition of stream S-IJ1. No issues observed.

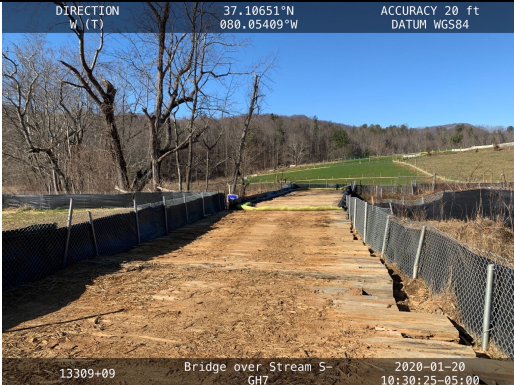
<p>DIRECTION W (T) 37.10651°N 080.05409°W ACCURACY 20 ft DATUM WGS84</p> <p>13309+09 Bridge over Stream S-GH7 2020-01-20 10:30:25-05:00</p>

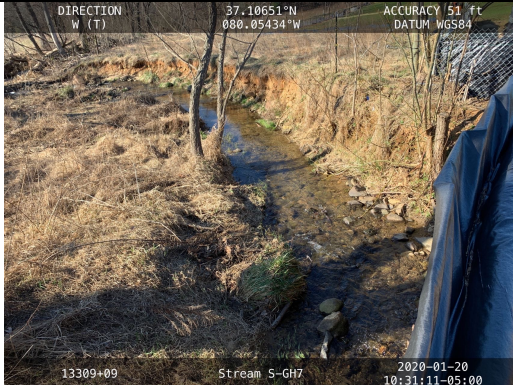
<p>DIRECTION W (T) 37.10651°N 080.05434°W ACCURACY 51 ft DATUM WGS84</p> <p>13309+09 Stream S-GH7 2020-01-20 10:31:11-05:00</p>

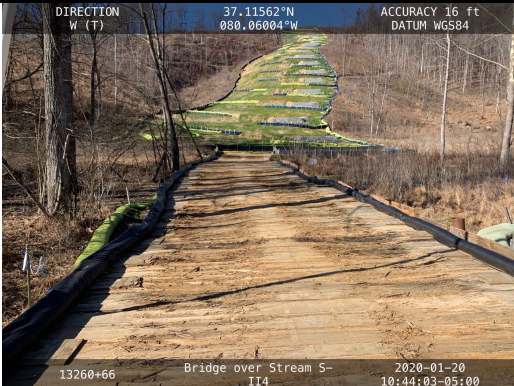
<p>DIRECTION W (T) 37.11562°N 080.06004°W ACCURACY 16 ft DATUM WGS84</p> <p>13260+66 Bridge over Stream S-II4 2020-01-20 10:44:03-05:00</p>

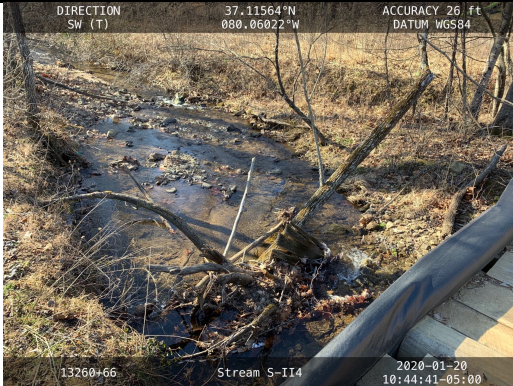
<p>DIRECTION SW (T) 37.11564°N 080.06022°W ACCURACY 26 ft DATUM WGS84</p> <p>13260+66 Stream S-II4 2020-01-20 10:44:41-05:00</p>			
GPS Location	See photo for gps location data.		GPS Location	See photo for gps location data.	
Field Station#	13260+66		Field Station#	13260+66	
Pic 5 Desc.	Photo shows the bridge over stream S-II4. No issues observed.		Pic 6 Desc.	Photo shows stream S-II4 downstream from the ROW. No issues observed.

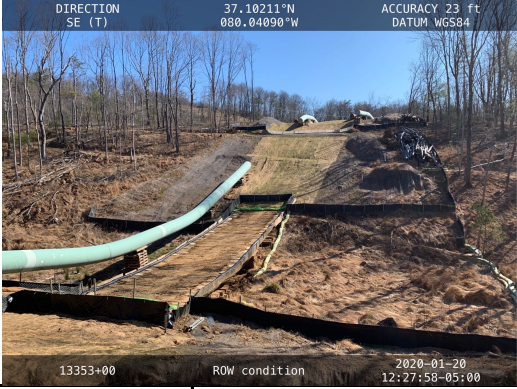
<p>DIRECTION SE (T) 37.10211°N 080.04090°W ACCURACY 23 ft DATUM WGS84</p> <p>13353+00 ROW condition 2020-01-20 12:27:50-05:00</p>			
GPS Location	See photo for gps location data.		GPS Location	See photo for gps location data.	
Field Station#	13196+31		Field Station#	13353+00	
Pic 7 Desc.	Photo shows stream S-D10 downstream of the access road. No issues observed.		Pic 8 Desc.	Photo shows the ROW condition from about 13353+00 to 13355+00. No issues observed.

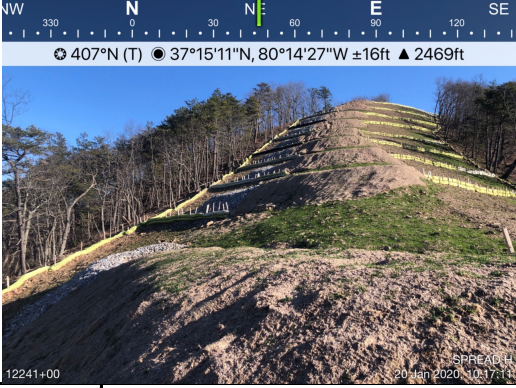
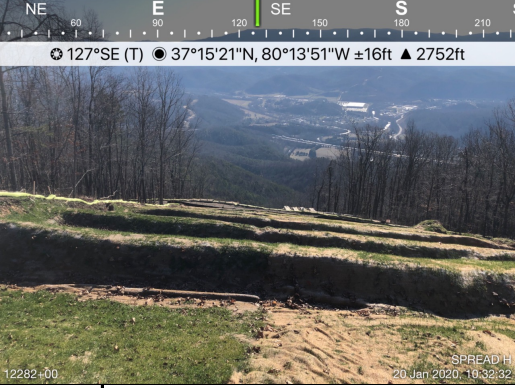
GPS Location	see photo	GPS Location	see photo		
Field Station#	12241+00	Field Station#	12282+00		
Pic 1 Desc.	Slope at the ar-276.03 switchback in good condition.	Pic 2 Desc.	Controls on place and vegetation filling in on this slope.

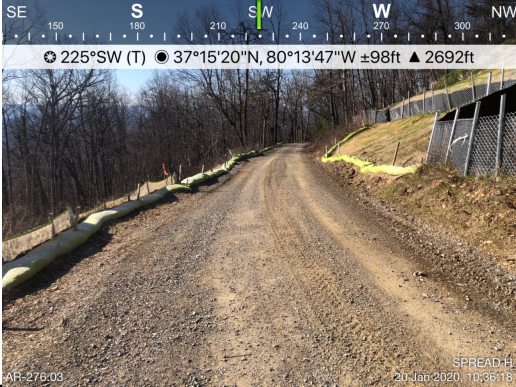
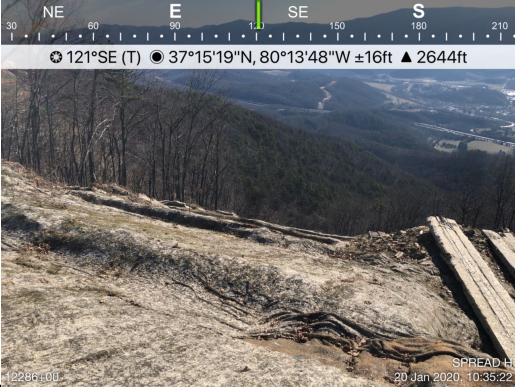
GPS Location	see photo	GPS Location	see photo		
Field Station#	276+03	Field Station#	12286+00		
Pic 3 Desc.	Controls along access road 276.03 in place	Pic 4 Desc.	GAS of ar-276.03 remains stabilized.

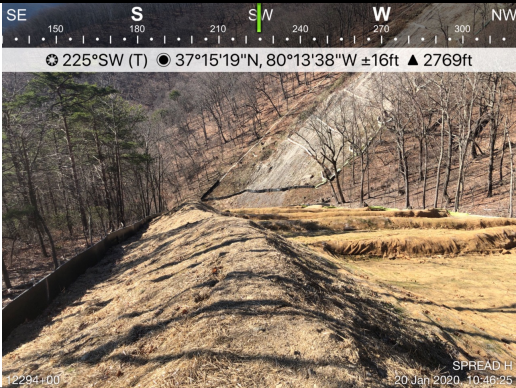
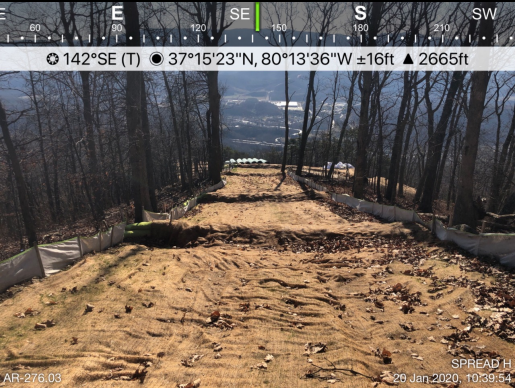
GPS Location	see photo	GPS Location	see photo		
Field Station#	12294+00	Field Station#	276+03		
Pic 5 Desc.	GAS of the "V" in good condition.	Pic 6 Desc.	Controls along access road 276.03 in place

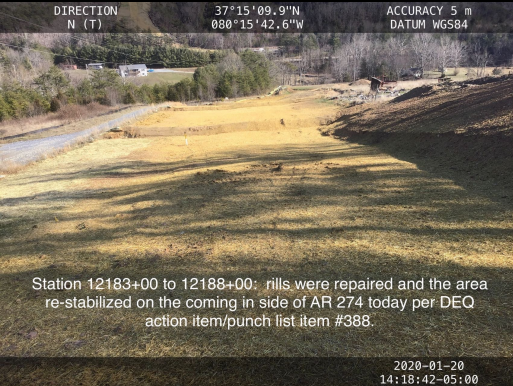
<p>Station 12183+00 to 12188+00: rills were repaired and the area re-stabilized on the coming in side of AR 274 today per DEQ action item/punch list item #388.</p> <p>2020-01-20 14:18:42-05:00</p>

GPS Location	See photo		GPS Location	See photo	
Field Station#	12132+73		Field Station#	12183+00	
Pic 5 Desc.	Stream S-C29, facing southeast		Pic 6 Desc.	A crew worked on the coming in side of AR 274 today where they fixed rill erosion and re-stabilized ROW per DEQ action item.

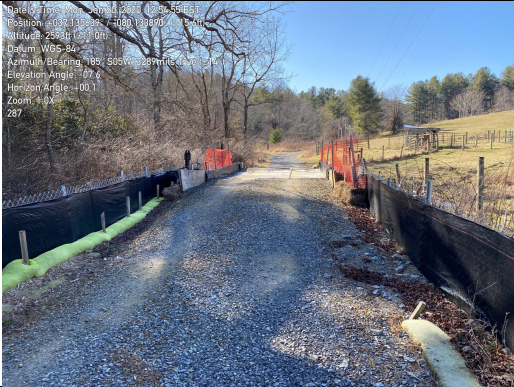
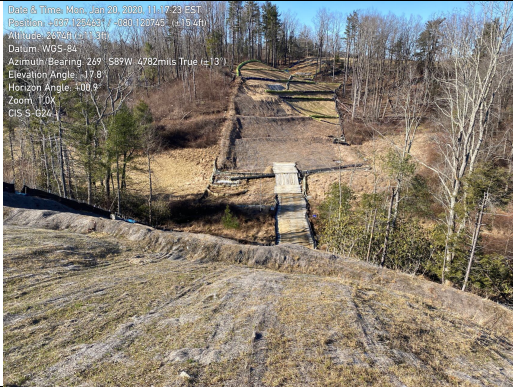
GPS Location	See photo for coordinates.		GPS Location	See photo for coordinates.	
Field Station#	12954+00		Field Station#	13026+00	
Pic 1 Desc.	MVP-RO-287, ECDs along access road in acceptable condition, no sediment released noted.		Pic 2 Desc.	S-G24 and S-G25, ROW stable with sparse vegetation, perimeter ECDs functioning acceptably.

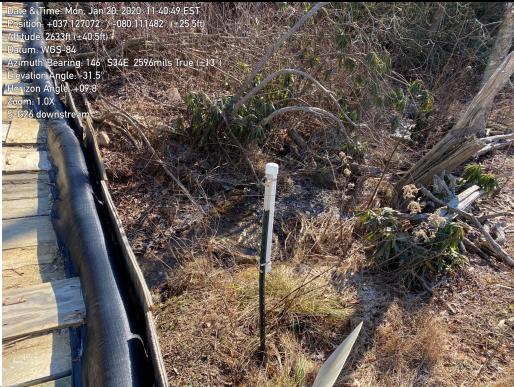
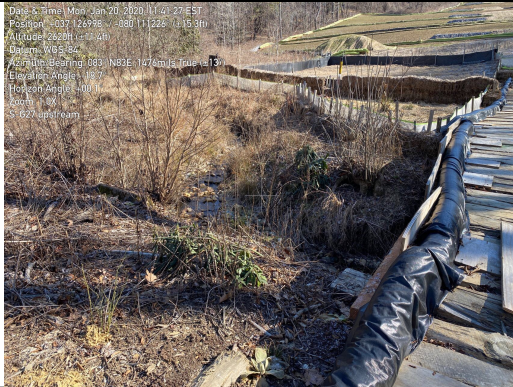
GPS Location	See photo for coordinates.		GPS Location	See photo for coordinates.	
Field Station#	13061+89		Field Station#	1302+96	
Pic 3 Desc.	S-G26, looking downstream of equipment bridge, ECDs functioning acceptably, no changes noted to stream bed or banks.		Pic 4 Desc.	S-G27, looking upstream of equipment bridge, no changes or environmental issues noted.

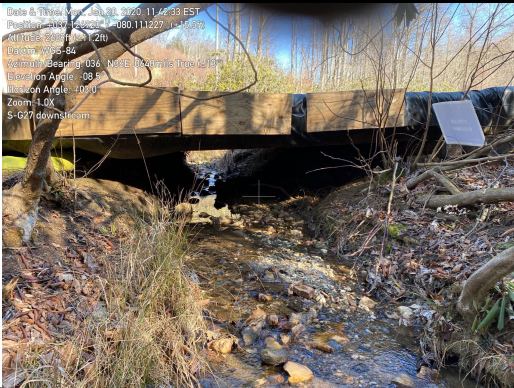
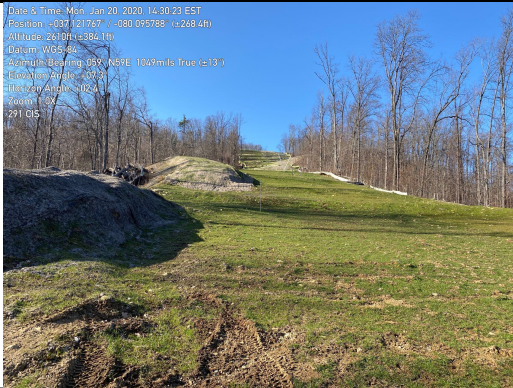
Pic 5 Desc.	S-G27, downstream side of equipment bridge, bridge in acceptable condition.		Pic 6 Desc.	ROW stabilized is moderate vegetation noted, soil piles stable, waterbars functioning acceptably.

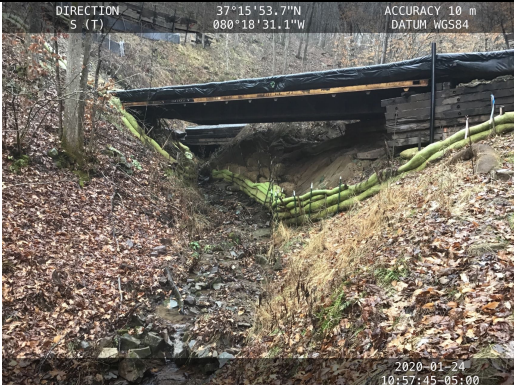
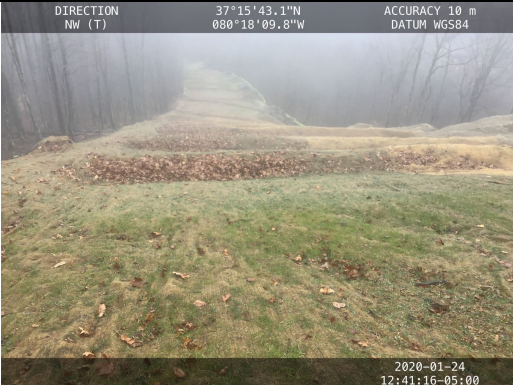
GPS Location	See photo		GPS Location	See photo	
Field Station#	12031+51		Field Station#	12153+00	
Pic 3 Desc.	Stream S-G39, facing south, upstream		Pic 4 Desc.	The long slope leading back toward stream S-G40, between Catawba and AR 270 remains well vegetated and stable.
