Visual Site Inspection Report

Project Name	H-600 Pipeline Spread H	AFE	124300138	Spread	H-600 Pipeline Spread H
Contractor	Precision			Report #	7763
Inspector	Logan Box			Date/Time	1/29/2020 5:30 PM
Permit #	TBD	Inspection Type	VA SWPP	Station Begin	13415+51
State	VA	Inspection Area	Partial	Station End	13670+00
County	Franklin	Ground	Damp	Temperature (°F)	48.00
Municipality	N/A	Weather	Cloudy	Rain Gauge (in)	0.00
				Rain Accumulation Time (days)	0.00

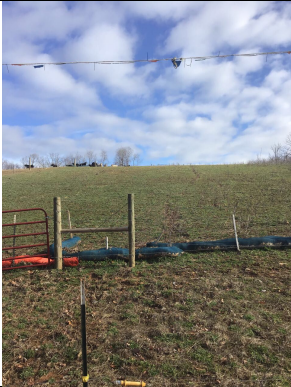
GPS Location	00000	GPS Location	00000		
Field Station#	13526+21	Field Station#	13522+78		
Pic 1 Desc.	Photo showing vegetation growth on row in a cow pasture.	Pic 2 Desc.	P1 requires maintenance, added to the punch list

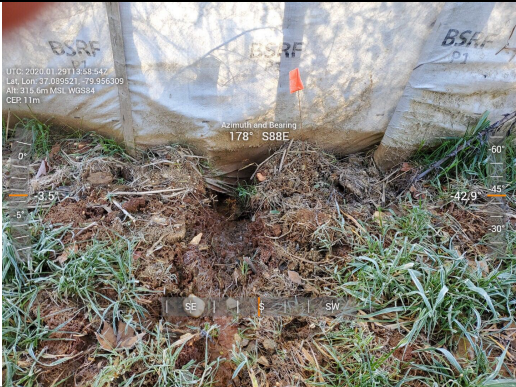
GPS Location	00000	GPS Location	0000		
Field Station#	13567+70	Field Station#	13565+30		
Pic 3 Desc.	P1 undermined, added to the punch list	Pic 4 Desc.	P1 requires maintenance, added to the punch list		
Insert image here		Insert image here			
GPS Location		GPS Location			
Field Station#		Field Station#			
Pic 5 Desc.		Pic 6 Desc.

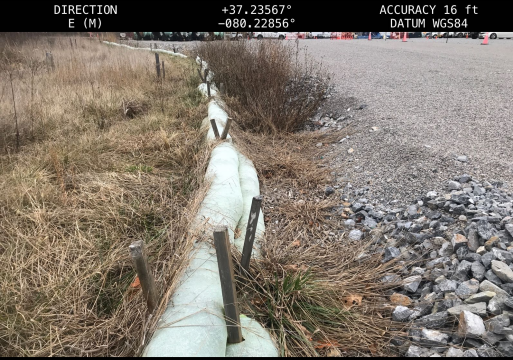
<p>DIRECTION E (M) +37.23567° -080.22656° ACCURACY 16 ft DATUM WGS84</p> <p>MVP-PY-006_013020 Condition of CFS north LOD 2020-01-30 08:32:10-05:00</p>			
GPS Location	MVP-PY-006 See photo for gps data		GPS Location	MVP-PY-006 See photo for gps data	
Field Station#	+0		Field Station#	+0	
Pic 1 Desc.	Signage and buffer flagging for feature in place. Looking NE.		Pic 2 Desc.	Condition of compost filter sock along North LOD. Looking E.

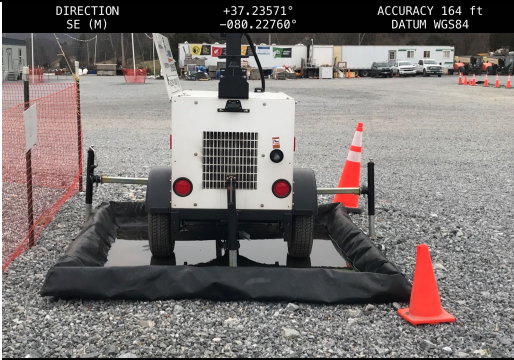
<p>DIRECTION SE (M) +37.23571° -080.22760° ACCURACY 164 ft DATUM WGS84</p> <p>MVP-PY-006_013020 Condition of containment 2020-01-30 08:34:15-05:00</p>

GPS Location	MVP-PY-006 See photo for gps data		GPS Location	MVP-PY-006 See photo for gps data	
Field Station#	+0		Field Station#	+0	
Pic 3 Desc.	Condition of containment under light plant. Looking SE. no		Pic 4 Desc.	No loose trash around dumpsters. Looking E.

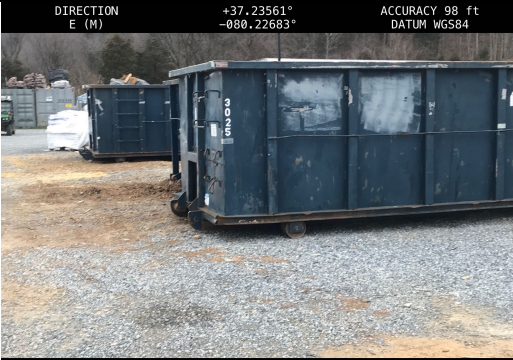
<p>DIRECTION E (M) +37.23561° -080.22683° ACCURACY 98 ft DATUM WGS84</p> <p>MVP-PY-006_013020 No loose trash around dumpsters 2020-01-30 08:35:39-05:00</p>

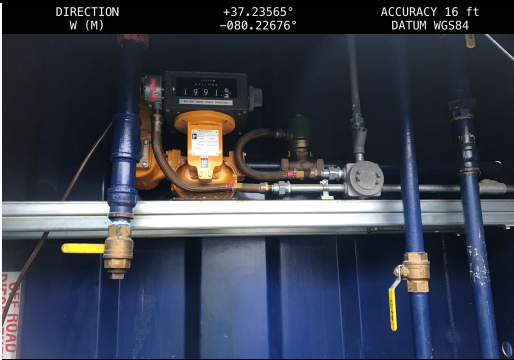
<p>DIRECTION W (M) +37.23565° -080.22676° ACCURACY 16 ft DATUM WGS84</p> <p>MVP-PY-006_013020 Blue Bulk Fuel tanks no leaky internal fittings 2020-01-30 08:36:31-05:00</p>

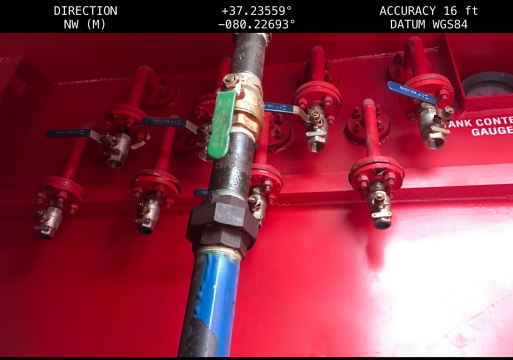
<p>DIRECTION NW (M) +37.23559° -080.22693° ACCURACY 16 ft DATUM WGS84</p> <p>MVP-PY-013020 Off Road Fuel unit no leaky internal fittings 2020-01-30 08:38:32-05:00</p>			
GPS Location	MVP-PY-006 See photo for gps data		GPS Location	MVP-PY-006 See photo for gps data	
Field Station#	+0		Field Station#	+0	
Pic 5 Desc.	Blue Bulk Fuel tanks no leaky internal fittings. Looking W.		Pic 6 Desc.	Off Road Fuel unit no leaky internal fittings. Looking W.

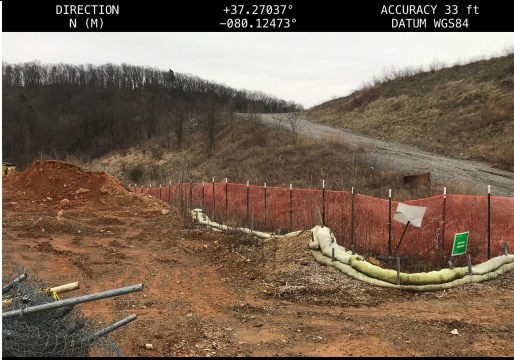
GPS Location	MVP-LY-049 See photo for gps data	GPS Location	MVP-LY-049 See photo for gps data		
Field Station#	+0	Field Station#	+0		
Pic 5 Desc.	Landowner disturbance along compost filter sock and feature. No impacts. Looking S.	Pic 6 Desc.	Condition of compost filter sock around sand pile. Looking W.

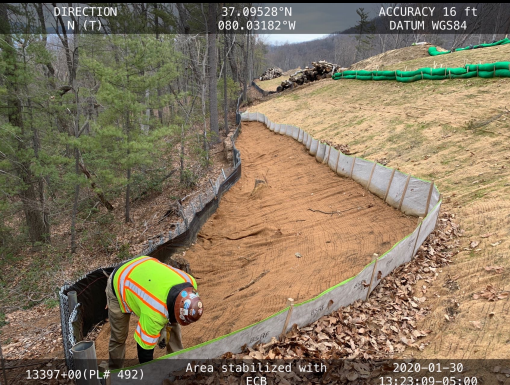
GPS Location	See photo for gps location data.		GPS Location	See photo for gps location data.	
Field Station#	13397+00		Field Station#	13373+00	
Pic 1 Desc.	Photo shows the area where the contractor smoothed rills and installed ECB (PL# 492).		Pic 2 Desc.	Photo shows the contractor repairing a section of SSF at about station 13373+00.
