# Visual Site Inspection Report

<b>Project Name</b>	H-600 Pipeline Spread H	<b>AFE</b>	124300138	<b>Spread</b>	H-600 Pipeline Spread H	
<b>Contractor</b>	Precision			<b>Report #</b>	6711	
<b>Inspector</b>	Pat Davis			<b>Date/Time</b>	12/17/2019 4:10 PM	
<b>Permit #</b>	TBD	<b>Inspection Type</b>	VA SWPP	<b>Station Begin</b>	+0	
<b>State</b>	VA	<b>Inspection Area</b>	Partial	<b>Station End</b>	+0	
<b>County</b>	Montgomery	<b>Ground</b>	Wet	<b>Temperature (°F)</b>	42.00	
<b>Municipality</b>	N/A	<b>Weather</b>	Light Rain	<b>Rain Gauge (in)</b>	0.10	
				<b>Rain Accumulation Time (days)</b>	0.00

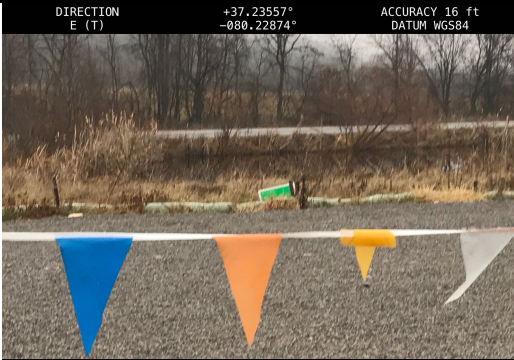
<p>DIRECTION E (T) +37.23557° -080.22674° ACCURACY 16 ft DATUM WGS84</p> <p>MVP-PY-006_121719 Signage and buffer flagging for feature 2019-12-17 08:09:24-05:00</p>

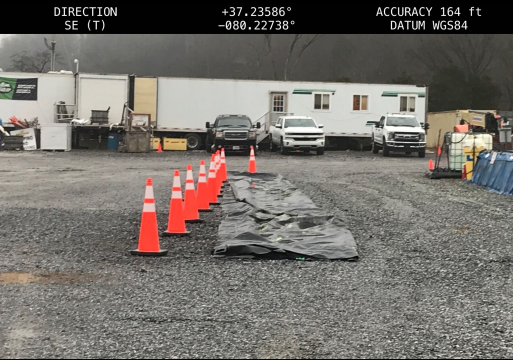
<p>DIRECTION SE (T) +37.23586° -080.22738° ACCURACY 164 ft DATUM WGS84</p> <p>MVP-PY-006_121719 Containment for tankers offloading o... 2019-12-17 08:10:16-05:00</p>			
<b>GPS Location</b>	MVP-PY-006 See photo for gps data		<b>GPS Location</b>	MVP-PY-006 See photo for gps data	
<b>Field Station#</b>	+0		<b>Field Station#</b>	+0	
<b>Pic 1 Desc.</b>	Signage and buffer flagging for feature. Looking N.		<b>Pic 2 Desc.</b>	Containment for tankers offloading fuel on site. Looking SE.

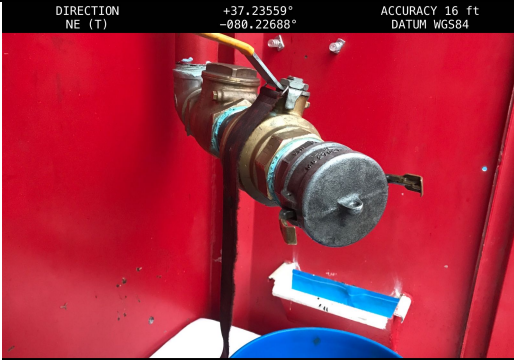
<p>DIRECTION NE (T) +37.23559° -080.22688° ACCURACY 16 ft DATUM WGS84</p> <p>MVP-PY-006_121719 Off Road Fuel unit no leaky internal fitti... 2019-12-17 08:11:47-05:00</p>

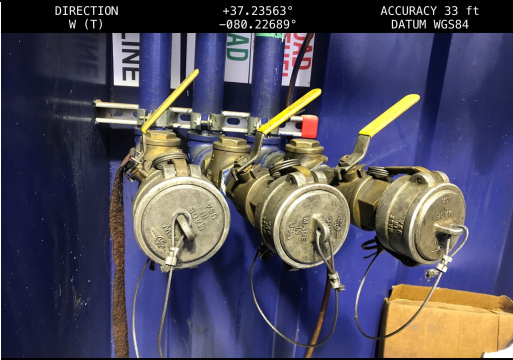
<p>DIRECTION W (T) +37.23563° -080.22689° ACCURACY 33 ft DATUM WGS84</p> <p>MVP-PY-006_121719 Blue Bulk Fuel tanks no leaky internal fi... 2019-12-17 08:13:47-05:00</p>

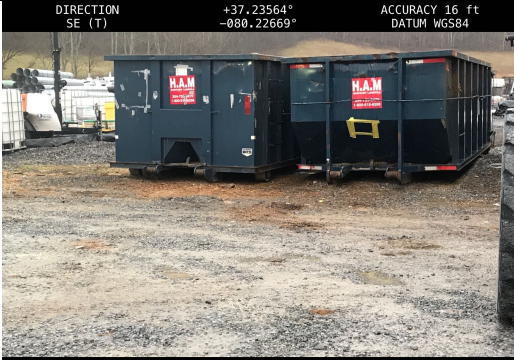
<p>DIRECTION SE (T) +37.23564° -080.22669° ACCURACY 16 ft DATUM WGS84</p> <p>MVP-PY-006_121719 No loose trash around dumpsters 2019-12-17 08:16:33-05:00</p>

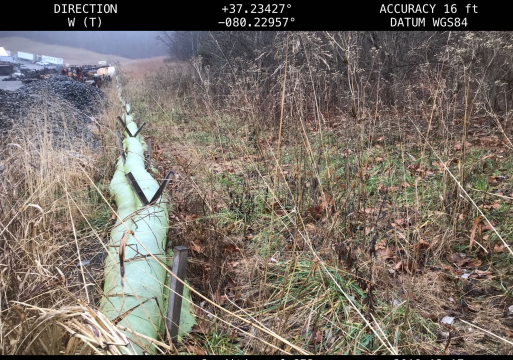
<p>DIRECTION W (T) +37.23427° -080.22957° ACCURACY 16 ft DATUM WGS84</p> <p>MVP-PY-006_121719 Condition of CFS south LOD 2019-12-17 08:21:36-05:00</p>			
<b>GPS Location</b>	MVP-PY-006 See photo for gps data		<b>GPS Location</b>	MVP-PY-006 See photo for gps data	
<b>Field Station#</b>	+0		<b>Field Station#</b>	+0	
<b>Pic 5 Desc.</b>	No loose trash around dumpsters. Looking SE.		<b>Pic 6 Desc.</b>	Condition of compost filter sock along south LOD. Looking E.

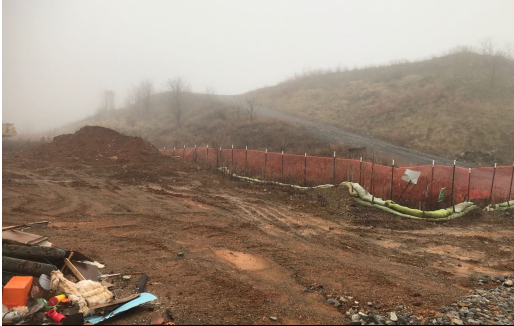
<div> MVP-LY-049_121719 Landowner disturbance along CFS &amp; feature 2019-12-17 09:20:47-05:00 </div>		<div> DIRECTION SW (T) +37.27197° -080.12280° ACCURACY 16 ft DATUM WGS84 </div>

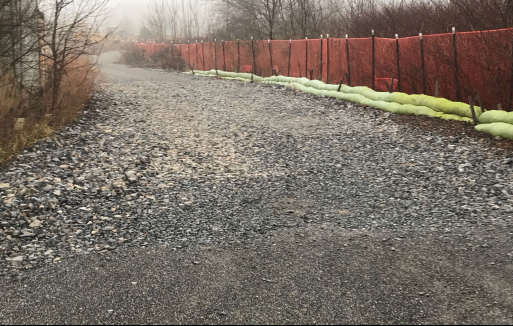
<div> MVP-LY-049_121719 Condition of rock entrance 2019-12-17 09:02:47-05:00 </div>			
<b>GPS Location</b>	MVP-LY-049 See photo for gps data		<b>GPS Location</b>	MVP-LY-049 See photo for gps data	
<b>Field Station#</b>	+0		<b>Field Station#</b>	+0	
<b>Pic 1 Desc.</b>	Landowner disturbance along CFS and feature. No impacts. Looking S.		<b>Pic 2 Desc.</b>	Condition of rock entrance on north drive. Looking SW.	
<div> DIRECTION S (T) +37.27047° -080.12142° ACCURACY 16 ft DATUM WGS84 </div>

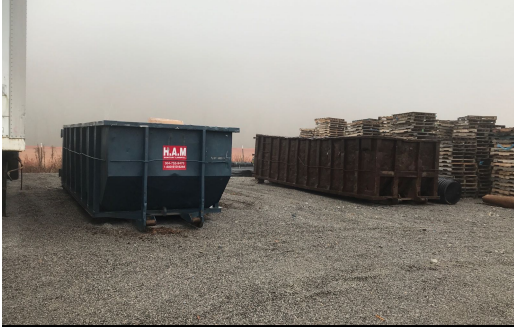
<div> MVP-LY-049_121719 No loose trash around south dumpsters 2019-12-17 09:09:07-05:00 </div>		<div> DIRECTION W (T) +37.26904° -080.12348° ACCURACY 16 ft DATUM WGS84 </div>

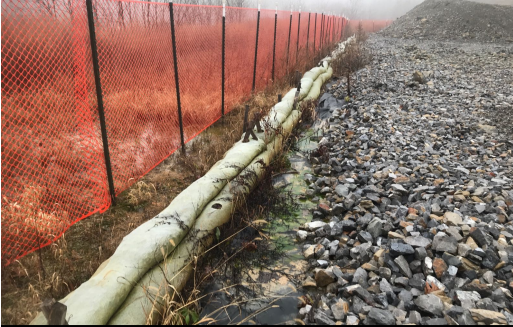
<div> MVP-LY-049_121719 Condition of CFS &amp; safety fence south L... 2019-12-17 09:14:17-05:00 </div>

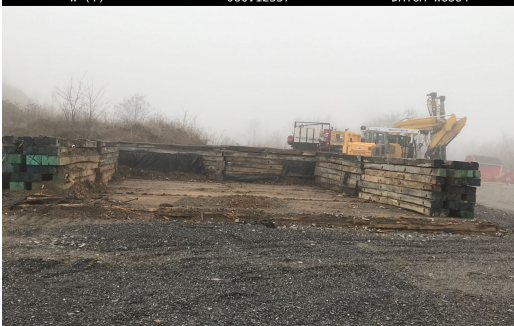
<div> MVP-LY-049_121719 Condition of temporary trash tran... 2019-12-17 09:19:55-05:00 </div>		<div> DIRECTION N (T) +37.26918° -080.12406° ACCURACY 16 ft DATUM WGS84 </div>

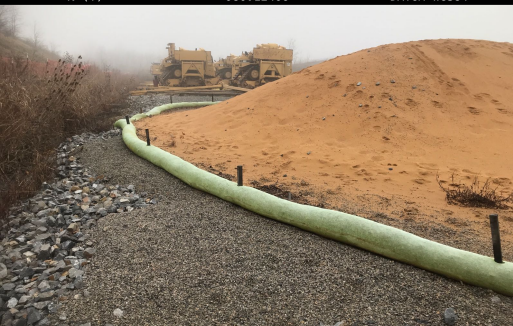
<div> MVP-LY-049_121719 Condition of CFS around sand pile 2019-12-17 09:16:25-05:00 </div>			
<b>GPS Location</b>	MVP-LY-049 See photo for gps data		<b>GPS Location</b>	MVP-LY-049 See photo for gps data	
<b>Field Station#</b>	+0		<b>Field Station#</b>	+0	
<b>Pic 5 Desc.</b>	Condition of the temporary trash transfer pit. Looking W.		<b>Pic 6 Desc.</b>	Condition of compost filter sock around sand pile. Looking N.

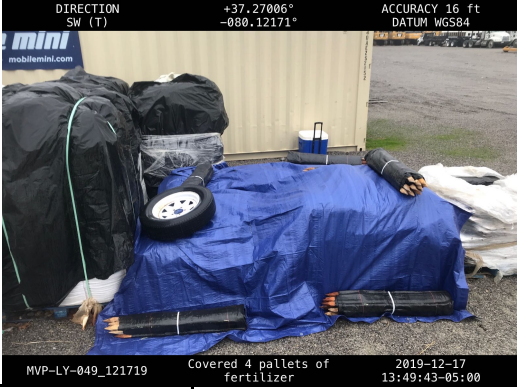
Insert image here			
<p> <small> DIRECTION SW (T) +37.27006° -080.12171° ACCURACY 16 ft DATUM WGS84 MVP-LY-049_121719 Covered 4 pallets of fertilizer 2019-12-17 13:49:43-05:00 </small> </p>					
<b>GPS Location</b>	See photo for gps data		<b>GPS Location</b>		
<b>Field Station#</b>	+0		<b>Field Station#</b>		
<b>Pic 7 Desc.</b>	Covered four pallets of fertilizer. Looking SW.		<b>Pic 8 Desc.</b>		
Insert image here			Insert image here		
<b>GPS Location</b>			<b>GPS Location</b>		
<b>Field Station#</b>			<b>Field Station#</b>		
<b>Pic 9 Desc.</b>			<b>Pic 10 Desc.</b>		
Insert image here			Insert image here		
<b>GPS Location</b>			<b>GPS Location</b>		
<b>Field Station#</b>			<b>Field Station#</b>		
<b>Pic 11 Desc.</b>			<b>Pic 12 Desc.</b>

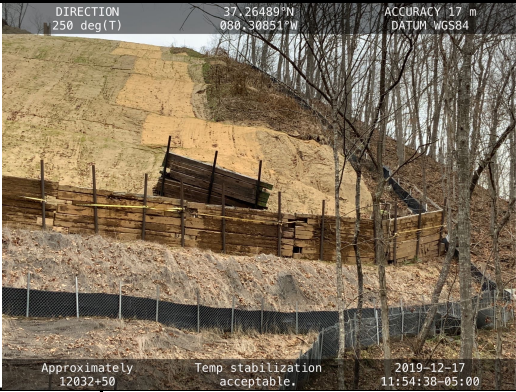
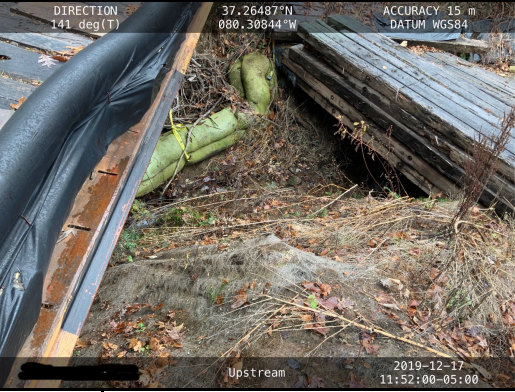
<b>Pic 5 Desc.</b>	All ECDs are in acceptable condition at this time in this area. Erosion blanket is in place and sumps functioning properly.		<b>Pic 6 Desc.</b>	S-G39 is clear and free of ROW sediment at time of inspection.

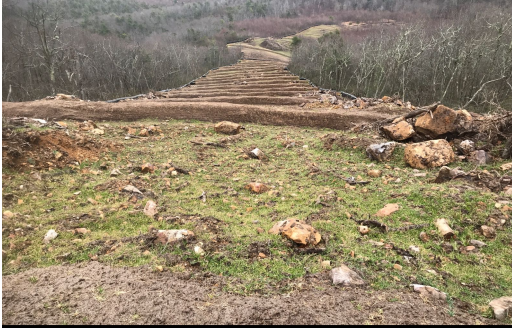
12692+47_121719 Condition of ROW and vegetation growth 2019-12-17 10:43:13-05:00			DIRECTION W (T) +37.19301° -080.15941° ACCURACY 16 ft DATUM WGS84

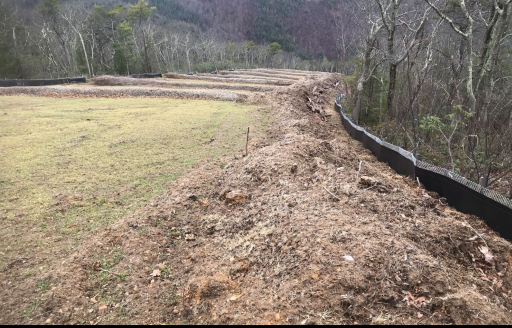
12683+09_121719 Condition of ROW & SSP 2019-12-17 11:15:43-05:00	
<b>GPS Location</b>	See photo for gps data		<b>GPS Location</b>	See photo for gps data	
<b>Field Station#</b>	12692+47		<b>Field Station#</b>	12683+09	
<b>Pic 1 Desc.</b>	Condition of ROW and vegetation growth. Looking E.		<b>Pic 2 Desc.</b>	Condition of super silt fence and ROW vegetation growth. Looking W.	
	DIRECTION SE (T) +37.19067° -080.15322° ACCURACY 16 ft DATUM WGS84

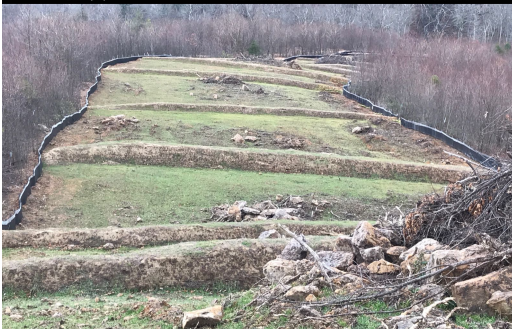
12703+08_121719 Condition of ROW and vegetation growth 2019-12-17 11:51:07-05:00			DIRECTION W (T) +37.19064° -080.15362° ACCURACY 16 ft DATUM WGS84

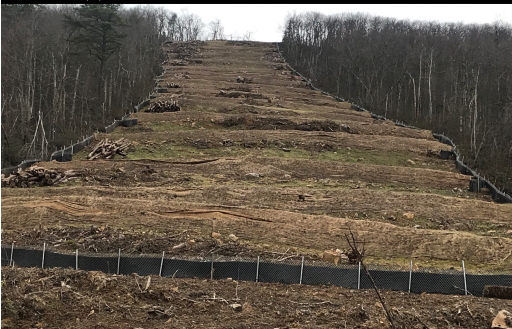
12702+53_121719 Condition of ROW and vegetation growth 2019-12-17 11:50:06-05:00

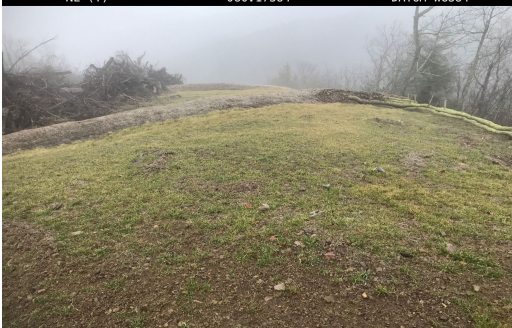
12640+00_121719 Condition of ROW and vegetation growth 2019-12-17 12:11:31-05:00			DIRECTION SW (T) +37.20578° -080.17383° ACCURACY 0.53 m1 DATUM WGS84

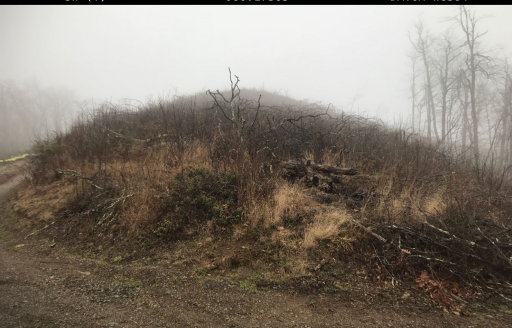
12637+71_121719 Condition of ROW down trees 2019-12-17 12:11:24-05:00	
<b>GPS Location</b>	See photo for gps data		<b>GPS Location</b>	See photo for gps data	
<b>Field Station#</b>	12640+00		<b>Field Station#</b>	12637+71	
<b>Pic 5 Desc.</b>	Condition of compost filter sock and ROW vegetation growth. Looking NE.		<b>Pic 6 Desc.</b>	Condition of ROW, I disturbed. Looking W.

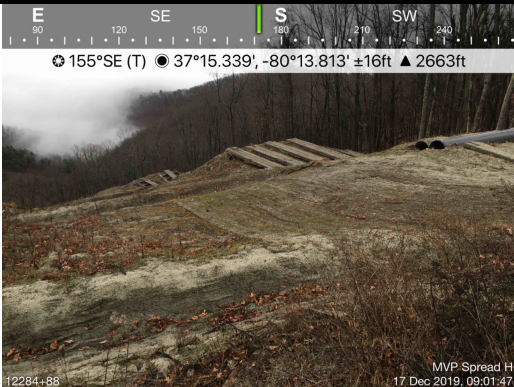
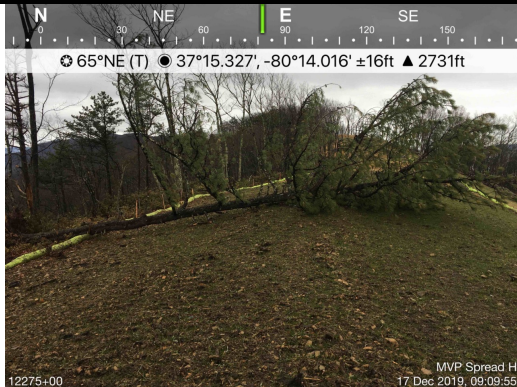
<b>GPS Location</b>	See Picture Watermark		<b>GPS Location</b>	See Picture Watermark	
<b>Field Station#</b>	12284+88		<b>Field Station#</b>	12275+00	
<b>Pic 3 Desc.</b>	CIS "V" remains stabilized and free of accelerated erosion.		<b>Pic 4 Desc.</b>	Fallen tree from off ROW.

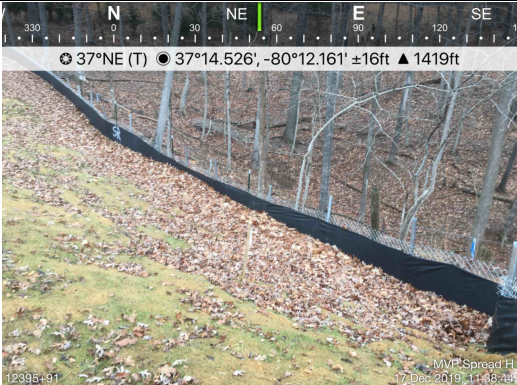
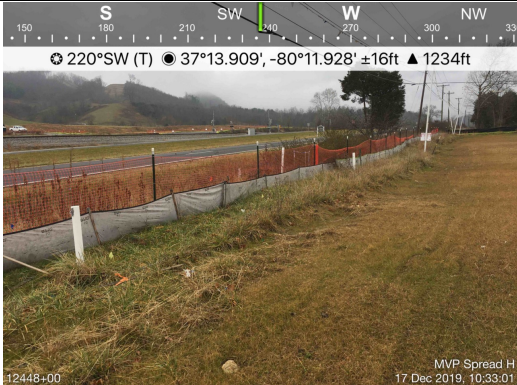
<b>Pic 17 Desc.</b>	SSF installed and in good condition.		<b>Pic 18 Desc.</b>	End of inspection area CIS Rt. 11 is well vegetated and free of any accelerated erosion.
