# Visual Site Inspection Report

<b>Project Name</b>	H-600 Pipeline Spread H	<b>AFE</b>	124300138	<b>Spread</b>	H-600 Pipeline Spread H
<b>Contractor</b>	Precision			<b>Report #</b>	7002
<b>Inspector</b>	Logan Box			<b>Date/Time</b>	12/31/2019 4:50 PM
<b>Permit #</b>	TBD	<b>Inspection Type</b>	VA SWPP	<b>Station Begin</b>	13415+51
<b>State</b>	VA	<b>Inspection Area</b>	Partial	<b>Station End</b>	13670+00
<b>County</b>	Franklin	<b>Ground</b>	Damp	<b>Temperature (°F)</b>	51.00
<b>Municipality</b>	N/A	<b>Weather</b>	Sunny	<b>Rain Gauge (in)</b>	0.00
				<b>Rain Accumulation Time (days)</b>	0.00

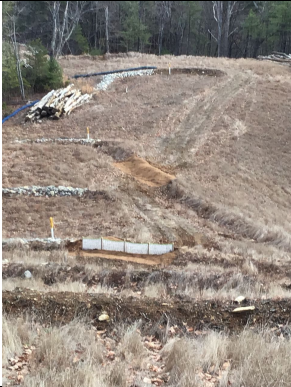
<b>GPS Location</b>	00000	<b>GPS Location</b>	0000		
<b>Field Station#</b>	13485+50	<b>Field Station#</b>	13430+00		
<b>Pic 1 Desc.</b>	Temporary repairs made to 3rd party damage to water bars until the row is dry enough for equipment to fix to spec.		<b>Pic 2 Desc.</b>	Row photo showing vegetation

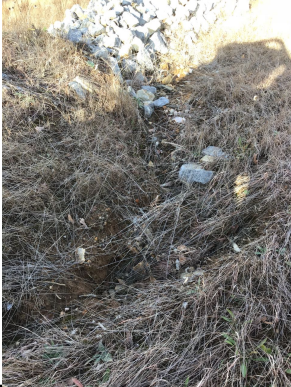
<b>GPS Location</b>	00000	<b>GPS Location</b>	00000		
<b>Field Station#</b>	13436+44	<b>Field Station#</b>	13425+33		
<b>Pic 3 Desc.</b>	Minor erosion channel, talked with environmental crew about making repairs while in the area.		<b>Pic 4 Desc.</b>	Minor erosion channel, talked with environmental crew and discussed making repairs while in the area	
Insert image here			Insert image here		
<b>GPS Location</b>		<b>GPS Location</b>			
<b>Field Station#</b>		<b>Field Station#</b>			
<b>Pic 5 Desc.</b>			<b>Pic 6 Desc.</b>

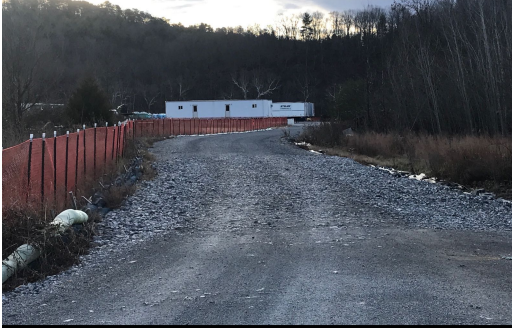
MVP-LY-049_010220 Condition of rock entrance 2020-01-02 08:58:39-05:00			DIRECTION Unavailable +37.27043° -080.12138° ACCURACY 16 ft DATUM WGS84

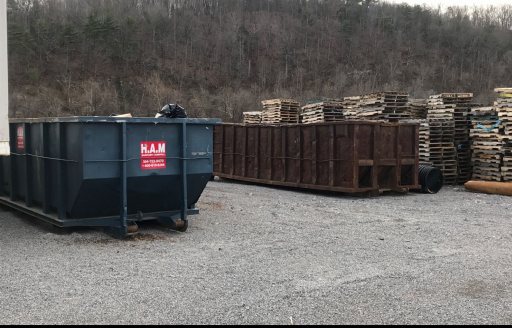
MVP-LY-049_010220 No loose trash around south dumpsters 2020-01-02 09:08:10-05:00	
<b>GPS Location</b>	MVP-LY-049 See photo for gps data		<b>GPS Location</b>	MVP-LY-049 See photo for gps data	
<b>Field Station#</b>	+0		<b>Field Station#</b>	+0	
<b>Pic 1 Desc.</b>	Condition of rock entrance on center driveway. Looking S.		<b>Pic 2 Desc.</b>	No loose trash around south dumpsters. Looking SW.	
	DIRECTION Unavailable +37.26897° -080.12342° ACCURACY 16 ft DATUM WGS84

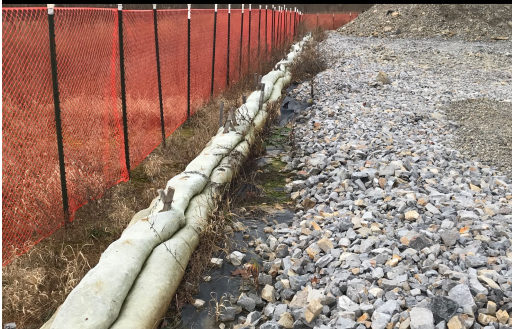
MVP-LY-049_010220 Condition of CFS & safety fence south 2020-01-02 09:12:17-05:00			DIRECTION Unavailable +37.27061° -080.12343° ACCURACY 33 ft DATUM WGS84

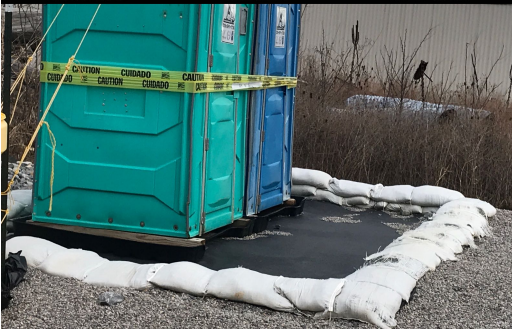
MVP-LY-049_010220 Condition of trays and containment 2020-01-02 09:17:39-05:00

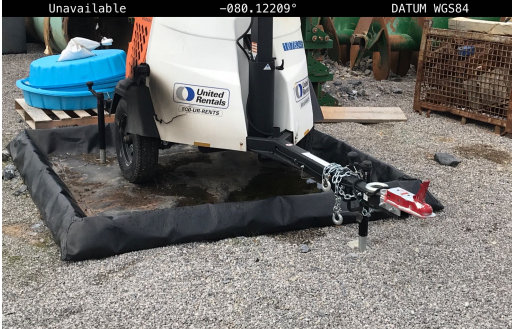
MVP-LY-049_010220 Condition of containment 2020-01-02 09:18:58-05:00			DIRECTION Unavailable +37.27041° -080.12470° ACCURACY 16 ft DATUM WGS84

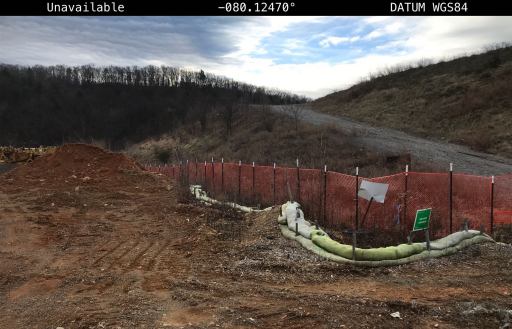
MVP-LY-049_010220 Landowner disturbance along CFS and feature 2020-01-02 09:16:41-05:00	
<b>GPS Location</b>	MVP-LY-049 See photo for gps data		<b>GPS Location</b>	MVP-LY-049 See photo for gps data	
<b>Field Station#</b>	+0		<b>Field Station#</b>	+0	
<b>Pic 5 Desc.</b>	Condition of containment under light plant. Looking NW.		<b>Pic 6 Desc.</b>	Landowner disturbance along compost filter sock and feature. No impacts. Looking S.

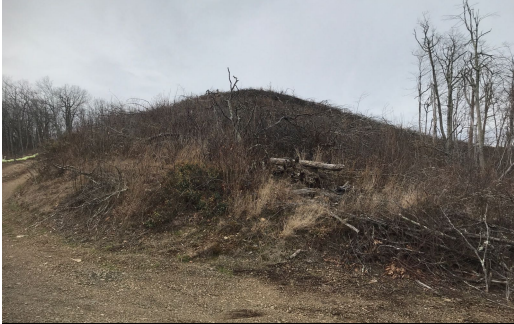
<div> 12637+71_010220 Condition of ROW 2020-01-02 11:20:22-05:00 </div>		<div> DIRECTION Unavailable +37.19288° -080.17407° ACCURACY 16 ft DATUM WGS84 </div>

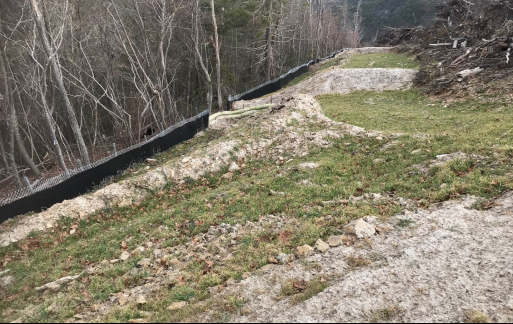
<div> 12640+00_010220 Condition of ROW &amp; erosion control meas... 2020-01-02 11:19:25-05:00 </div>			
<b>GPS Location</b>	See photo for gps data		<b>GPS Location</b>	See photo for gps data	
<b>Field Station#</b>	12637+71		<b>Field Station#</b>	12640+00	
<b>Pic 1 Desc.</b>	Condition of uncleared ROW. Looking NW.		<b>Pic 2 Desc.</b>	Condition of super silt fence and waterbars. Looking SE.	
<div> DIRECTION Unavailable +37.19156° -080.15676° ACCURACY 33 ft DATUM WGS84 </div>

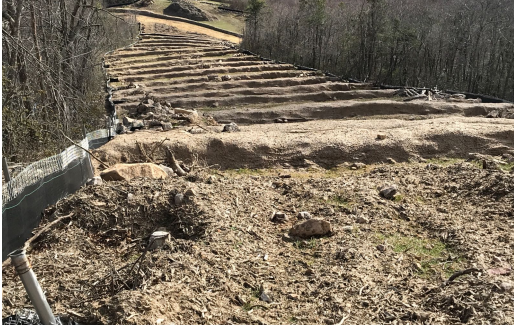
<div> 12692+47_010220 Condition of ROW &amp; erosion control meas... 2020-01-02 10:23:11-05:00 </div>		<div> DIRECTION Unavailable +37.19295° -080.15949° ACCURACY 33 ft DATUM WGS84 </div>

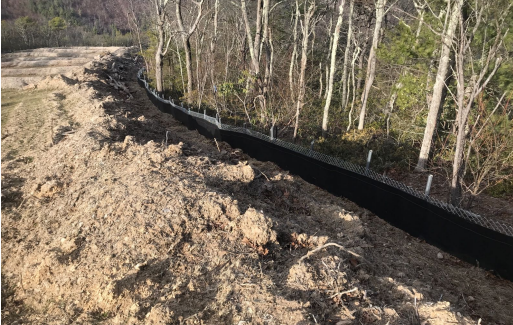
<div> 12683+09_010220 Condition of ROW &amp; erosion control meas... 2020-01-02 10:32:24-05:00 </div>

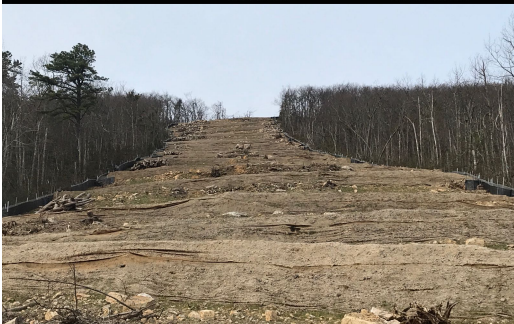
<div> 12702+53_010220 Condition of ROW &amp; erosion control meas... 2020-01-02 10:56:18-05:00 </div>		<div> DIRECTION Unavailable +37.19065° -080.15314° ACCURACY 16 ft DATUM WGS84 </div>

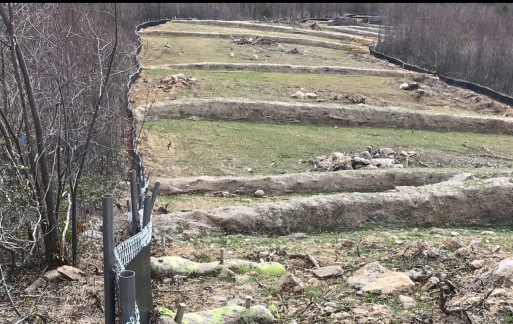
<div> 12703+08_010220 Condition of ROW &amp; erosion control meas... 2020-01-02 10:58:39-05:00 </div>			
<b>GPS Location</b>	See photo for gps data		<b>GPS Location</b>	See photo for gps data	
<b>Field Station#</b>	12702+53		<b>Field Station#</b>	12703+08	
<b>Pic 5 Desc.</b>	Condition of ROW, super silt fence and waterbars. Looking NW.		<b>Pic 6 Desc.</b>	Condition of ROW, super silt fence and waterbars. Looking SE.

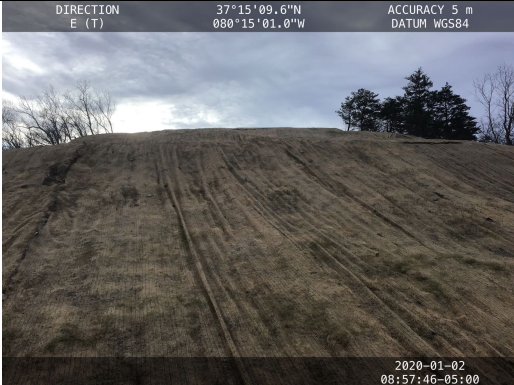
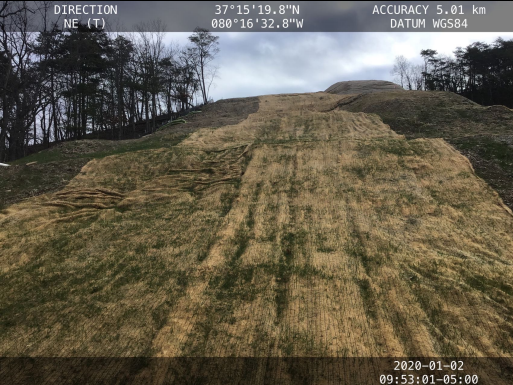
<b>GPS Location</b>	See photo		<b>GPS Location</b>	See photo	
<b>Field Station#</b>	12222+00		<b>Field Station#</b>	12206+00	
<b>Pic 1 Desc.</b>	The hillside below the switchback on Reese Mountain remains stable.		<b>Pic 2 Desc.</b>	The first slope going away from the railroad crossing at Bradshaw Road area is stable.

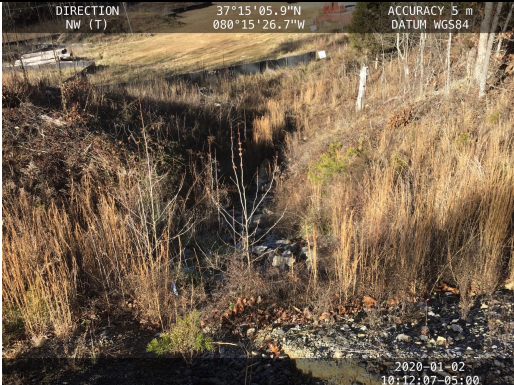
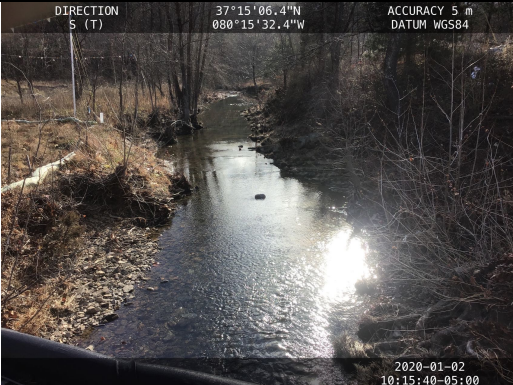
<b>GPS Location</b>	See photo		<b>GPS Location</b>	See photo	
<b>Field Station#</b>	12197+37		<b>Field Station#</b>	12192+50	
<b>Pic 3 Desc.</b>	Stream S-0011, facing northwest, downstream		<b>Pic 4 Desc.</b>	Stream S-C21, Bradshaw Creek, facing south, downstream

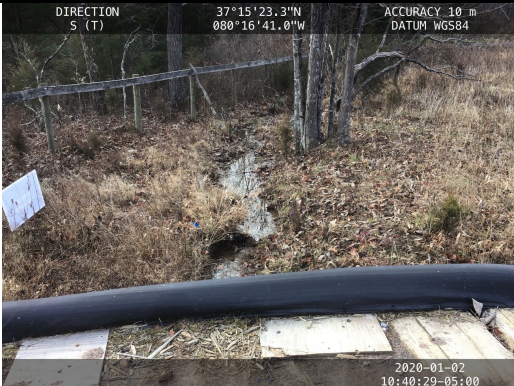
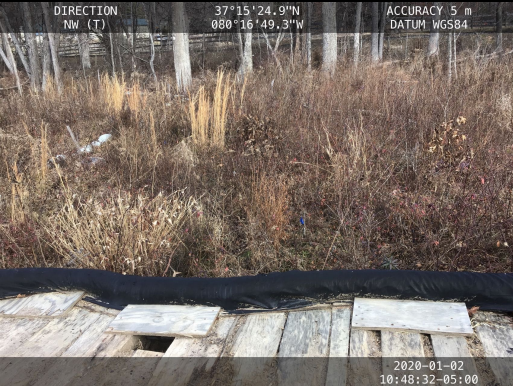
<b>GPS Location</b>	See photo		<b>GPS Location</b>	See photo	
<b>Field Station#</b>	12132+73		<b>Field Station#</b>	12125+65	
<b>Pic 5 Desc.</b>	Stream S-C29, facing south, downstream		<b>Pic 6 Desc.</b>	Stream S-MM15, facing northwest, upstream

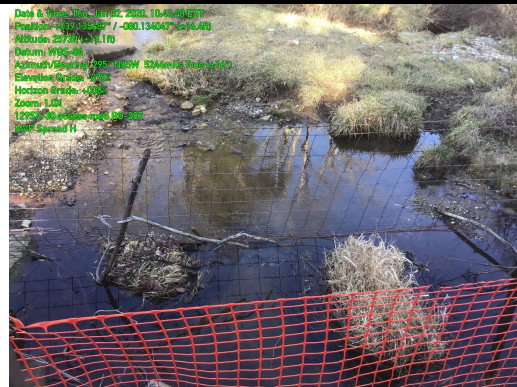
GPS Location		See pic for GPS location		GPS Location		See pic for GPS location
Field Station#		12957+30		Field Station#		12957+30
Pic 3 Desc.		Access road remains in good condition. No significant use for project needs has occurred.		Pic 4 Desc.		No impacts observed at stream S-Z17.
<div><div>Date &amp; Time: Thu, Jan 02, 2020, 10:46:05 EST</div><div>Position: +037.135354° / -080.128326° (±16.4M)</div><div>Altitude: 2572ft (±19.1ft)</div><div>Datum: WGS-84</div><div>Azimuth/Bearing: 108° S33E 1920mils True (±100°)</div><div>Elevation Grade: -00%</div><div>Horizon Grade: -000%</div><div>Zoom: 1.0M</div><div>12957+30 Access Road RO-288</div><div>MVP Spread H.</div></div>  			<div><div>Date &amp; Time: Thu, Jan 02, 2020, 10:49:42 EST</div><div>Position: +037.132135° / -080.131263° (±16.4M)</div><div>Altitude: 2572ft (±19.1ft)</div><div>Datum: WGS-84</div><div>Azimuth/Bearing: 030° N30E 5344mils True (±140°)</div><div>Elevation Grade: -00%</div><div>Horizon Grade: -000%</div><div>Zoom: 1.0M</div><div>12974+29 Access Road RO-288 ATWS near US 221</div><div>MVP Spread H.</div></div>

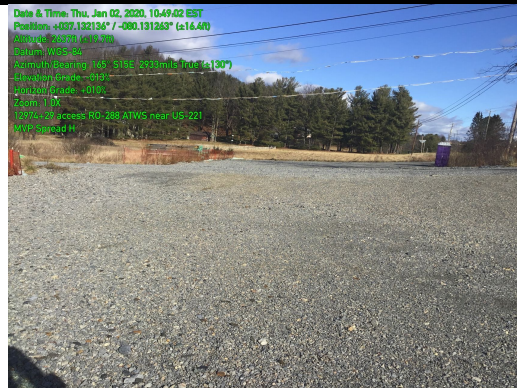
GPS Location		See pic for GPS location		GPS Location		See pic for GPS location
Field Station#		12957+30		Field Station#		12974+29
Pic 5 Desc.		S-Z16 was free from any impacts at the time of inspection.		Pic 6 Desc.		No issues or impacts observed at RO-288.

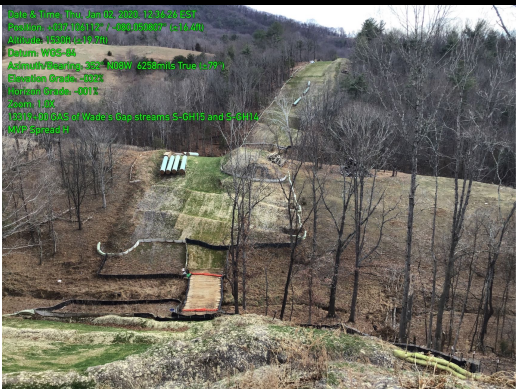
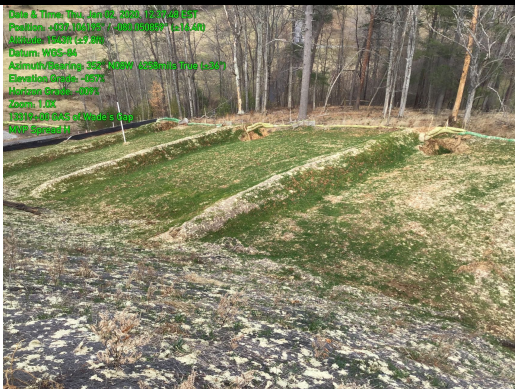
GPS Location	See pic for GPS location		GPS Location	See pic for GPS location	
Field Station#	13319+00		Field Station#	13319+00	
Pic 1 Desc.	No stream impacts observed at streams S-GH14 or S-GH15.		Pic 2 Desc.	ROW stabilized with temporary vegetative cover, ProGanics and FlexTera. Curlex applied to spoil piles and waterbar channels.

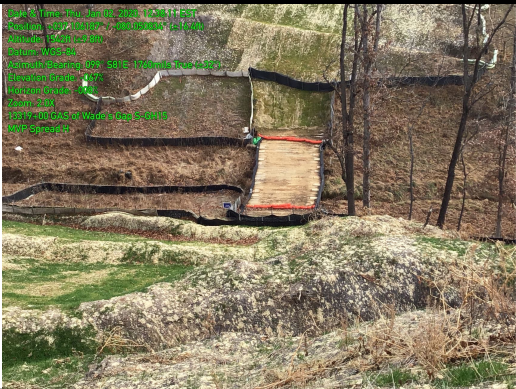
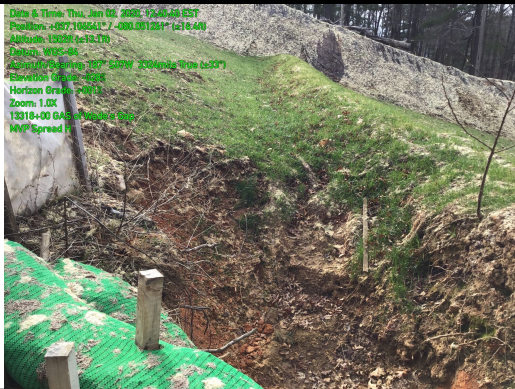
GPS Location	See pic for GPS location		GPS Location	See pic for GPS location	
Field Station#	13319+00		Field Station#	13318+00	
Pic 3 Desc.	All perimeter and buffer ECD's were in sufficient condition.		Pic 4 Desc.	Sumps were adequate and waterbars with in specifications.

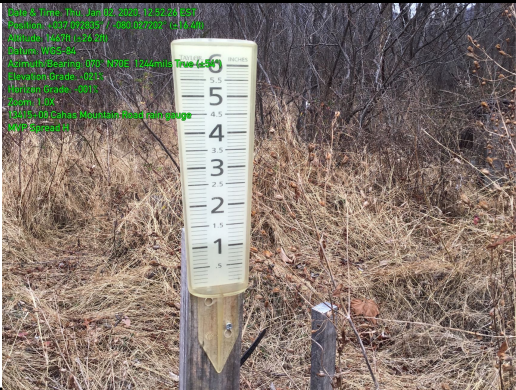
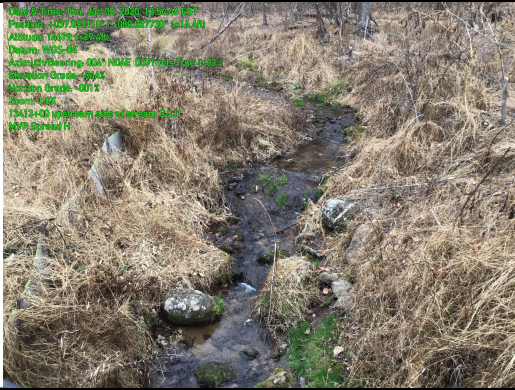
GPS Location	See pic for GPS location		GPS Location	See pic for GPS location	
Field Station#	13415+00		Field Station#	13413+00	
Pic 5 Desc.	0.0" total precipitation at Cahas Mountain Road.		Pic 6 Desc.	No impacts observed at stream S-IJ1.

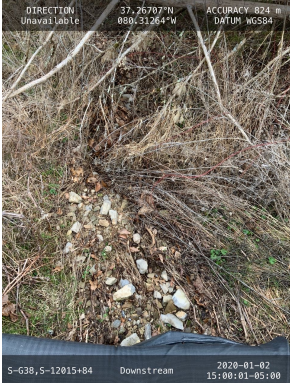
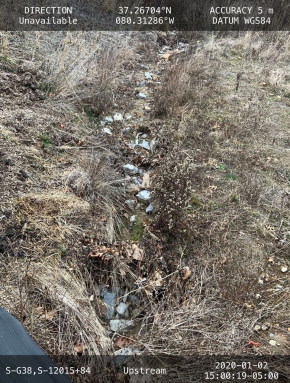
<b>GPS Location</b>	See photo GPS for location		<b>GPS Location</b>	See photo GPS for location	
<b>Field Station#</b>	12015+84		<b>Field Station#</b>	12015+84	
<b>Pic 7 Desc.</b>	Stream is dry and there is no ROW sediment visible in this stream bed.		<b>Pic 8 Desc.</b>	Stream is dry and there is no ROW sediment visible in this stream bed.

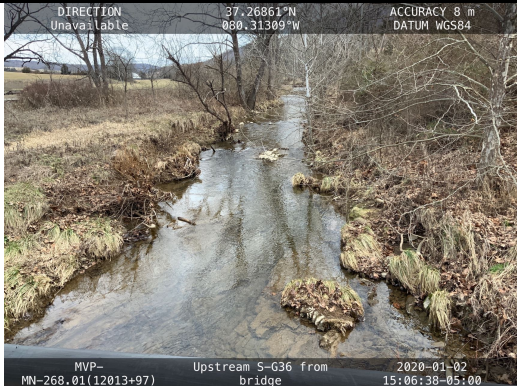
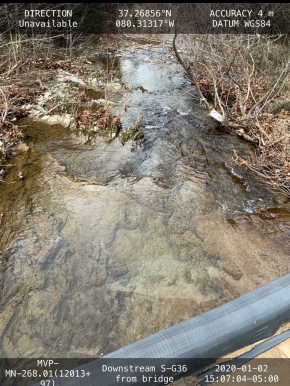
<b>GPS Location</b>	See photo GPS for location		<b>GPS Location</b>	See photo GPS for location	
<b>Field Station#</b>	12013+97		<b>Field Station#</b>	12013+97	
<b>Pic 9 Desc.</b>	Stream is flowing slow with no turbid water and no bank disturbance.		<b>Pic 10 Desc.</b>	Stream is flowing slow with no turbid water and no bank disturbance.	
Insert image here			Insert image here		
<b>GPS Location</b>			<b>GPS Location</b>		
<b>Field Station#</b>			<b>Field Station#</b>

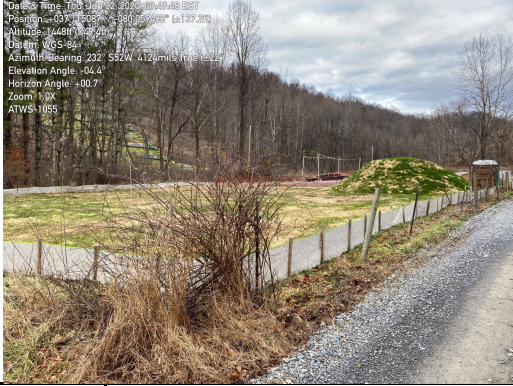
<p>Date &amp; Time: Thu Jan 02 2020 09:49:48 EST Position: +037 073735 / -080 057240 (+64363 IN) Altitude: 1249ft (+38.7m) Datum: WGS-84 Azimuth/Bearing: 232° S52W 412mils True (+10°) Elevation Angle: +04.4° Horizon Angle: +00.7° Zoom: 1.0X ATWS-1055</p>		<b>GPS Location</b>	See photo for coordinates.
<b>Field Station#</b>	13196+71	<b>Field Station#</b>	13263+00	<b>Field Station#</b>	13263+00
<b>Pic 1 Desc.</b>	S-D8 and MVP-MLV-AR-29, no disturbance at stream, access road in acceptable condition, ATV noted on access road.	<b>Pic 2 Desc.</b>	ATWS-1055, restored section of alternate workspace, vegetation establishing, perimeter priority 1 fence in acceptable condition.	<b>Pic 2 Desc.</b>	ATWS-1055, restored section of alternate workspace, vegetation establishing, perimeter priority 1 fence in acceptable condition.

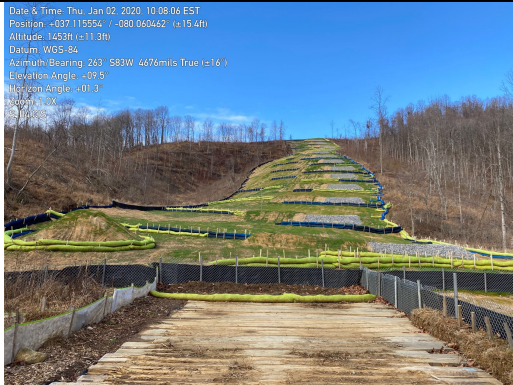
<p>Date &amp; Time: Thu Jan 02 2020 10:08:06 EST Position: +037 115554 / -080 060462 (+15.4m) Altitude: 1453ft (+44.3m) Datum: WGS-84 Azimuth/Bearing: 267° S83W 4676mils True (+16°) Elevation Angle: +09.5° Horizon Angle: +01.3° Zoom: 1.0X S-II4 downstream</p>		<b>GPS Location</b>	See photo for coordinates.
<b>Field Station#</b>	13260+60	<b>Field Station#</b>	13260+00	<b>Field Station#</b>	13260+00
<b>Pic 3 Desc.</b>	S-II4, looking upstream of equipment bridge, ECDs functioning acceptably, stream bed and banks appear stable.	<b>Pic 4 Desc.</b>	ROW, CIS of S-II4, permanent and temporary vegetation near bridge establishing well across ROW.	<b>Pic 4 Desc.</b>	ROW, CIS of S-II4, permanent and temporary vegetation near bridge establishing well across ROW.
