Visual Site Inspection Report

Project Name	H-600 Pipeline Spread H	AFE	124300138	Spread	H-600 Pipeline Spread H
Contractor	Precision			Report #	6481
Inspector	Randy Clark			Date/Time	12/9/2019 9:11 AM
Permit #	TBD	Inspection Type	VA SWPP	Station Begin	12119+17
State	VA	Inspection Area	Partial	Station End	12234+50
County	Montgomery	Ground	Dry	Temperature (°F)	56.00
Municipality	N/A	Weather	Sunny	Rain Gauge (in)	0.00
				Rain Accumulation Time (days)	1.00

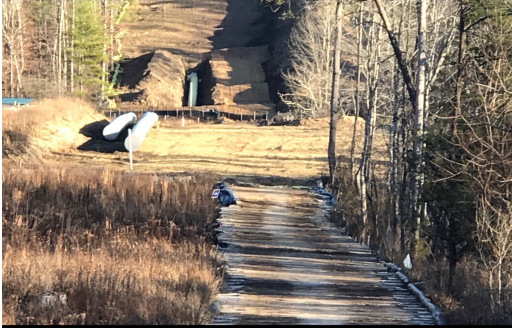
12122+00 to 12125+00 Re-seeded & Mulched 2019-12-05 15:43:56-05:00			DIRECTION E (T) 37.25733°N 080.28219°W ACCURACY 6 m DATUM WGS84

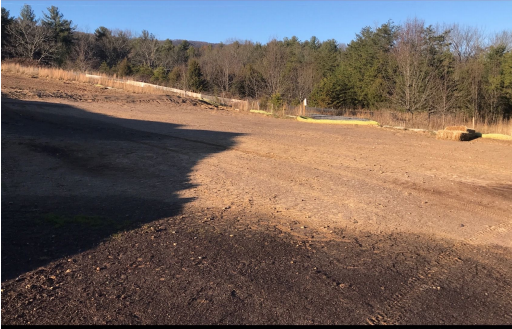
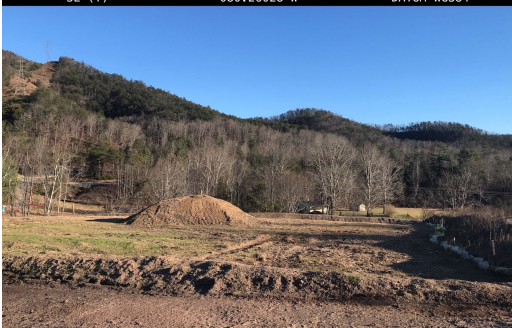
Field Station#	12189+00		Field Station#	12189+00	
Pic 3 Desc.	MVP-MN-274, access road in good condition.		Pic 4 Desc.	Pro-Ganics Duel product providing stabile cover for the right of way.	
	DIRECTION SE (T) 37.25207°N 080.26028°W ACCURACY 8 m DATUM WGS84

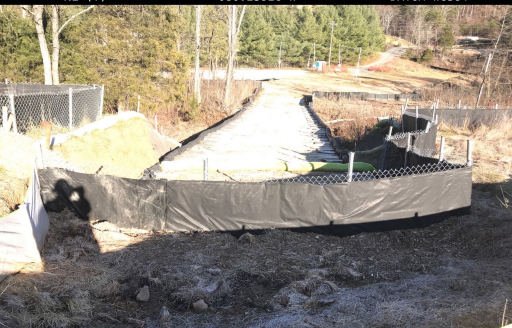
Bradshaw Creek S-C21 12192+36 2019-12-05 15:15:33-05:00	
GPS Location	Please see photo for GPS Data.		GPS Location	Please see photo for GPS Data.	
Field Station#	12189+00		Field Station#	12192+36	
Pic 5 Desc.	Topsoil storage area stabile, Pro-Ganics Duel product was used to stabilize right of way, temp. vegetative cover starting to come in.		Pic 6 Desc.	S-C21 Bradshaw Creek bridge clean and free of any spoil.

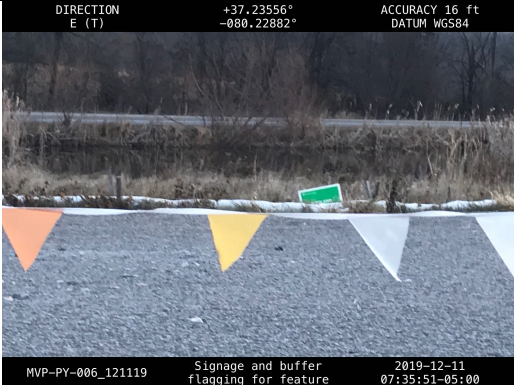
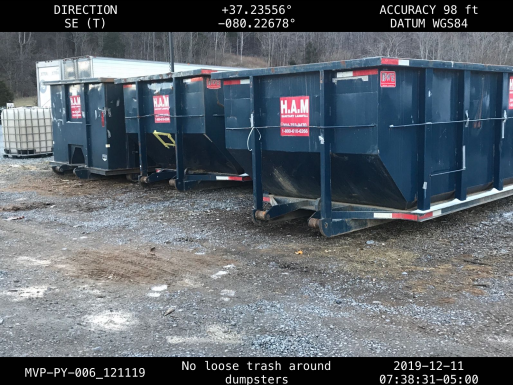
GPS Location	MVP-PY-006 See photo for gps data		GPS Location	MVP-PY-006 See photo for gps data	
Field Station#	+0		Field Station#	+0	
Pic 1 Desc.	The buffer flagging and signage for feature W-008 were in good condition. Looking N.		Pic 2 Desc.	No loose trash around dumpsters. Looking SE.

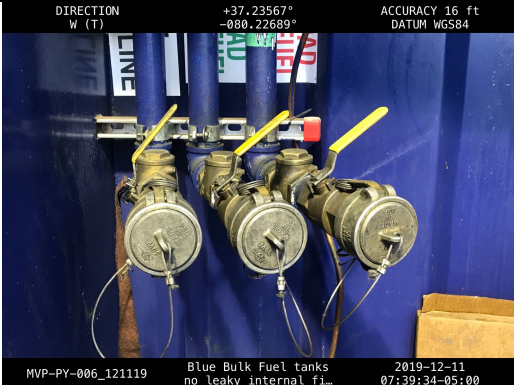
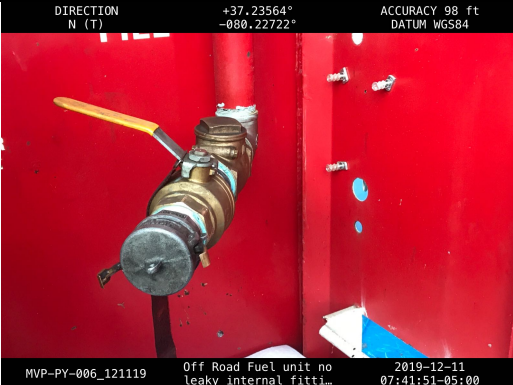
GPS Location	MVP-PY-006 See photo for gps data		GPS Location	MVP-PY-006 See photo for gps data	
Field Station#	+0		Field Station#	+0	
Pic 3 Desc.	Blue Bulk Fuel tanks no leaky internal fittings. Looking W.		Pic 4 Desc.	Off Road Fuel unit no leaky internal fittings. Looking W.

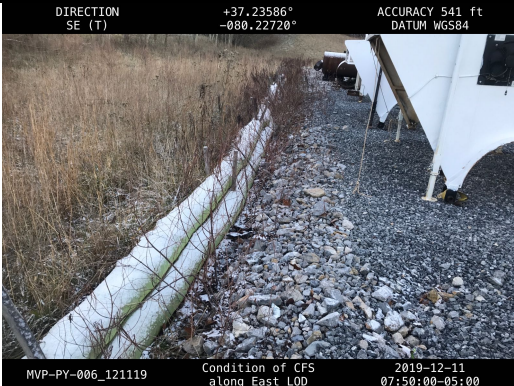
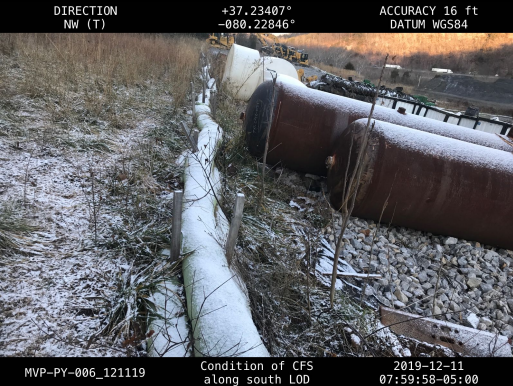
GPS Location	MVP-PY-006 See photo for gps data		GPS Location	MVP-PY-006 See photo for gps data	
Field Station#	+0		Field Station#	+0	
Pic 5 Desc.	Condition of compost filter sock along the East LOD. Looking SE.		Pic 6 Desc.	Condition of the compost filter sock along the South LOD. Looking NW.

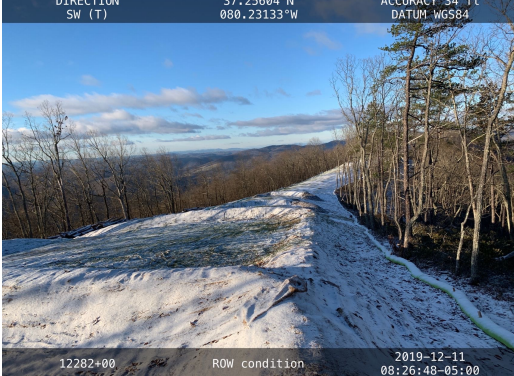
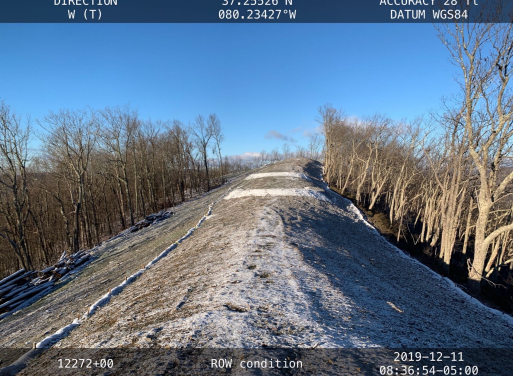
12272+00 ROW condition 2019-12-11 08:36:54-05:00	
GPS Location	See photo for gps data.		GPS Location	See photo for gps data.	
Field Station#	12282+00		Field Station#	12272+00	
Pic 1 Desc.	Photo shows the ROW condition from about 12280+00 to 12282+00.		Pic 2 Desc.	Photo shows the ROW condition from about 12268+00 to 12272+00.	
	DIRECTION SW (T) 37.25530°N 080.23613°W ACCURACY 31 ft DATUM WGS84

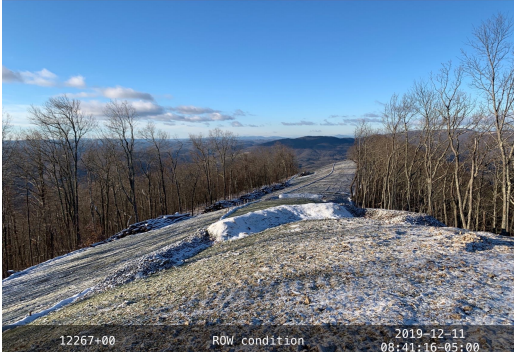
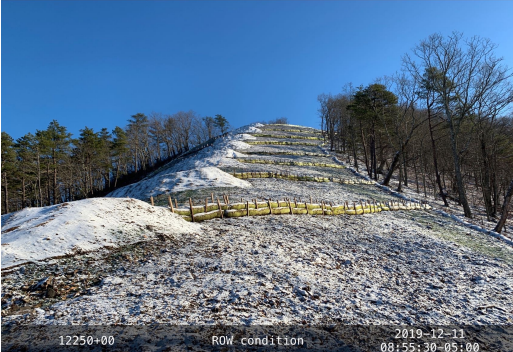
Field Station#	12267+00		Field Station#	12250+00	
Pic 3 Desc.	Photo shows the ROW condition from about 12264+0 to 12267+00.		Pic 4 Desc.	Photo shows the ROW condition from about 12250+00 to 12253+00.	
	DIRECTION NE (T) 37.25164°N 080.24581°W ACCURACY 15 ft DATUM WGS84

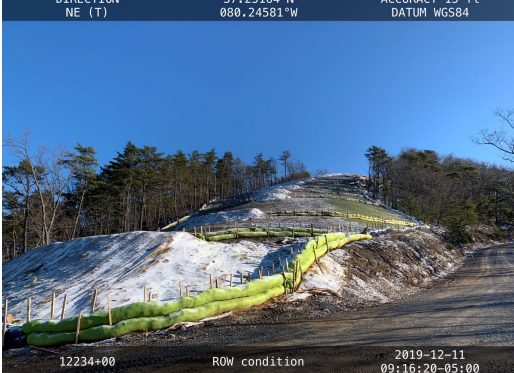
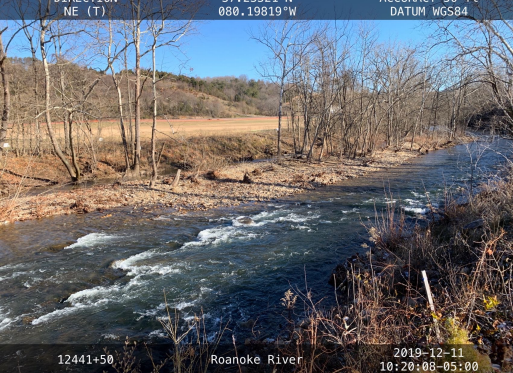
12441+50 Roanoke River 2019-12-11 10:20:08-05:00	
GPS Location	See photo for gps data.		GPS Location	See photo for gps data.	
Field Station#	12234+00		Field Station#	12241+50	
Pic 5 Desc.	Photo shows the ROW condition from about 12234+00 to 12237+00.		Pic 6 Desc.	Photo shows the Roanoke River (S-NN16) crossing.

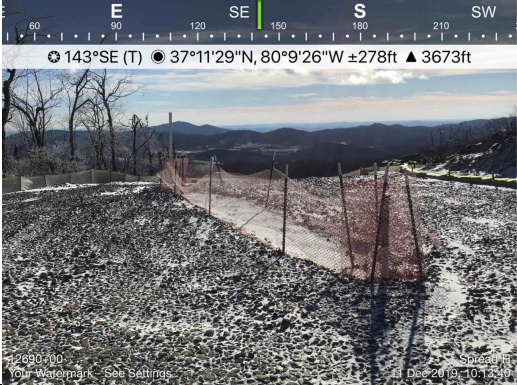
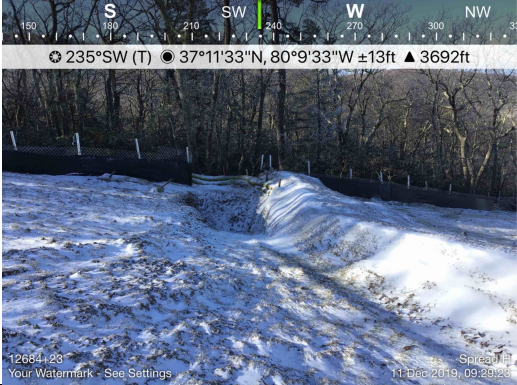
GPS Location	See photo		GPS Location	See photo	
Field Station#	12690+00		Field Station#	12684+23	
Pic 7 Desc.	Rock CE in good condition near the GAS of honeysuckle		Pic 8 Desc.	Waterbar and end treatment in good condition.

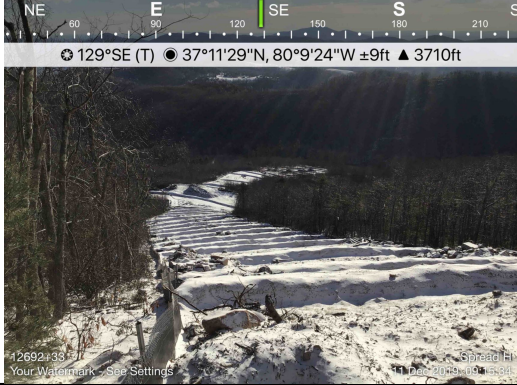
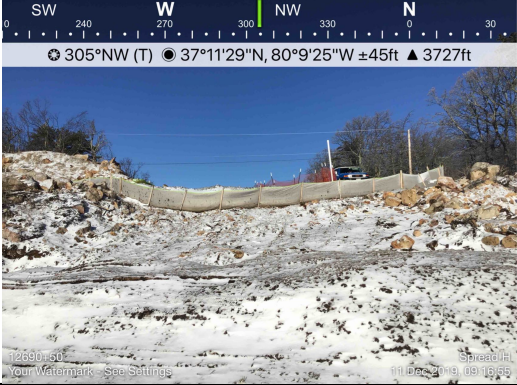
GPS Location	See photo		GPS Location	See photo	
Field Station#	12692+33		Field Station#	12690+50	
Pic 9 Desc.	Controls on the GAS of honeysuckle in good condition		Pic 10 Desc.	Silt fence controls keyed in and in good condition.

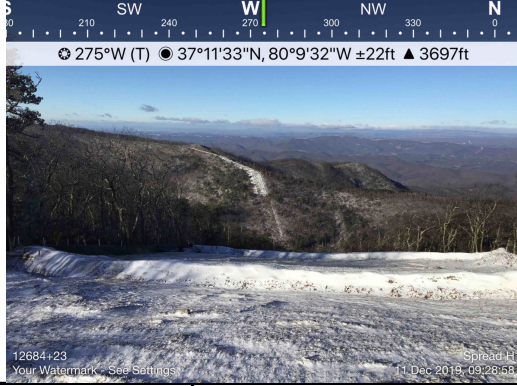
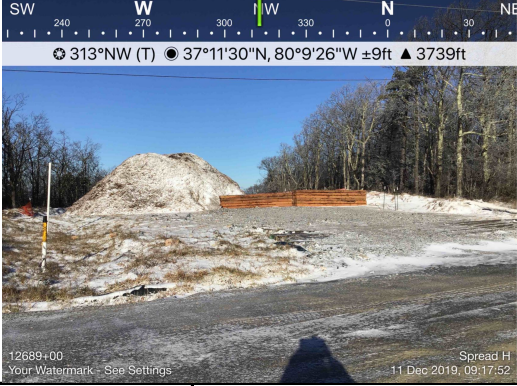
GPS Location	See photo		GPS Location	See photo	
Field Station#	12684+23		Field Station#	12689+00	
Pic 11 Desc.	CIS of honeysuckle in good condition		Pic 12 Desc.	Stockpiles stabilized and remain in good condition.

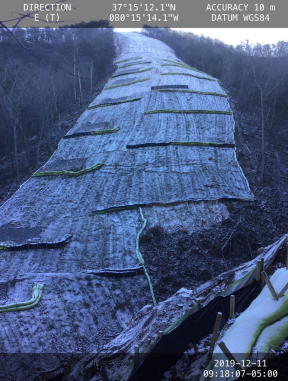
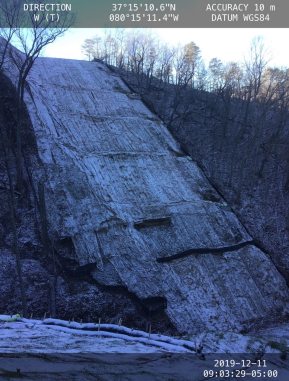
GPS Location	See photo		GPS Location	See photo	
Field Station#	12214+00		Field Station#	12210+00	
Pic 1 Desc.	Permanently restored ROW below the switchback on Reese Mountain remains stable and has approximately 60% vegetative cover.		Pic 2 Desc.	The temporarily stabilized slope on the coming in side of the ravine between Bradshaw Road and Reese Mountain remains stable.

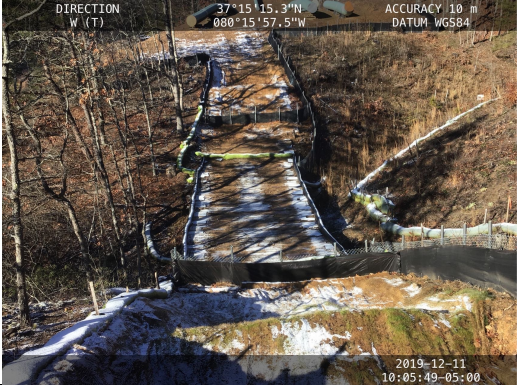
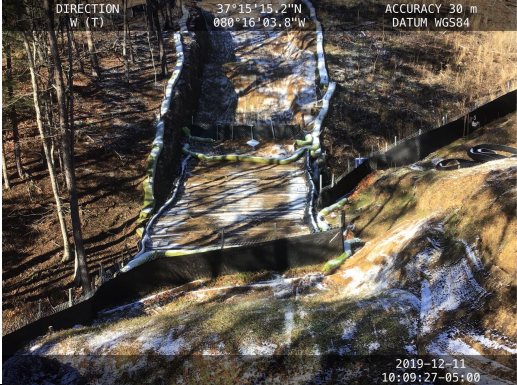
GPS Location	See photo		GPS Location	See photo	
Field Station#	12166+47		Field Station#	12163+05	
Pic 7 Desc.	Stream S-C24, facing west		Pic 8 Desc.	Stream S-C25, facing west

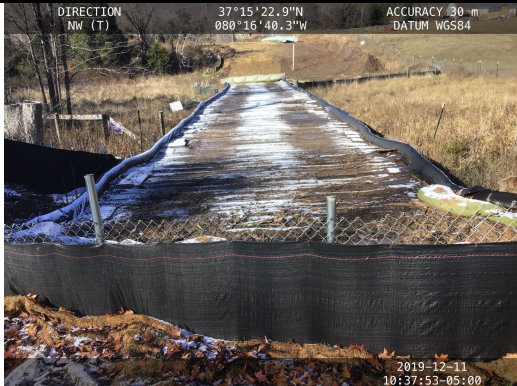
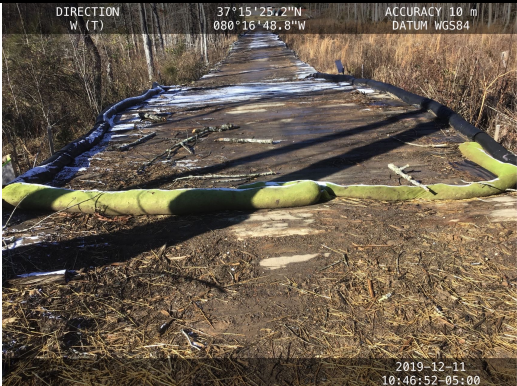
GPS Location	See photo		GPS Location	See photo	
Field Station#	12132+73		Field Station#	12125+65	
Pic 9 Desc.	Stream S-C29, facing northwest		Pic 10 Desc.	Stream S-MM31, facing west

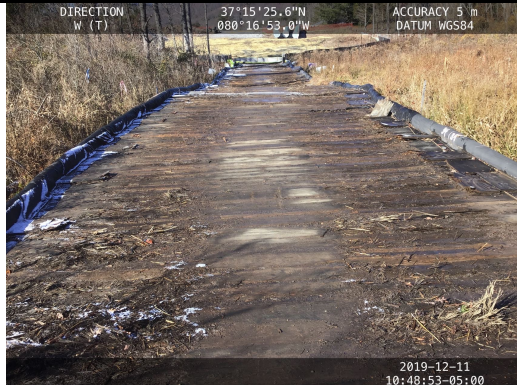
<p style="text-align: center;">Insert image here</p>			
GPS Location	See photo		GPS Location		
Field Station#	12121+83		Field Station#		
Pic 11 Desc.	Streams S-C36 and S-C33, facing west		Pic 12 Desc.

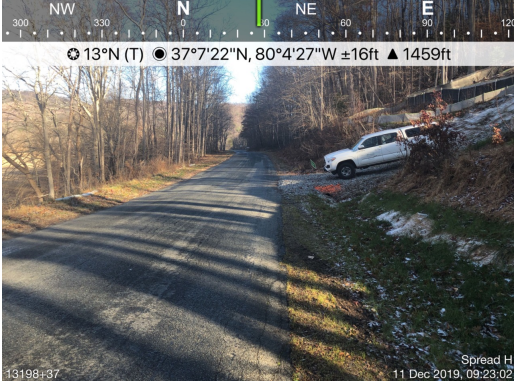
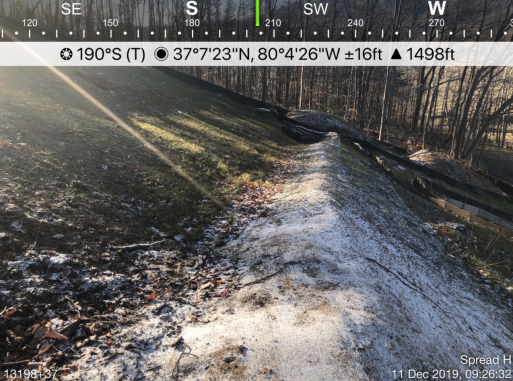
GPS Location	see photo		GPS Location	see photo	
Field Station#	13198+37		Field Station#	13198+37	
Pic 1 Desc.	CE at Dillons Mill crossing in good condition.		Pic 2 Desc.	Waterbars throughout this area are in good condition

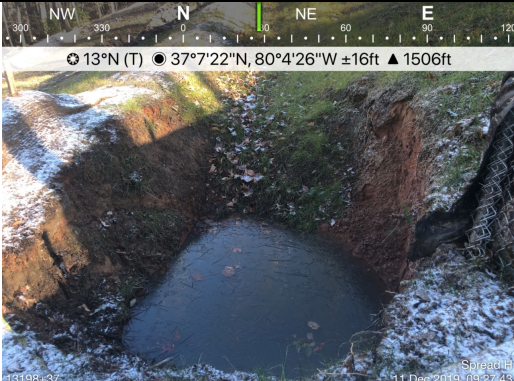
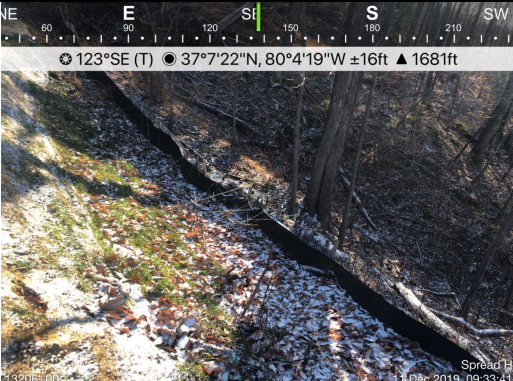
GPS Location	see photo		GPS Location	see photo	
Field Station#	13198+37		Field Station#	13206+00	
Pic 3 Desc.	Sumps throughout this area have received minimal amounts of water and are in good condition.		Pic 4 Desc.	Hay bale reinforcement at this location is functioning.

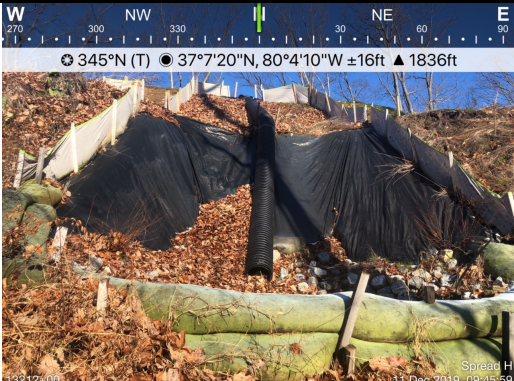
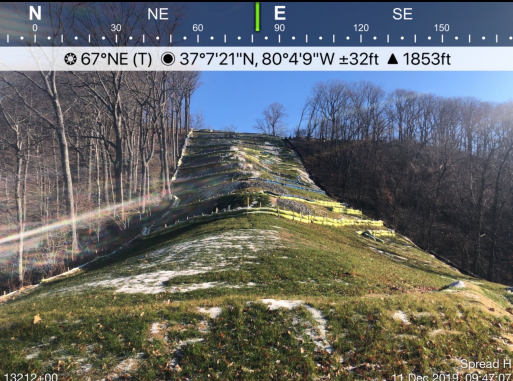
GPS Location	see photo		GPS Location	see photo	
Field Station#	13212+00		Field Station#	13212+00	
Pic 5 Desc.	slope drain at this location in good condition and functioning.		Pic 6 Desc.	controls on this steep slope are in good condition and functioning.

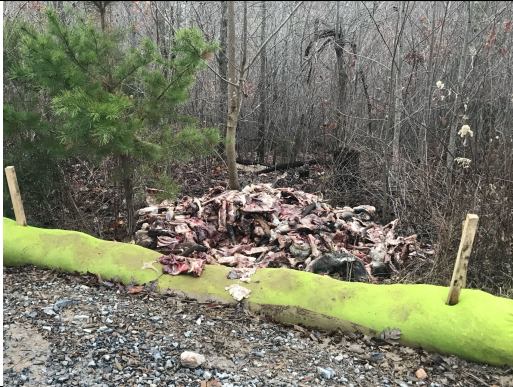
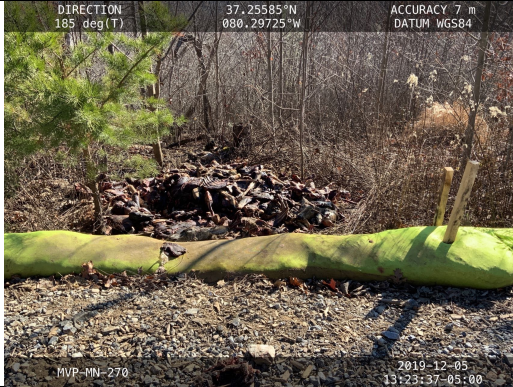
GPS Location	Unknown		GPS Location	See photo GPS for location	
Field Station#	12071+80		Field Station#	12071+80	
Pic 1 Desc.	On 12/2/2019 I discovered this pile of deer carcasses along MVP-MN-270.		Pic 2 Desc.	Same carcass pile three days later.

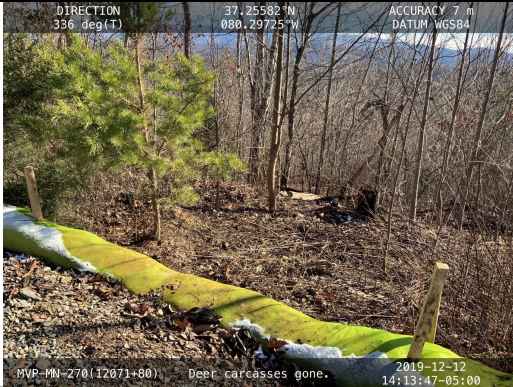
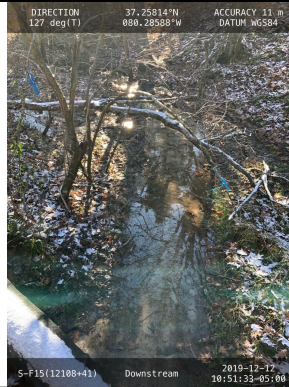
GPS Location	See photo GPS for location		GPS Location	See photo GPS for location	
Field Station#	12071+80		Field Station#	12108+41	
Pic 3 Desc.	Deer carcass pile gone.		Pic 4 Desc.	Bridge and stream in acceptable condition. No evidence of ROW sediment in stream.

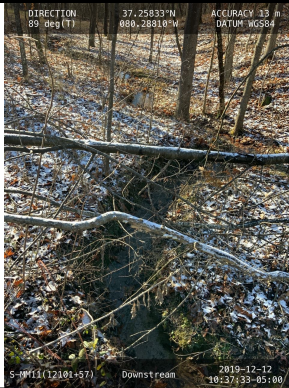
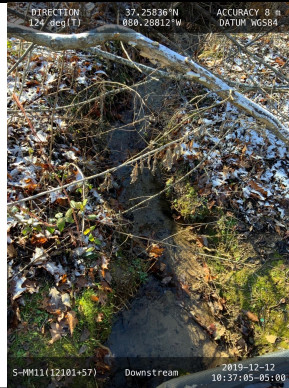
GPS Location	See photo GPS for location		GPS Location	See photo GPS for location	
Field Station#	12101+57		Field Station#	12101+57	
Pic 5 Desc.	Bridge and stream in acceptable condition. No evidence of ROW sediment in stream.		Pic 6 Desc.	Bridge and stream in acceptable condition. No evidence of ROW sediment in stream.

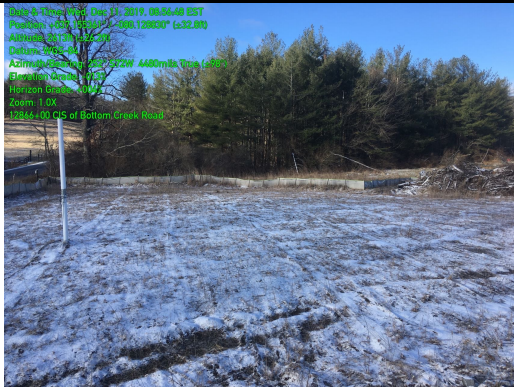
GPS Location	See pic for GPS location		GPS Location	See pic for GPS location	
Field Station#	12866+50		Field Station#	12866+00	
Pic 1 Desc.	All installed P1 silt fence was in good condition.		Pic 2 Desc.	No issues or impacts observed in the area.

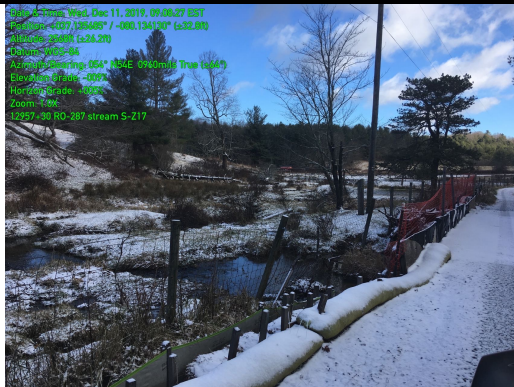
GPS Location	See pic for GPS location		GPS Location	See pic for GPS location	
Field Station#	12957+30		Field Station#	12957+30	
Pic 3 Desc.	Access road RO-287 in good condition.		Pic 4 Desc.	No impacts observed at stream S-Z17.

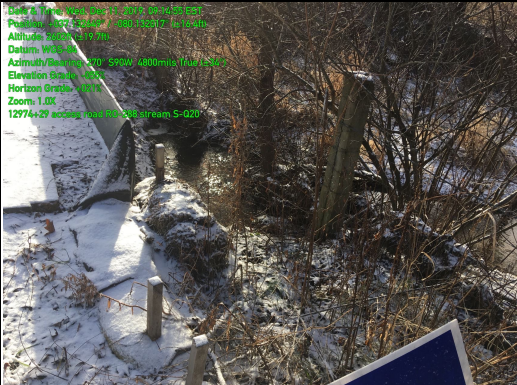
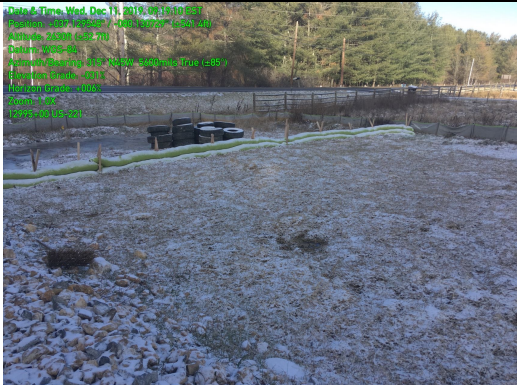
<p>Date & Time: Wed, Dec 11, 2019, 09:22:55 EST Position: 3272.220000° N, -80.126572° W (s14.49) Altitude: 2330ft (s14.49) Datum: WGS-84 Azimuth/Bearing: 279° N81W 4960mils True (s10°) Elevation Grade: +017X Horizon Grade: +010X Zoom: 1.0X 12974+29 access road FR-228 stream S-Q20</p>			<p>Date & Time: Wed, Dec 11, 2019, 09:18:00 EST Position: 3295.000000° N, -80.126572° W (s14.49) Altitude: 2330ft (s14.49) Datum: WGS-84 Azimuth/Bearing: 279° N81W 4960mils True (s10°) Elevation Grade: +017X Horizon Grade: +010X Zoom: 1.0X 12995+00 access road FR-228 stream S-Q20</p>			
GPS Location			See pic for GPS location			
Field Station#			12974+29			
Pic 7 Desc.			No issues or impacts on the upstream side of S-Q20.

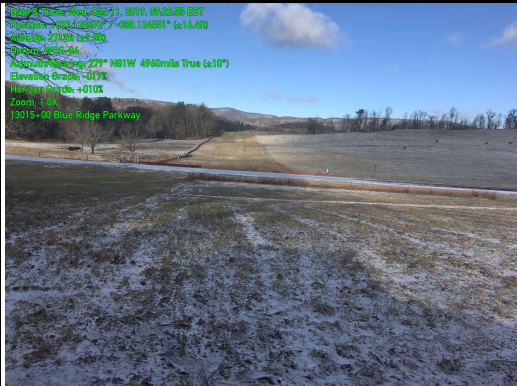
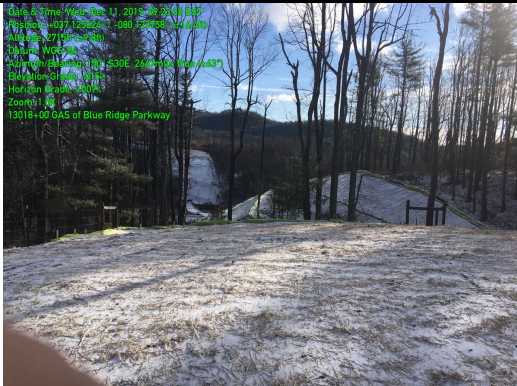
GPS Location			See pic for GPS location			
Field Station#			13015+00			
Pic 9 Desc.			Current conditions of the BRP are good.

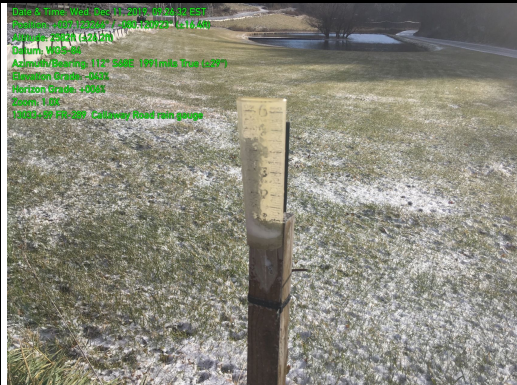
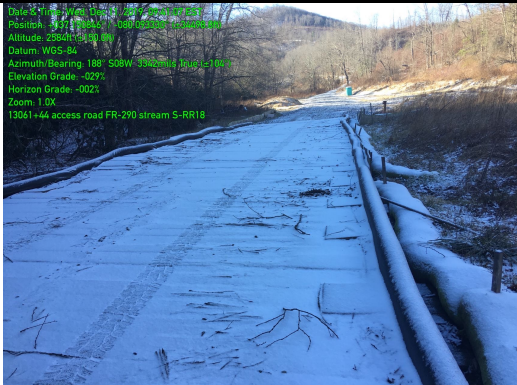
Pic 12 Desc.			Mat bridge over stream S-RR18 in sufficient condition.

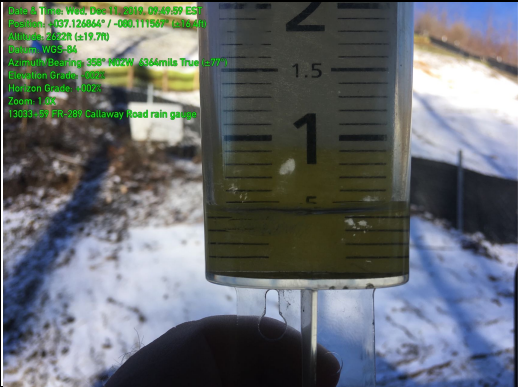
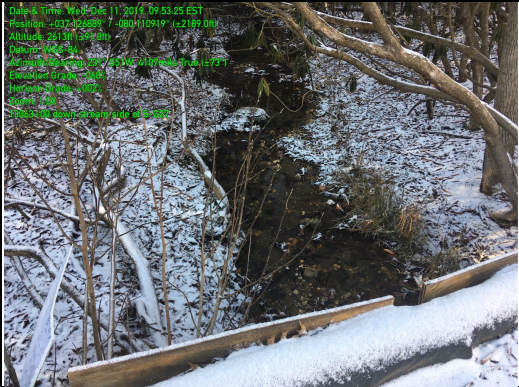
GPS Location	See pic for GPS location		GPS Location	See pic for GPS location	
Field Station#	13033+59		Field Station#	13063+00	
Pic 13 Desc.	0.5" of precipitation total for Callaway road.		Pic 14 Desc.	No impacts to stream S-G27.

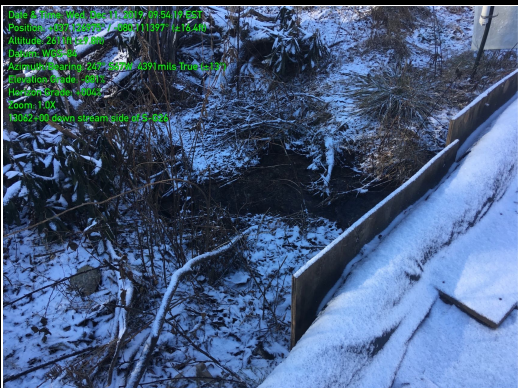
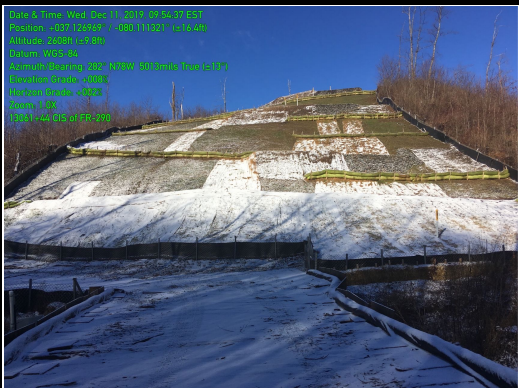
GPS Location	See pic for GPS location		GPS Location	See pic for GPS location	
Field Station#	13062+00		Field Station#	13061+44	
Pic 15 Desc.	No impacts observed at stream S-G26.		Pic 16 Desc.	No issues found on the CIS of FR-290.

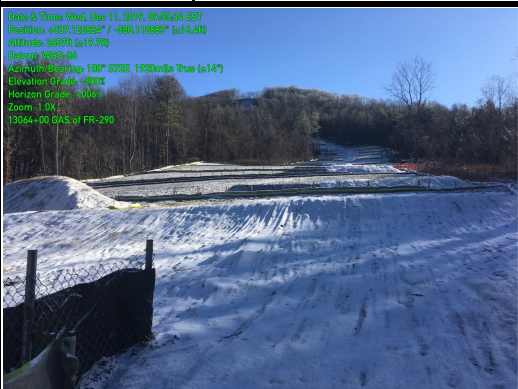
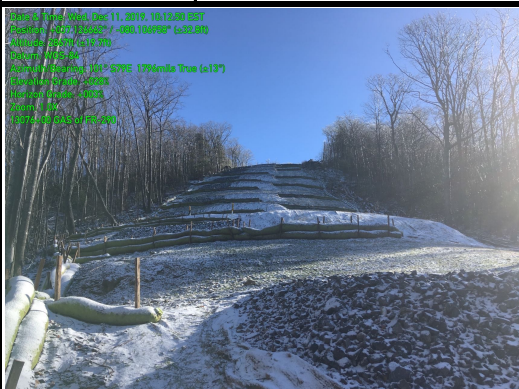
GPS Location	See pic for GPS location		GPS Location	See pic for GPS location	
Field Station#	13064+00		Field Station#	13076+00	
Pic 17 Desc.	GAS of FR-290 has final restoration performed and no issues were found throughout the area.		Pic 18 Desc.	Permanent and temporary BMP's in good condition.

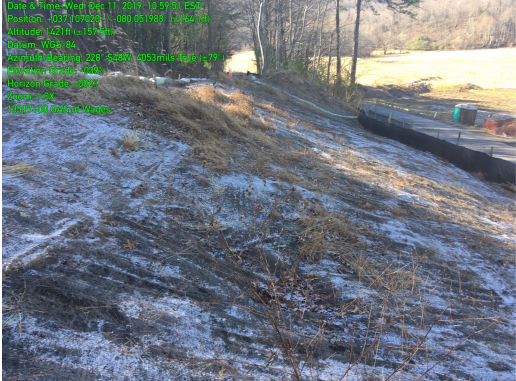
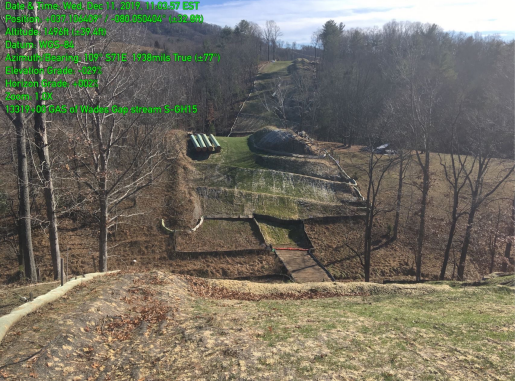
GPS Location	See pic for GPS location		GPS Location	See pic for GPS location	
Field Station#	13317+00		Field Station#	13319+00	
Pic 1 Desc.	Temporary stabilization on the GAS of Wade's Gap Road remains in good condition.		Pic 2 Desc.	Stream S-GH15 and the ROW were free from any impacts or ECD deficiencies.

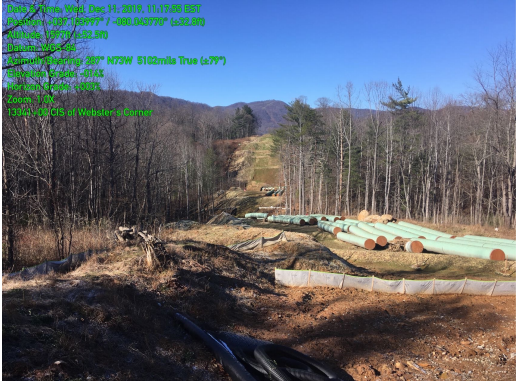
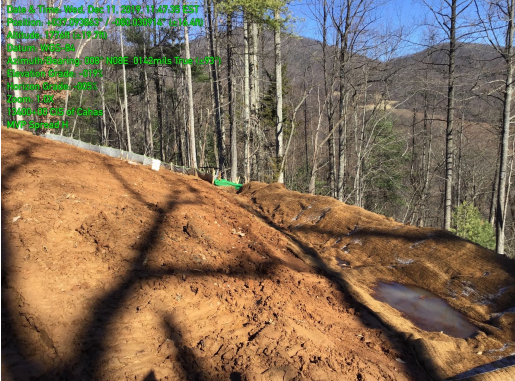
GPS Location	See pic for GPS location		GPS Location	See pic for GPS location	
Field Station#	13341+00		Field Station#	13400+00	
Pic 3 Desc.	No issues or impacts observed between Wade's Gap and Webster's Corner.		Pic 4 Desc.	Waterbars recently reconstructed and lined with erosion control blanket.

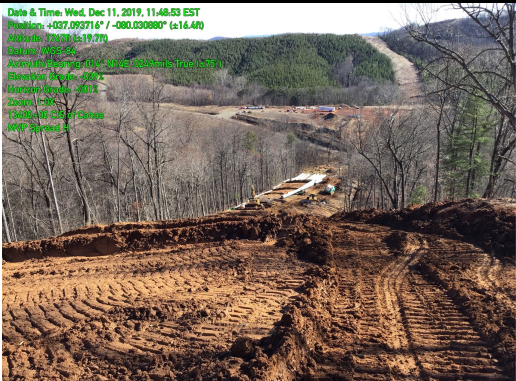
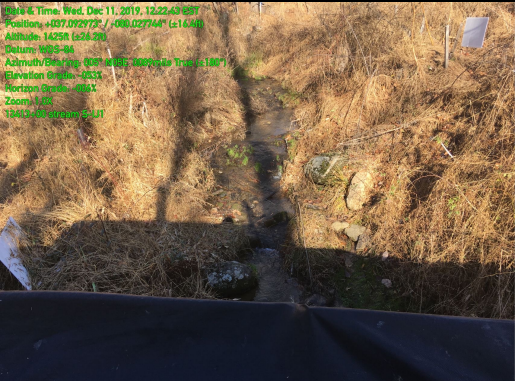
GPS Location	See pic for GPS location		GPS Location	See pic for GPS location	
Field Station#	13400+00		Field Station#	13413+00	
Pic 5 Desc.	Crew replacing CFS end treatments on the CIS of Cahas Mountain Road.		Pic 6 Desc.	No issues or impacts to streams S-IJ1, S-IJ2, and S-IJ3.

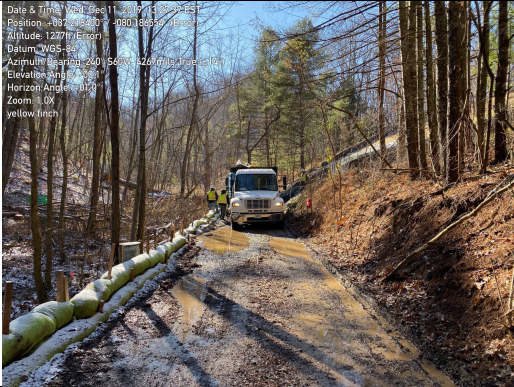
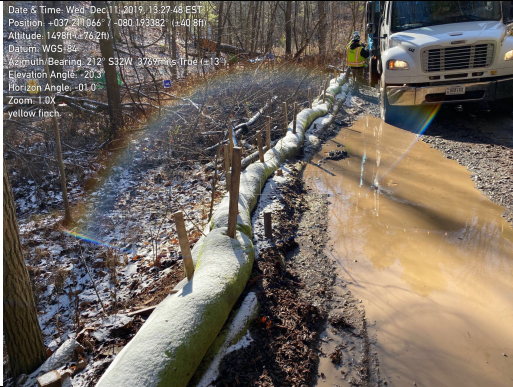
GPS Location	See photo for coordinates.		GPS Location	See photo for coordinates.	
Field Station#	12544+06		Field Station#	12544+06	
Pic 1 Desc.	MVP-MN-278.01, Yellow Finch Road, PPL removing stump along access road.		Pic 2 Desc.	MVP-MN-278.01, turbid water on road no bypassing triple stack compost filter sock.

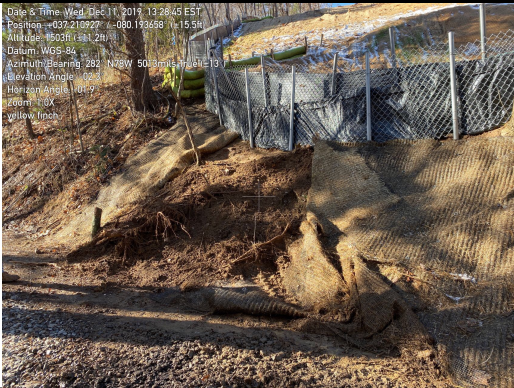
GPS Location	See photo for coordinates.		GPS Location	See photo for coordinates.	
Field Station#	12544+06		Field Station#	12544+06	
Pic 5 Desc.	MVP-MN-278.01, stump removed from roadside.		Pic 6 Desc.	MVP-MN-278.01, bank stabilized with high velocity erosion control blanket.

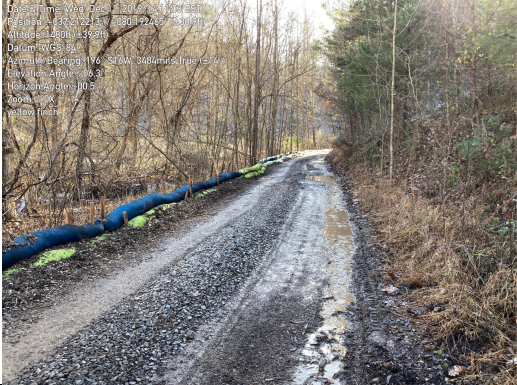
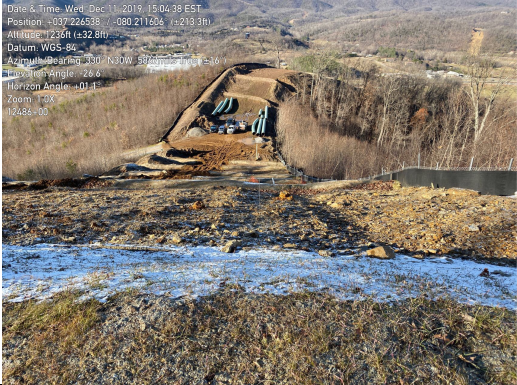
GPS Location	See photo for coordinates.		GPS Location	See photo for coordinates.	
Field Station#	12544+06		Field Station#	12486+00	
Pic 7 Desc.	MVP-MN-278.01, additional triple stack compost filter sock added along access road.		Pic 8 Desc.	Waterbars and end treatments functioning acceptably, maintenance items in area will be addressed during stabilization.

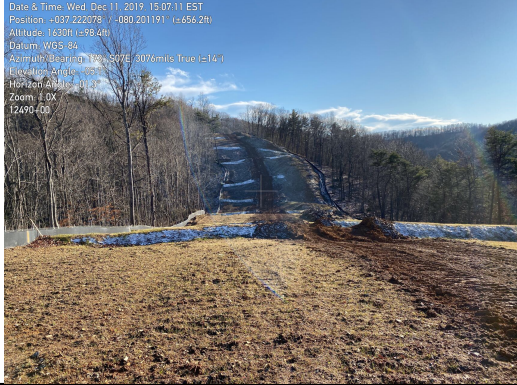
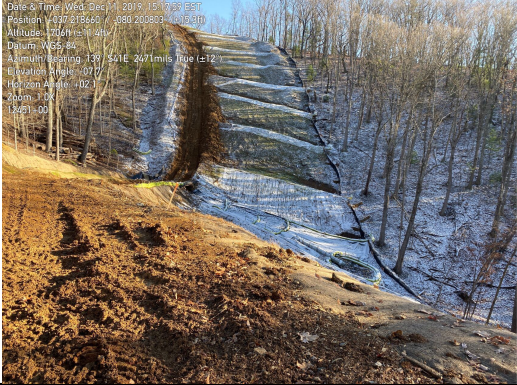
GPS Location	See photo for coordinates.		GPS Location	See photo for coordinates.	
Field Station#	12490+00		Field Station#	12451+00	
Pic 9 Desc.	Waterbars and end treatments functioning acceptably, maintenance items in area will be addressed during stabilization.		Pic 10 Desc.	Waterbars and end treatments functioning acceptably.

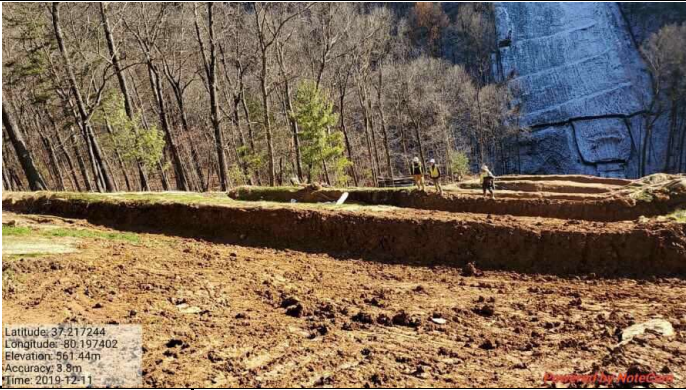
GPS Location	See photo for coordinates.	GPS Location	See photo for coordinates.		
Field Station#	12513+00	Field Station#	12513+00		
Pic 17 Desc.	Repaired waterbar in travel lane, stabilization in progress.	Pic 18 Desc.	Stabilization complete.
