# Visual Site Inspection Report

<b>Project Name</b>	H-600 Pipeline Spread H	<b>AFE</b>	124300138	<b>Spread</b>	H-600 Pipeline Spread H
<b>Contractor</b>	Precision			<b>Report #</b>	8101
<b>Inspector</b>	Logan Box			<b>Date/Time</b>	2/10/2020 5:14 PM
<b>Permit #</b>	TBD	<b>Inspection Type</b>	VA SWPP	<b>Station Begin</b>	13415+51
<b>State</b>	VA	<b>Inspection Area</b>	Partial	<b>Station End</b>	13670+00
<b>County</b>	Franklin	<b>Ground</b>	Wet	<b>Temperature (°F)</b>	42.00
<b>Municipality</b>	N/A	<b>Weather</b>	Light Rain	<b>Rain Gauge (in)</b>	0.00
				<b>Rain Accumulation Time (days)</b>	0.00

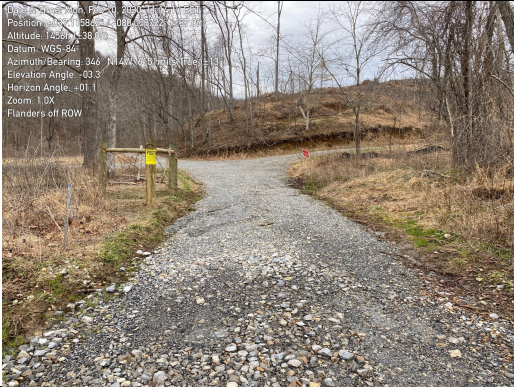
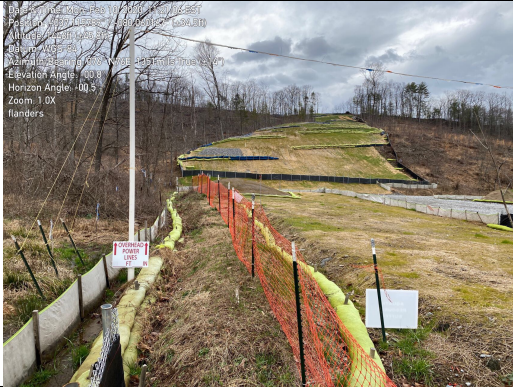
<b>GPS Location</b>	See photo for coordinates.		<b>GPS Location</b>	See photo for coordinates.	
<b>Field Station#</b>	13262+50		<b>Field Station#</b>	13261+00	
<b>Pic 1 Desc.</b>	Flanders Road, no drainage observed from W-II5 onto access road.		<b>Pic 2 Desc.</b>	Water flowing along perimeter controls from W-II4.

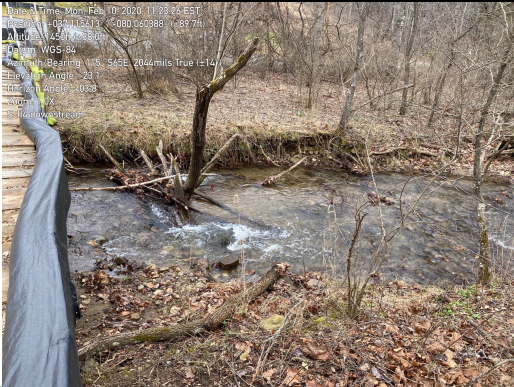
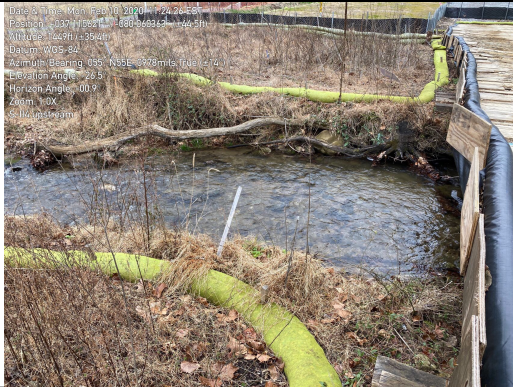
<b>GPS Location</b>	See photo for coordinates.		<b>GPS Location</b>	See photo for coordinates.	
<b>Field Station#</b>	13260+60		<b>Field Station#</b>	13260+60	
<b>Pic 3 Desc.</b>	S-II4, downstream side of equipment bridge, water clear.		<b>Pic 4 Desc.</b>	S-II4, upstream side of equipment bridge, ECDs functioning acceptably along stream banks and equipment bridge.

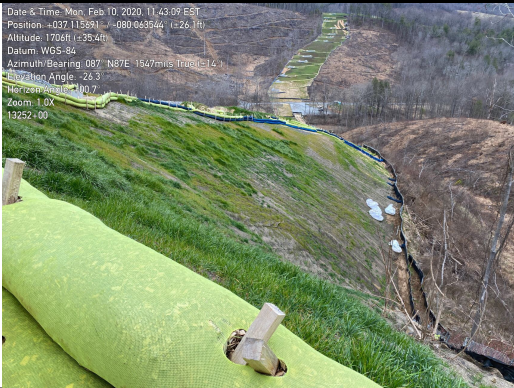
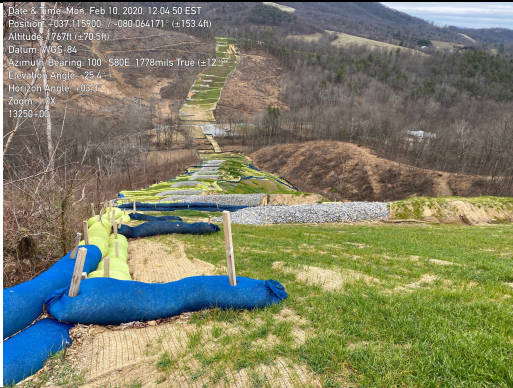
<b>Pic 5 Desc.</b>	Vegetative cover establishing on side slope, some sediment build up noted at bottom along SSF.		<b>Pic 6 Desc.</b>	Permanent waterbars functioning acceptably, permanent vegetation establishing acceptably.

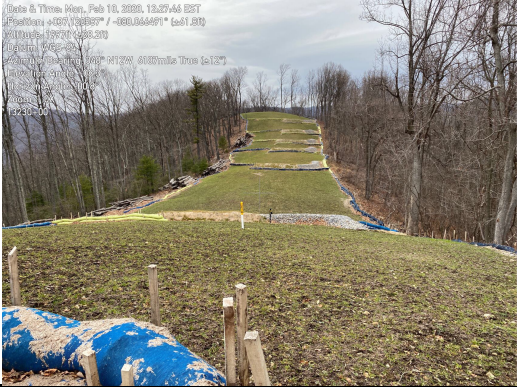
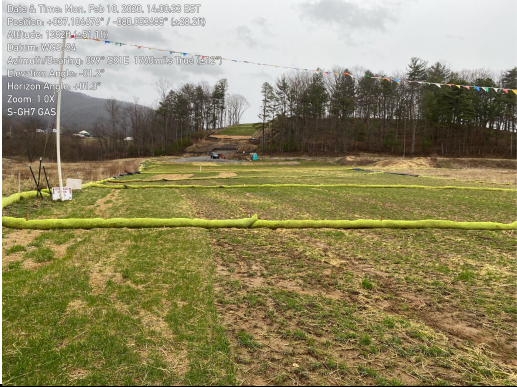
<b>GPS Location</b>	See photo for coordinates.		<b>GPS Location</b>	See photo for coordinates.	
<b>Field Station#</b>	13230+00		<b>Field Station#</b>	13311+00	
<b>Pic 7 Desc.</b>	ROW stable, vegetation noted across LOD, permanent waterbars functioning acceptably.		<b>Pic 8 Desc.</b>	Vegetative over moderate, erosion control blanket reducing rilling.

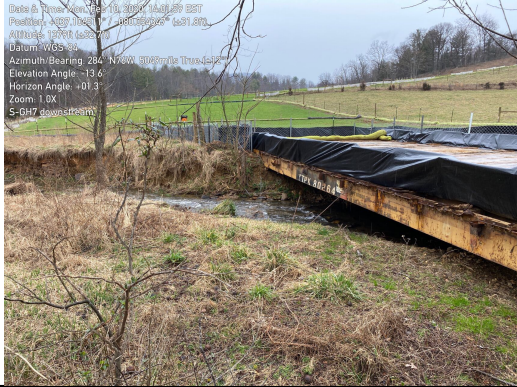
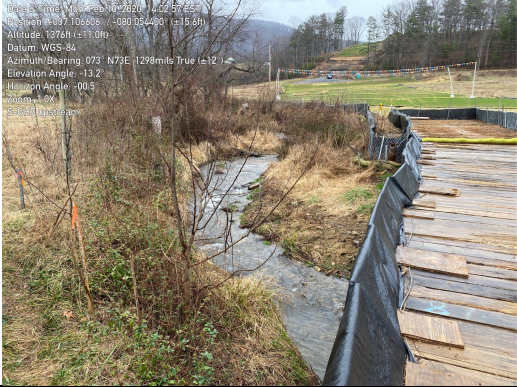
<b>GPS Location</b>	See photo for coordinates.		<b>GPS Location</b>	See photo for coordinates.	
<b>Field Station#</b>	13309+09		<b>Field Station#</b>	13309+09	
<b>Pic 9 Desc.</b>	S-GH7, downstream side of equipment bridge, no sediment impacts noted from ROW.		<b>Pic 10 Desc.</b>	S-GH7, upstream side of equipment bridge, bridge in acceptable condition, water flowing clear.

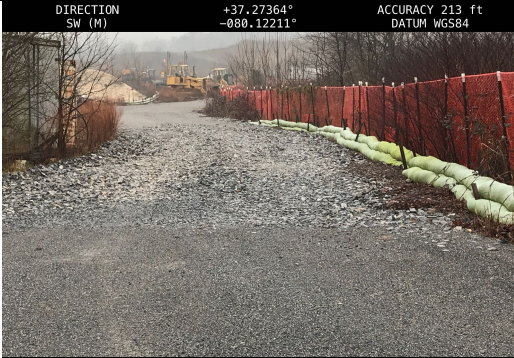
<p>DIRECTION SW (M) +37.27364° -080.12211° ACCURACY 213 ft DATUM WGS84</p> <p>MVP-LY-049_021120 Condition of rock entrance north drive... 2020-02-11 09:22:12-05:00</p>

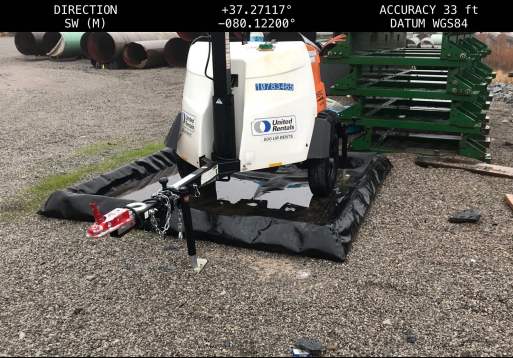
<p>DIRECTION SW (M) +37.27117° -080.12200° ACCURACY 33 ft DATUM WGS84</p> <p>MVP-LY-049_021120 Condition of containment 2020-02-11 09:23:19-05:00</p>			
<b>GPS Location</b>	MVP-LY-049 See photo for gps data		<b>GPS Location</b>	MVP-LY-049 See photo for gps data	
<b>Field Station#</b>	+0		<b>Field Station#</b>	+0	
<b>Pic 1 Desc.</b>	Condition of rock entrance on the north driveway. Looking SW.		<b>Pic 2 Desc.</b>	Condition of containment under light plant. Looking SW.

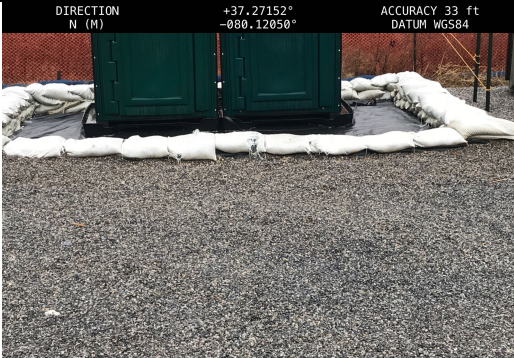
<p>DIRECTION N (M) +37.27152° -080.12050° ACCURACY 33 ft DATUM WGS84</p> <p>MVP-LY-049_021120 Condition of trays and containment 2020-02-11 09:25:02-05:00</p>

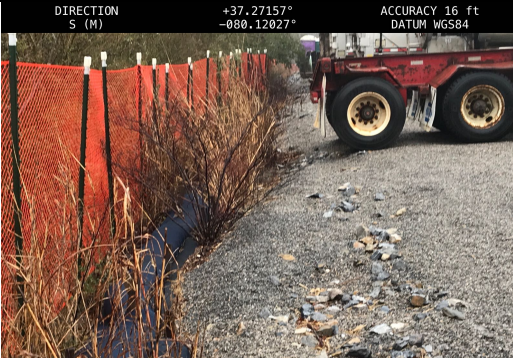
<p>DIRECTION S (M) +37.27157° -080.12027° ACCURACY 16 ft DATUM WGS84</p> <p>MVP-LY-049_021120 Condition of CFS &amp; safety fence East LOD 2020-02-11 09:25:31-05:00</p>

<b>GPS Location</b>	MVP-LY-049 See photo for gps data		<b>GPS Location</b>	MVP-LY-049 See photo for gps data	
<b>Field Station#</b>	+0		<b>Field Station#</b>	+0	
<b>Pic 3 Desc.</b>	Condition of trays and containment under toilets. Looking N.		<b>Pic 4 Desc.</b>	Condition of compost filter sock and safety fence along East LOD. Looking S.

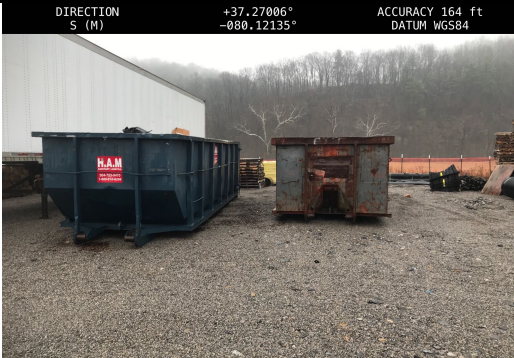
<p>DIRECTION S (M) +37.27006° -080.12135° ACCURACY 164 ft DATUM WGS84</p> <p>MVP-LY-049_021120 No loose trash around south dumpsters 2020-02-11 09:28:53-05:00</p>

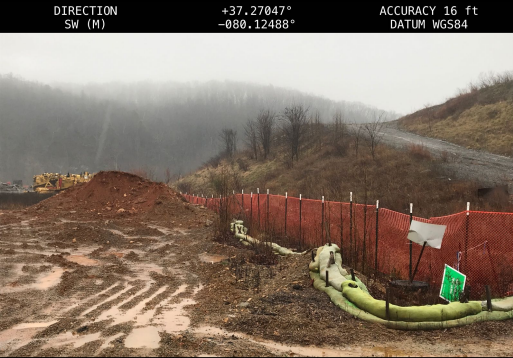
<p>DIRECTION SW (M) +37.27047° -080.12488° ACCURACY 16 ft DATUM WGS84</p> <p>MVP-LY-049_021120 Landowner disturbance along CFS and feature 2020-02-11 09:32:18-05:00</p>			
<b>GPS Location</b>	MVP-LY-049 See photo for gps data		<b>GPS Location</b>	MVP-LY-049 See photo for gps data	
<b>Field Station#</b>	+0		<b>Field Station#</b>	+0	
<b>Pic 5 Desc.</b>	No loose trash around south dumpsters. Looking S.		<b>Pic 6 Desc.</b>	Landowner disturbance along compost filter sock and feature. Looking SW.

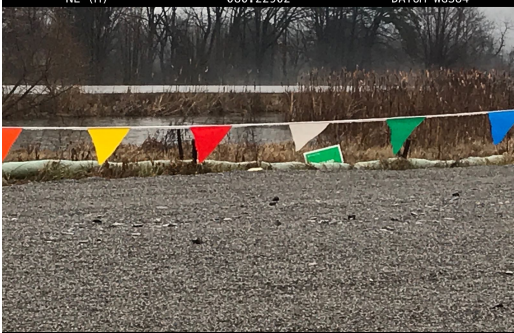
<p>DIRECTION NE (M) +37.23561° -080.22902° ACCURACY 33 ft DATUM WGS84</p> <p>MVP-PY-006_021120 Signage and buffer flagging for feature 2020-02-11 08:29:17-05:00</p>

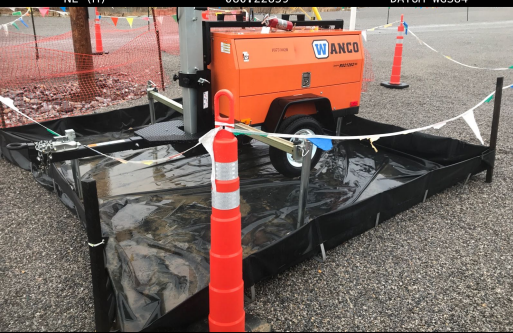
<p>DIRECTION NE (M) +37.23555° -080.22859° ACCURACY 33 ft DATUM WGS84</p> <p>MVP-PY-006_021120 Condition of containment 2020-02-11 08:29:41-05:00</p>			
<b>GPS Location</b>	MVP-PY-006 See photo for gps data		<b>GPS Location</b>	MVP-PY-006 See photo for gps data	
<b>Field Station#</b>	+0		<b>Field Station#</b>	+0	
<b>Pic 1 Desc.</b>	Signage and buffer flagging for feature in place. Looking NE.		<b>Pic 2 Desc.</b>	Condition of containment under light plant. Looking NE.

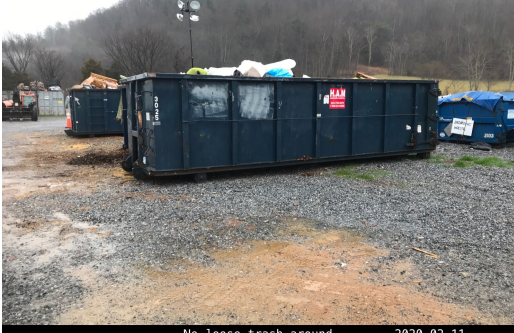
<p>DIRECTION E (M) +37.23555° -080.22678° ACCURACY 16 ft DATUM WGS84</p> <p>MVP-PY-006_021120 No loose trash around dumpsters 2020-02-11 08:31:32-05:00</p>

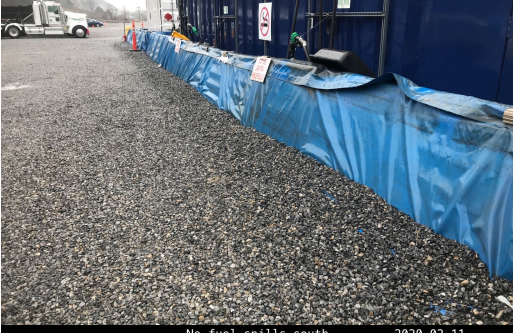
<p>DIRECTION NW (M) +37.23548° -080.22669° ACCURACY 98 ft DATUM WGS84</p> <p>MVP-PY-006_021120 No fuel spills south of bulk tanks 2020-02-11 08:32:18-05:00</p>

<b>GPS Location</b>	MVP-PY-006 See photo for gps data		<b>GPS Location</b>	MVP-PY-006 See photo for gps data	
<b>Field Station#</b>	+0		<b>Field Station#</b>	+0	
<b>Pic 3 Desc.</b>	No loose trash around dumpsters. Looking E.		<b>Pic 4 Desc.</b>	No fuel spills on the south side of the blue bulk fuel tanks. Looking NW.

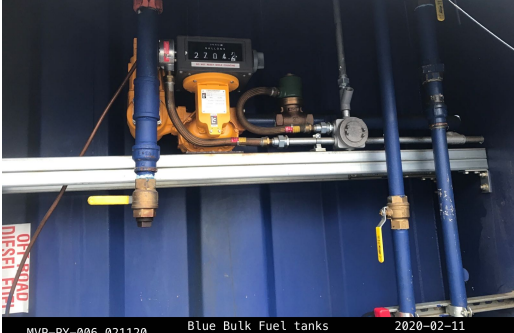
<p>DIRECTION NW (M) +37.23567° -080.22673° ACCURACY 16 ft DATUM WGS84</p> <p>MVP-PY-006_021120 Blue Bulk Fuel tanks no leaky internal fittings 2020-02-11 08:33:04-05:00</p>

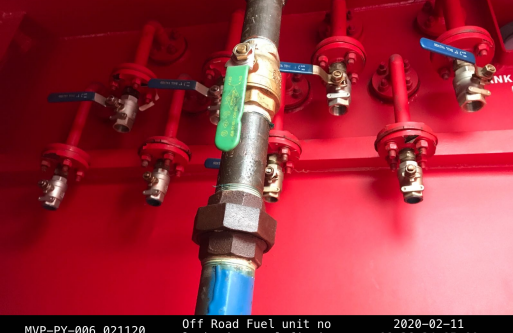
<p>DIRECTION NW (M) +37.23561° -080.22692° ACCURACY 16 ft DATUM WGS84</p> <p>MVP-PY-006_021120 Off Road Fuel unit no leaky internal fittings 2020-02-11 08:36:34-05:00</p>			
<b>GPS Location</b>	MVP-PY-006 See photo for gps data		<b>GPS Location</b>	MVP-PY-006 See photo for gps data	
<b>Field Station#</b>	+0		<b>Field Station#</b>	+0	
<b>Pic 5 Desc.</b>	Blue Bulk Fuel tanks no leaky internal fittings. Looking NW.		<b>Pic 6 Desc.</b>	Off Road Fuel unit no leaky internal fittings. Looking NW.

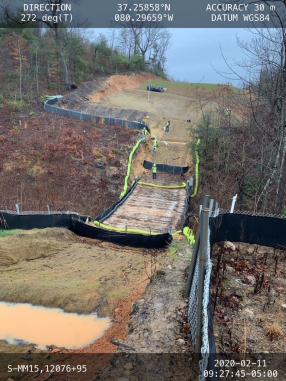
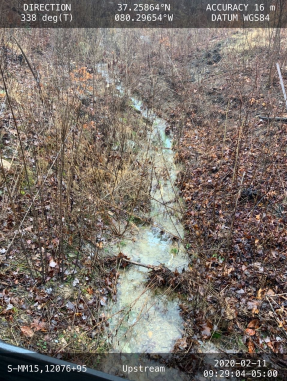
<b>GPS Location</b>	See GPS for location		<b>GPS Location</b>	See GPS for location	
<b>Field Station#</b>	12076+95		<b>Field Station#</b>	12076+95	
<b>Pic 1 Desc.</b>	Erosion blanket was reprinted to cut bank.		<b>Pic 2 Desc.</b>	Stream running clear.

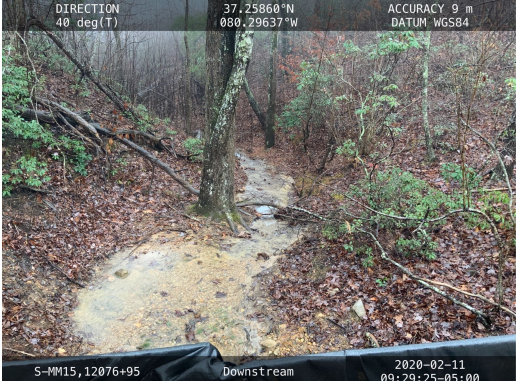
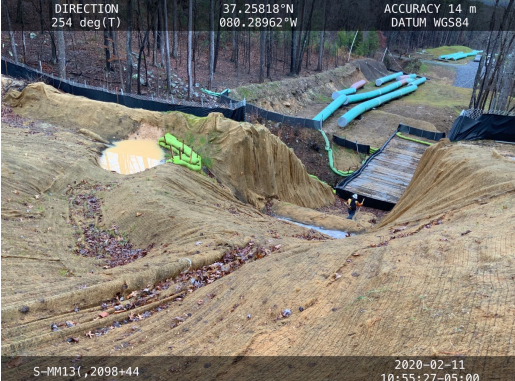
<b>GPS Location</b>	See GPS for location		<b>GPS Location</b>	See GPS for location	
<b>Field Station#</b>	12076+95		<b>Field Station#</b>	12098+44	
<b>Pic 3 Desc.</b>	Stream running clear.		<b>Pic 4 Desc.</b>	ECDs surrounding stream are in good condition and functioning properly.

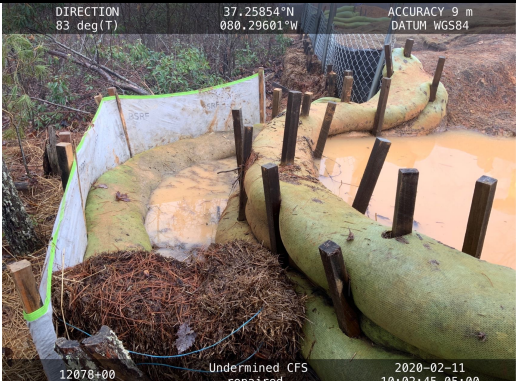
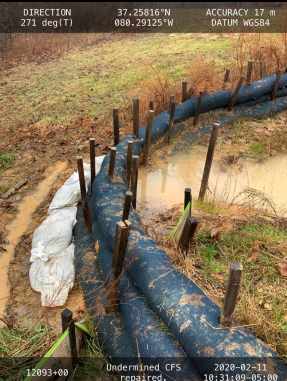
<b>GPS Location</b>	See GPS for location		<b>GPS Location</b>	See GPS for location	
<b>Field Station#</b>	12078+00		<b>Field Station#</b>	12093+00	
<b>Pic 5 Desc.</b>	End treatment undercut repaired and additional checks installed.		<b>Pic 6 Desc.</b>	End treatment undercut repaired.

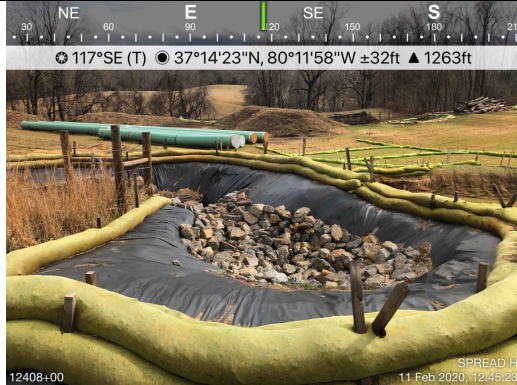
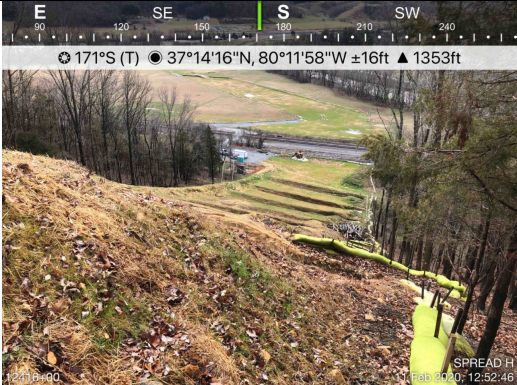
<b>GPS Location</b>	see photo		<b>GPS Location</b>	see photo	
<b>Field Station#</b>	12408+00		<b>Field Station#</b>	12416+00	
<b>Pic 11 Desc.</b>	CWD functioning at this location.		<b>Pic 12 Desc.</b>	Slope on the CIS of the railroad tracks is temporarily stabilized with controls in place.

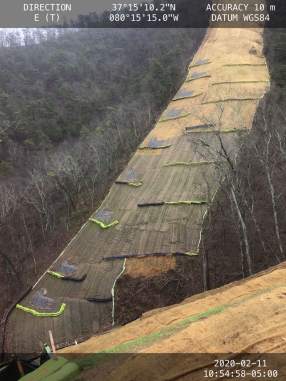
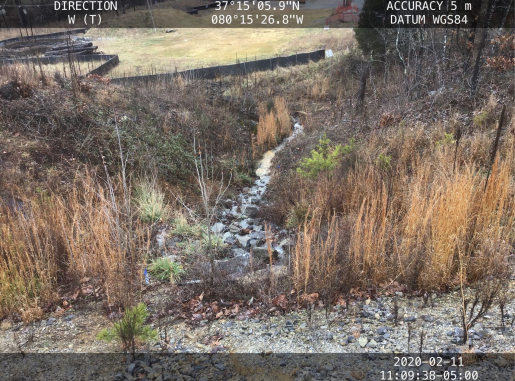
<b>GPS Location</b>	See photo		<b>GPS Location</b>	See photo	
<b>Field Station#</b>	12215+25		<b>Field Station#</b>	12197+37	
<b>Pic 1 Desc.</b>	Permanent restoration below the switchback on Reese Mountain remains intact and stable.		<b>Pic 2 Desc.</b>	Stream S-0011, facing west, downstream

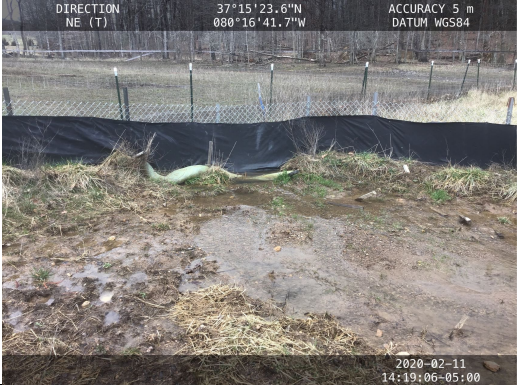
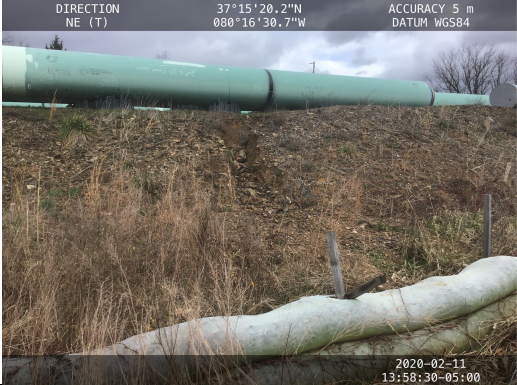
<b>GPS Location</b>	See photo		<b>GPS Location</b>	See photo	
<b>Field Station#</b>	12132+00		<b>Field Station#</b>	12141+00	
<b>Pic 7 Desc.</b>	Undermined super silt fence on the coming in side of stream S-C29.		<b>Pic 8 Desc.</b>	A bit of gully erosion needs to be repaired and stabilized on the going away side access road MVP-MN-272.	
Insert image here			Insert image here		
<b>GPS Location</b>			<b>GPS Location</b>		
<b>Field Station#</b>			<b>Field Station#</b>		
<b>Pic 9 Desc.</b>			<b>Pic 10 Desc.</b>		
Insert image here			Insert image here		
<b>GPS Location</b>			<b>GPS Location</b>		
<b>Field Station#</b>			<b>Field Station#</b>		
<b>Pic 11 Desc.</b>			<b>Pic 12 Desc.</b>

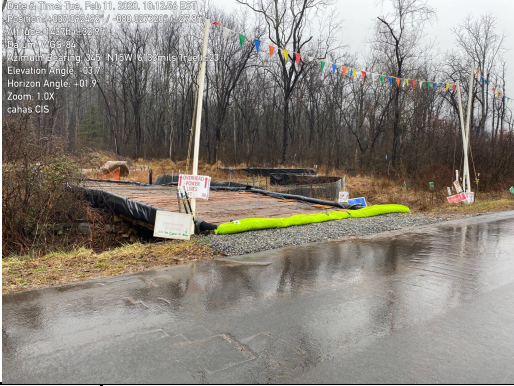
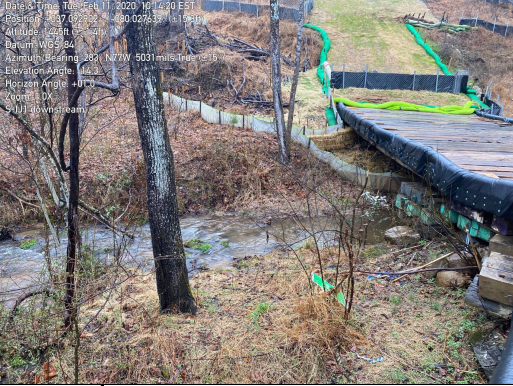
<b>GPS Location</b>	See photo for coordinates.		<b>GPS Location</b>	See photo for coordinates.	
<b>Field Station#</b>	13415+41		<b>Field Station#</b>	13413+01	
<b>Pic 1 Desc.</b>	Cahas Mountain Road, crossing clean, mats and equipment bridges in acceptably condition, ECDs functioning acceptably.		<b>Pic 2 Desc.</b>	S-IJ1, downstream side of equipment bridge, water flowing clear, ECDs functioning acceptably.

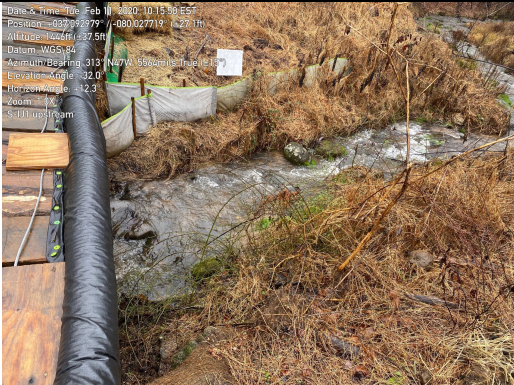
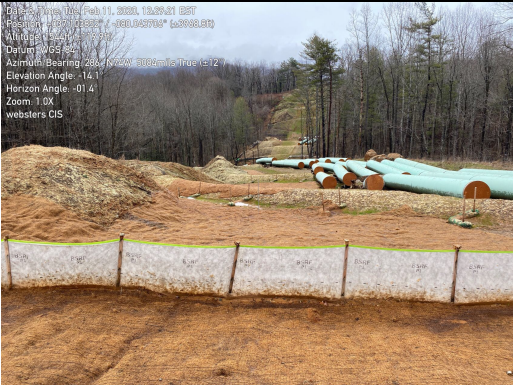
<b>GPS Location</b>	See photo for coordinates.		<b>GPS Location</b>	See photo for coordinates.	
<b>Field Station#</b>	13413+01		<b>Field Station#</b>	13341+00	
<b>Pic 3 Desc.</b>	S-IJ1, upstream of equipment bridge, ECDs functioning acceptably.		<b>Pic 4 Desc.</b>	GAS of Websters Corner, ROW stabilized.

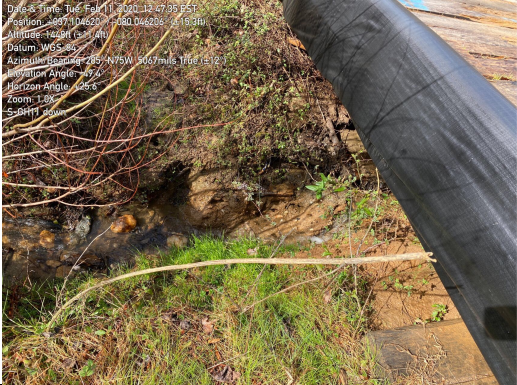
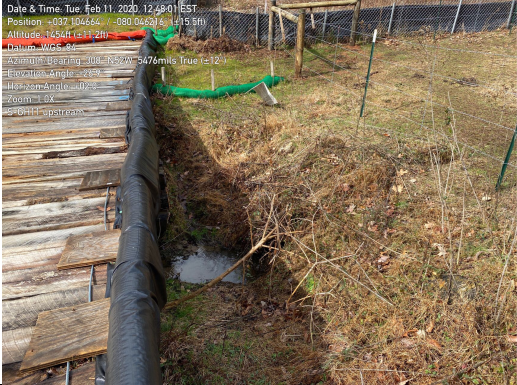
<b>GPS Location</b>	See photo for coordinates.		<b>GPS Location</b>	See photo for coordinates.	
<b>Field Station#</b>	13334+17		<b>Field Station#</b>	13334+17	
<b>Pic 7 Desc.</b>	S-GH11, downstream side of equipment bridge, downward scour noted, no impacts from ROW noted.		<b>Pic 8 Desc.</b>	S-GH11, upstream side of equipment bridge, culvert clear, ECDs functioning acceptably.

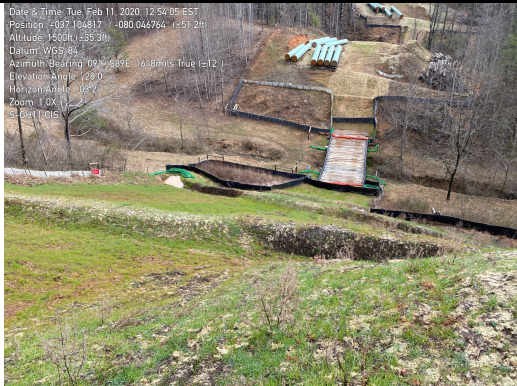
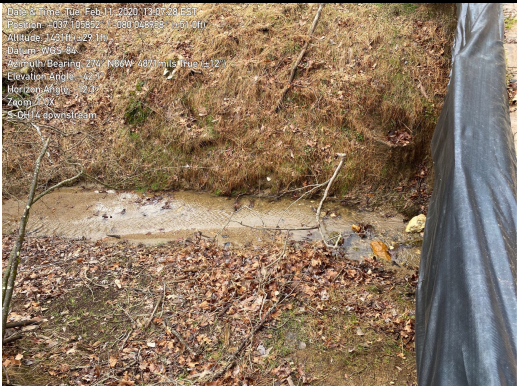
<b>GPS Location</b>	See photo for coordinates.		<b>GPS Location</b>	See photo for coordinates.	
<b>Field Station#</b>	13333+00		<b>Field Station#</b>	13325+30	
<b>Pic 9 Desc.</b>	S-GH11, CIS, ROW stabilized, ECDs functioning acceptably along stream.		<b>Pic 10 Desc.</b>	S-GH14, downstream side of equipment bridge, sediment noted in stream from previous weather event.

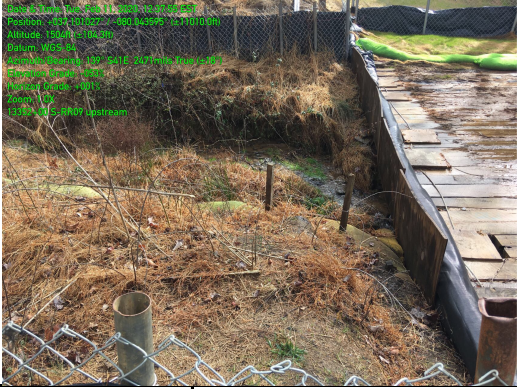
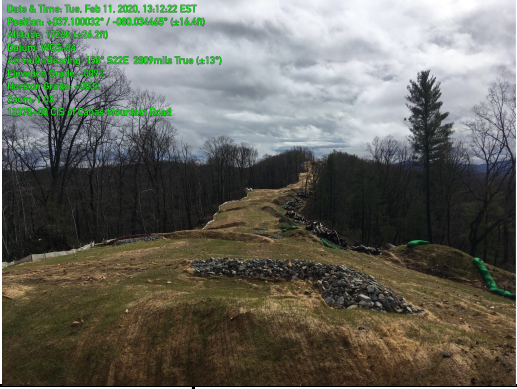
<b>GPS Location</b>	See photo for coordinates.	<b>GPS Location</b>	See photo for coordinates.		
<b>Field Station#</b>	13352+00	<b>Field Station#</b>	13375+00		
<b>Pic 13 Desc.</b>	S-RR09, upstream side of equipment bridge, ECDs functioning acceptably, no issues noted to stream bed or banks.	<b>Pic 14 Desc.</b>	ROW stabilized, perimeter ECDs and waterbars functioning acceptably.

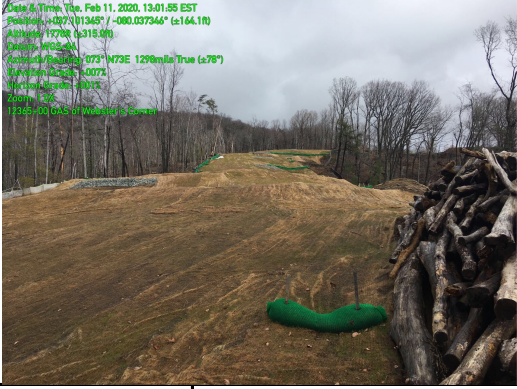
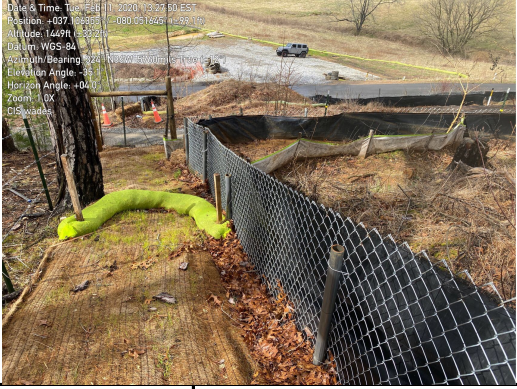
<b>GPS Location</b>	See photo for coordinates.	<b>GPS Location</b>	See photo for coordinates.		
<b>Field Station#</b>	13365+00	<b>Field Station#</b>	13316+00		
<b>Pic 15 Desc.</b>	TOW stabilized with erosion control blanket, sparse vegetation noted, ECDs functioning acceptably.	<b>Pic 16 Desc.</b>	GAS of Wades Gap, sediment noted in corner SSF, added to punch list as a 3 day maintenance item.

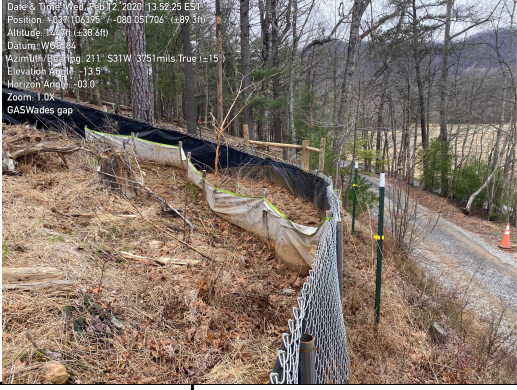
<b>GPS Location</b>	See photo for coordinates.	<b>GPS Location</b>	See photo for coordinates.		
<b>Field Station#</b>	13316+00	<b>Field Station#</b>			
<b>Pic 17 Desc.</b>	Completed punch list item.	<b>Pic 18 Desc.</b>

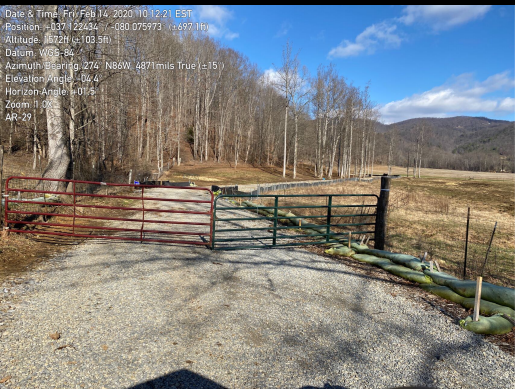
<p>Date &amp; Time: Fri, Feb 14, 2020 10:12:21 EST Position: +037.124301 / -080.075973 (+308.6ft) Altitude: 1222ft (+103.5ft) Datum: WGS-84 Azimuth/Bearing: 276° NB&amp;W 4871mils True (+15°) Elevation Angle: -05.0° Horizon Angle: -00.9° Zoom: 1.0x AR-29</p>	
GPS Location	See photo for coordinates.		GPS Location	See photo for coordinates.	
Field Station#	13142+00		Field Station#	13190+00	
Pic 1 Desc.	MVP-FR-292, access road in acceptable condition, ECDs functioning acceptably.		Pic 2 Desc.	MVP-AR-29, access road in acceptable condition, cattle disturbance noted.
