Visual Site Inspection Report

Project Name	H-600 Pipeline Spread H	AFE	124300138	Spread	H-600 Pipeline Spread H
Contractor	Precision			Report #	8570
Inspector	Dustin Lyons			Date/Time	2/24/2020 3:22 PM
Permit #	TBD	Inspection Type	VA SWPP	Station Begin	12443+00
State	VA	Inspection Area	Partial	Station End	12544+50
County	Montgomery	Ground	Wet	Temperature (°F)	45.00
Municipality	N/A	Weather	Cloudy	Rain Gauge (in)	0.00
				Rain Accumulation Time (days)	3.00

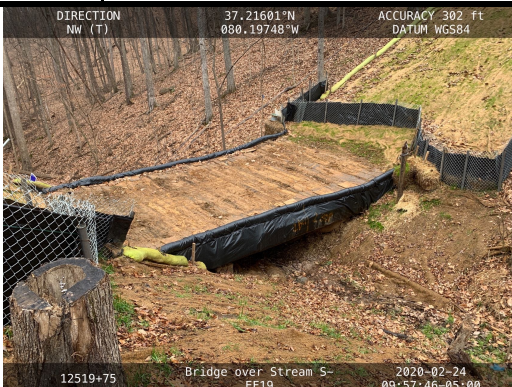
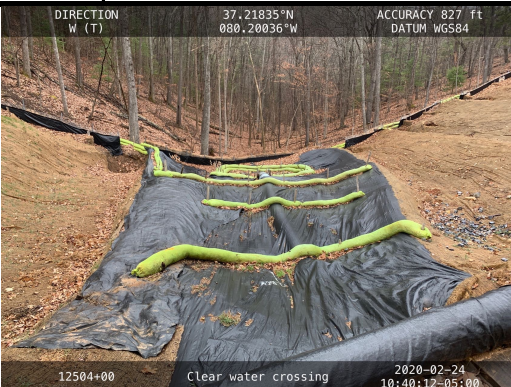
GPS Location	See photo for gps location data.		GPS Location	See photo for gps location data.	
Field Station#	12542+00		Field Station#	12524+00	
Pic 3 Desc.	Photo shows the stabilized spoil piles between about 12541+00 and 12543+00.		Pic 4 Desc.	Photo shows the ROW condition from about 12513+00 to 12524+00.

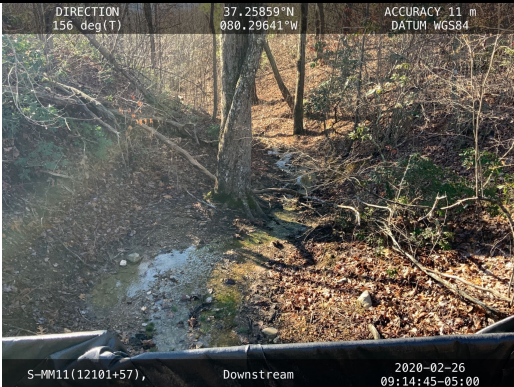
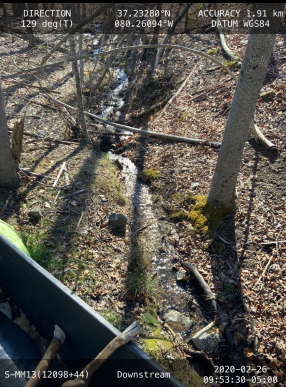
GPS Location	See GPS for location		GPS Location	See GPS for location	
Field Station#	12101+57		Field Station#	12098+44	
Pic 1 Desc.	Stream free of turbidity.		Pic 2 Desc.	Stream free of turbidity.

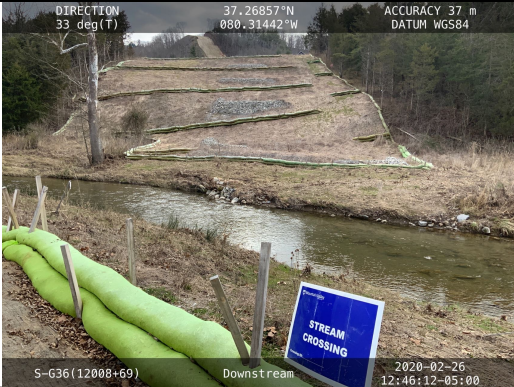
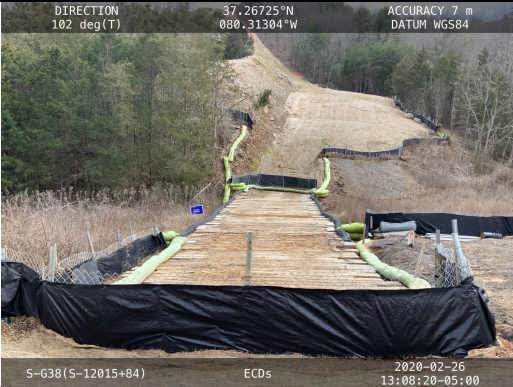
GPS Location	See GPS for location		GPS Location	See GPS for location	
Field Station#	12008+69		Field Station#	12015+84	
Pic 3 Desc.	Stream banks are in tact and permanent restoration is in acceptable condition.		Pic 4 Desc.	ECDs are in acceptable condition.

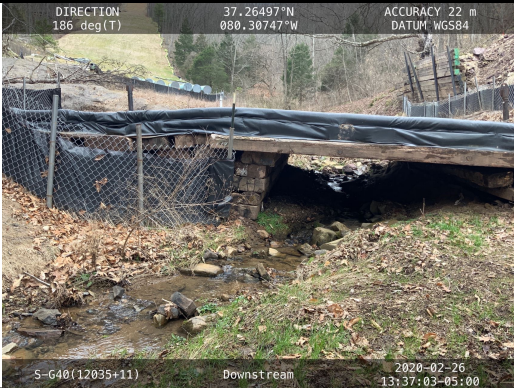
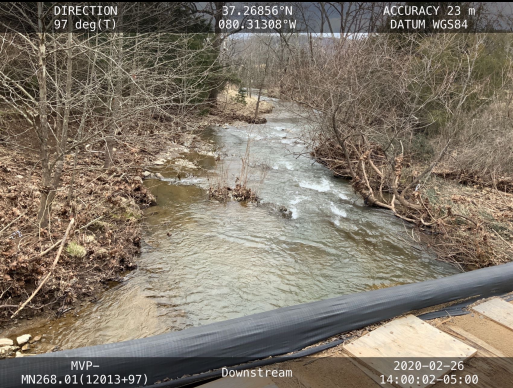
GPS Location	See GPS for location		GPS Location	See GPS for location	
Field Station#	12035+11		Field Station#	12013+97	
Pic 5 Desc.	Stream free of turbidity.		Pic 6 Desc.	Stream is free of turbidity.

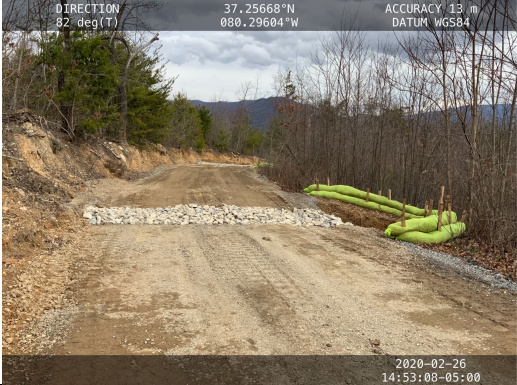
GPS Location	See GPS for location	GPS Location			
Field Station#	12071+80	Field Station#			
Pic 7 Desc.	Crew still in process of broad based dip installation.	Pic 8 Desc.			
Insert image here		Insert image here			
GPS Location		GPS Location			
Field Station#		Field Station#			
Pic 9 Desc.		Pic 10 Desc.			
Insert image here		Insert image here			
GPS Location		GPS Location			
Field Station#		Field Station#			
Pic 11 Desc.		Pic 12 Desc.

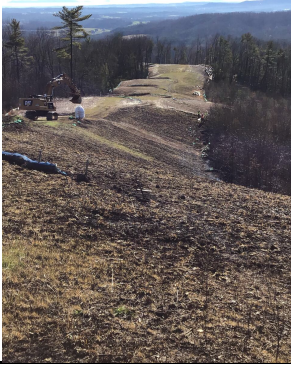
GPS Location	0000	GPS Location	0000		
Field Station#	13460+00	Field Station#	13459+50		
Pic 1 Desc.	Environmental crew working to replace damaged ECDs and stabilize the area of row that was burned	Pic 2 Desc.	Environmental crew working to replace ECDs

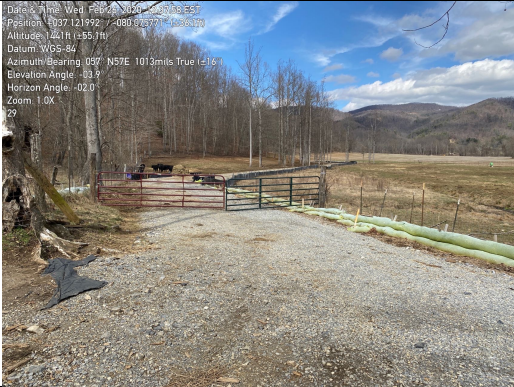
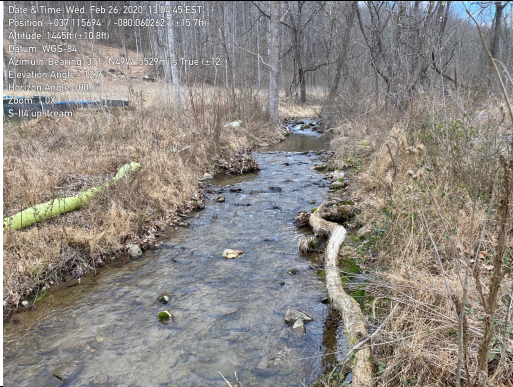
GPS Location	See photo for coordinates.		GPS Location	See photo for coordinates.	
Field Station#	13190+00		Field Station#	13260+60	
Pic 1 Desc.	MVP-AR-29, access road in acceptable condition, cattle noted on and along access road.		Pic 2 Desc.	S-II4, upstream side of equipment bridge, no environmental issues noted.

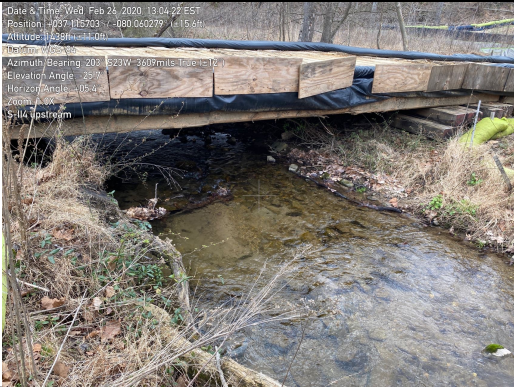
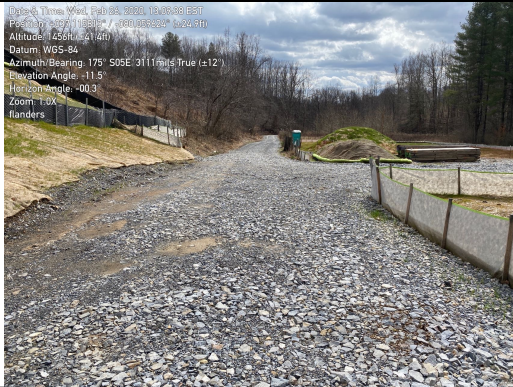
GPS Location	See photo for coordinates.		GPS Location	See photo for coordinates.	
Field Station#	13260+60		Field Station#	13262+50	
Pic 3 Desc.	S-II4, upstream side of equipment bridge looking downstream, no issues noted with bridge.		Pic 4 Desc.	Flanders Road, road crossing in acceptably condition, ECDs functioning acceptably.

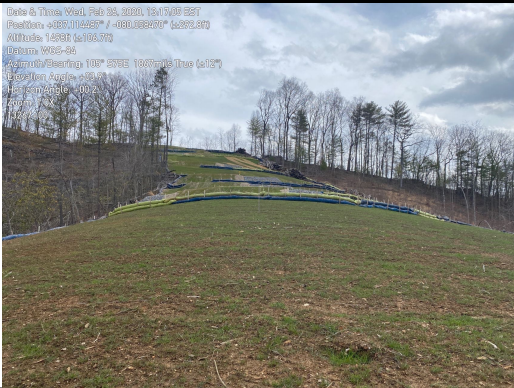
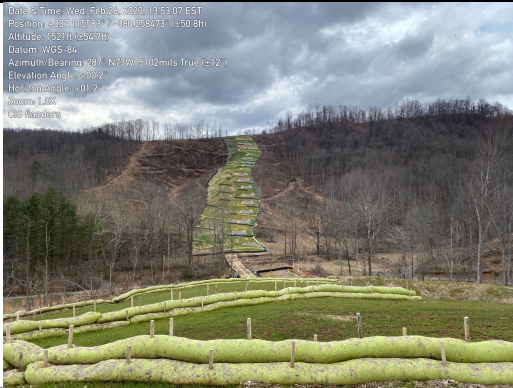
GPS Location	See photo for coordinates.		GPS Location	See photo for coordinates.	
Field Station#	13267+00		Field Station#	13264+00	
Pic 5 Desc.	ROW restored, vegetative cover moderate, temporary ECDs functioning acceptably.		Pic 6 Desc.	ROW restored, vegetative cover moderate, temporary ECDs functioning acceptably.

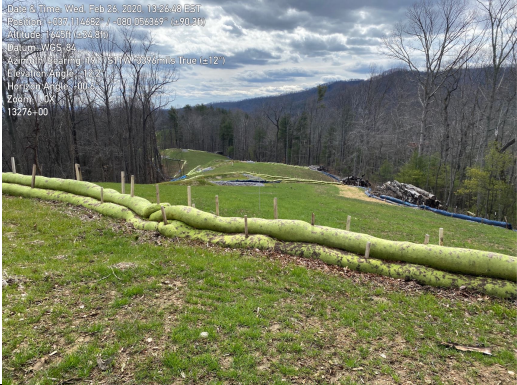
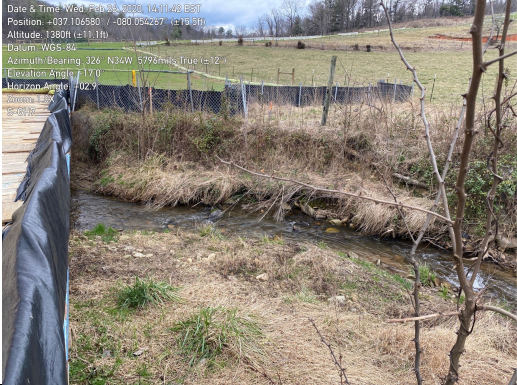
GPS Location	See photo for coordinates.		GPS Location	See photo for coordinates.	
Field Station#	13276+00		Field Station#	13309+09	
Pic 7 Desc.	ROW restored, vegetative cover moderate, temporary ECDs functioning acceptably.		Pic 8 Desc.	S-GH7, upstream side of equipment bridge, deposition noted under right descending bank under equipment bridge.	
Insert image here			Insert image here		
GPS Location			GPS Location		
Field Station#			Field Station#		
Pic 9 Desc.			Pic 10 Desc.		
Insert image here			Insert image here		
GPS Location			GPS Location		
Field Station#			Field Station#		
Pic 11 Desc.			Pic 12 Desc.

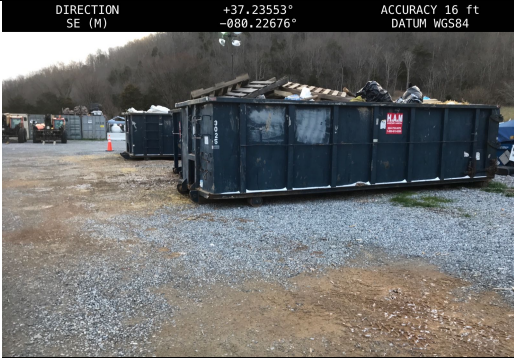
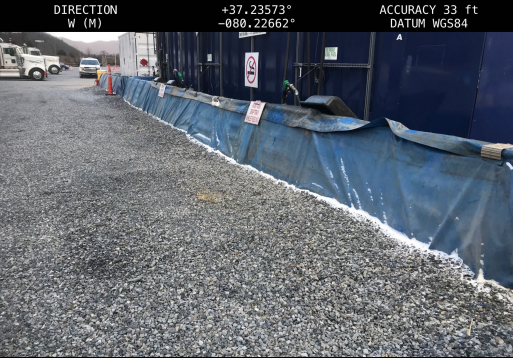
GPS Location	MVP-PY-006 See photo for gps data		GPS Location	MVP-PY-006 See photo for gps data	
Field Station#	+0		Field Station#	+0	
Pic 1 Desc.	No loose trash around the dumpsters. Looking SE.		Pic 2 Desc.	No fuel spills south of the blue bulk fuel tanks. Looking W.

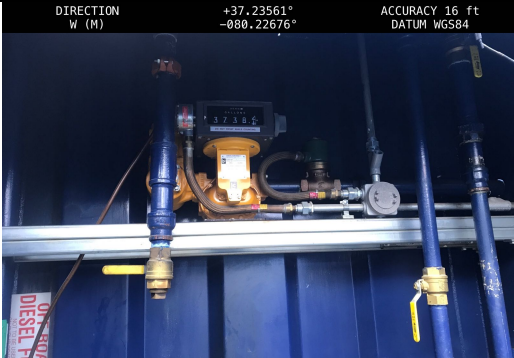
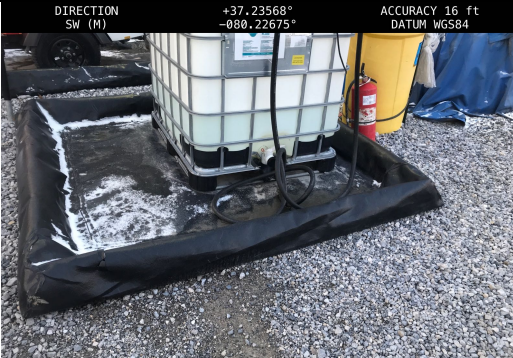
GPS Location	MVP-PY-006 See photo for gps data		GPS Location	MVP-PY-006 See photo for gps data	
Field Station#	+0		Field Station#	+0	
Pic 3 Desc.	Blue Bulk Fuel tanks no leaky internal fittings. Looking W.		Pic 4 Desc.	Containment under the DEF tank in good condition. Looking SW.

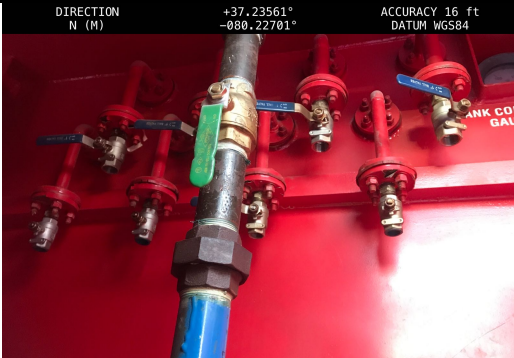
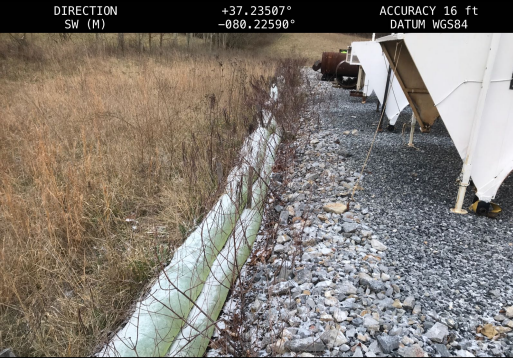
GPS Location	MVP-PY-006 See photo for gps data		GPS Location	MVP-PY-006 See photo for gps data	
Field Station#	+0		Field Station#	+0	
Pic 5 Desc.	Off Road Fuel unit no leaky internal fittings. Looking NW.		Pic 6 Desc.	Compost filter sock along East LOD in good condition. Showing signs of weathering. Looking SW.

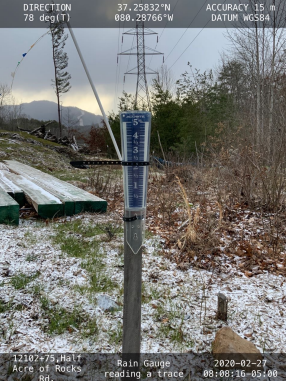
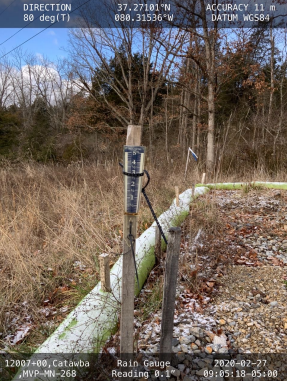
GPS Location	See GPS for location		GPS Location	See GPS for location	
Field Station#	12102+75		Field Station#	12007+00	
Pic 1 Desc.	Rain gauge measured a trace.		Pic 2 Desc.	Rain gauge reading was 0.10"

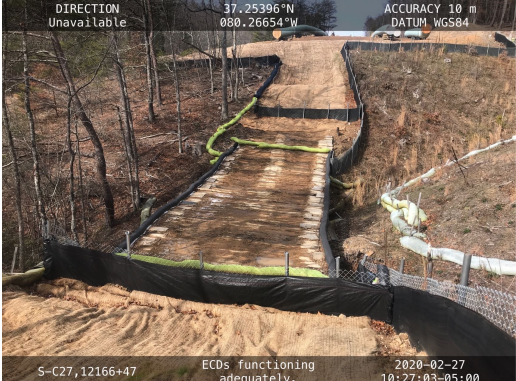
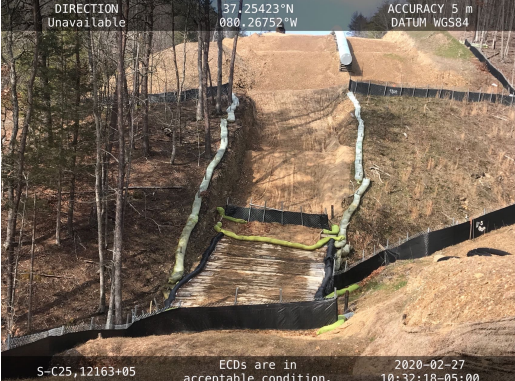
GPS Location	See GPS for location		GPS Location	See GPS for location	
Field Station#	12166+47		Field Station#	12163+05	
Pic 3 Desc.	ECDs were in place and functioning properly.		Pic 4 Desc.	ECDs were in place and functioning properly.

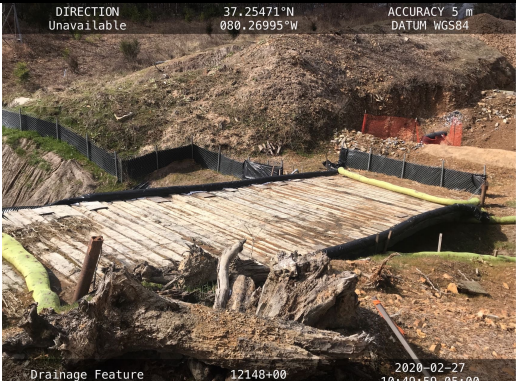
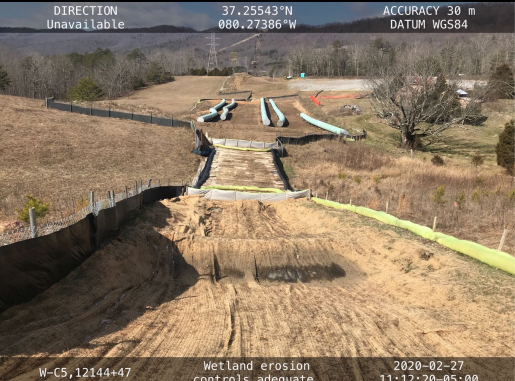
GPS Location	See GPS for location		GPS Location	See GPS for location	
Field Station#	12148+00		Field Station#	12144+47	
Pic 5 Desc.	ECDs were in place and functioning properly.		Pic 6 Desc.	Wetland erosion controls are in place and functioning acceptably.

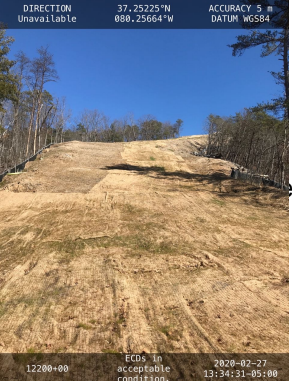
GPS Location	See GPS for location		GPS Location	See GPS for location	
Field Station#	12132+73		Field Station#	12200+00	
Pic 7 Desc.	ECDs were in place at this stream and functioning properly.		Pic 8 Desc.	Erosion blanket, SSF, sumps, and end treatments are in place and functioning properly.

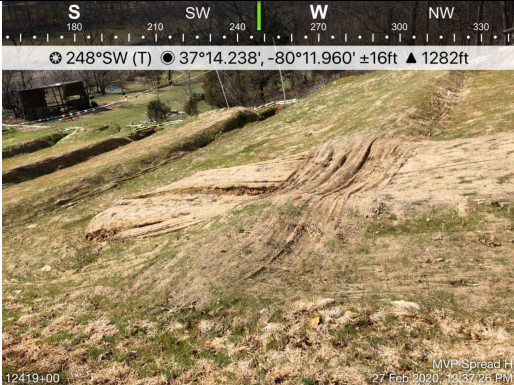
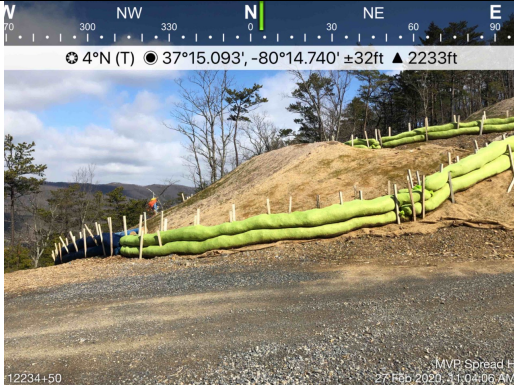
GPS Location	See Picture Watermark		GPS Location	See Picture Watermark	
Field Station#	12419+00		Field Station#	12234+50	
Pic 1 Desc.	Waterbar failure. Punchlist item (24 hr) communicated to LEI.		Pic 2 Desc.	Beginning of inspection area. All installed controls are in good condition and functioning as intended.

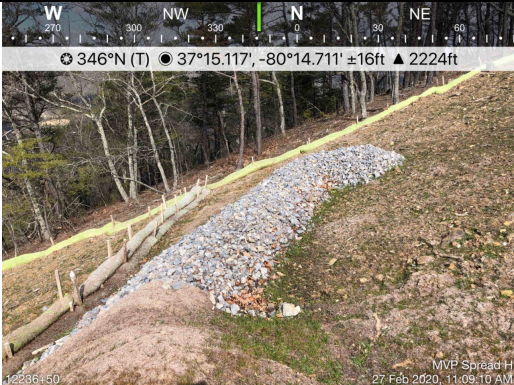
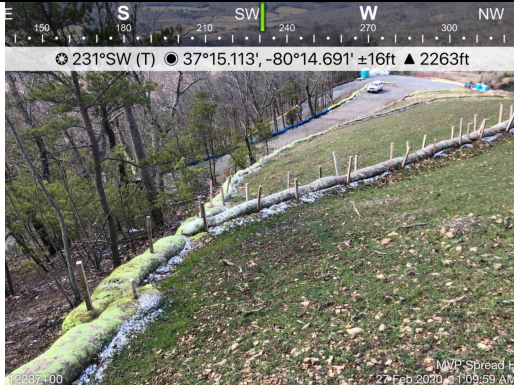
GPS Location	See Picture Watermark		GPS Location	See Picture Watermark	
Field Station#	12236+50		Field Station#	12237+50	
Pic 3 Desc.	Permanent waterbar end treatment in good condition and functioning.		Pic 4 Desc.	CFS diversions and perimeter controls in good condition and functioning.

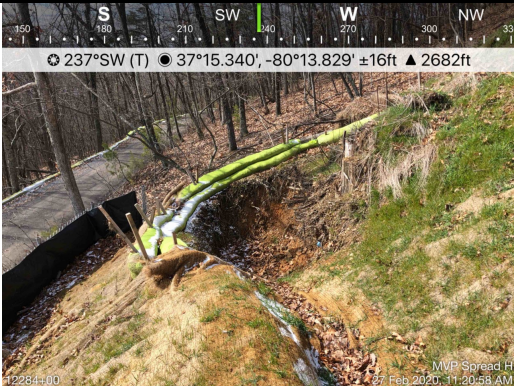
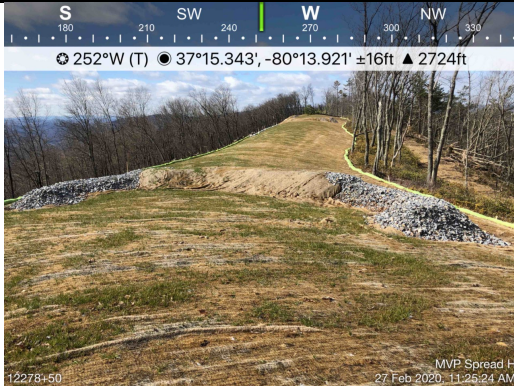
GPS Location	See Picture Watermark		GPS Location	See Picture Watermark	
Field Station#	12284+00		Field Station#	12278+50	
Pic 5 Desc.	Waterbar sump and end treatment in good condition.		Pic 6 Desc.	Permanent waterbar, end treatments, and ROW stabilization in good condition.

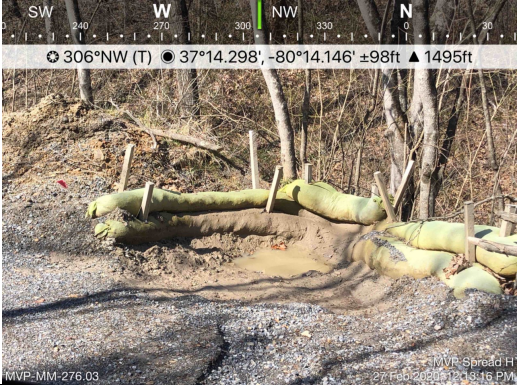
GPS Location	See Picture Watermark		GPS Location	See Picture Watermark	
Field Station#	12297+50		Field Station#	12234+50	
Pic 7 Desc.	Perimeter controls along ROW functioning and in good condition.		Pic 8 Desc.	Controls along access road MVP-MN-276.01 are in good condition.

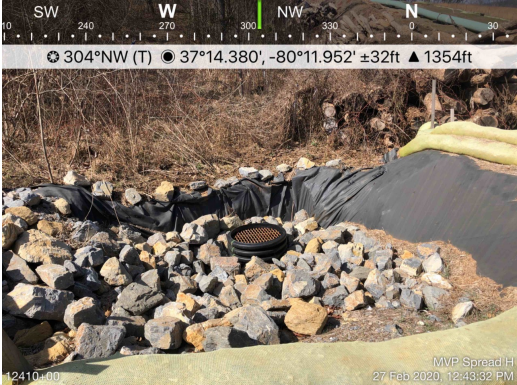
GPS Location	See Picture Watermark		GPS Location	See Picture Watermark	
Field Station#	12421+00		Field Station#	12410+00	
Pic 9 Desc.	Rock construction entrance in good condition and free of accumulated sediment.		Pic 10 Desc.	Clean water diversion inlet structure in good condition and free of sediment.

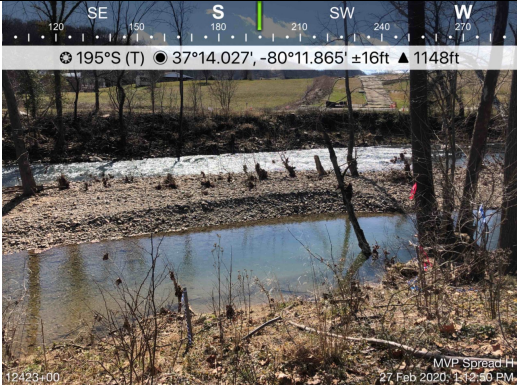
GPS Location	See Picture Watermark		GPS Location	See Picture Watermark	
Field Station#	12410+00		Field Station#	12433+00	
Pic 11 Desc.	Clean water diversion outlet plunge pool in good condition and free of sediment.		Pic 12 Desc.	Roanoke River buffer zone remains in good condition and unimpacted. (Typo in stationing on picture).

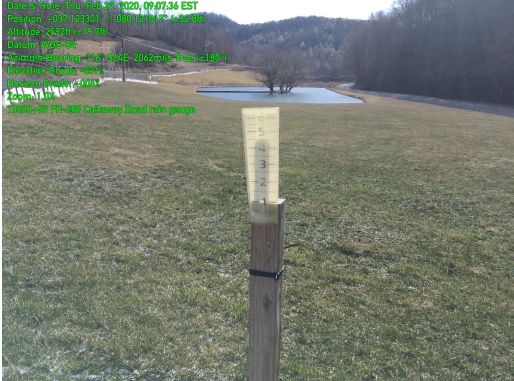
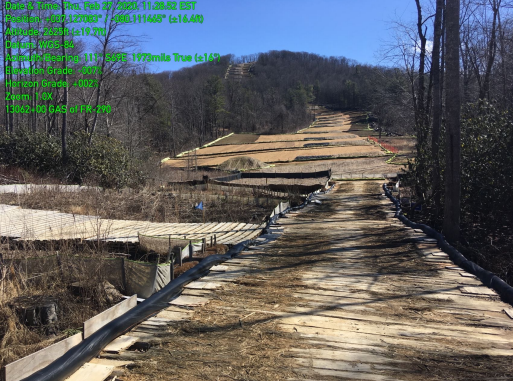
GPS Location	See pic for GPS location	GPS Location	See pic for GPS location		
Field Station#	13033+59	Field Station#	13062+00		
Pic 1 Desc.	0.3" total precipitation after melting the ice.	Pic 2 Desc.	The GAS of FR-290 equipment bridge and ROW with permanent restoration applied.

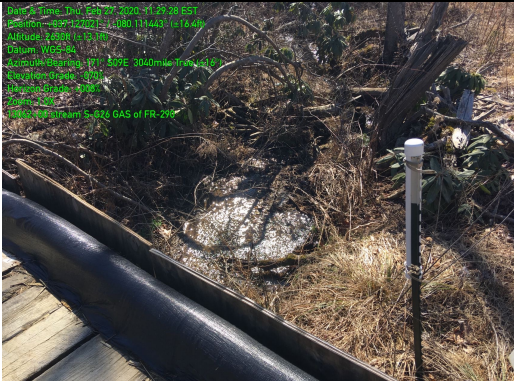
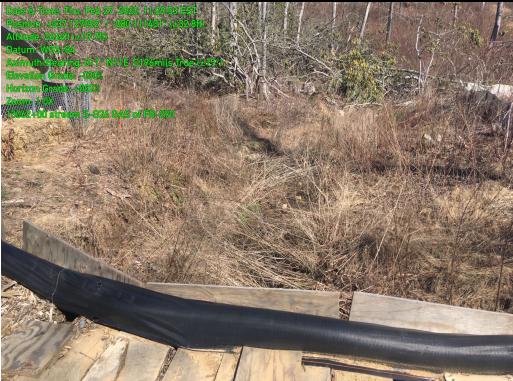
GPS Location	See pic for GPS location	GPS Location	See pic for GPS location		
Field Station#	13062+00	Field Station#	130062+00		
Pic 3 Desc.	No impacts observed on the downstream side of stream S-G26.	Pic 4 Desc.	No impacts observed on the upstream side of stream S-G26.

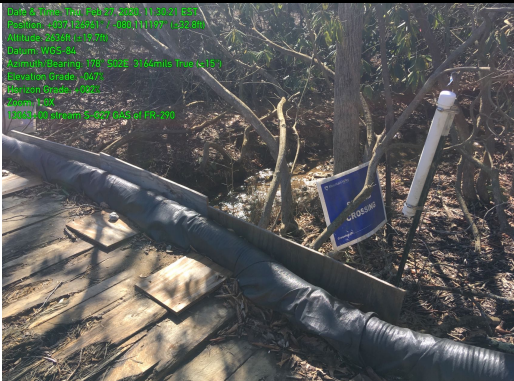
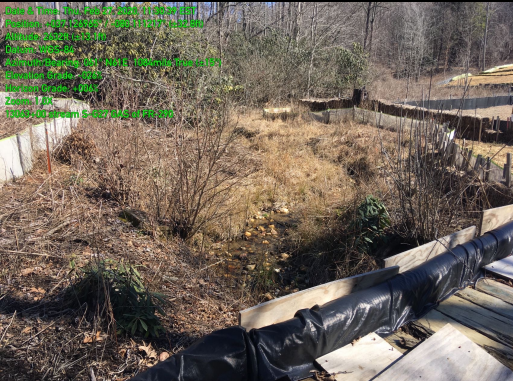
GPS Location	See pic for GPS location	GPS Location	See pic for GPS location		
Field Station#	13063+00	Field Station#	13063+00		
Pic 5 Desc.	No impacts observed on the downstream side of stream S-G27.	Pic 6 Desc.	No impacts observed on the upstream side of stream S-G27.

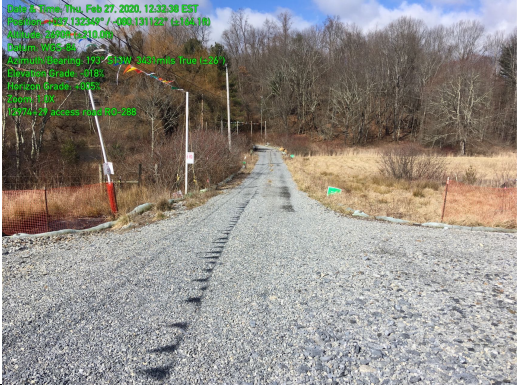
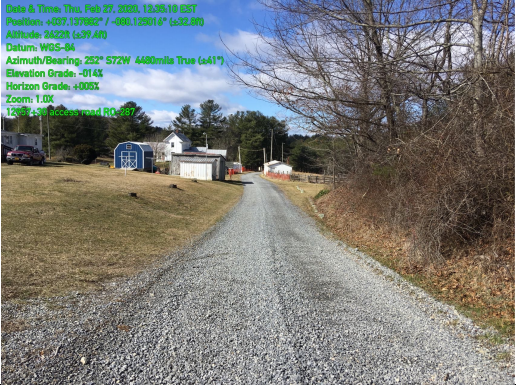
GPS Location	See pic for GPS location		GPS Location	See pic for GPS location	
Field Station#	12974+29		Field Station#	12957+30	
Pic 13 Desc.	Access road RO-288 showed no signs of impacts or maintenance needs.		Pic 14 Desc.	Access road RO-287 showed no signs of impacts or maintenance needs.

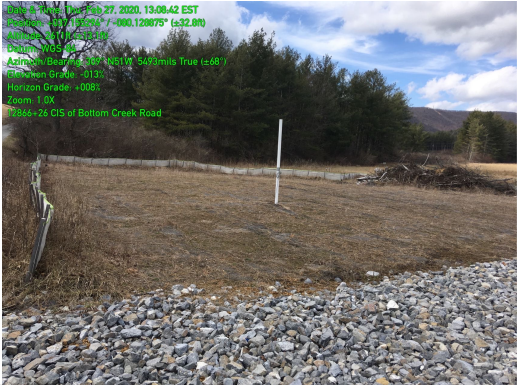
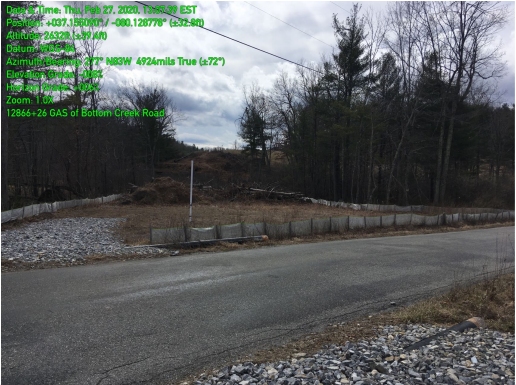
GPS Location	See pic for GPS location		GPS Location	See pic for GPS location	
Field Station#	12866+26		Field Station#	12866+26	
Pic 15 Desc.	CIS of the Bottom Creek Road crossing with temporary stabilization measures in place.		Pic 16 Desc.	GAS of the Bottom Creek Road showed no signs of impacts or maintenance issues.

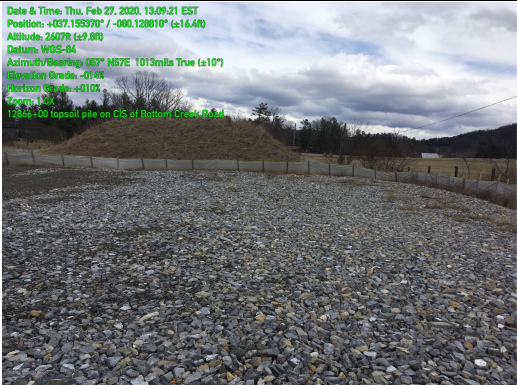
<p>Insert image here</p>			
GPS Location	See pic for GPS location		GPS Location		
Field Station#	12866+00		Field Station#		
Pic 17 Desc.	Topsoil pile remains well stabilized with vegetation and P1 silt fence in good condition.		Pic 18 Desc.

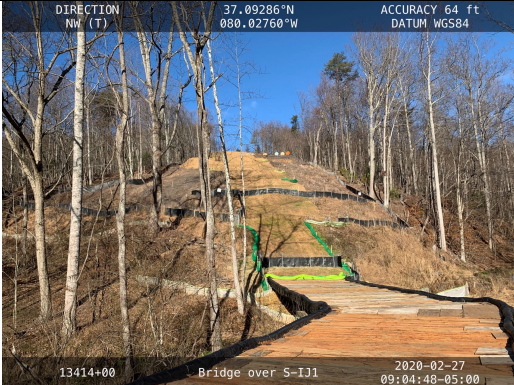
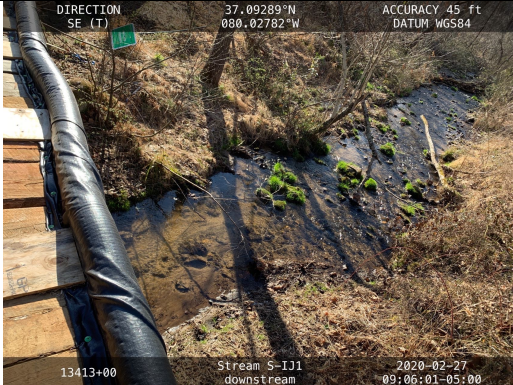
GPS Location	See photo for gps data.		GPS Location	See photo for gps data.	
Field Station#	13414+00		Field Station#	13413+00	
Pic 1 Desc.	Photo shows the ROW and bridge over stream S-IJ1. No environmental issues were observed.		Pic 2 Desc.	Photo shows stream S-IJ1 downstream from the ROW. No environmental issues were observed.

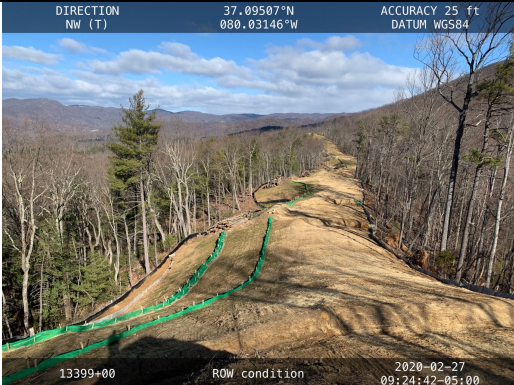
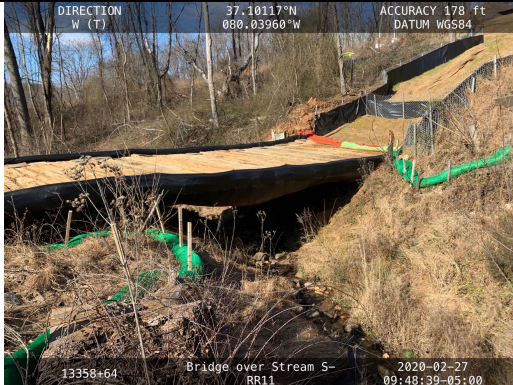
GPS Location	See photo for gps data.		GPS Location	See photo for gps data.	
Field Station#	13399+00		Field Station#	13358+64	
Pic 3 Desc.	Photo shows the ROW condition from about 13395+00 to 13399+00. No environmental issues were observed.		Pic 4 Desc.	Photo shows the bridge over stream S-RR11. No environmental issues were observed.

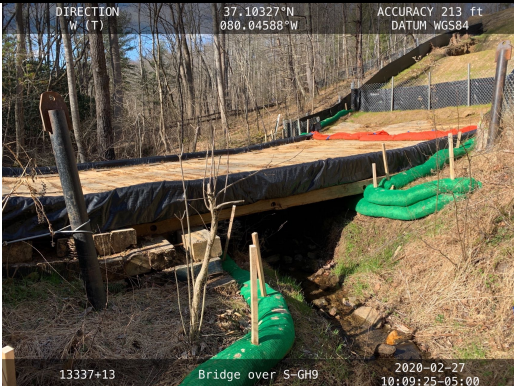
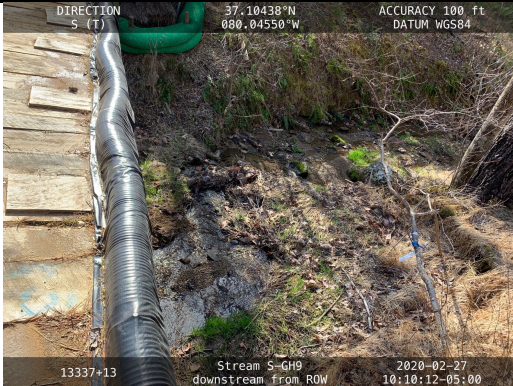
GPS Location	See photo for gps data.		GPS Location	See photo for gps data.	
Field Station#	13337+13		Field Station#	13337+13	
Pic 5 Desc.	Photo shows the bridge over stream S-GH9. No environmental issues were observed.		Pic 6 Desc.	Photo shows stream S-GH9, downstream from the ROW. No environmental issues were observed.

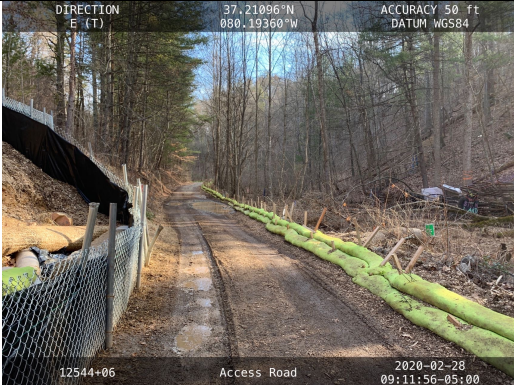
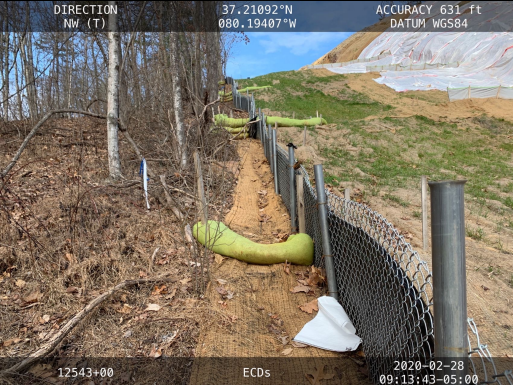
GPS Location	See photo for gos location data.		GPS Location	See photo for gos location data.	
Field Station#	12544+06		Field Station#	12542+00	
Pic 1 Desc.	Photo shows the ECDs along access road MVP-MN-278.01. No environmental issues were observed.		Pic 2 Desc.	Photo shows the ECDs along the ROW. No environmental issues were observed.

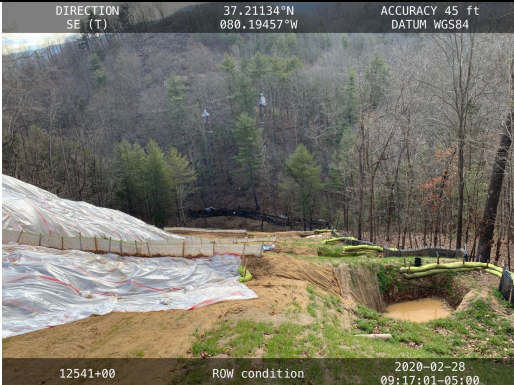
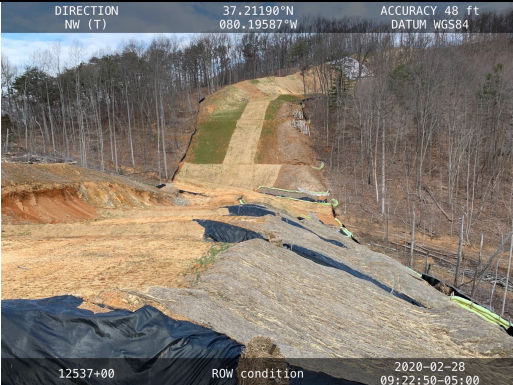
GPS Location	See photo for gos location data.		GPS Location	See photo for gos location data.	
Field Station#	12541+00		Field Station#	12537+00	
Pic 3 Desc.	Photo shows the ROW and stabilized stockpiles from about 12541+00 to 12543+00. No environmental issues were observed.		Pic 4 Desc.	Photo shows the ROW condition from about 12532+00 to 12537+00. No environmental issues were observed.

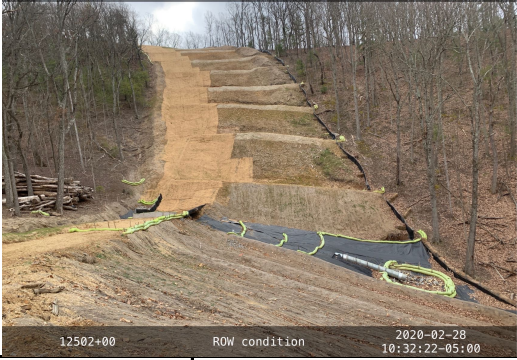
12502+00 ROW condition 2020-02-28 10:32:22-05:00			
GPS Location	See photo for gos location data.		GPS Location	See photo for gos location data.	
Field Station#	12519+41		Field Station#	12502+00	
Pic 7 Desc.	Photo shows stream S-EF19 downstream from the ROW. No environmental issues were observed.		Pic 8 Desc.	Photo shows the ROW condition from about 12502+00 to 12506+00. No environmental issues were observed.	
DIRECTION N (T) 37.22271°N 080.20185°W ACCURACY 31 ft DATUM WGS84

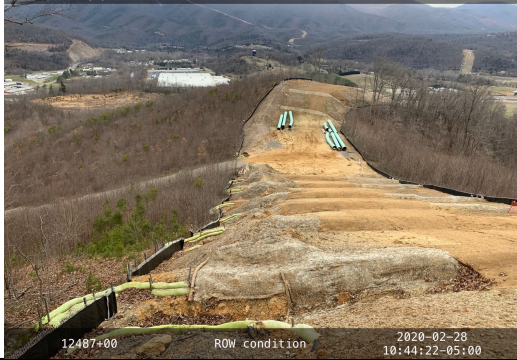
12487+00 ROW condition 2020-02-28 10:44:22-05:00		DIRECTION NE (T) 37.22872°N 080.20388°W ACCURACY 25 ft DATUM WGS84

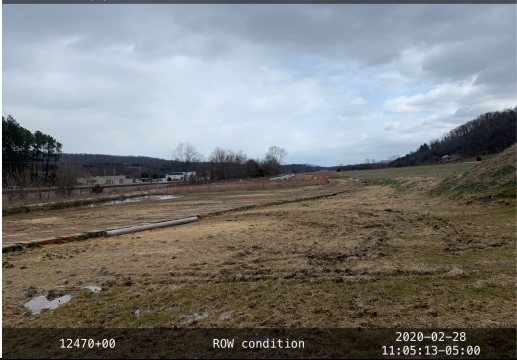
12470+00 ROW condition 2020-02-28 11:05:13-05:00

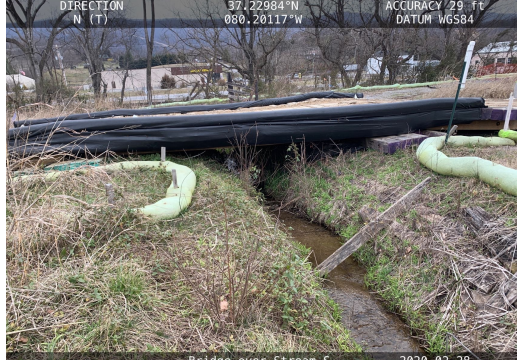
12455+21 Bridge over Stream S-CD12b 2020-02-28 11:09:54-05:00		DIRECTION NW (T) 37.22980°N 080.20122°W ACCURACY 15 ft DATUM WGS84

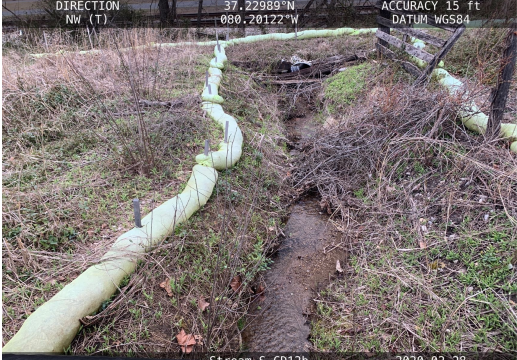
12455+21 Stream S-CD12b downstream from ROW 2020-02-28 11:10:31-05:00			
GPS Location	See photo for gos location data.		GPS Location	See photo for gos location data.	
Field Station#	12455+21		Field Station#	1455+21	
Pic 11 Desc.	Photo shows the bridge over stream S-CD12b. No environmental issues were observed.		Pic 12 Desc.	Photo shows stream S-CD12b downstream from the bridge. No environmental issues were observed.
