## Visual Site Inspection Report

<b>Project Name</b>	H-600 Pipeline Spread H	<b>AFE</b>	124300138	<b>Spread</b>	H-600 Pipeline Spread H
<b>Contractor</b>	Precision			<b>Report #</b>	8777
<b>Inspector</b>	Tammy Kruizenga			<b>Date/Time</b>	3/3/2020 6:32 AM
<b>Permit #</b>	TBD	<b>Inspection Type</b>	VA SWPP	<b>Station Begin</b>	12005+00
<b>State</b>	VA	<b>Inspection Area</b>	Partial	<b>Station End</b>	12119+17
<b>County</b>	Montgomery	<b>Ground</b>	Wet	<b>Temperature (°F)</b>	59.00
<b>Municipality</b>	N/A	<b>Weather</b>	Light Rain	<b>Rain Gauge (in)</b>	0.20
				<b>Rain Accumulation Time (days)</b>	1.00

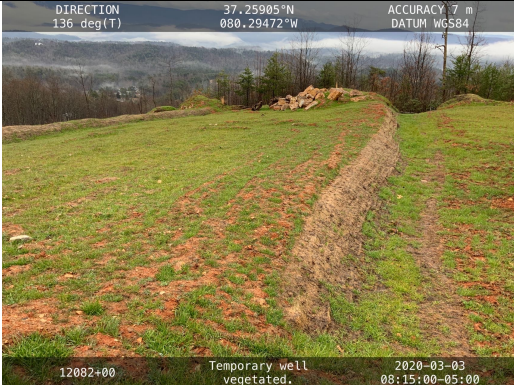
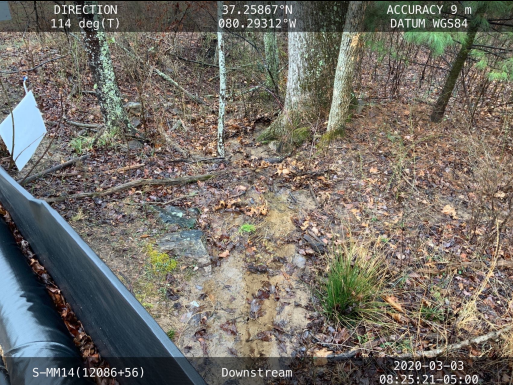
<b>GPS Location</b>	See GPS for location		<b>GPS Location</b>	See GPS for location	
<b>Field Station#</b>	12082+00		<b>Field Station#</b>	12086+56	
<b>Pic 1 Desc.</b>	Temporary stabilization is well vegetated.		<b>Pic 2 Desc.</b>	No sediment impact to stream.

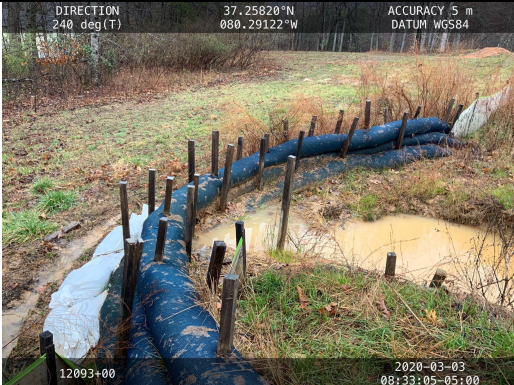
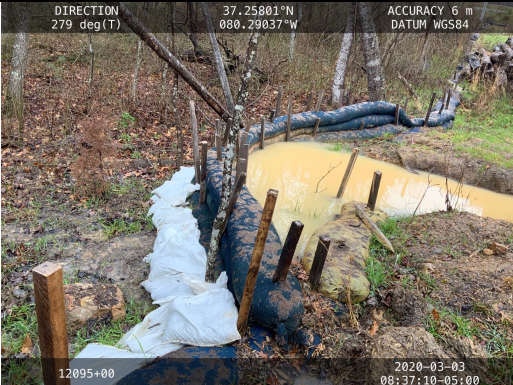
<b>GPS Location</b>	See GPS for location		<b>GPS Location</b>	See GPS for location	
<b>Field Station#</b>	12093+00		<b>Field Station#</b>	12095+00	
<b>Pic 3 Desc.</b>	Sandbag temporary repair to undermined CFS is functioning acceptably.		<b>Pic 4 Desc.</b>	Sandbag temporary repair to undermined CFS is functioning acceptably.

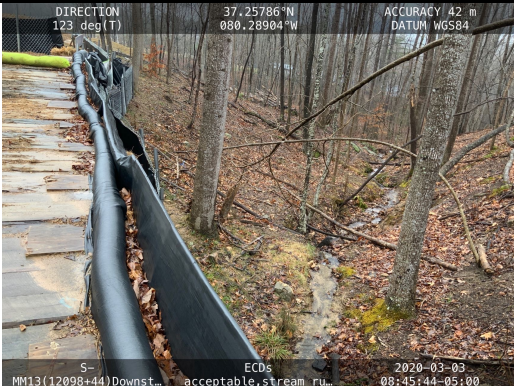
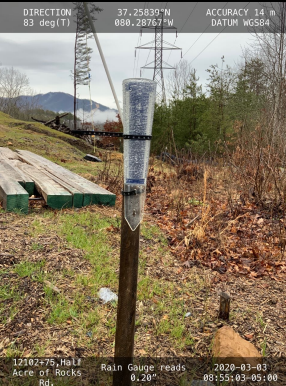
<b>GPS Location</b>	See GPS for location		<b>GPS Location</b>	See GPS for location	
<b>Field Station#</b>	12098+44		<b>Field Station#</b>	12102+75	
<b>Pic 5 Desc.</b>	No sediment impact to stream. ECDs are in acceptable condition.		<b>Pic 6 Desc.</b>	Rain gauge reading on Half Acre of Rocks Rd. is 0.20".

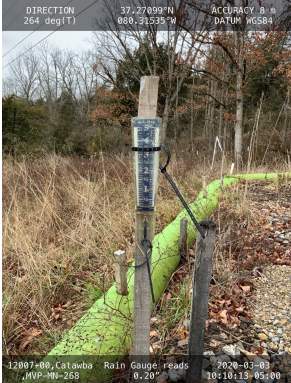
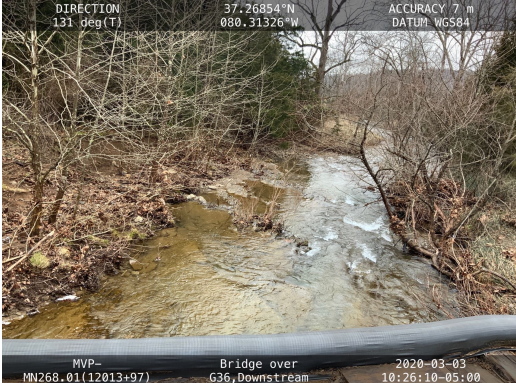
<b>GPS Location</b>	See GPS for location	<b>GPS Location</b>	See GPS for location		
<b>Field Station#</b>	12007+00	<b>Field Station#</b>	12013+97		
<b>Pic 7 Desc.</b>	Rain gauge reading on Catawba Rd. is 0.20".	<b>Pic 8 Desc.</b>	No sediment impact to stream.

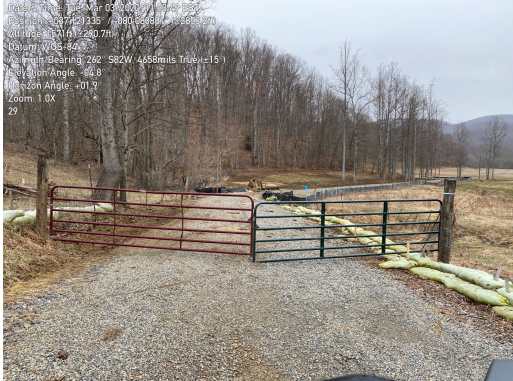
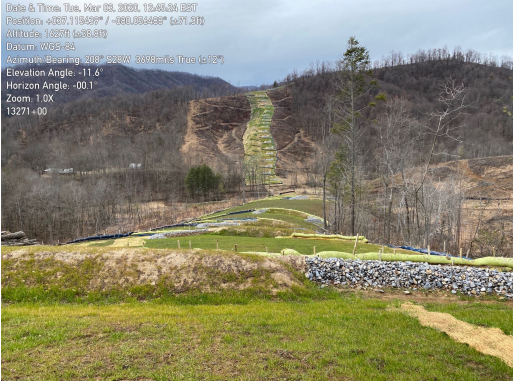
GPS Location				See photo for coordinates.				GPS Location				See photo for coordinates.			
Field Station#				13190+00				Field Station#				13271+00			
Pic 1 Desc.				MVP-MLV-AR-29, ECDs functioning acceptably.				Pic 2 Desc.				ROW stable with moderate to good vegetative cover, permanent waterbars stable.

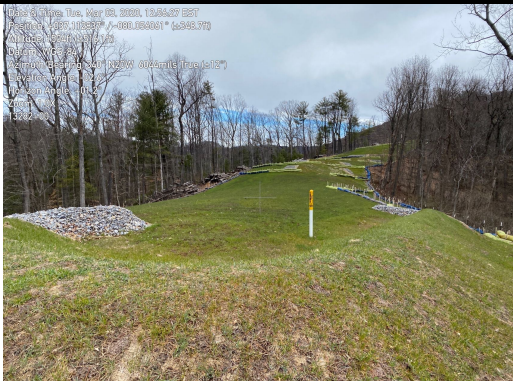
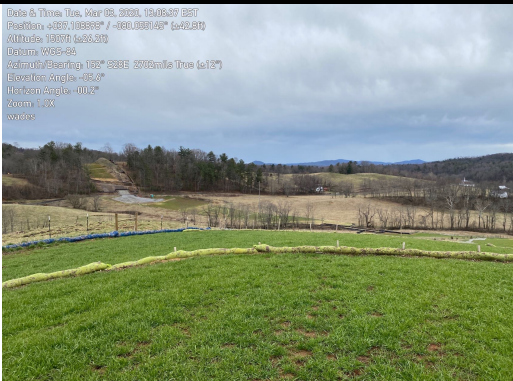
GPS Location				See photo for coordinates.				GPS Location				See photo for coordinates.			
Field Station#				13282+00				Field Station#				13301+00			
Pic 3 Desc.				ROW stable with moderate to good vegetative cover, permanent waterbars stable.				Pic 4 Desc.				ROW stable with good vegetative cover.

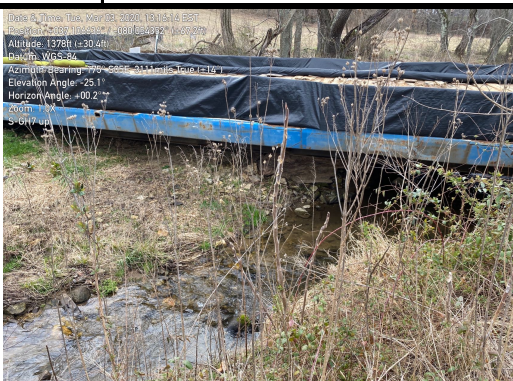
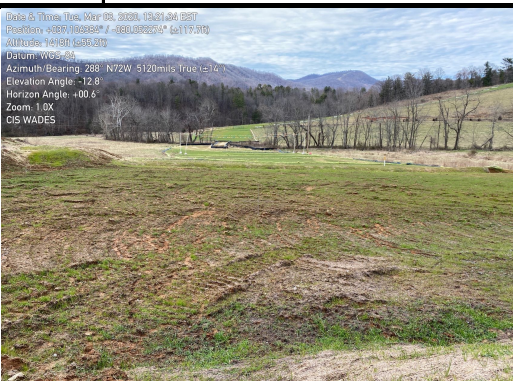
Pic 5 Desc.				S-GH7, upstream side of equipment bridge, no environmental issues noted.				Pic 6 Desc.				CIS of Wades Gap, vegetation moderate in temporarily stabilized area.

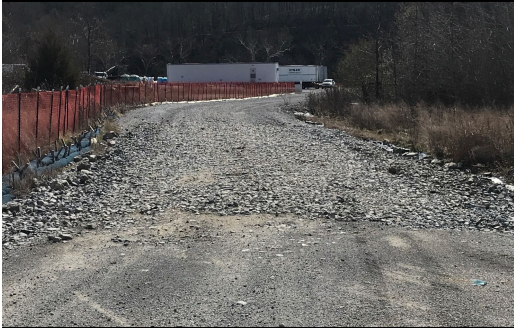
<div>MVP-LY-049_030420</div> <div>Condition of rock entrance</div> <div>2020-03-04 11:24:00-05:00</div> </div>		<div> <div>DIRECTION N (M)</div> <div>+37.27167° -080.12050°</div> <div>ACCURACY 33 ft DATUM WGS84</div>

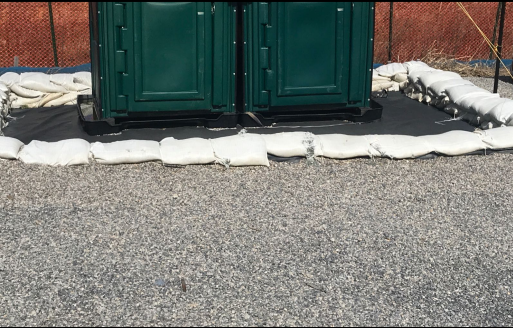
<div>MVP-LY-049_030420</div> <div>Condition of trays and containment</div> <div>2020-03-04 11:25:52-05:00</div> </div>			
<b>GPS Location</b>	MVP-LY-09 See photo for gps data		<b>GPS Location</b>	MVP-LY-09 See photo for gps data	
<b>Field Station#</b>	+0		<b>Field Station#</b>	+0	
<b>Pic 1 Desc.</b>	Condition of rock entrance on center driveway. Looking S.		<b>Pic 2 Desc.</b>	Condition of trays and containment under toilets. Looking N.	
<div> <div>DIRECTION N (M)</div> <div>+37.27028° -080.12143°</div> <div>ACCURACY 33 ft DATUM WGS84</div>

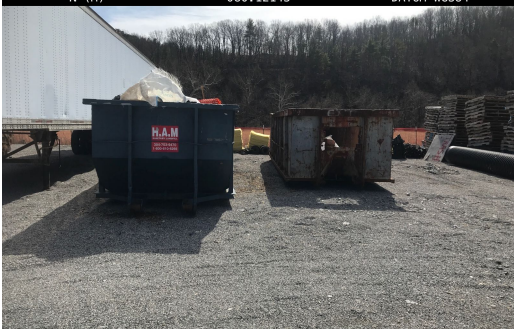
<div>MVP-LY-049_030420</div> <div>No loose trash around south dumpsters</div> <div>2020-03-04 11:29:34-05:00</div> </div>		<div> <div>DIRECTION W (M)</div> <div>+37.27047° -080.12340°</div> <div>ACCURACY 16 ft DATUM WGS84</div>

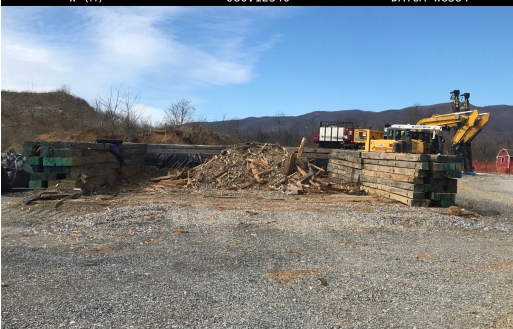
<div>MVP-LY-049_030420</div> <div>Condition of temporary trash transfer</div> <div>2020-03-04 11:33:40-05:00</div> </div>

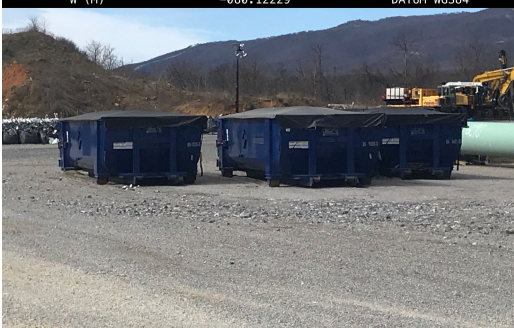
<div>MVP-LY-049_030420</div> <div>3 covered dumpsters for contaminated materials</div> <div>2020-03-04 11:32:58-05:00</div> </div>		<div> <div>DIRECTION S (M)</div> <div>+37.27039° -080.12477°</div> <div>ACCURACY 16 ft DATUM WGS84</div>

<b>Pic 5 Desc.</b>	Three covered dumpsters for contaminated materials. No liquid leakage. Looking W.		<b>Pic 6 Desc.</b>	Landowner disturbance along compost filter sock and feature. No impacts. Looking S.

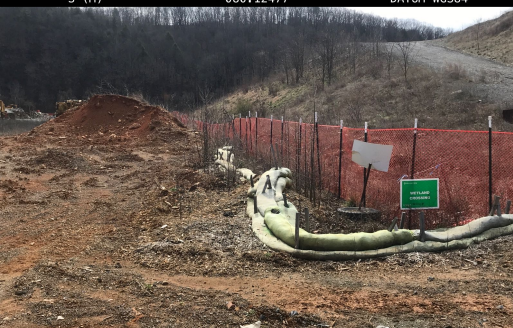
<div>MVP-LY-049_030420</div> <div>Landowner disturbance along CFS and feature</div> <div>2020-03-04 11:34:35-05:00</div> </div>			
<b>GPS Location</b>	MVP-LY-09 See photo for gps data		<b>GPS Location</b>	MVP-LY-09 See photo for gps data	
<b>Field Station#</b>	+0		<b>Field Station#</b>	+0

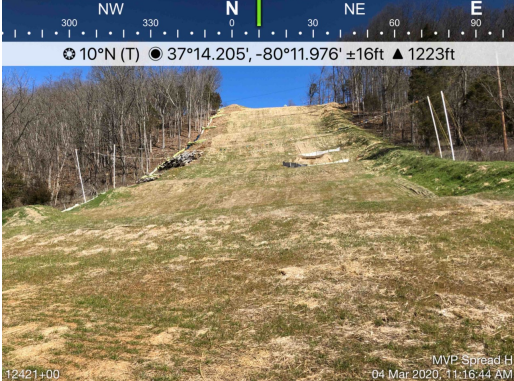
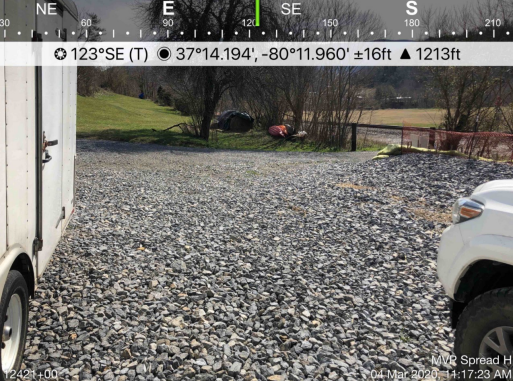
<b>GPS Location</b>	See Picture Watermark		<b>GPS Location</b>	See Picture Watermark	
<b>Field Station#</b>	12421+00		<b>Field Station#</b>	12421+00	
<b>Pic 1 Desc.</b>	Vegetated and stable ROW is in good condition.		<b>Pic 2 Desc.</b>	Rock construction entrance in good condition and free of sediment.

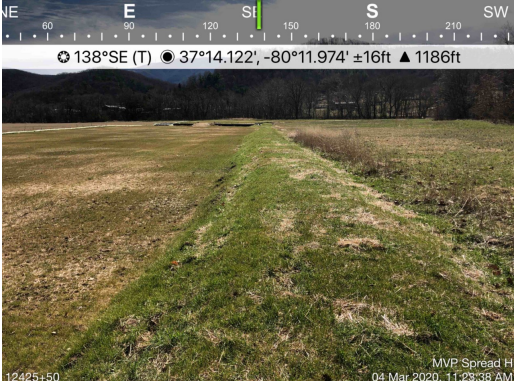
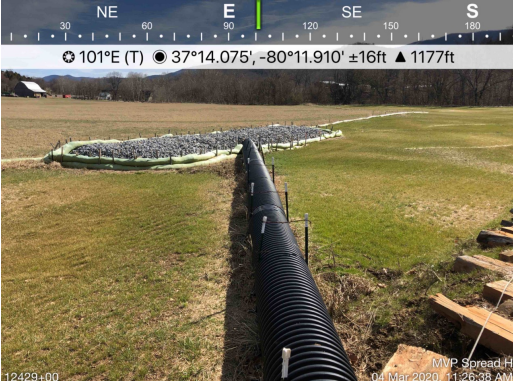
<b>GPS Location</b>	See Picture Watermark		<b>GPS Location</b>	See Picture Watermark	
<b>Field Station#</b>	12425+50		<b>Field Station#</b>	12429+00	
<b>Pic 3 Desc.</b>	Clean water diversion berm well vegetated and functioning as intended.		<b>Pic 4 Desc.</b>	Clean water diversion pipe and outlet treatment structure in good condition.

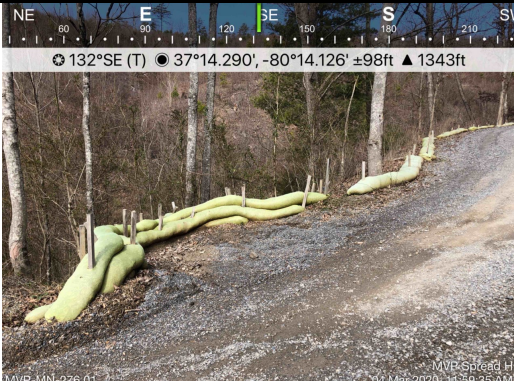
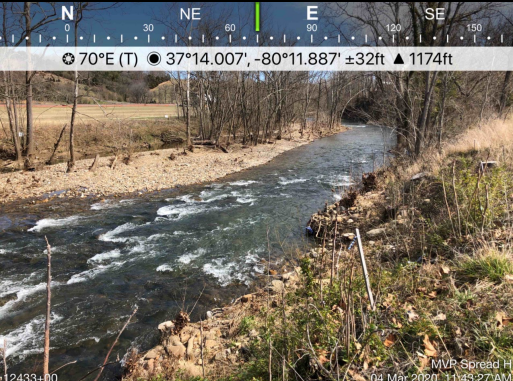
<b>Pic 5 Desc.</b>	Controls on access road MVP-MN-276.01 are in good condition.		<b>Pic 6 Desc.</b>	Roanoke River buffer area and feature in good condition and remains unimpacted.

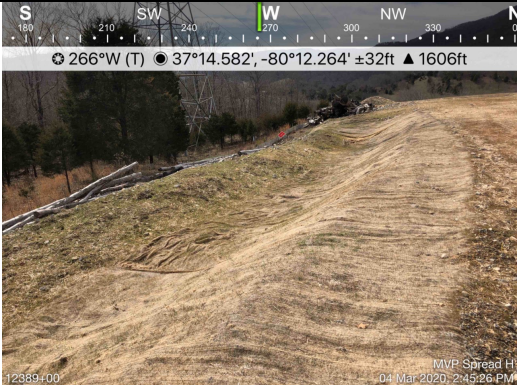
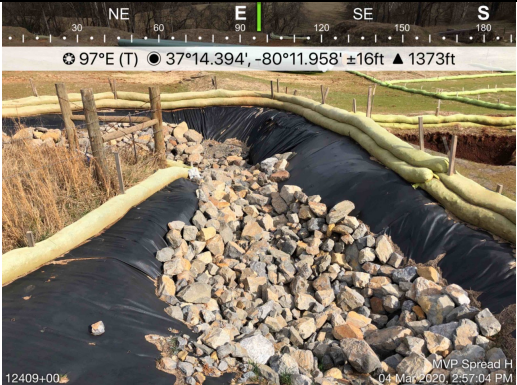
<b>GPS Location</b>	See Picture Watermark		<b>GPS Location</b>	See Picture Watermark	
<b>Field Station#</b>	12389+00		<b>Field Station#</b>	12409+00	
<b>Pic 13 Desc.</b>	Conveyance channel remains stabilized and free of accelerated erosion.		<b>Pic 14 Desc.</b>	Clean water diversion inlet structure remains free of excess sediment and is functional.

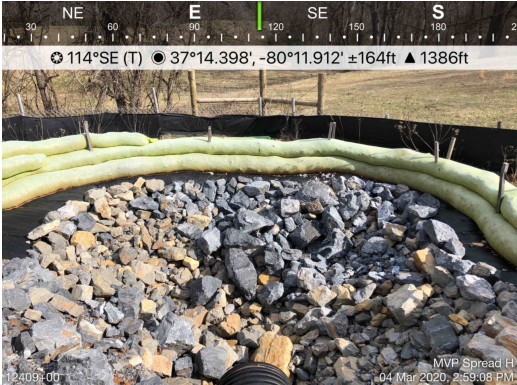
Insert image here	
<b>GPS Location</b>	See Picture Watermark		<b>GPS Location</b>		
<b>Field Station#</b>	12409+00		<b>Field Station#</b>		
<b>Pic 15 Desc.</b>	Clean water diversion outlet structure plunge pool remains installed and in good condition.		<b>Pic 16 Desc.</b>		
Insert image here		Insert image here			
<b>GPS Location</b>			<b>GPS Location</b>		
<b>Field Station#</b>			<b>Field Station#</b>		
<b>Pic 17 Desc.</b>			<b>Pic 18 Desc.</b>

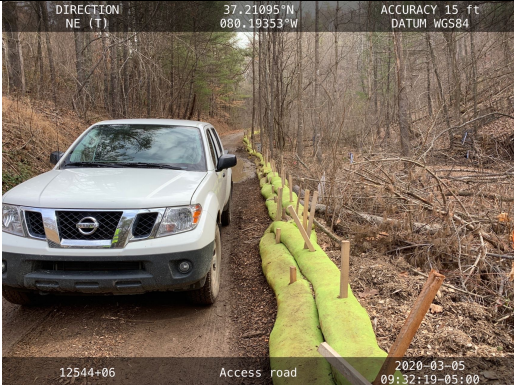
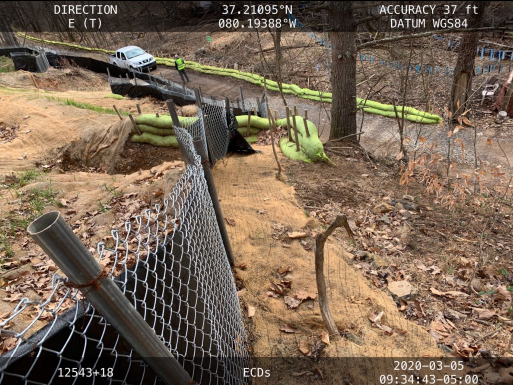
<b>GPS Location</b>	See photo for gps location data.		<b>GPS Location</b>	See photo for gps location data.	
<b>Field Station#</b>	12544+06		<b>Field Station#</b>	12543+18	
<b>Pic 1 Desc.</b>	Photo shows the ECDs along Yellowfinch Road. No environmental issues were observed.		<b>Pic 2 Desc.</b>	Photo shows the ECDs along the ROW. No environmental issues were observed.

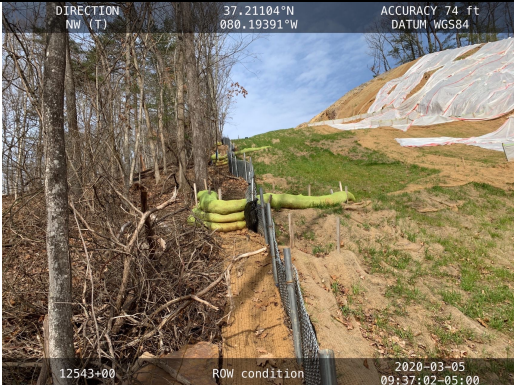
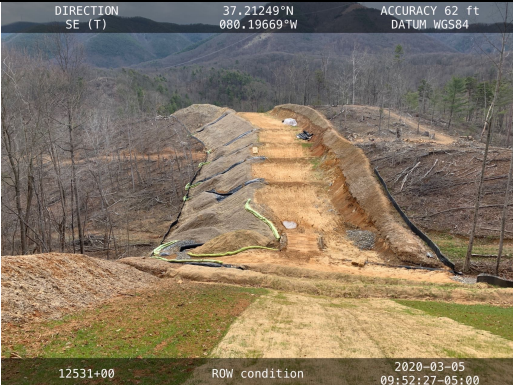
<b>GPS Location</b>	See photo for gps location data.		<b>GPS Location</b>	See photo for gps location data.	
<b>Field Station#</b>	12543+00		<b>Field Station#</b>	12531+00	
<b>Pic 3 Desc.</b>	Photo shows the ECDs along the ROW. No environmental issues were observed.		<b>Pic 4 Desc.</b>	Photo shows the ROW condition from about 12531+00 to 12537+00. No environmental issues were observed.

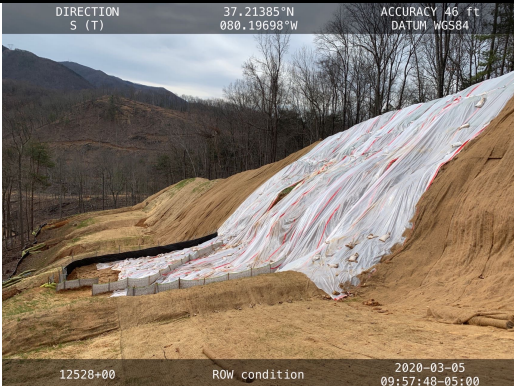
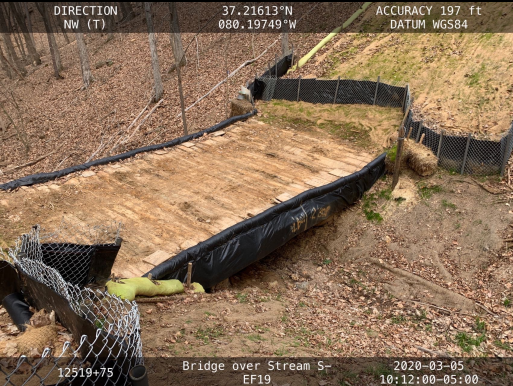
<b>Field Station#</b>	12528+00		<b>Field Station#</b>	12519+00	
<b>Pic 5 Desc.</b>	Photo shows the ROW conditions and stabilized spoil piles.		<b>Pic 6 Desc.</b>	Photo shows the bridge over stream S-EF19. No environmental issues were observed.

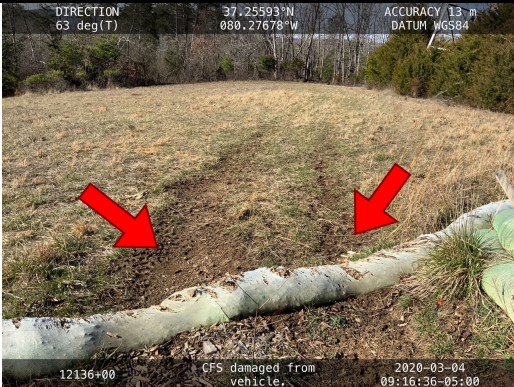
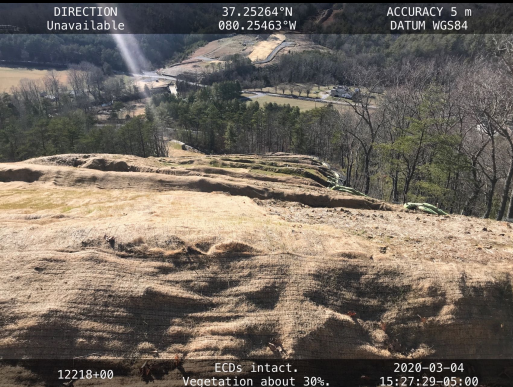
<b>GPS Location</b>	See GPS for location		<b>GPS Location</b>	See GPS for location	
<b>Field Station#</b>	12136+00		<b>Field Station#</b>	12218+00	
<b>Pic 1 Desc.</b>	Damaged CFS was reported to contractor and will be repaired tomorrow.		<b>Pic 2 Desc.</b>	ECDs intact and vegetation at approximately 30%.

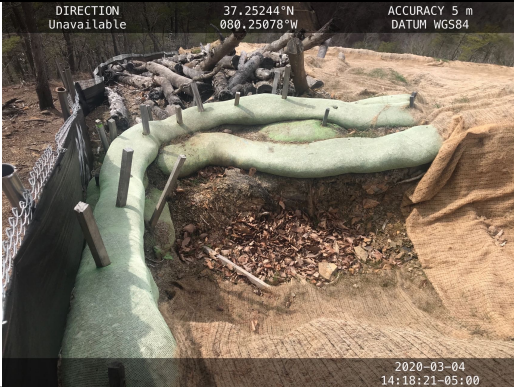
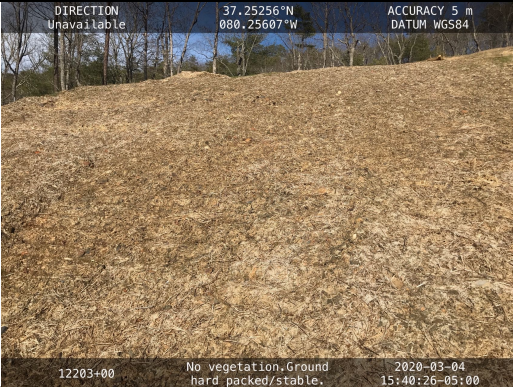
<b>GPS Location</b>	See GPS for location		<b>GPS Location</b>	See GPS for location	
<b>Field Station#</b>	12215+00		<b>Field Station#</b>	12303+00	
<b>Pic 3 Desc.</b>	Sump in acceptable condition. End treatments functioning acceptably.		<b>Pic 4 Desc.</b>	No vegetation. Ground is hard packed and stable.

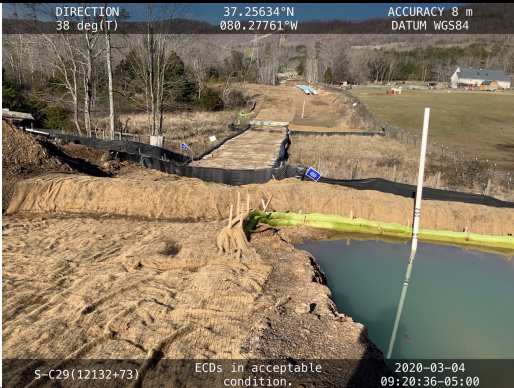
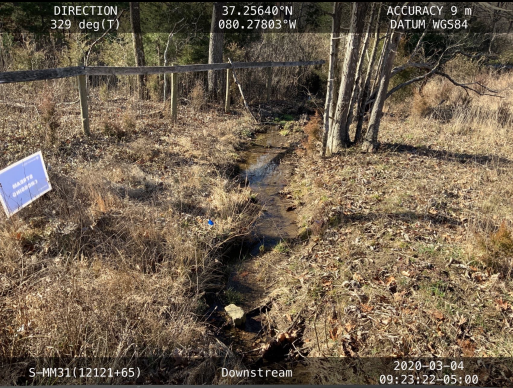
<b>GPS Location</b>	See GPS for location		<b>GPS Location</b>	See GPS for location	
<b>Field Station#</b>	12132+73		<b>Field Station#</b>	12121+65	
<b>Pic 5 Desc.</b>	ECDs are functioning acceptably.		<b>Pic 6 Desc.</b>	No sediment impact to stream.
