Visual Site Inspection Report

Project Name	H-600 Pipeline Spread H	AFE	124300138	Spread	H-600 Pipeline Spread H
Contractor	Precision			Report #	9415
Inspector	John Brcic			Date/Time	3/23/2020 11:20 AM
Permit #	TBD	Inspection Type	VA SWPP	Station Begin	12443+75
State	VA	Inspection Area	Partial	Station End	12544+06
County	Montgomery	Ground	Damp	Temperature (°F)	41.00
Municipality	N/A	Weather	Light Rain	Rain Gauge (in)	0.50
				Rain Accumulation Time (days)	3.00

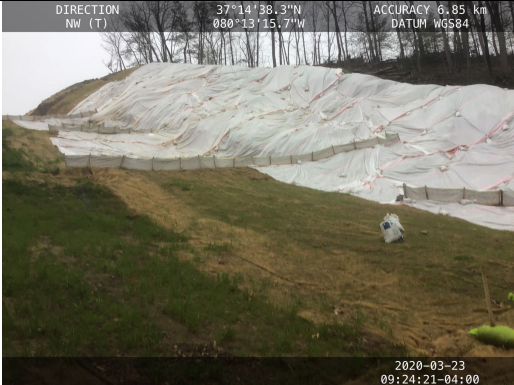
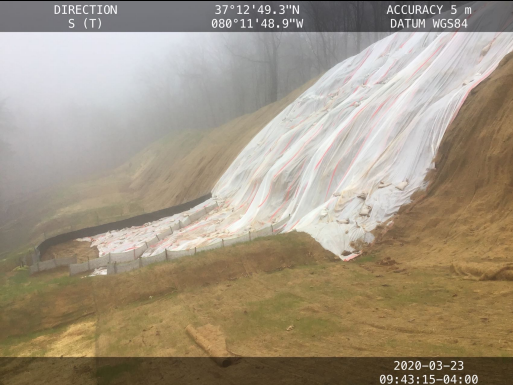
GPS Location	See photo		GPS Location	See photo	
Field Station#	12543+00		Field Station#	12529+00	
Pic 1 Desc.	No further erosion was observed where plastic sheeting was used to stabilize this stockpile close to Yellow Finch Road.		Pic 2 Desc.	Stockpiles remain relatively stable where plastic sheeting was used for stabilization.

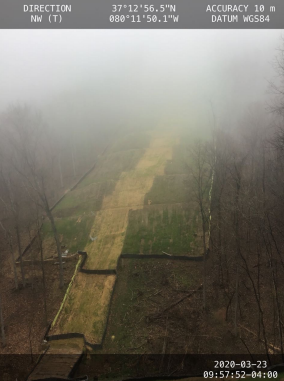
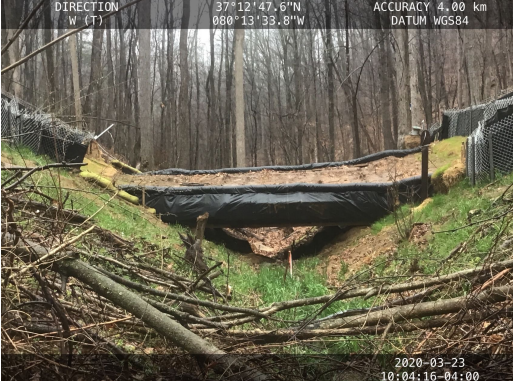
GPS Location	See photo		GPS Location	See photo	
Field Station#	12517+00		Field Station#	12519+47	
Pic 3 Desc.	The slope on the coming in side of stream S-EF19 remains stable.		Pic 4 Desc.	Stream S-EF19, facing west, downstream

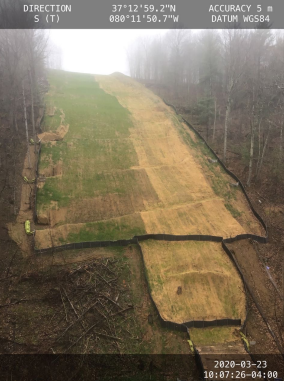
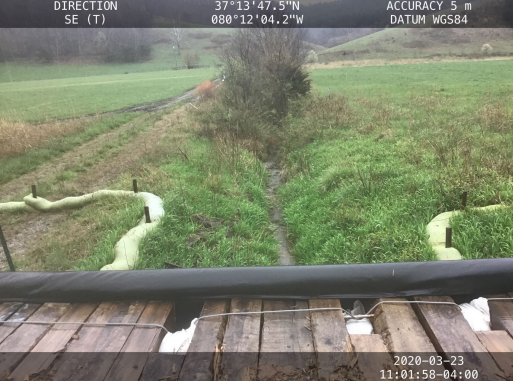
GPS Location	See photo		GPS Location	See photo	
Field Station#	12523+00		Field Station#	12464+98	
Pic 5 Desc.	The slope on the going away side of stream S-EF19 remains stable.		Pic 6 Desc.	Stream S-CD12, facing southeast, upstream

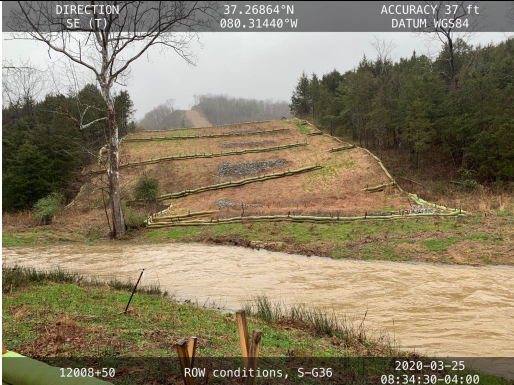
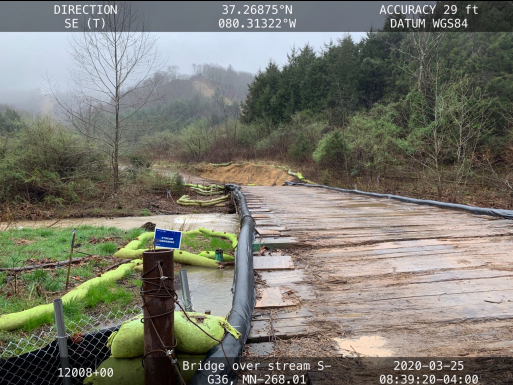
GPS Location	See photo for gps location data.		GPS Location	See photo for gps location data.	
Field Station#	12008+50		Field Station#	12008+00	
Pic 1 Desc.	Photo shows the ROW adjacent to stream S-G36.		Pic 2 Desc.	Photo shows the bridge over stream S-G36 n access road MN-268.01.

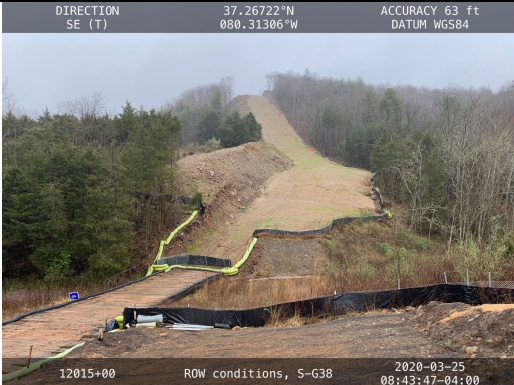
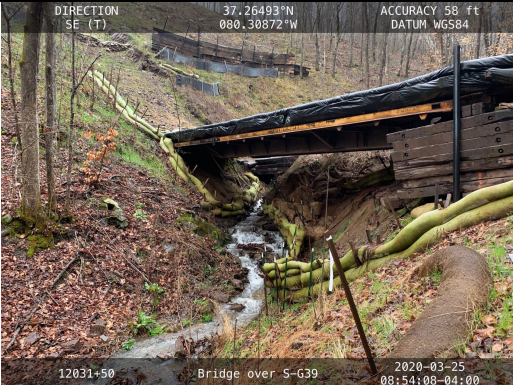
GPS Location	See photo for gps location data.		GPS Location	See photo for gps location data.	
Field Station#	12015+00		Field Station#	12031+50	
Pic 3 Desc.	Photo shows the ROW condition from about 12015+00 to 12026+00 and the bridge over stream S-G38.		Pic 4 Desc.	Photo shows the bridge over stream S-G39.

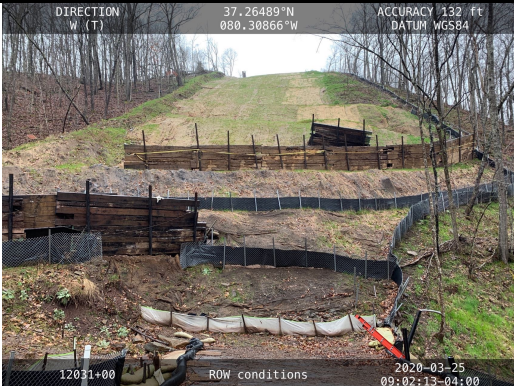
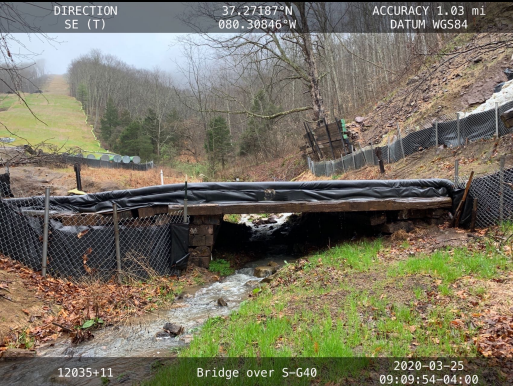
GPS Location	See photo for gps location data.		GPS Location	See photo for gps location data.	
Field Station#	12031+00		Field Station#	12035+11	
Pic 5 Desc.	Photo shows the ROW condition from about 12028+00 to 12031+00.		Pic 6 Desc.	Photo shows the bridge over stream S-G40.

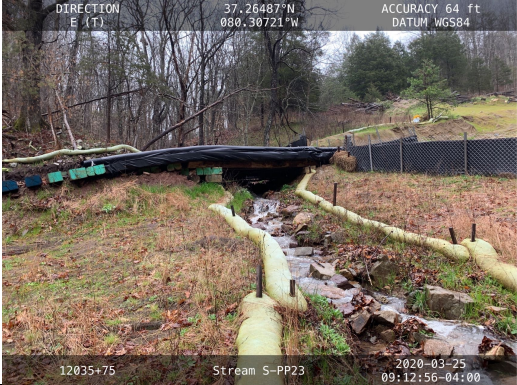
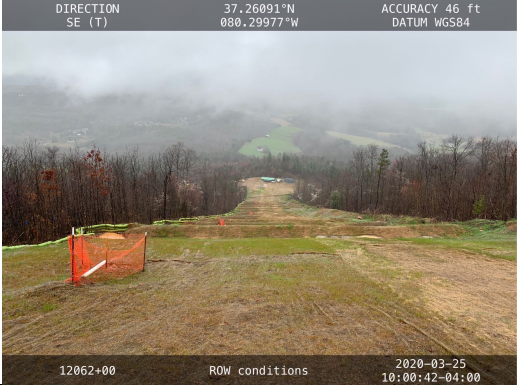
GPS Location	See photo for gps location data.		GPS Location	See photo for gps location data.	
Field Station#	12035+75		Field Station#	12062+00	
Pic 7 Desc.	Photo shows the bridge over stream S-PP23.		Pic 8 Desc.	Photo shows the ROW condition from about 12062+00 to 12071+00.

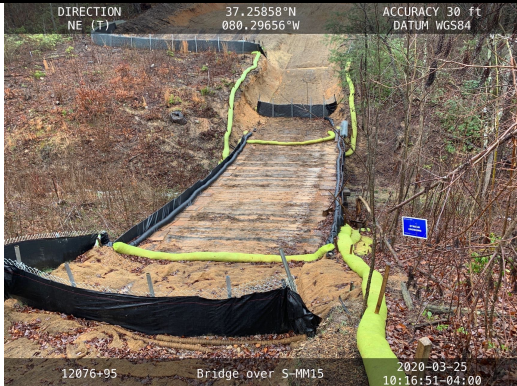
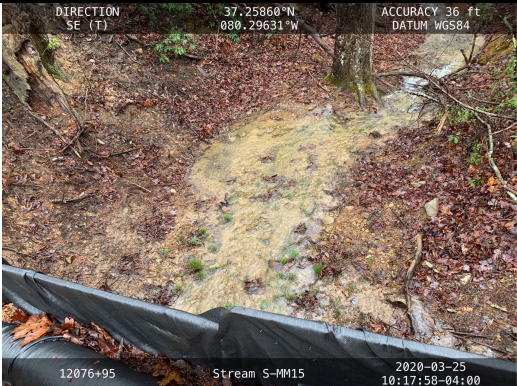
GPS Location	See photo for gps location data.		GPS Location	See photo for gps location data.	
Field Station#	12076+95		Field Station#	12076+95	
Pic 9 Desc.	Photo shows the bridge over stream S-MM15.		Pic 10 Desc.	Photo shows stream S-MM15 downstream from the ROW crossing.

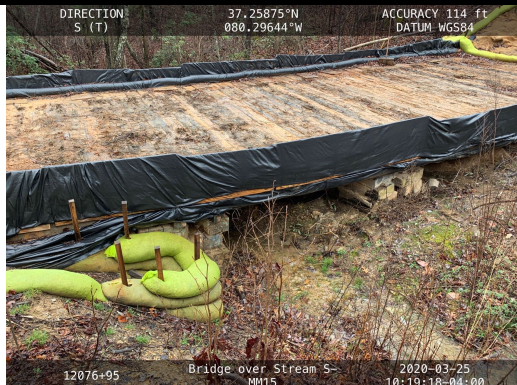
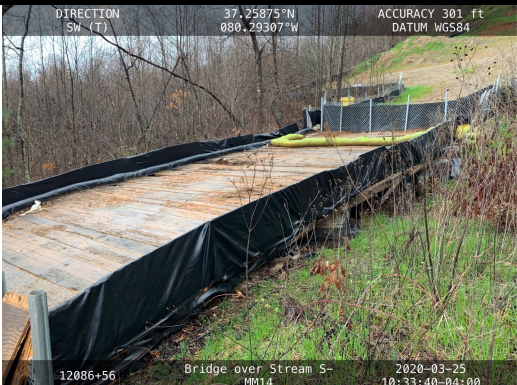
GPS Location	See photo for gps location data.		GPS Location	See photo for gps location data.	
Field Station#	12076+95		Field Station#	12086+56	
Pic 11 Desc.	Photo shows the bridge over stream S-MM15.		Pic 12 Desc.	Photo shows the bridge over stream S-MM14.

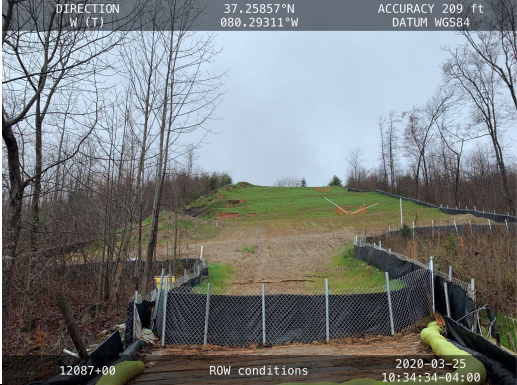
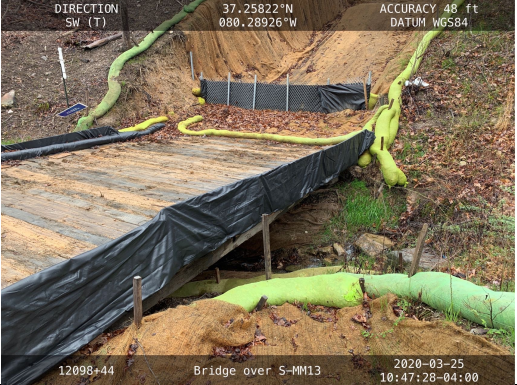
GPS Location	See photo for gps location data.		GPS Location	See photo for gps location data.	
Field Station#	12087+00		Field Station#	12098+44	
Pic 13 Desc.	Photo shows the ROW condition from 12083+00 to 12087+00.		Pic 14 Desc.	Photo shows the bridge over stream S-MM13.

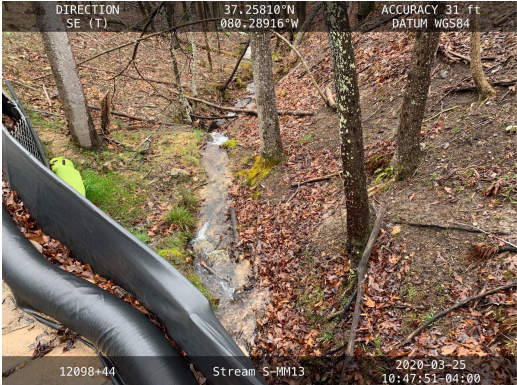
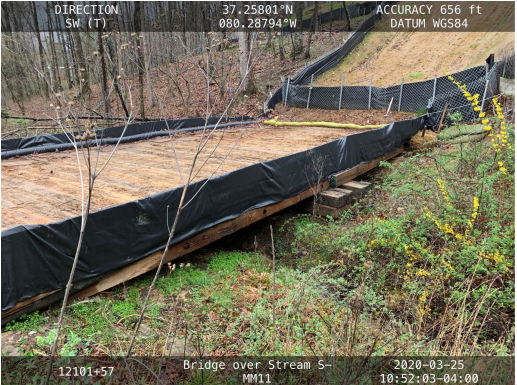
GPS Location	See photo for gps location data.		GPS Location	See photo for gps location data.	
Field Station#	12098+44		Field Station#	12101+57	
Pic 15 Desc.	Photo shows stream S-MM13 downstream from the ROW crossing.		Pic 16 Desc.	Photo shows the bridge over stream S-MM11.

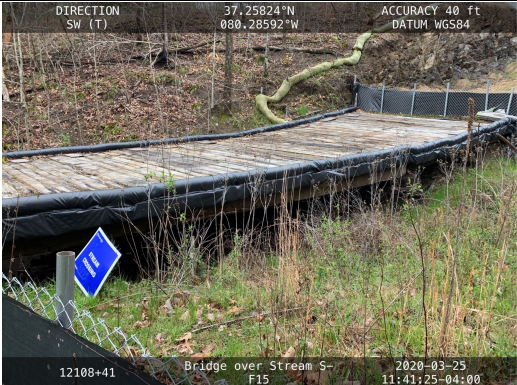
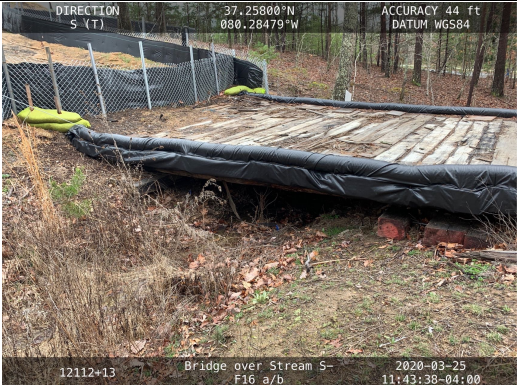
GPS Location	See photo for gps location data.		GPS Location	See photo for gps location data.	
Field Station#	12108+41		Field Station#	12112+13	
Pic 17 Desc.	Photo shows the bridge over stream S-F15.		Pic 18 Desc.	Photo shows the bridge over stream S-F16 a/b.

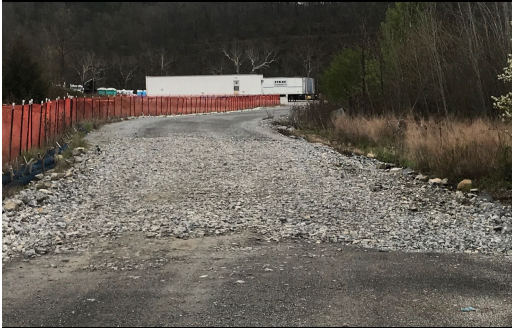
MVP-LY-049_032620 Condition of rock entrance 2020-03-26 08:56:49-04:00			DIRECTION E (M) +37.27111° -080.12170° ACCURACY 16 ft DATUM WGS84

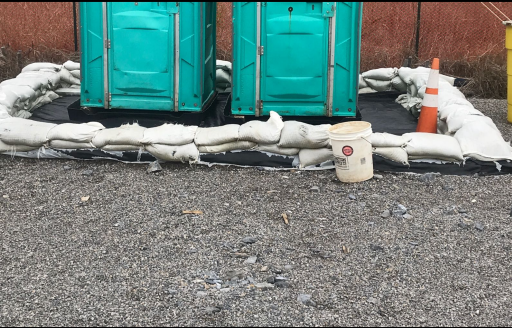
MVP-LY-049_032620 Condition of trays and containment 2020-03-26 08:58:32-04:00	
GPS Location	MVP-LY-049 See photo for gps data		GPS Location	MVP-LY-049 See photo for gps data	
Field Station#	+0		Field Station#	+0	
Pic 1 Desc.	Condition of rock entrance on center drive. Looking SE.		Pic 2 Desc.	Condition of trays and containment under toilets. Looking N.	
	DIRECTION S (M) +37.27039° -080.12150° ACCURACY 33 ft DATUM WGS84

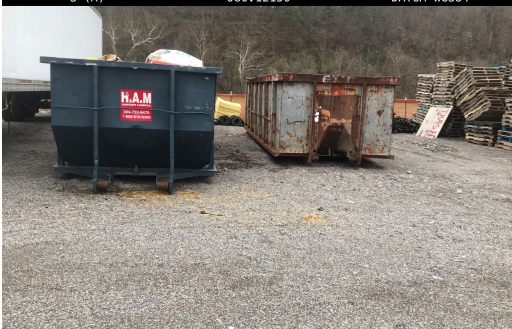
MVP-LY-049_032620 No loose trash around south dumpsters 2020-03-26 09:02:44-04:00			DIRECTION W (M) +37.27054° -080.12239° ACCURACY 16 ft DATUM WGS84

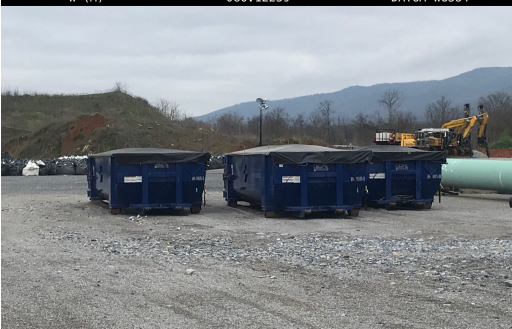
MVP-LY-049_032620 3 covered dumpsters for contaminated mat... 2020-03-26 09:03:41-04:00

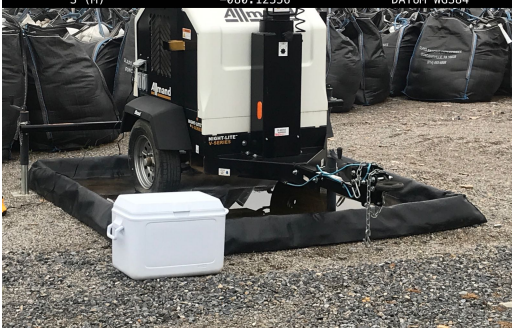
MVP-LY-049_032620 Condition of containment 2020-03-26 09:04:28-04:00			DIRECTION S (M) +37.27042° -080.12465° ACCURACY 16 ft DATUM WGS84

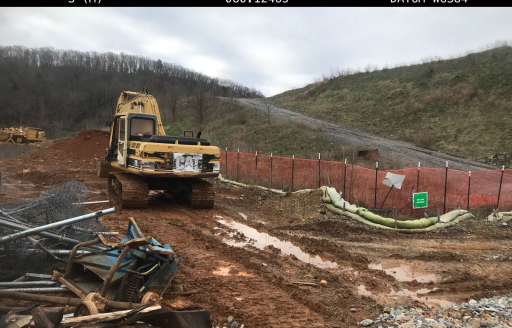
MVP-LY-049_032620 Landowner disturbance equipment next to fe... 2020-03-26 09:06:25-04:00	
GPS Location	MVP-LY-049 See photo for gps data		GPS Location	MVP-LY-049 See photo for gps data	
Field Station#	+0		Field Station#	+0	
Pic 5 Desc.	Condition of containment under light plant. Holding some stormwater. Looking NW.		Pic 6 Desc.	Landowner disturbance and parked equipment next to compost filter sock and feature. No impacts. Looking S.

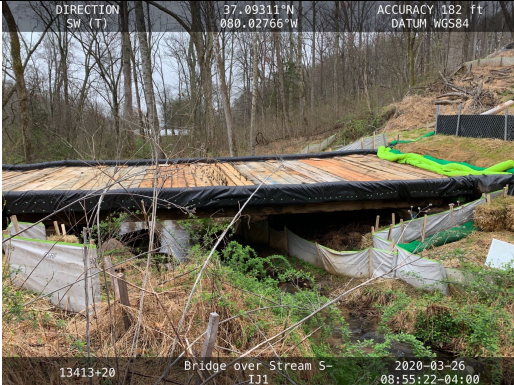
GPS Location	See photo for gps location data.		GPS Location	See photo for gps location data.	
Field Station#	13413+20		Field Station#	13413+00	
Pic 1 Desc.	Photo shows the bridge over stream S-IJ1.		Pic 2 Desc.	Photo shows stream S-IJ1 downstream from the ROW crossing.

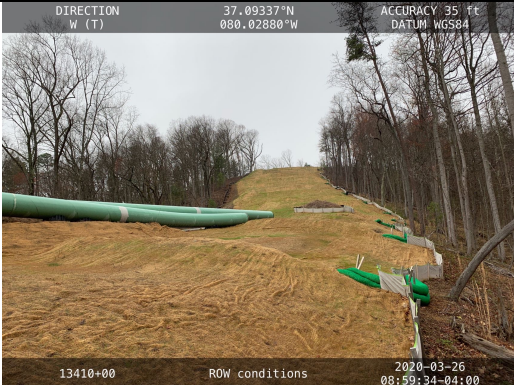
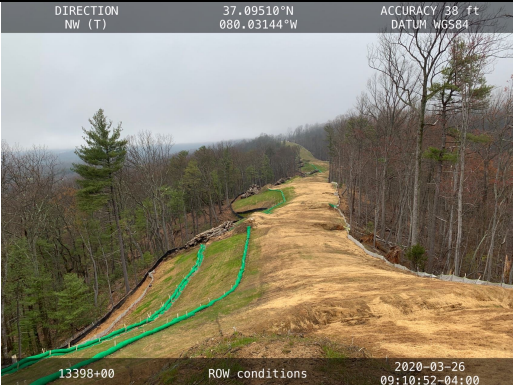
GPS Location	See photo for gps location data.		GPS Location	See photo for gps location data.	
Field Station#	13410+00		Field Station#	13398+00	
Pic 3 Desc.	Photo shows the ROW condition from about 13403+00 to 13410+00.		Pic 4 Desc.	Photo shows the ROW condition from about 13385+00 to 13398+00.

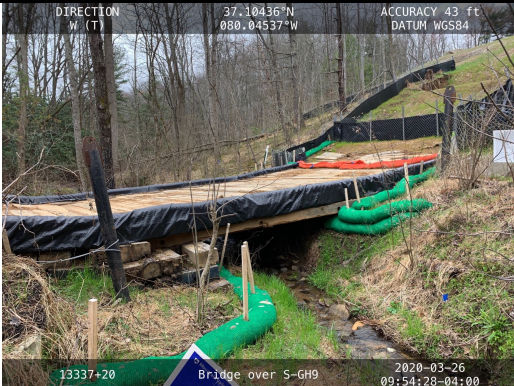
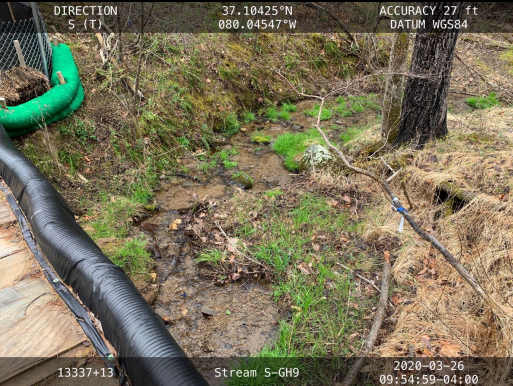
GPS Location	See photo for gps location data.		GPS Location	See photo for gps location data.	
Field Station#	13337+20		Field Station#	13337+13	
Pic 5 Desc.	Photo shows the bridge over stream S-GH9.		Pic 6 Desc.	Photo shows stream S-GH9 downstream from the ROW crossing.

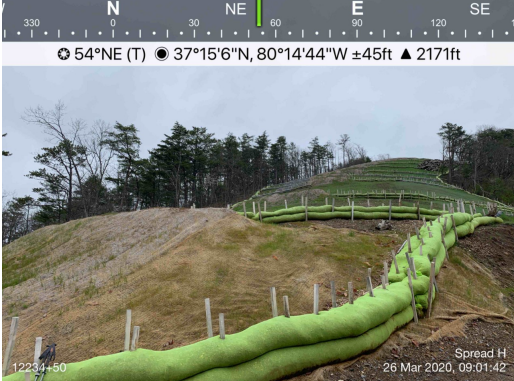
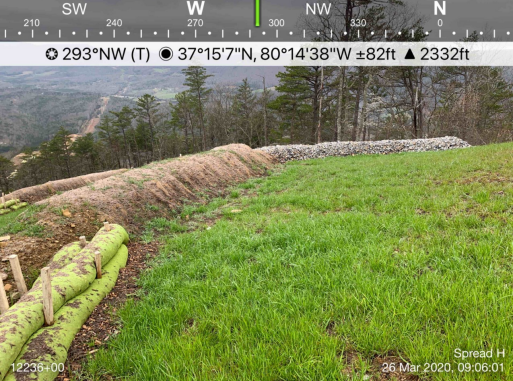
GPS Location	See Photo		GPS Location	See Photo	
Field Station#	12234+50		Field Station#	12236+00	
Pic 1 Desc.	Compost filter socks are installed and in acceptable condition.		Pic 2 Desc.	Waterbar and end treatments are in acceptable condition.

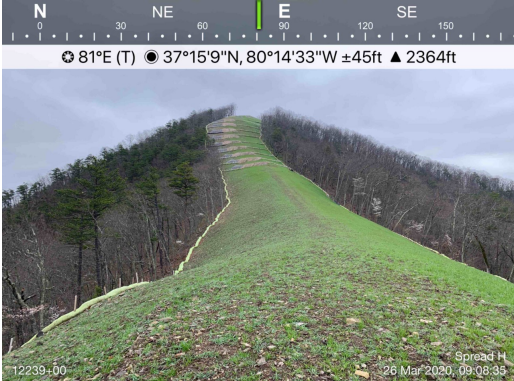
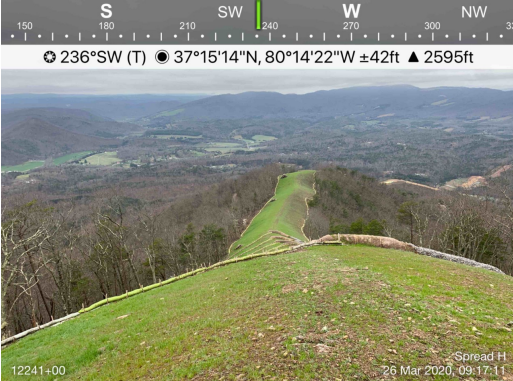
GPS Location	See Photo		GPS Location	See Photo	
Field Station#	12239+00		Field Station#	12241+00	
Pic 3 Desc.	ROW is stabilized with temporary vegetation.		Pic 4 Desc.	Waterbars and end treatments are in acceptable condition.

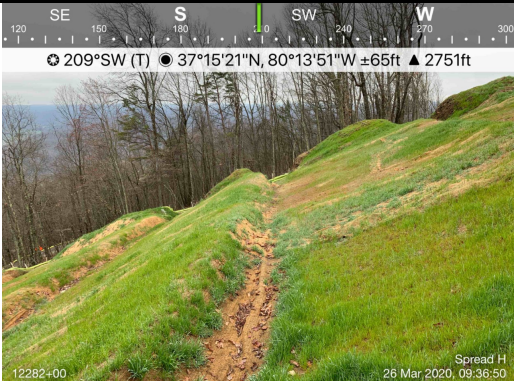
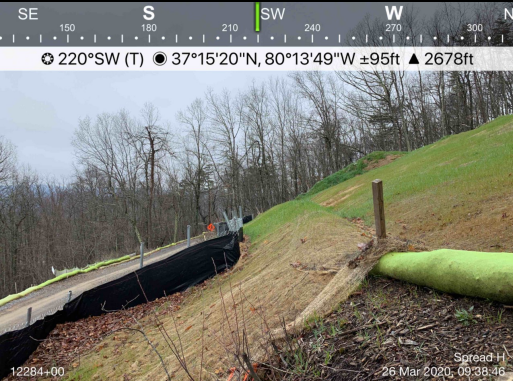
GPS Location	See Photo		GPS Location	See Photo	
Field Station#	12282+00		Field Station#	12284+00	
Pic 5 Desc.	Waterbar, sumps, and end treatments are in acceptable condition.		Pic 6 Desc.	SSF is in acceptable condition.

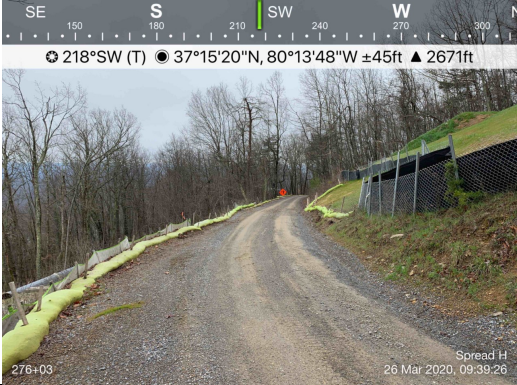
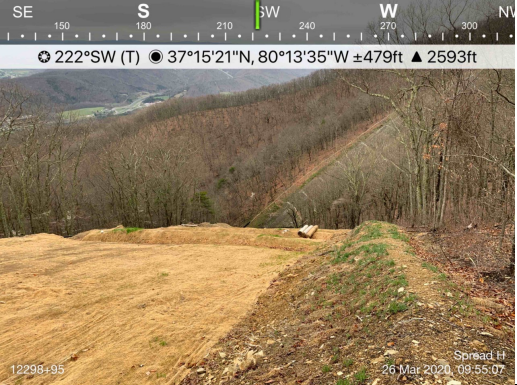
GPS Location	See Photo		GPS Location	See Photo	
Field Station#	276+03		Field Station#	12298+95	
Pic 7 Desc.	AR-176.03 is in acceptable condition. Maintenance ongoing during inspection.		Pic 8 Desc.	ROW is stable and in acceptable condition.

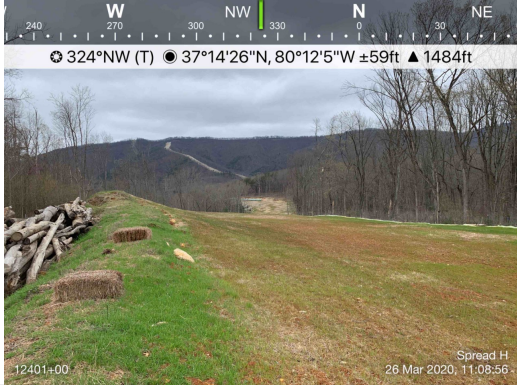
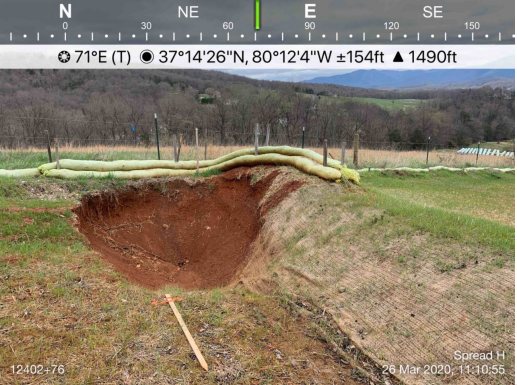
GPS Location	See Photo		GPS Location	See Photo	
Field Station#	12401+00		Field Station#	12402+76	
Pic 9 Desc.	ROW is stabilized with temporary vegetation.		Pic 10 Desc.	Sump and end treatments are in acceptable condition.

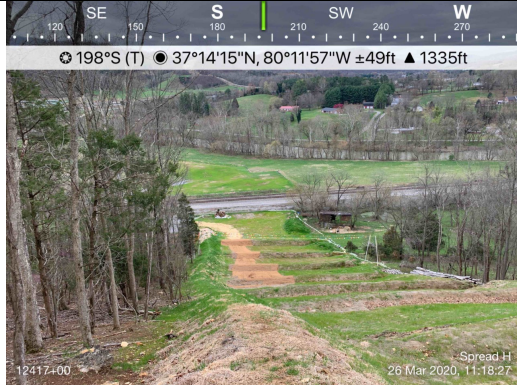
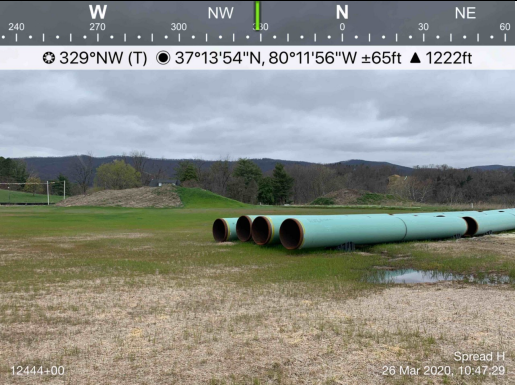
GPS Location	See Photo		GPS Location	See Photo	
Field Station#	12417+00		Field Station#	12444+00	
Pic 11 Desc.	Waterbars, sumps, and end treatments are in acceptable condition.		Pic 12 Desc.	ROW and stockpiles are stabilized with temporary vegetation.

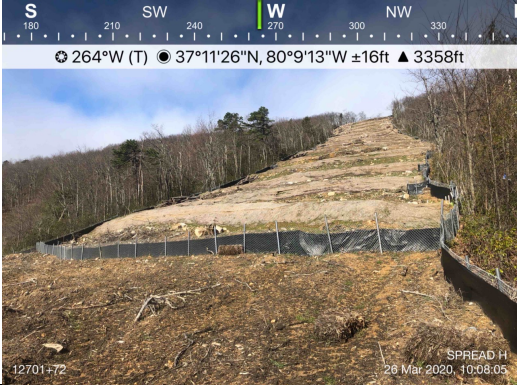
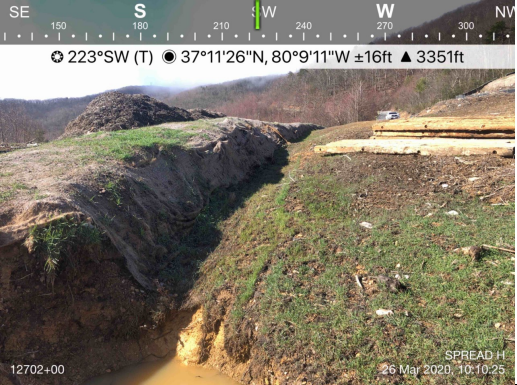
GPS Location	see photo		GPS Location	see photo	
Field Station#	12701+72		Field Station#	12702+00	
Pic 7 Desc.	Additional controls at this location are in good condition and functioning.		Pic 8 Desc.	Waterbars at this location in good condition.

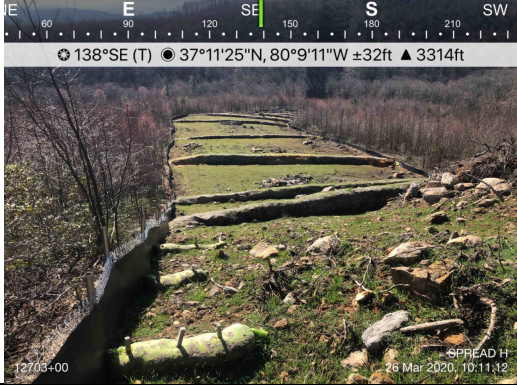
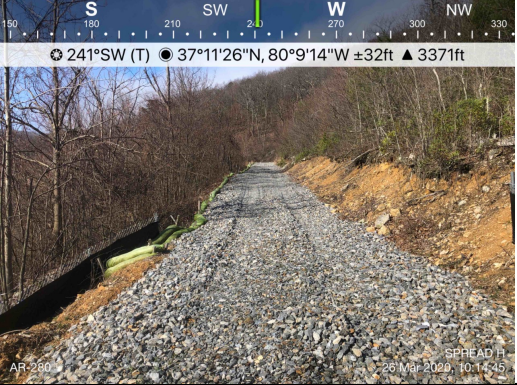
GPS Location	see photo		GPS Location	see photo	
Field Station#	12703+00		Field Station#	280+00	
Pic 9 Desc.	Slope on the GAS of AR-280 is stable with controls in place.		Pic 10 Desc.	AR-280 in good condition with stone and CFS in place.

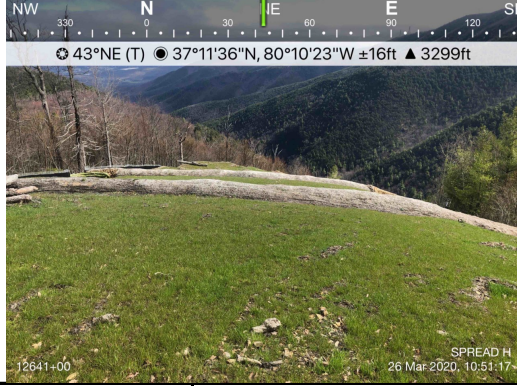
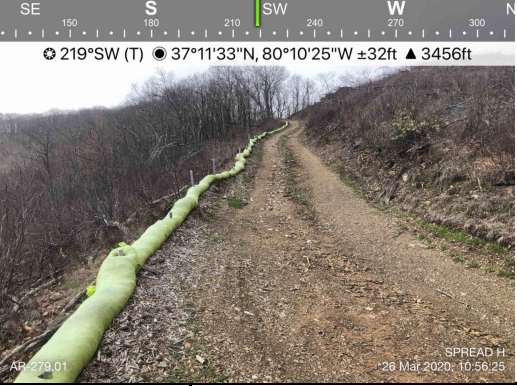
GPS Location	see photo		GPS Location	see photo	
Field Station#	12641+00		Field Station#	279+01	
Pic 11 Desc.	GAS of AR-279.01 is stable with controls in place.		Pic 12 Desc.	AR-279.01 in good condition with controls in place.

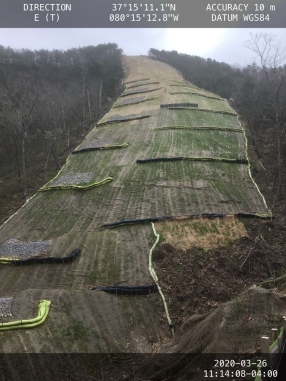
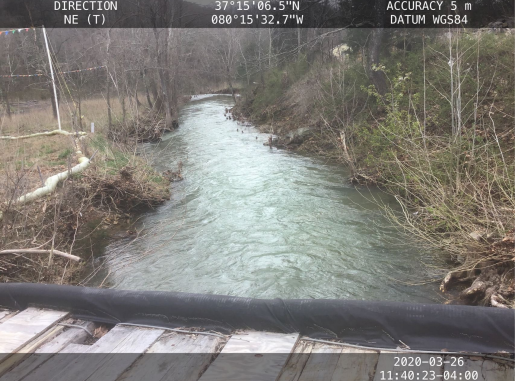
GPS Location	See photo		GPS Location	See photo	
Field Station#	12215+25		Field Station#	12192+50	
Pic 1 Desc.	The permanently restored section of ROW below the switchback on Reese Mountain remains stable, more vegetation sprouting.		Pic 2 Desc.	Stream S-C21, facing northeast

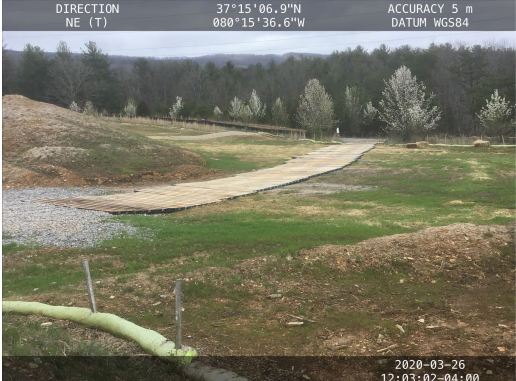
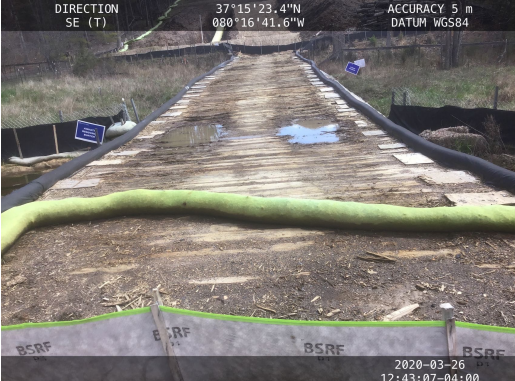
GPS Location	See photo		GPS Location	See photo	
Field Station#	12188+34		Field Station#	12132+73	
Pic 3 Desc.	AEP has installed timber mats across the MVP ROW in preparation for beginning construction of substation adjacent to MVP ROW.		Pic 4 Desc.	Stream S-C29, facing southeast

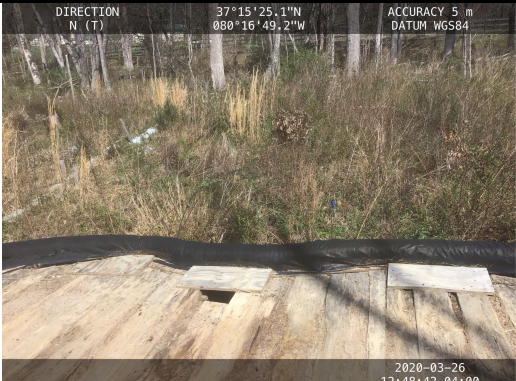
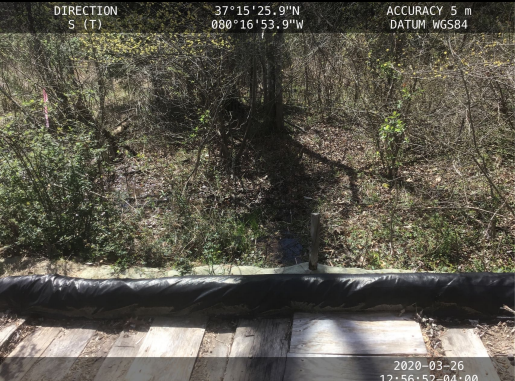
GPS Location	See photo		GPS Location	See photo	
Field Station#	12125+65		Field Station#	12121+83	
Pic 5 Desc.	Stream S-MM31, facing north, upstream		Pic 6 Desc.	Stream S-C36, facing south, downstream

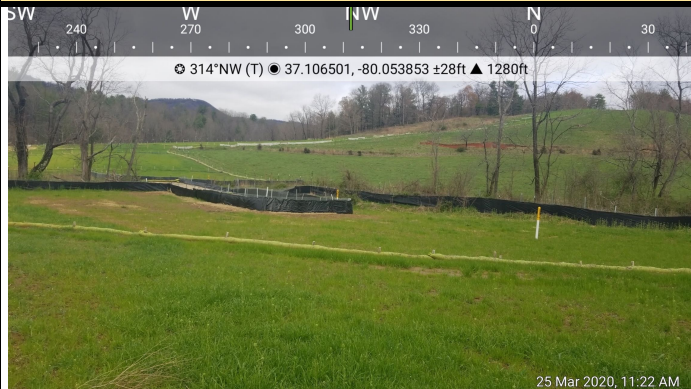
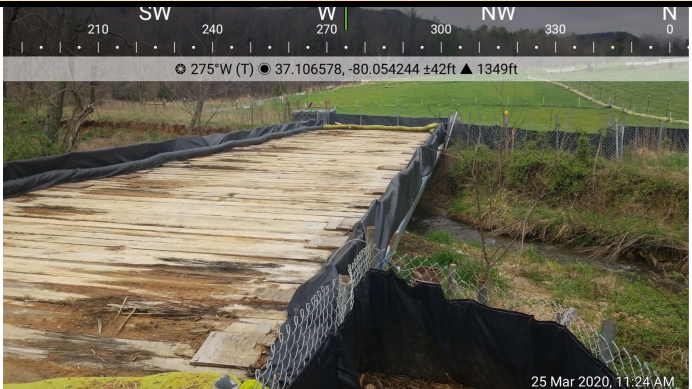
GPS Location	See photo for coordinates.		GPS Location	See photo for coordinates.	
Field Station#	13312+00		Field Station#	13309+25	
Pic 1 Desc.	ROW restored, ECDs functioning acceptably at stream crossing (S-GH7).		Pic 2 Desc.	S-GH7, no environmental issues noted at stream crossing, stream material depositing along cut bank on right bank under bridge.

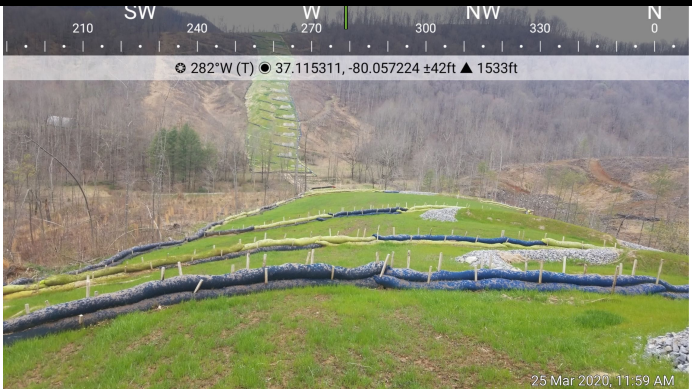
GPS Location	See photo for coordinates.		GPS Location	See photo for coordinates.	
Field Station#	13292+00		Field Station#	13273+00	
Pic 3 Desc.	Good vegetative cover across LOD, permanent waterbars stable.		Pic 4 Desc.	Good vegetative cover across LOD, permanent waterbars stable, very minor rills from prior rain events noted.

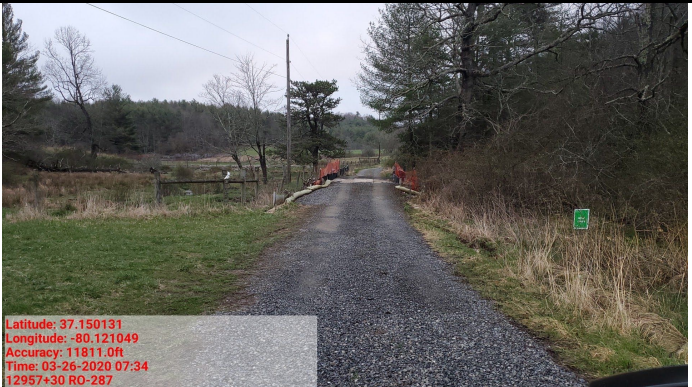
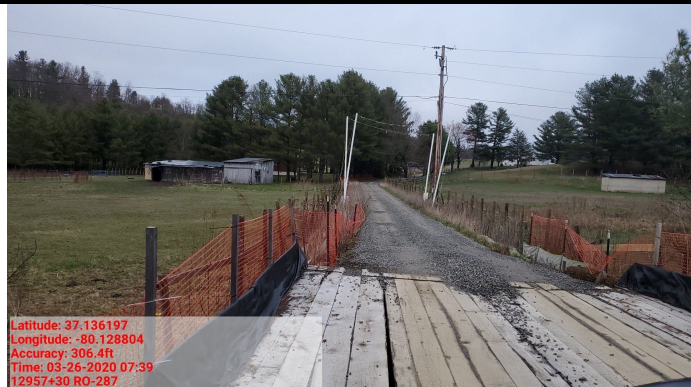
<p>Latitude: 37.150131 Longitude: -80.121049 Accuracy: 11811.0ft Time: 03-26-2020 07:34 12957+30 RO-287</p>		
GPS Location	See pic for GPS location		GPS Location	See pic for GPS location	
Field Station#	12865+00		Field Station#	12957+30	
Pic 1 Desc.	CIS of Bottom Creek road. No issues or impacts observed.		Pic 2 Desc.	No issues or impacts found along access road RO-287.

Pic 3 Desc.	Access road RO-287 at stream S-Z16. No impacts observed.		Pic 4 Desc.	ROW in good condition no ground disturbance in the area and perimeter ECD's remain in compliance.
