Visual Site Inspection Report

Project Name	H-600 Pipeline Spread H	AFE	124300138	Spread	H-600 Pipeline Spread H
Contractor	Precision			Report #	8972
Inspector	Tammy Kruizenga			Date/Time	3/9/2020 6:53 AM
Permit #	TBD	Inspection Type	VA SWPP	Station Begin	12005+00
State	VA	Inspection Area	Partial	Station End	12119+17
County	Montgomery	Ground	Dry	Temperature (°F)	65.00
Municipality	N/A	Weather	Sunny	Rain Gauge (in)	0.00
				Rain Accumulation Time (days)	1.00

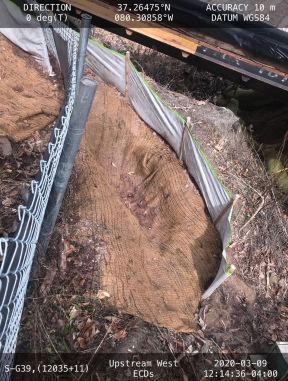
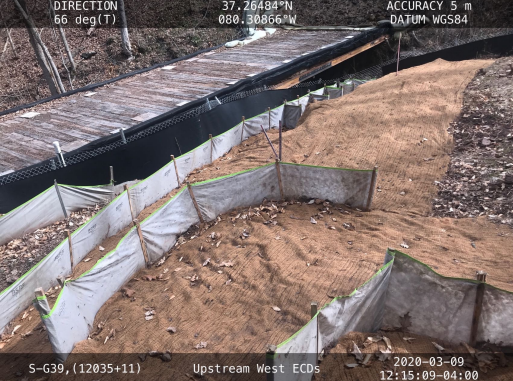
GPS Location	See GPS for location		GPS Location	See GPS for location	
Field Station#	12035+11		Field Station#	12035+11	
Pic 1 Desc.	Erosion blanket to west side of bridge over S-G39. ECDs in acceptable condition.		Pic 2 Desc.	Erosion blanket to west side of bridge over S-G39. ECDs in acceptable condition.

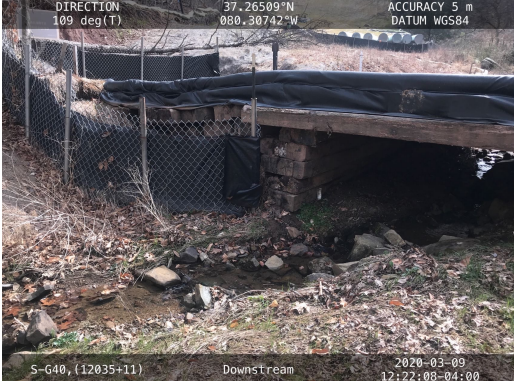
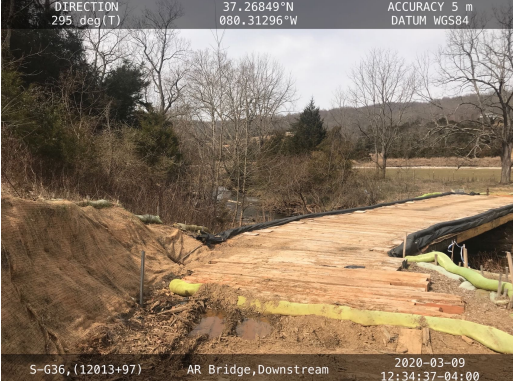
GPS Location	See GPS for location		GPS Location	See GPS for location	
Field Station#	12035+11		Field Station#	12013+97	
Pic 3 Desc.	Downstream is free of ROW sediment. ECDs are in acceptable condition.		Pic 4 Desc.	ECDs surrounding bridge crossing S-G36 on MVP-MN-268.01 are in acceptable condition since opening up road for landowner use.

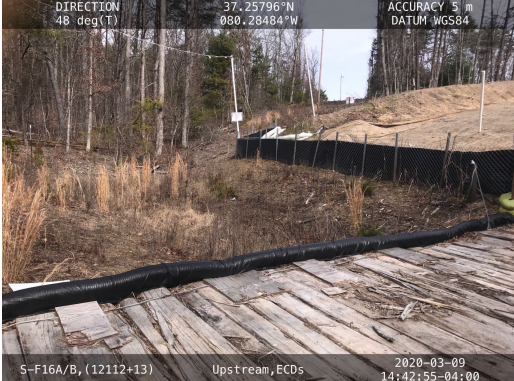
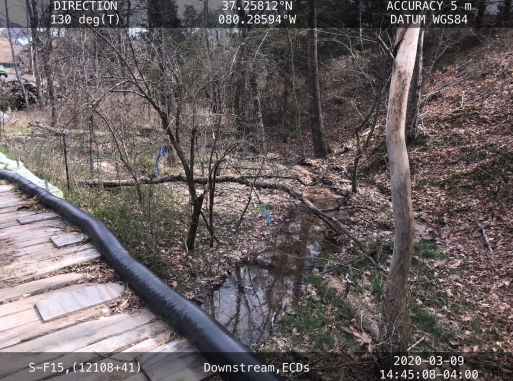
GPS Location	See GPS for location		GPS Location	See GPS for location	
Field Station#	12112+13		Field Station#	12108+41	
Pic 5 Desc.	S-F16A/B is dry. All ECDs surrounding area are in acceptable condition.		Pic 6 Desc.	S-F15 downstream is free of turbidity. ECDs are in acceptable condition.

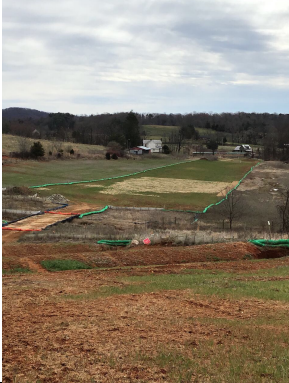
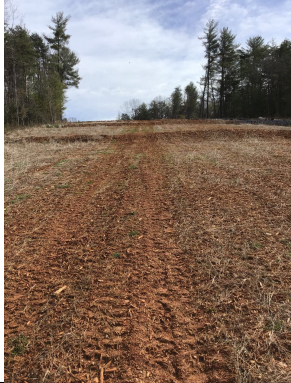
GPS Location	00000	GPS Location	0000		
Field Station#	13663+00	Field Station#	13655+00		
Pic 1 Desc.	Row photo showing vegetation	Pic 2 Desc.	Monitored area that had sparse vegetation and notice new vegetation starting to come with . Will continue to monitor

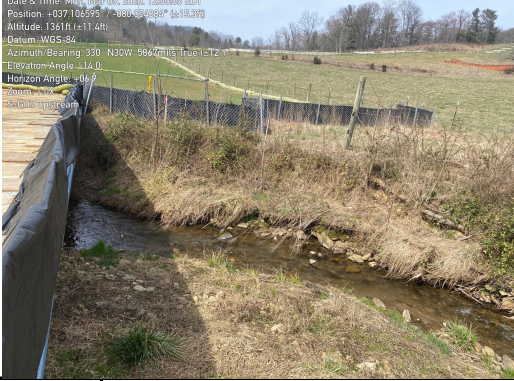
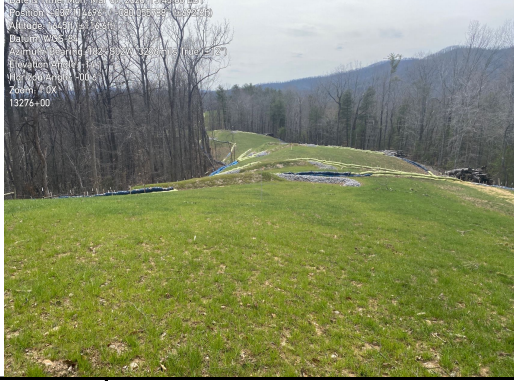
Field Station#	13309+09		Field Station#	13276+00	
Pic 5 Desc.	S-GH7, upstream side of equipment bridge, no changed noted to stream bed or banks, deposition noted on right descending bank.		Pic 6 Desc.	ROW restored with moderate to good vegetative cover across LOD, permanent waterbars stable.

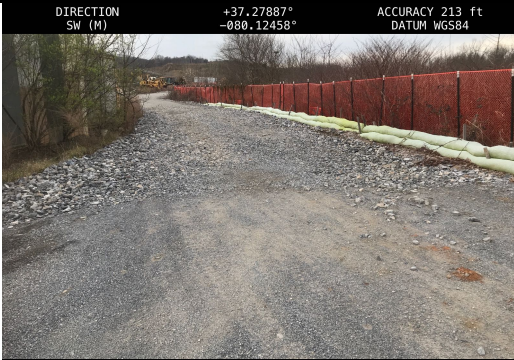
<p>DIRECTION SW (M) +37.27887° -080.12458° ACCURACY 213 ft DATUM WGS84</p> <p>MVP-LY-049_031020 Condition of rock entrance 2020-03-10 09:10:01-04:00</p>

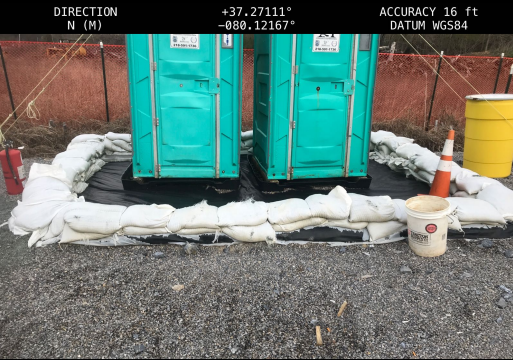
<p>DIRECTION N (M) +37.27111° -080.12167° ACCURACY 16 ft DATUM WGS84</p> <p>MVP-LY-049_031020 Condition of trays and containment 2020-03-10 09:11:20-04:00</p>			
GPS Location	MVP-LY-049 See photo for gps data		GPS Location	MVP-LY-049 See photo for gps data	
Field Station#	+0		Field Station#	+0	
Pic 1 Desc.	Condition of rock entrance on north driveway. Looking SW.		Pic 2 Desc.	Condition of trays and containment under toilets. Looking N.

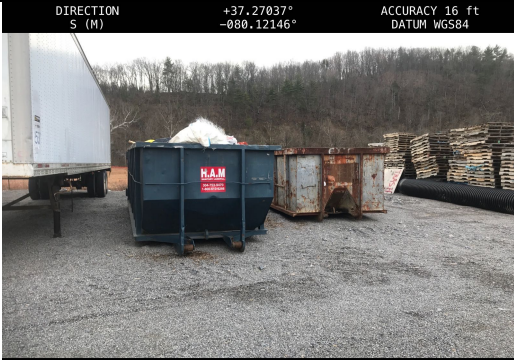
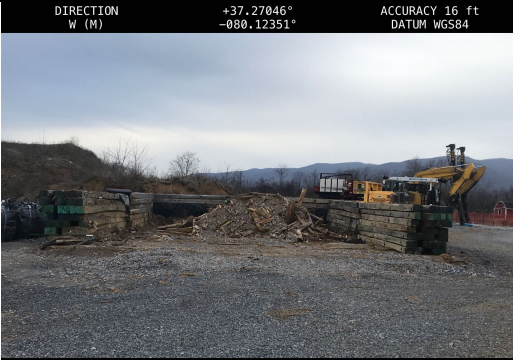
GPS Location	MVP-LY-049 See photo for gps data		GPS Location	MVP-LY-049 See photo for gps data	
Field Station#	+0		Field Station#	+0	
Pic 3 Desc.	No loose trash around south dumpsters. Looking S.		Pic 4 Desc.	Condition of temporary trash transfer pit. Looking W.

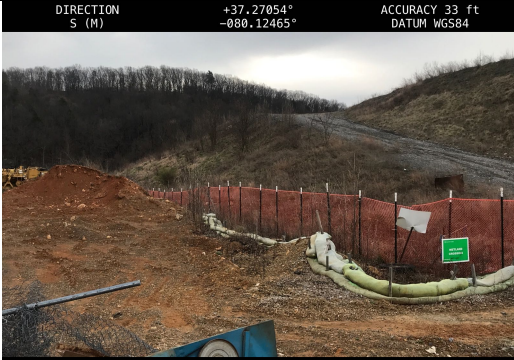
<p>DIRECTION S (M) +37.27054° -080.12465° ACCURACY 33 ft DATUM WGS84</p> <p>MVP-LY-049_031020 Landowner disturbance along CFS and feature 2020-03-10 09:17:19-04:00</p>

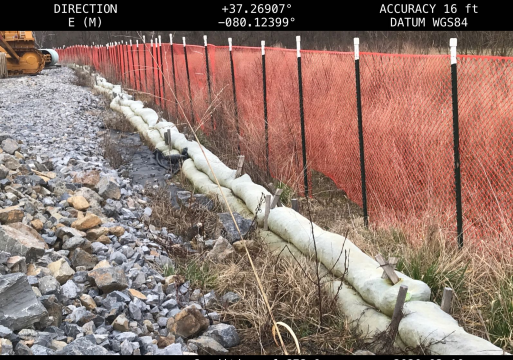
<p>DIRECTION E (M) +37.26907° -080.12399° ACCURACY 16 ft DATUM WGS84</p> <p>MVP-LY-049_031020 Condition of CFS & safety fence south L... 2020-03-10 09:20:56-04:00</p>			
GPS Location	MVP-LY-049 See photo for gps data		GPS Location	MVP-LY-049 See photo for gps data	
Field Station#	+0		Field Station#	+0	
Pic 5 Desc.	Landowner disturbance along compost filter sock and feature. No impacts. Looking S.		Pic 6 Desc.	Condition of compost filter sock and safety fence along south LOD. Looking E.

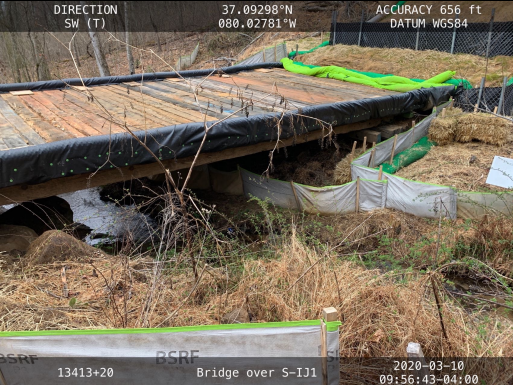
GPS Location	See photo for gps data.		GPS Location	See photo for gps data.	
Field Station#	13414+00		Field Station#	13413+20	
Pic 1 Desc.	Photo shows bridge over stream S-IJ1 and adjacent ROW conditions.		Pic 2 Desc.	Photo shows the bridge over stream S-IJ1.

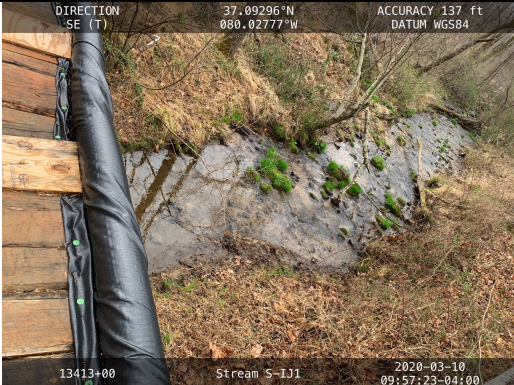
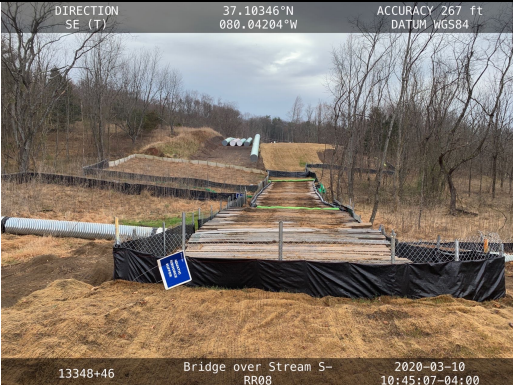
GPS Location	See photo for gps data.		GPS Location	See photo for gps data.	
Field Station#	13413+00		Field Station#	13348+30	
Pic 3 Desc.	Photo shows stream S-IJ1 downstream from the ROW.		Pic 4 Desc.	Photo shows the bridge over stream S-RR08.

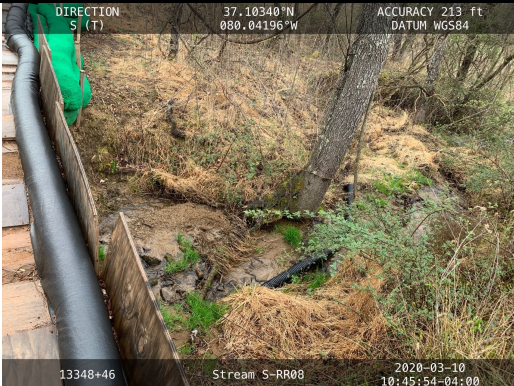
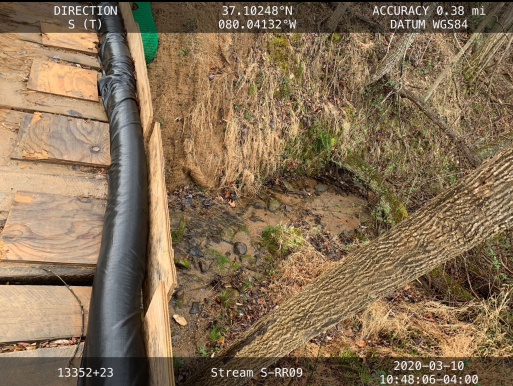
GPS Location	See photo for gps data.		GPS Location	See photo for gps data.	
Field Station#	13348+46		Field Station#	13352+23	
Pic 5 Desc.	Photo shows stream S-RR08 downstream from the ROW.		Pic 6 Desc.	Photo shows stream S-RR09 downstream from the ROW.

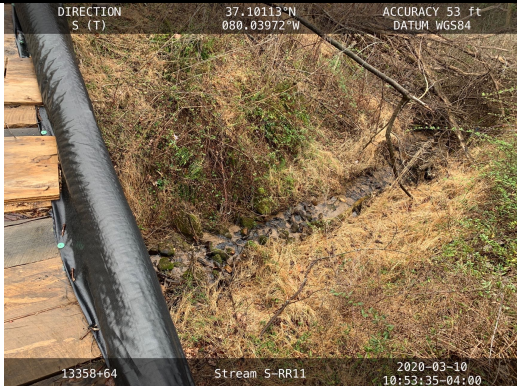
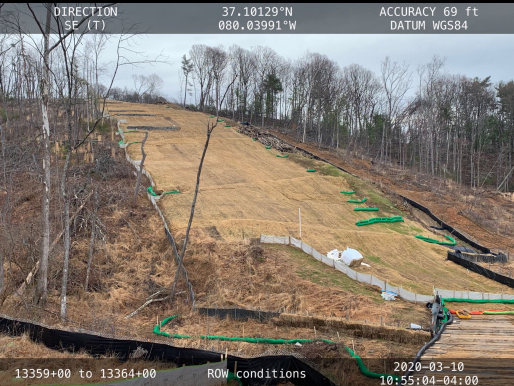
GPS Location	See photo for gps data.		GPS Location	See photo for gps data.	
Field Station#	13358+64		Field Station#	13359+00	
Pic 9 Desc.	Photo shows stream S-RR11 downstream from the ROW.		Pic 10 Desc.	Photo shows the ROW condition from about 13359+00 to 13364+00.

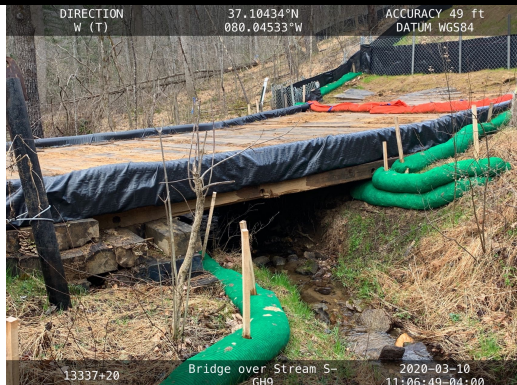
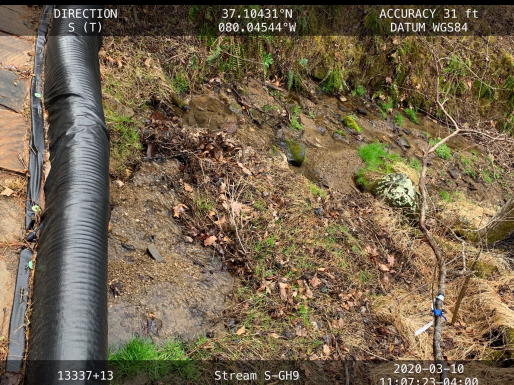
GPS Location	See photo for gps data.		GPS Location	See photo for gps data.	
Field Station#	13337+20		Field Station#	13337+13	
Pic 11 Desc.	Photo shows the bridge over stream S-GH9.		Pic 12 Desc.	Photo shows stream S-GH9 downstream from the ROW.

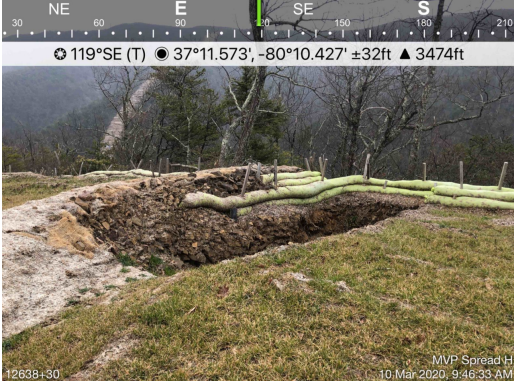
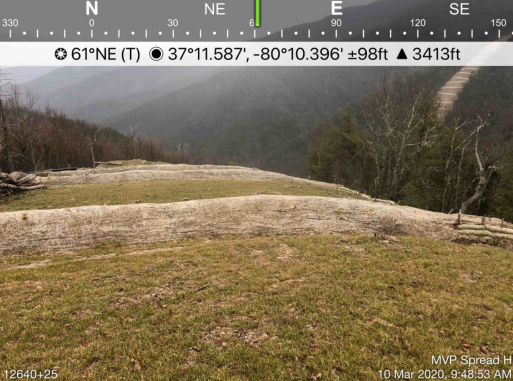
GPS Location	See Picture Watermark		GPS Location	See Picture Watermark	
Field Station#	12638+30		Field Station#	12640+25	
Pic 1 Desc.	Waterbar end treatment near start of inspection is in good condition.		Pic 2 Desc.	Waterbars and ROW remain vegetated/stabilized, and in good condition.

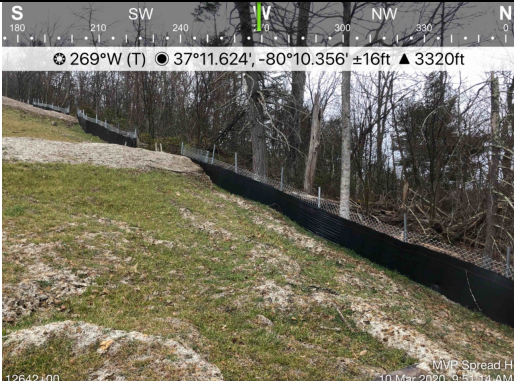
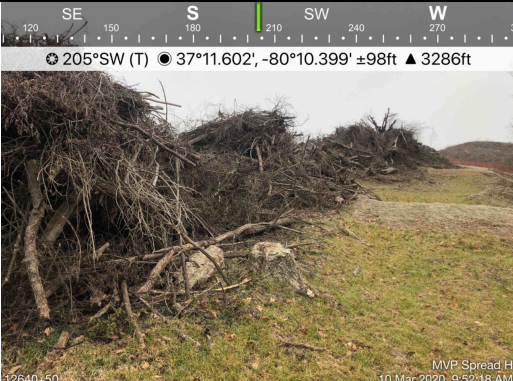
GPS Location	See Picture Watermark		GPS Location	See Picture Watermark	
Field Station#	12642+00		Field Station#	12640+50	
Pic 3 Desc.	Super silt fence along perimeter of ROW is in good condition and functioning.		Pic 4 Desc.	Woody debris from clearing stockpiled in middle of ROW and is in good condition.

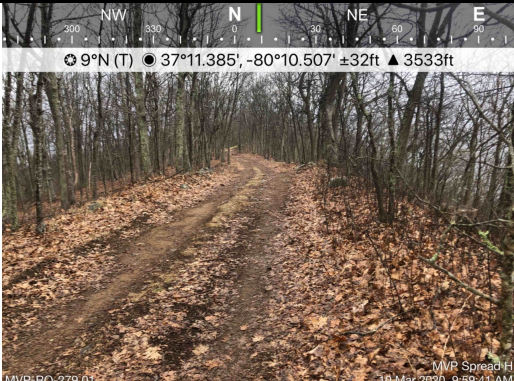
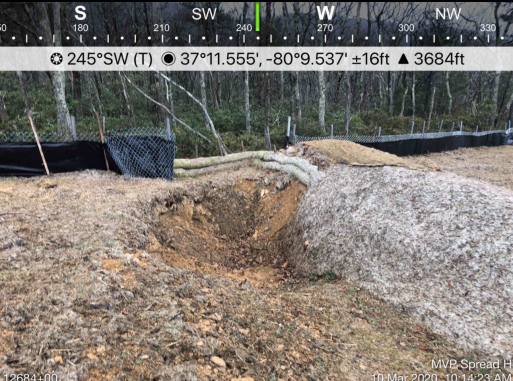
GPS Location	See Picture Watermark		GPS Location	See Picture Watermark	
Field Station#	12638+24		Field Station#	12684+00	
Pic 5 Desc.	Access road MVP-RO-279.01 is in good condition.		Pic 6 Desc.	Waterbar and end treatment on CIS Honeysuckle Rd is in good condition.

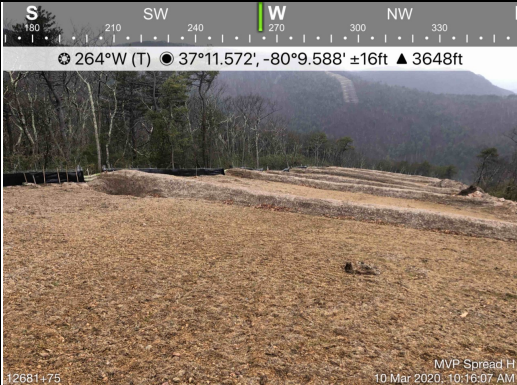
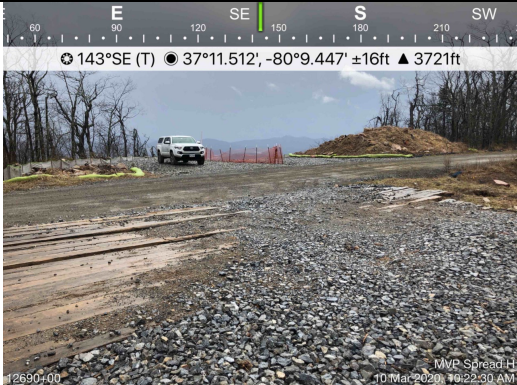
GPS Location	See Picture Watermark		GPS Location	See Picture Watermark	
Field Station#	12681+75		Field Station#	12690+00	
Pic 7 Desc.	ROW and waterbars remain stabilized with matting and no accelerated erosion was observed.		Pic 8 Desc.	Rock construction entrances on both sides of Honeysuckle Road are in good condition and no sediment tracking was observed.

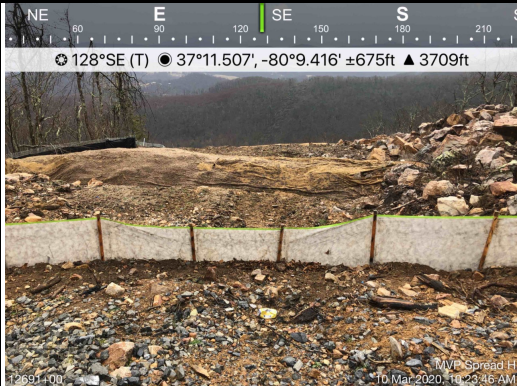
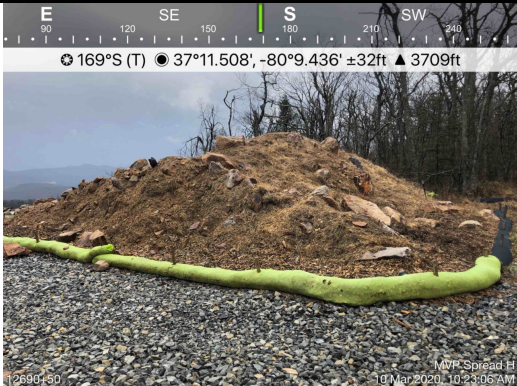
GPS Location	See Picture Watermark		GPS Location	See Picture Watermark	
Field Station#	12691+00		Field Station#	12690+50	
Pic 9 Desc.	P1 silt fence behind construction entrance on GAS of Honeysuckle is in good condition and functioning.		Pic 10 Desc.	Stockpile near Honeysuckle Road construction entrances remains stabilized and in good condition.

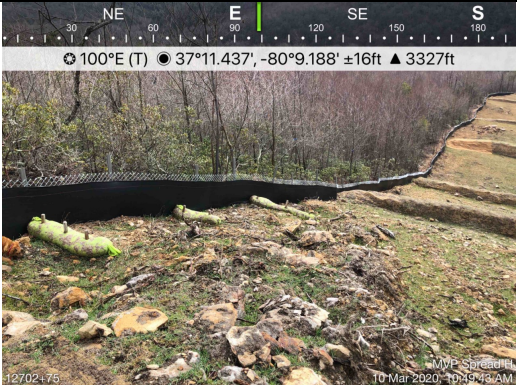
GPS Location	See Picture Watermark		GPS Location	See Picture Watermark	
Field Station#	12702+00		Field Station#	12702+75	
Pic 13 Desc.	Waterbar end treatment collected and contained all stormwater runoff from previous rain events.		Pic 14 Desc.	Perimeter stormwater controls are installed and remain in good condition.

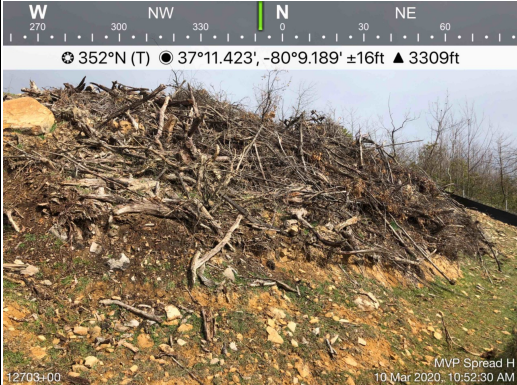
GPS Location	See Picture Watermark		GPS Location	See Picture Watermark	
Field Station#	12703+00		Field Station#	12702+00	
Pic 15 Desc.	Woody debris from clearing stockpiled on ROW and in good condition.		Pic 16 Desc.	MVP-ATWS-1225 in good condition and was not active.

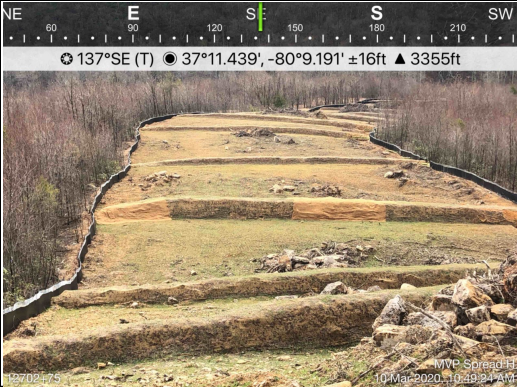
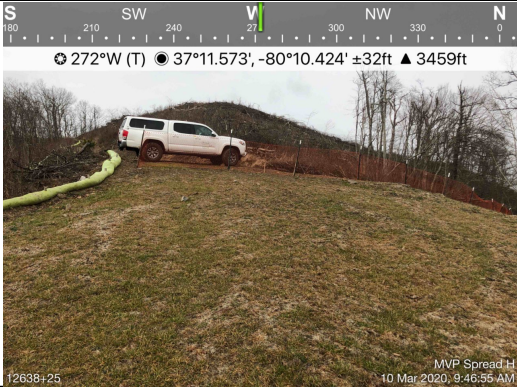
GPS Location	See Picture Watermark		GPS Location	See Picture Watermark	
Field Station#	12702+75		Field Station#	12638+25	
Pic 17 Desc.	ROW remains well stabilized with matting and in good condition.		Pic 18 Desc.	ROW is vegetated and stable near beginning of inspection area.

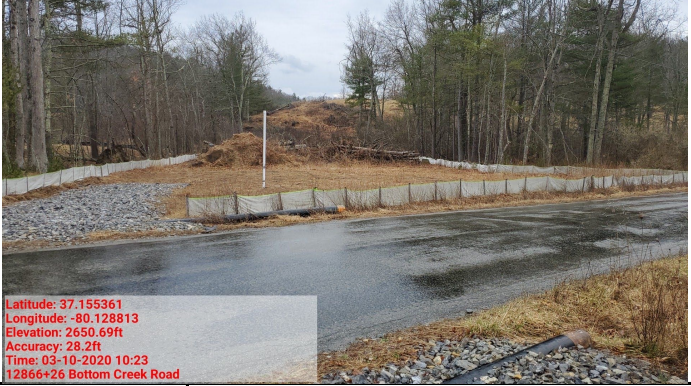
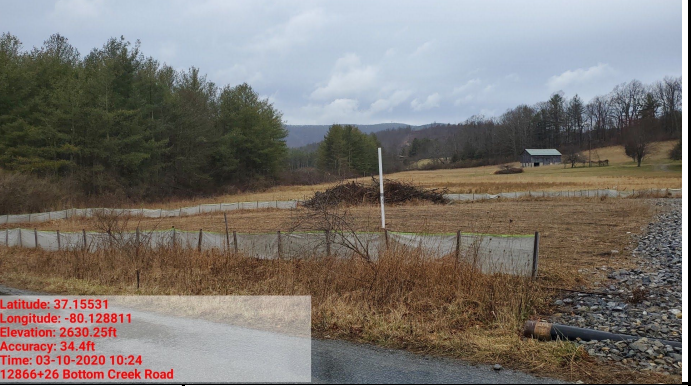
GPS Location	See pic for GPS location		GPS Location	See pic for GPS location	
Field Station#	12866+26		Field Station#	12866+26	
Pic 1 Desc.	GAS of Bottom Creek Road had no issues or impacts.		Pic 2 Desc.	CIS of Bottom Creek Road had no impacts or issues.

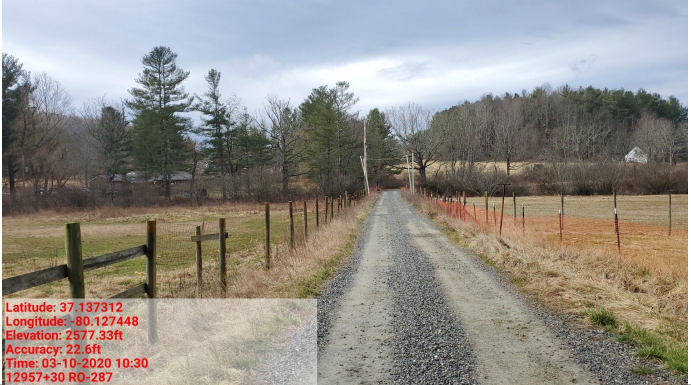
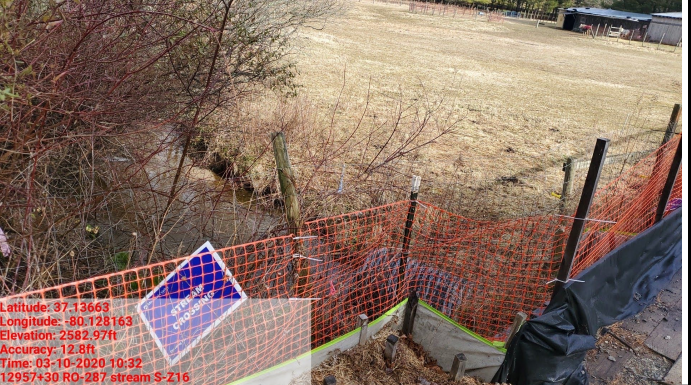
GPS Location	See pic for GPS location		GPS Location	See pic for GPS location	
Field Station#	12957+30		Field Station#	12957+30	
Pic 3 Desc.	No issues or impacts observed on access road RO-287 near stream S-Z16.		Pic 4 Desc.	No impacts to stream S-Z16 found today.

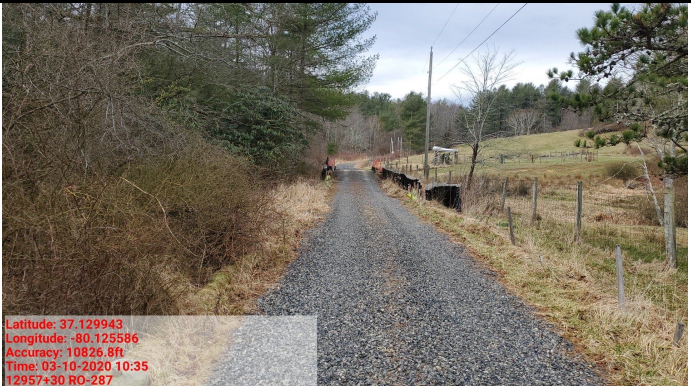
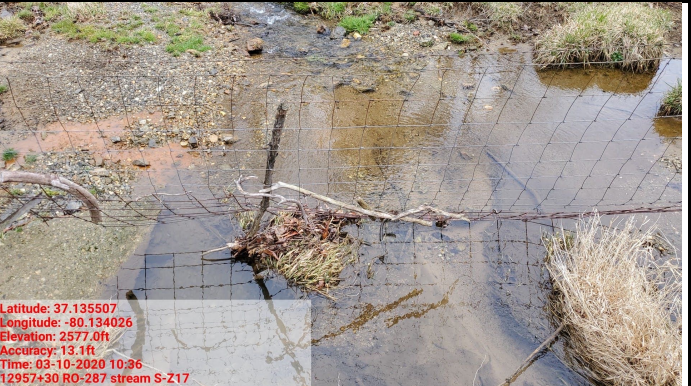
GPS Location	See pic for GPS location		GPS Location	See pic for GPS location	
Field Station#	12957+30		Field Station#	12957+30	
Pic 5 Desc.	No issues or impacts observed on the access road near stream crossing S-Z17		Pic 6 Desc.	No recent impacts to stream S-Z17 observed.

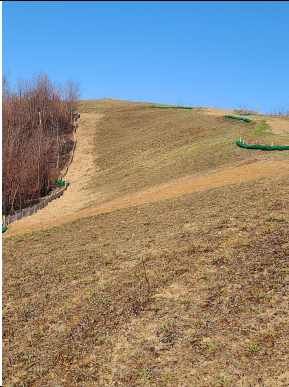
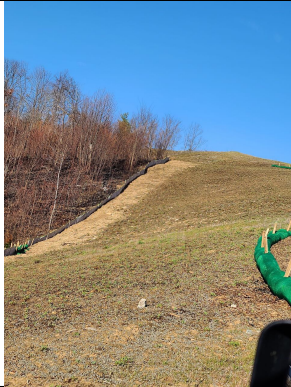
GPS Location	00000	GPS Location	0000		
Field Station#	13463+33	Field Station#	13462+60		
Pic 1 Desc.	Area where wild fire burned part of the LOD now has new vegetation starting to come up		Pic 2 Desc.	Area where wild fire burned part of the LOD now has new vegetation starting to come up

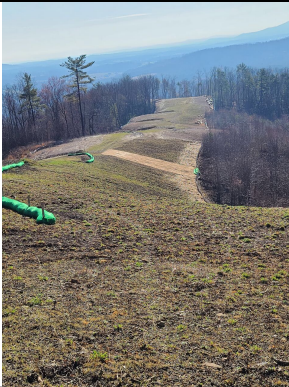
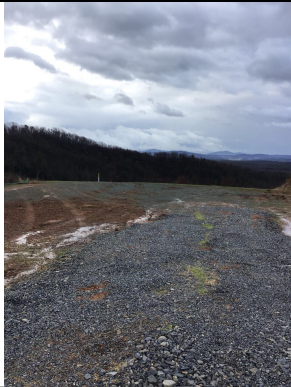
GPS Location	0000	GPS Location	0000		
Field Station#	13461+00	Field Station#	13437+72		
Pic 3 Desc.	Area where wild fire burned part of the LOD now has new vegetation starting to come up		Pic 4 Desc.	Inspected row conditions during light rain showers	
Insert image here			Insert image here		
GPS Location		GPS Location			
Field Station#		Field Station#			
Pic 5 Desc.			Pic 6 Desc.

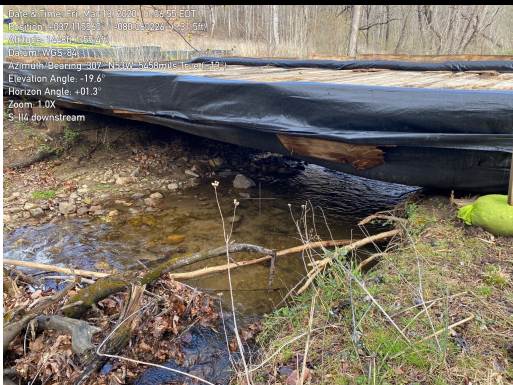
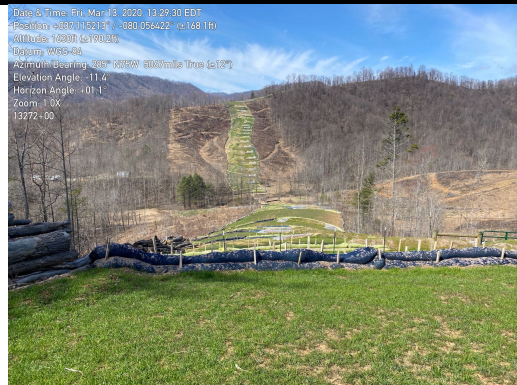
<p>Date & Time: Fri, Mar 13, 2020 11:33:55 EDT Position: +037.125372, -080.054417, +17.5m Altitude: 1388ft (+11.4m) Datum: WGS 84 Azimuth: Bearing: 307, N30W, 1607mils True (+14) Elevation Angle: -19.8 Horizon Angle: +01.3 Zoom: 1.0X S-II4 downstream</p>			<p>Date & Time: Fri, Mar 13, 2020 12:27:30 EDT Position: +037.125372, -080.054422, +16.8m Altitude: 1388ft (+11.4m) Datum: WGS 84 Azimuth: Bearing: 307, N30W, 1607mils True (+14) Elevation Angle: -11.4 Horizon Angle: +01.1 Zoom: 1.0X 13272+00</p>			
GPS Location			See photo for coordinates.			
Field Station#			13260+60			
Pic 5 Desc.			S-II4, downstream side of equipment bridge, bridge in good condition, ECDs functioning acceptably.
