# Visual Site Inspection Report

<b>Project Name</b>	H-600 Pipeline Spread H	<b>AFE</b>	124300138	<b>Spread</b>	H-600 Pipeline Spread H
<b>Contractor</b>	Precision			<b>Report #</b>	10254
<b>Inspector</b>	John Brcic			<b>Date/Time</b>	4/20/2020 8:27 PM
<b>Permit #</b>	TBD	<b>Inspection Type</b>	VA SWPP	<b>Station Begin</b>	12433+75
<b>State</b>	VA	<b>Inspection Area</b>	Partial	<b>Station End</b>	12544+06
<b>County</b>	Montgomery	<b>Ground</b>	Damp	<b>Temperature (°F)</b>	58.00
<b>Municipality</b>	N/A	<b>Weather</b>	Heavy Rain	<b>Rain Gauge (in)</b>	0.60
				<b>Rain Accumulation Time (days)</b>	3.00

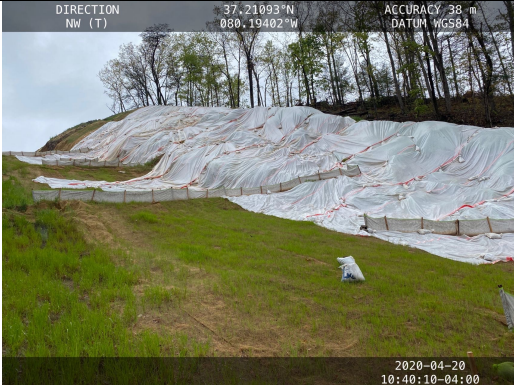
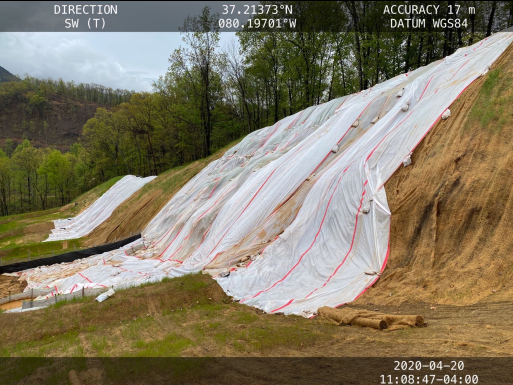
<b>GPS Location</b>	See photo		<b>GPS Location</b>	See photo	
<b>Field Station#</b>	12542+00		<b>Field Station#</b>	12529+00	
<b>Pic 1 Desc.</b>	Plastic sheeting remains intact and effective on this stockpile nearest to Yellow Finch Road.		<b>Pic 2 Desc.</b>	Plastic sheeting on the stockpiles approximately 1500 feet to the CIS of Yellow Finch Road.

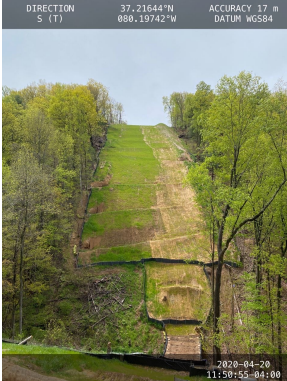
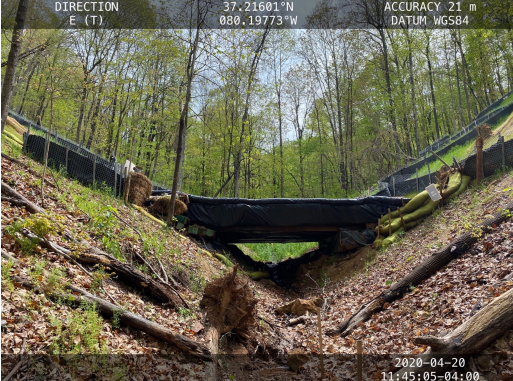
<b>GPS Location</b>	See photo		<b>GPS Location</b>	See photo	
<b>Field Station#</b>	12522+00		<b>Field Station#</b>	12519+41	
<b>Pic 3 Desc.</b>	The steep slope on the going away side of stream S-EF19 is well vegetated and stable.		<b>Pic 4 Desc.</b>	Stream S-EF19, facing east, upstream

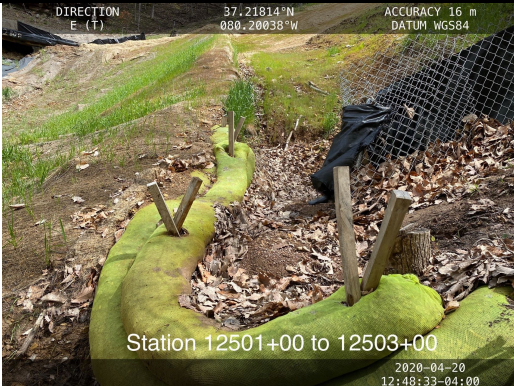
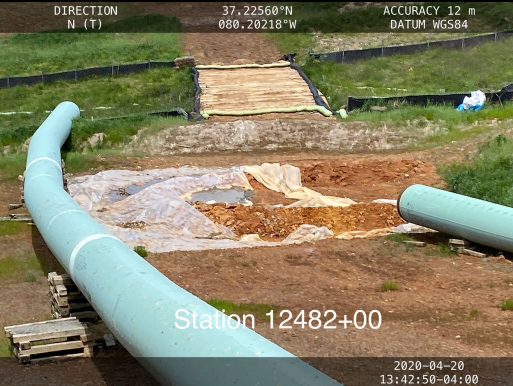
<b>GPS Location</b>	See photo		<b>GPS Location</b>	See photo	
<b>Field Station#</b>	12501+00		<b>Field Station#</b>	12482+00	
<b>Pic 5 Desc.</b>	Sediment needs to be cleaned out of the end treatments and velocity checks between stations 12501+00 and 12503+00.		<b>Pic 6 Desc.</b>	The plastic on the site of the pig parts excavation is damaged and needs to be replaced.

E&S BMPs	Compliance Level	Corrective Action	Corrective Time Frame	Date Repaired
Compost Filter Sock	Acceptable			
Silt Fence (Filter Fabric Fence)	Acceptable			
Silt Fence (Reinforced Filter Fabric Fence)	Acceptable			
Waterbar	Acceptable			
Waterbar End Treatment	Communication	12503+00: clean out sediment		
Sump Pit	Acceptable			
Sensitive Resource Buffer	Acceptable			
Erosion Control Blanket	Acceptable			
Other - Explain in Comments	Communication	12482+00: replace plastic pig parts

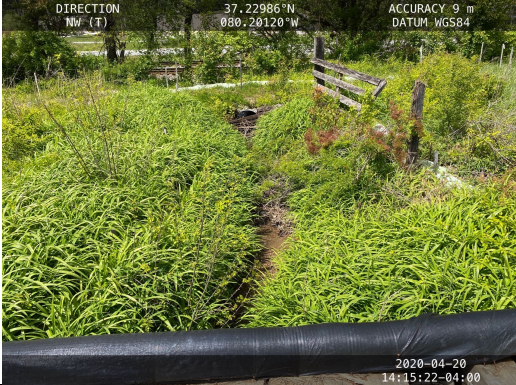
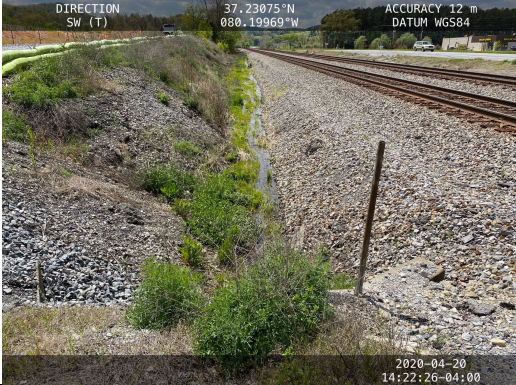
<b>GPS Location</b>	See photo		<b>GPS Location</b>	See photo	
<b>Field Station#</b>	12455+21		<b>Field Station#</b>	12444+94	
<b>Pic 7 Desc.</b>	Stream S-CD12, facing northwest, downstream		<b>Pic 8 Desc.</b>	Stream S-11, facing southwest, upstream	
Insert image here			Insert image here		
<b>GPS Location</b>			<b>GPS Location</b>		
<b>Field Station#</b>			<b>Field Station#</b>		
<b>Pic 9 Desc.</b>			<b>Pic 10 Desc.</b>		
Insert image here			Insert image here		
<b>GPS Location</b>			<b>GPS Location</b>		
<b>Field Station#</b>			<b>Field Station#</b>		
<b>Pic 11 Desc.</b>			<b>Pic 12 Desc.</b>

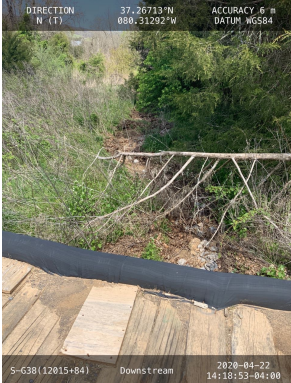
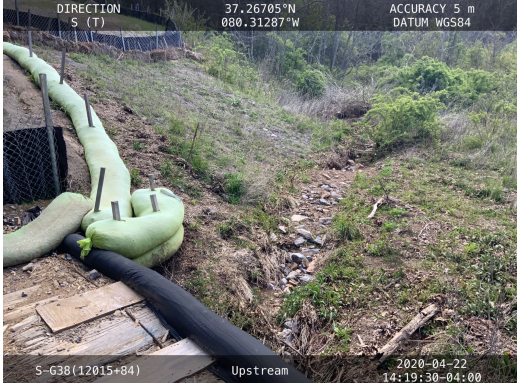
<b>GPS Location</b>	See photo GPS for location		<b>GPS Location</b>	See photo GPS for location	
<b>Field Station#</b>	12015+84		<b>Field Station#</b>	12015+84	
<b>Pic 7 Desc.</b>	Bridge is intact and stream is dry.		<b>Pic 8 Desc.</b>	ECDs are in acceptable condition surrounding stream.

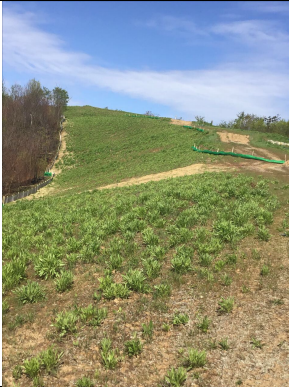
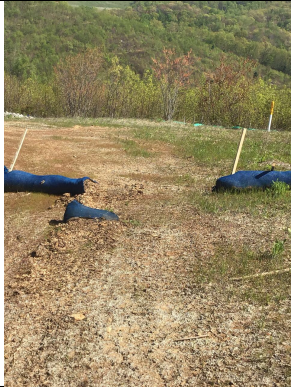
<b>GPS Location</b>	0000	<b>GPS Location</b>	0000		
<b>Field Station#</b>	13460+00	<b>Field Station#</b>	13450+00		
<b>Pic 1 Desc.</b>	Wild fire area showing vegetation growth	<b>Pic 2 Desc.</b>	Land owner continues to drive over CFS with ATV's , will continue to monitor the area

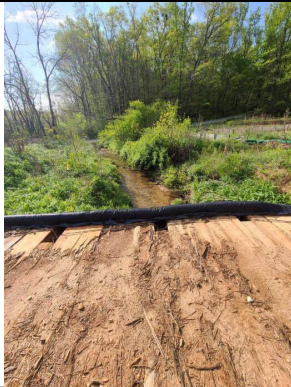
<b>GPS Location</b>	000	<b>GPS Location</b>	0000		
<b>Field Station#</b>	13643+53	<b>Field Station#</b>	13643+53		
<b>Pic 3 Desc.</b>	Stream crossing photo facing upstream	<b>Pic 4 Desc.</b>	Stream crossing photo facing downstream		
Insert image here			Insert image here		
<b>GPS Location</b>		<b>GPS Location</b>			
<b>Field Station#</b>		<b>Field Station#</b>			
<b>Pic 5 Desc.</b>		<b>Pic 6 Desc.</b>

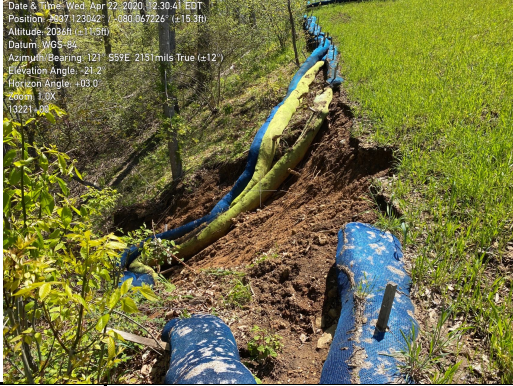
<p>Date &amp; Time: Wed, Apr 22, 2020 12:30:41 EDT Position: 43°37'12.02"N / -88°06'52.28"W (1616.3m) Altitude: 1820ft (554.9m) Datum: WGS 84 Azimuth Bearing: 121° 59'E 215mils True (±12°) Elevation Angle: -21.2° Horizon Angle: -03.0° Zoom: 1.0x S-114 13221+00</p>			
<b>GPS Location</b>	See photo for coordinates.		<b>GPS Location</b>	See photo for coordinates.	
<b>Field Station#</b>	13210+00		<b>Field Station#</b>	13221+00	
<b>Pic 1 Desc.</b>	Permanently restored ROW, good vegetative cover noted across LOD.		<b>Pic 2 Desc.</b>	Slip noted along LOD, triple stack CFS perimeter control collapsed, further investigation in process.

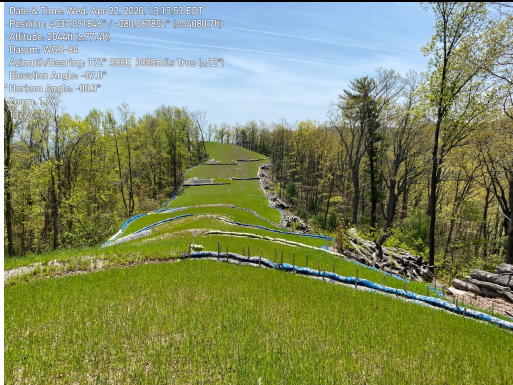
<p>Date &amp; Time: Wed, Apr 22, 2020 13:14:45 EDT Position: 43°37'13.24"N / -88°06'53.27"W (1616.3m) Altitude: 1820ft (554.9m) Datum: WGS 84 Azimuth Bearing: 121° 59'E 215mils True (±12°) Elevation Angle: -21.2° Horizon Angle: -03.0° Zoom: 1.0x S-114 13221+00</p>			
<b>GPS Location</b>	See photo for coordinates.		<b>GPS Location</b>	See photo for coordinates.	
<b>Field Station#</b>	13221+00		<b>Field Station#</b>	13227+00	
<b>Pic 3 Desc.</b>	Slip noted along LOD, triple stack CFS perimeter control collapsed, further investigation in process.		<b>Pic 4 Desc.</b>	Permanently restored ROW, good vegetative cover noted across LOD.

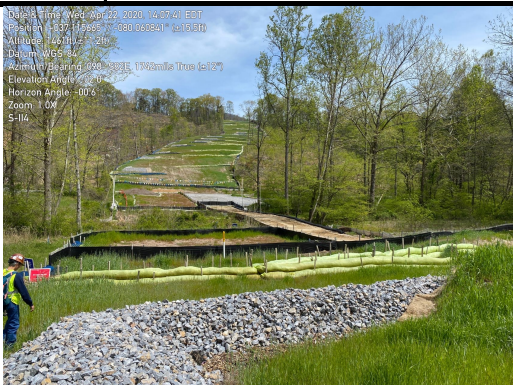
<p>Date &amp; Time: Wed, Apr 22, 2020 14:24:24 EDT Position: 43°37'14.55"N / -88°06'53.47"W (1616.3m) Altitude: 1820ft (554.9m) Datum: WGS 84 Azimuth Bearing: 121° 59'E 215mils True (±12°) Elevation Angle: -21.2° Horizon Angle: -03.0° Zoom: 1.0x S-114 13258+00</p>			
<b>GPS Location</b>	See photo for coordinates.		<b>GPS Location</b>	See photo for coordinates.	
<b>Field Station#</b>	13252+00		<b>Field Station#</b>	13258+00	
<b>Pic 5 Desc.</b>	Permanent waterbar stable, good vegetative cover across LOD.		<b>Pic 6 Desc.</b>	CIS S-II4, ECDs along stream functioning acceptably, bridge in acceptable condition.

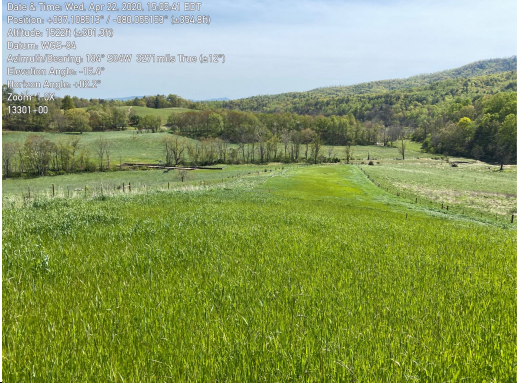
<p>Photo 8 Time: Wed Apr 22 2020 7:33:01 PM Position: +38° 11' 38.8" N / -88° 05' 02.1" W Altitude: 1560 ft (476.1 m) Datum: WGS-84 Magnetic Bearing: 103° 50' E 2342 mls True (±12°) Elevation Angle: +16.7° Horizon Angle: +100.8° Zoom: 1.0X 13301+00</p>			
<b>GPS Location</b>	See photo for coordinates.	<b>GPS Location</b>	See photo for coordinates.		
<b>Field Station#</b>	13277+00	<b>Field Station#</b>	13301+00		
<b>Pic 7 Desc.</b>	Permanent waterbars stable, CFS perimeters functioning acceptably.	<b>Pic 8 Desc.</b>	ROW restored, good vegetative cover noted across LOD.

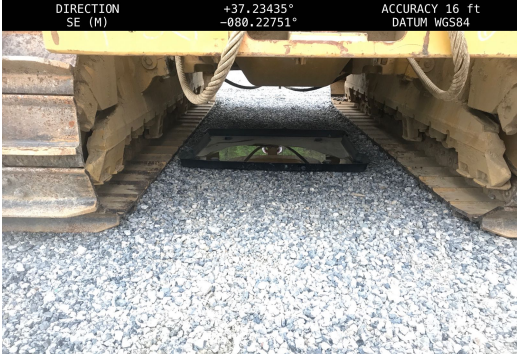
<p>DIRECTION SE (M)    +37.23435°    -080.22751°    ACCURACY 16 ft    DATUM WGS84</p> <p>MVP-PY-006_042320    Condition of trays under equipment    2020-04-23    07:45:14-04:00</p>

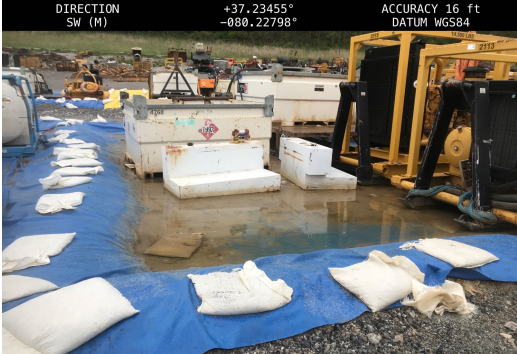
<p>DIRECTION SW (M)    +37.23455°    -080.22798°    ACCURACY 16 ft    DATUM WGS84</p> <p>MVP-PY-006_042320    Condition of poly lined containment    2020-04-23    07:47:34-04:00</p>			
<b>GPS Location</b>	MVP-PY-006 See photo for gps data		<b>GPS Location</b>	MVP-PY-006 See photo for gps data	
<b>Field Station#</b>	+0		<b>Field Station#</b>	+0	
<b>Pic 7 Desc.</b>	Condition of containment under stored leaky equipment. Looking SE.		<b>Pic 8 Desc.</b>	Condition of poly lined/gravel berm containment holding some stormwater. Looking SW.	
Insert image here			Insert image here		
<b>GPS Location</b>			<b>GPS Location</b>

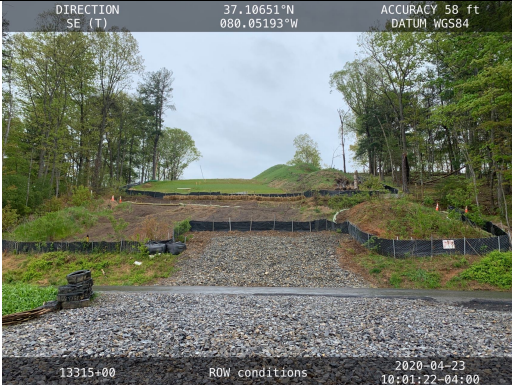
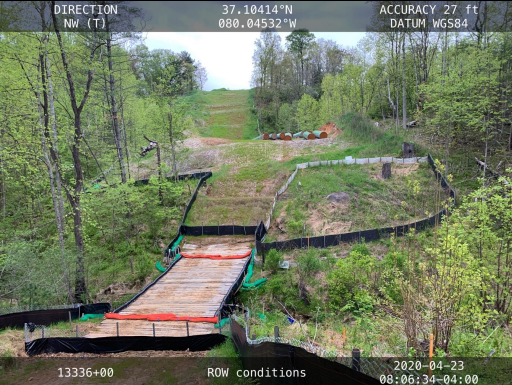
<b>GPS Location</b>	See photo for gps location data.		<b>GPS Location</b>	See photo for gps location data.	
<b>Field Station#</b>	13315+00		<b>Field Station#</b>	13336+00	
<b>Pic 1 Desc.</b>	Photo shows the RCE on the east side of Wades Gap Road.		<b>Pic 2 Desc.</b>	Photo shows the bridge over stream S-GH9 and adjacent ROW conditions.

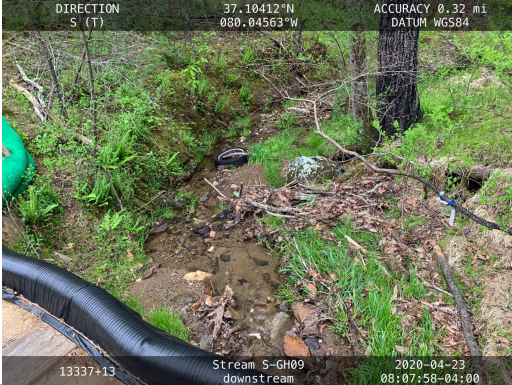
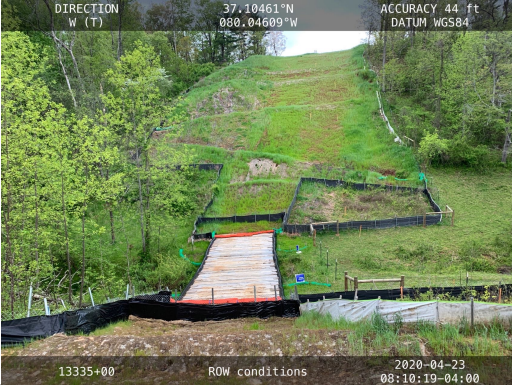
<b>GPS Location</b>	See photo for gps location data.		<b>GPS Location</b>	See photo for gps location data.	
<b>Field Station#</b>	13337+13		<b>Field Station#</b>	13335+00	
<b>Pic 3 Desc.</b>	Photo shows stream S-GH9 downstream from the ROW crossing.		<b>Pic 4 Desc.</b>	Photo shows the bridge over stream S-GH11 and adjacent ROW conditions.

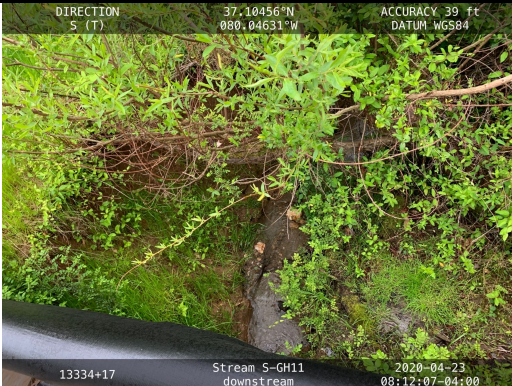
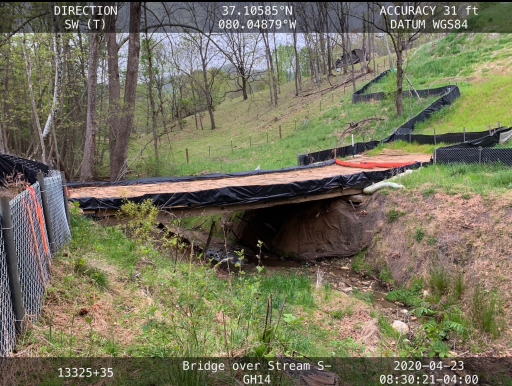
<b>Field Station#</b>	13334+17		<b>Field Station#</b>	13325+35	
<b>Pic 5 Desc.</b>	Photo shows stream S-GH11, downstream from the ROW.		<b>Pic 6 Desc.</b>	Photo shows the bridge over stream S-GH14.

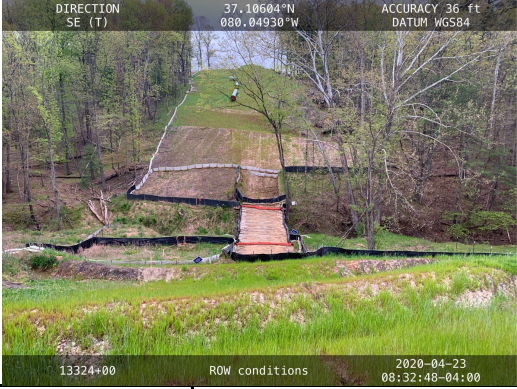
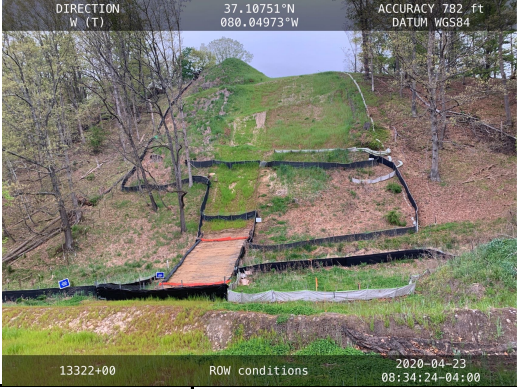
<b>GPS Location</b>	See photo for gps location data.		<b>GPS Location</b>	See photo for gps location data.	
<b>Field Station#</b>	13324+00		<b>Field Station#</b>	13322+00	
<b>Pic 7 Desc.</b>	Photo shows the bridge over stream S-GH14 and adjacent ROW conditions.		<b>Pic 8 Desc.</b>	Photo shows the bridge over stream S-GH15 and adjacent ROW conditions.

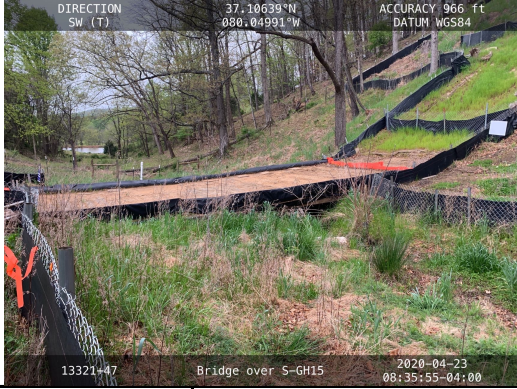
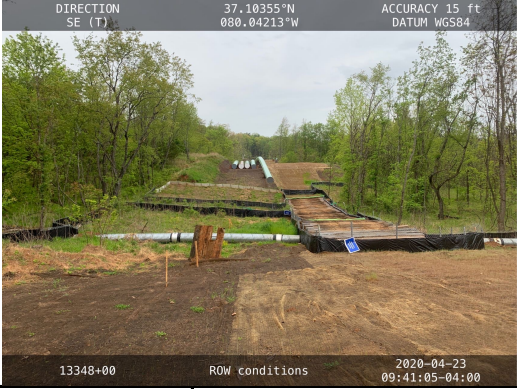
<b>GPS Location</b>	See photo for gps location data.		<b>GPS Location</b>	See photo for gps location data.	
<b>Field Station#</b>	13321+47		<b>Field Station#</b>	13348+00	
<b>Pic 9 Desc.</b>	Photo shows the bridge over stream S-GH15.		<b>Pic 10 Desc.</b>	Photo shows the bridge over stream S-RR08 and adjacent ROW conditions.

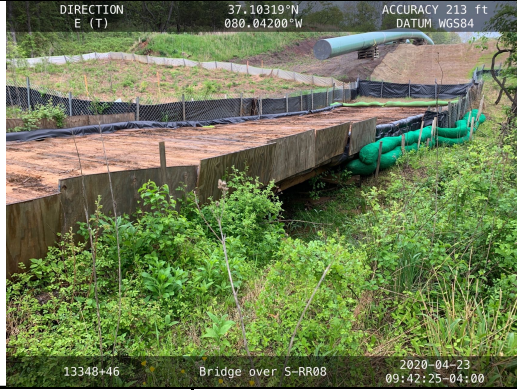
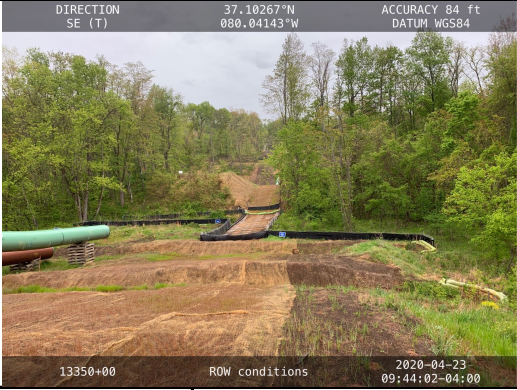
<b>Field Station#</b>	13348+46		<b>Field Station#</b>	13350+00	
<b>Pic 11 Desc.</b>	Photo shows the bridge over stream S-RR08.		<b>Pic 12 Desc.</b>	Photo shows the bridge over stream S-RR09 and adjacent ROW conditions.

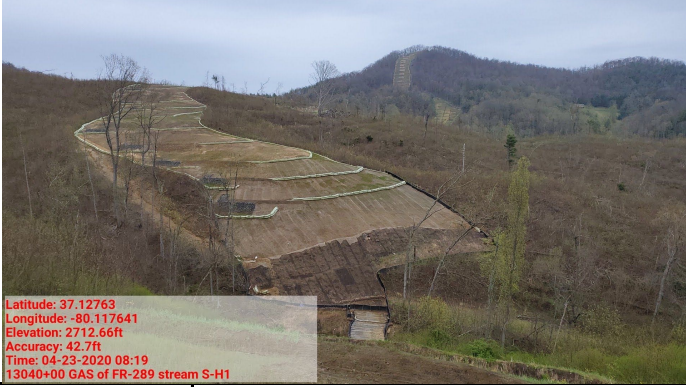
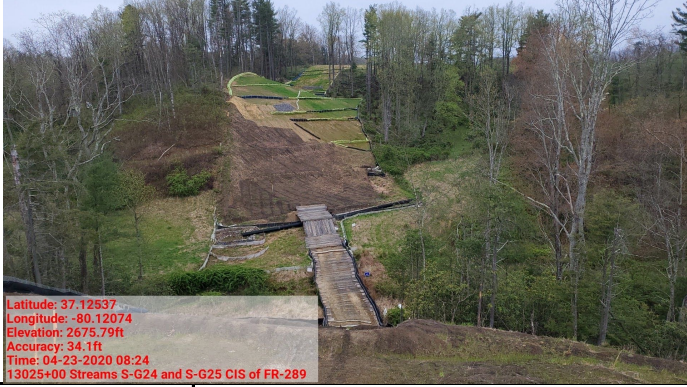
<b>GPS Location</b>	See pic for GPS location		<b>GPS Location</b>	See pic for GPS location	
<b>Field Station#</b>	13040+00		<b>Field Station#</b>	13025+00	
<b>Pic 7 Desc.</b>	No stream impacts observed at stream S-H1.		<b>Pic 8 Desc.</b>	No stream impacts observed at streams S-G24 and S-G25.

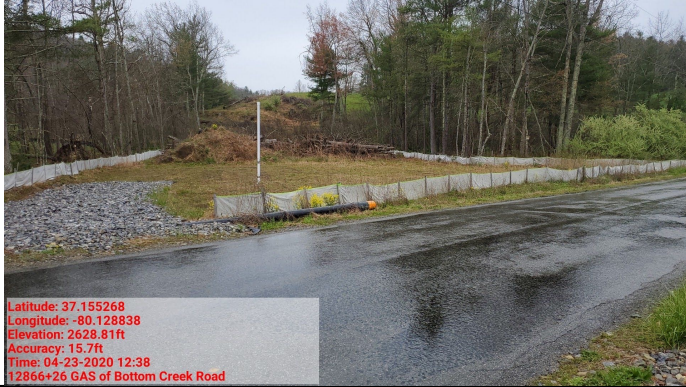
<b>GPS Location</b>	See pic for GPS location		<b>GPS Location</b>	See pic for GPS location	
<b>Field Station#</b>	12866+26		<b>Field Station#</b>	12866+26	
<b>Pic 9 Desc.</b>	Installed ECD's and BMP's remain in compliance at Bottom Creek Road.		<b>Pic 10 Desc.</b>	No maintenance issues or impacts were found at Bottom Creek Road.

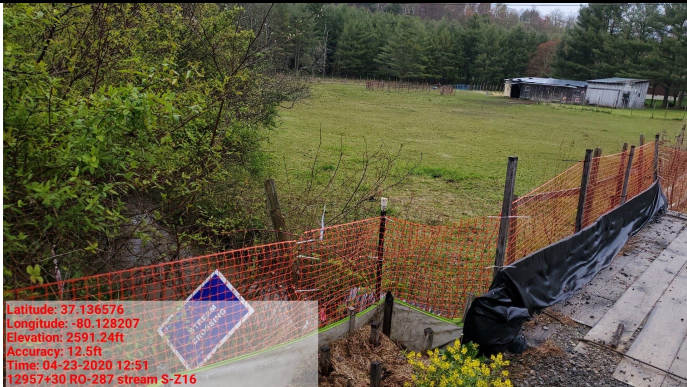
<b>GPS Location</b>	See pic for GPS location		<b>GPS Location</b>	See pic for GPS location	
<b>Field Station#</b>	12957+30		<b>Field Station#</b>	12957+30	
<b>Pic 11 Desc.</b>	No stream impacts observed at stream S-Z17 on access road RO-287.		<b>Pic 12 Desc.</b>	No stream impacts observed at stream S-Z16 on access road RO-287.

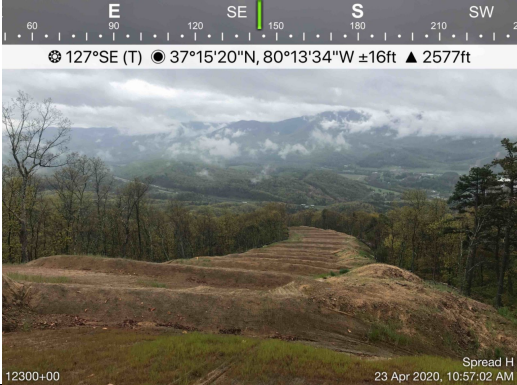
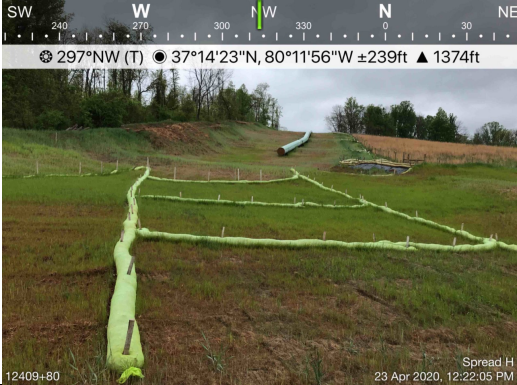
<b>GPS Location</b>	See photo		<b>GPS Location</b>	See photo	
<b>Field Station#</b>	12300+00		<b>Field Station#</b>	12409+80	
<b>Pic 7 Desc.</b>	Waterbars and end treatments in good condition along this slope.		<b>Pic 8 Desc.</b>	CFS controls in good condition.

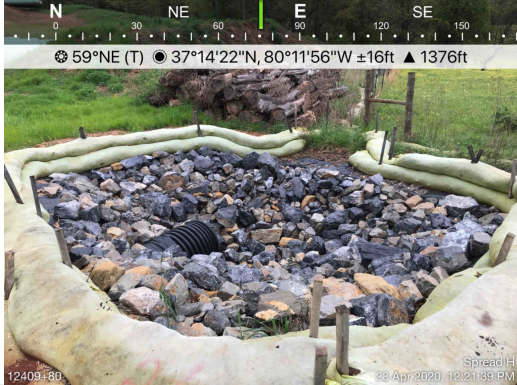
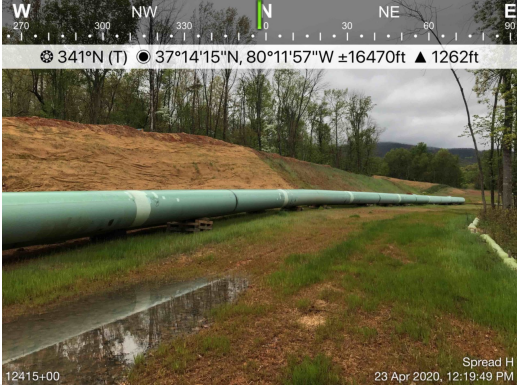
<b>GPS Location</b>	See photo		<b>GPS Location</b>	See photo	
<b>Field Station#</b>	12409+90		<b>Field Station#</b>	12415+00	
<b>Pic 9 Desc.</b>	CWD outlet protection in good condition.		<b>Pic 10 Desc.</b>	Berm is stabilized and in acceptable condition.

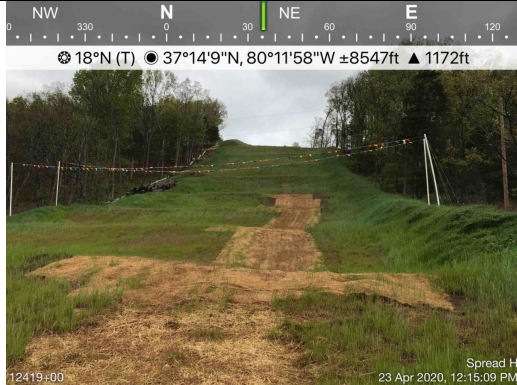
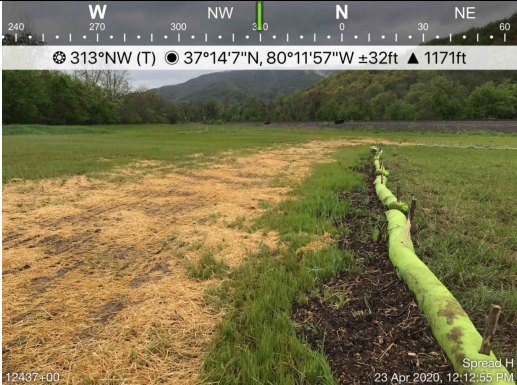
<b>GPS Location</b>	See photo		<b>GPS Location</b>	See photo	
<b>Field Station#</b>	12419+00		<b>Field Station#</b>	12437+00	
<b>Pic 11 Desc.</b>	Waterbars along this slope are stabilized and in acceptable condition.		<b>Pic 12 Desc.</b>	Area has been re-stabilized with a uniform straw cover.

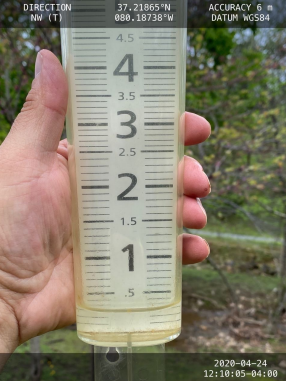
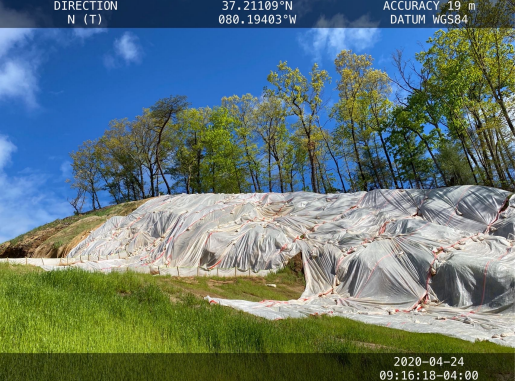
<b>GPS Location</b>	See photo		<b>GPS Location</b>	See photo	
<b>Field Station#</b>	12544+06		<b>Field Station#</b>	12543+00	
<b>Pic 1 Desc.</b>	0.4 inches of precipitation accumulated in the rain gauge at Yellow Finch Road overnight.		<b>Pic 2 Desc.</b>	Plastic sheeting used for stabilization on stockpiles nearest to Yellow Finch Road remains intact.

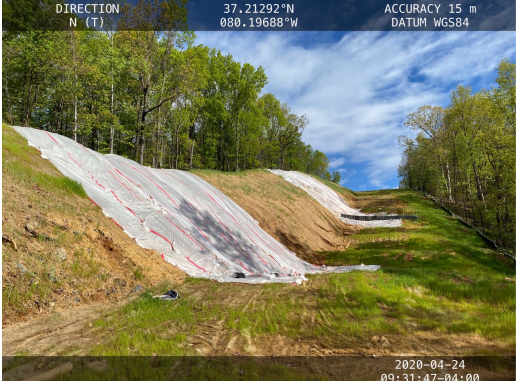
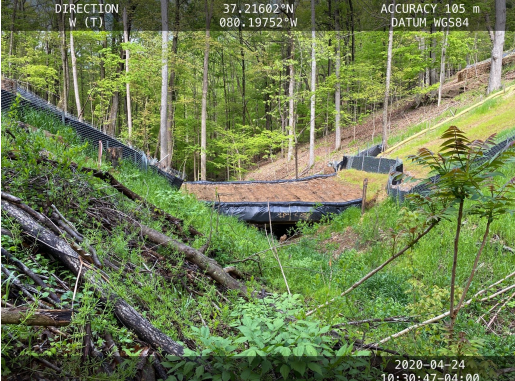
<b>GPS Location</b>	See photo		<b>GPS Location</b>	See photo	
<b>Field Station#</b>	12530+00		<b>Field Station#</b>	12519+41	
<b>Pic 3 Desc.</b>	Plastic sheeting approximately 1500 feet to coming in side of Yellow Finch Road remains intact and effective.		<b>Pic 4 Desc.</b>	Stream S-EF19, facing west, downstream

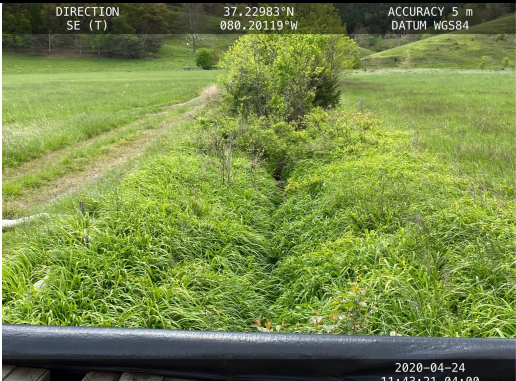
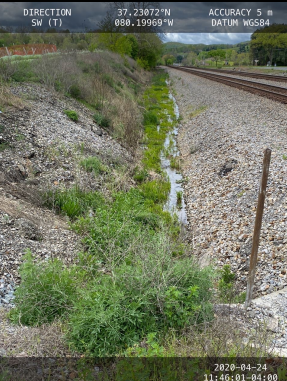
<b>Pic 5 Desc.</b>	Stream S-CD12, facing southeast, upstream		<b>Pic 6 Desc.</b>	Stream S-I1, facing southwest, upstream

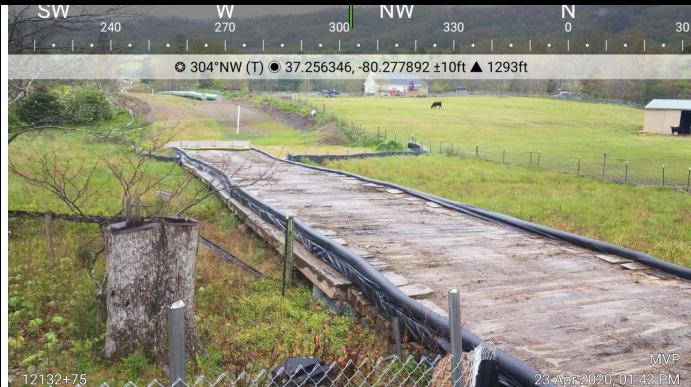
<b>GPS Location</b>	See Above		<b>GPS Location</b>	See Above	
<b>Field Station#</b>	12132+75		<b>Field Station#</b>	12163+00	
<b>Pic 1 Desc.</b>	Stream S-C29, Looking NorthWest.		<b>Pic 2 Desc.</b>	Stream S-C24, Looking NorthWest.

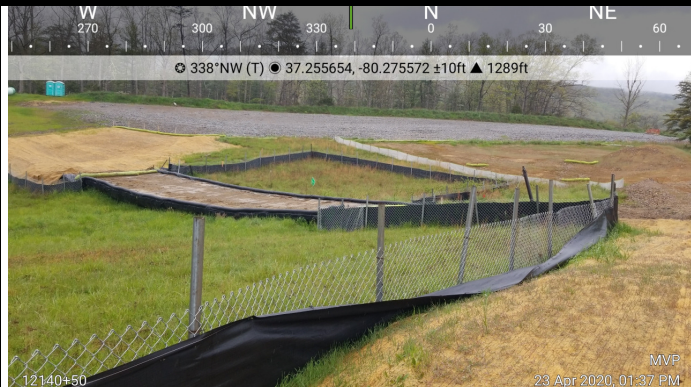
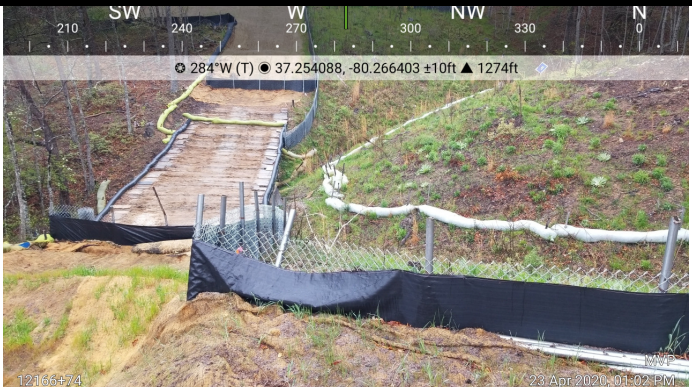
<b>GPS Location</b>	See Above		<b>GPS Location</b>	See Above	
<b>Field Station#</b>	12140+50		<b>Field Station#</b>	12166+74	
<b>Pic 3 Desc.</b>	Punchlist Item. Super Siltfence requires repair near Wetland W-C6.		<b>Pic 4 Desc.</b>	Punchlist Item. Super Siltfence requires repair near Stream S-C24.

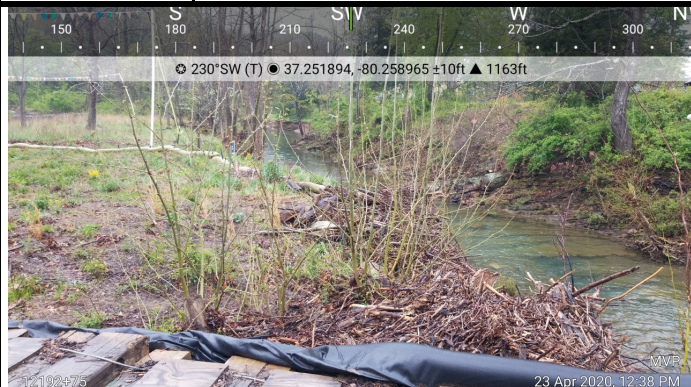
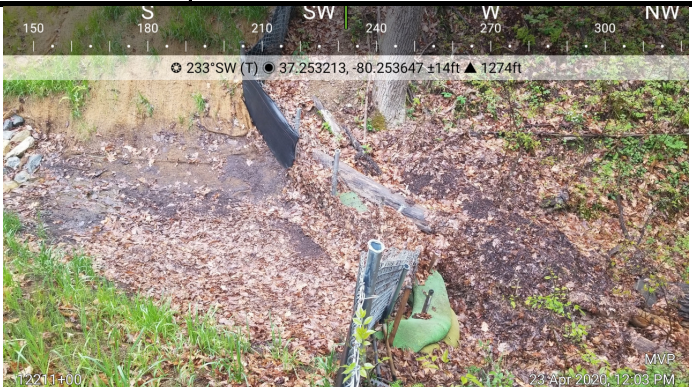
<b>GPS Location</b>	See Above		<b>GPS Location</b>	See Above	
<b>Field Station#</b>	12192+75		<b>Field Station#</b>	12211+00	
<b>Pic 5 Desc.</b>	Punchlist Item. Compost Filter Sock requires repair/maintenance near Stream S-C21.		<b>Pic 6 Desc.</b>	Punchlist Item. Supersiltfence and CFS require repair/maintenance near Station 12211+00 in "ravine" area.
