Visual Site Inspection Report

Project Name	H-600 Pipeline Spread H	AFE	124300138	Spread	H-600 Pipeline Spread H
Contractor	Precision			Report #	10488
Inspector	Logan Box			Date/Time	4/28/2020 7:00 PM
Permit #	TBD	Inspection Type	VA SWPP	Station Begin	13415+51
State	VA	Inspection Area	Partial	Station End	13670+00
County	Franklin	Ground	Damp	Temperature (°F)	72.00
Municipality	N/A	Weather	Cloudy	Rain Gauge (in)	1.50
				Rain Accumulation Time (days)	6.00

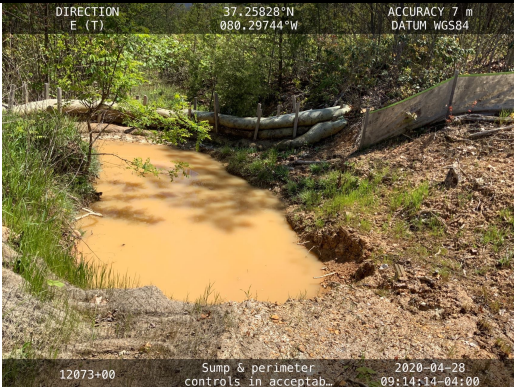
GPS Location	See photo GPS for location		GPS Location	See photo GPS for location	
Field Station#	12073+00		Field Station#	12071+80	
Pic 1 Desc.	Sump and perimeter controls are in acceptable condition.		Pic 2 Desc.	Broad based dips, rock check dams, and sumps with end treatments are in acceptable condition on MVP-MN-270.

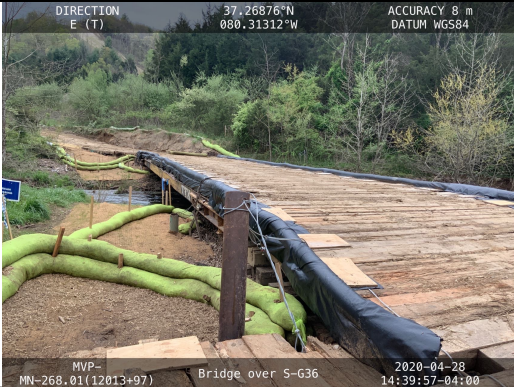
GPS Location	See photo GPS for location		GPS Location	See photo GPS for location	
Field Station#	12013+97		Field Station#	12008+00	
Pic 3 Desc.	Bridge and buffers are in acceptable condition after repairs are complete following flooding on 04/12/2020.		Pic 4 Desc.	Excavator tracks on temporary stabilization were seeded and mulched. Ground disturbance due to mat retrieval downstream.

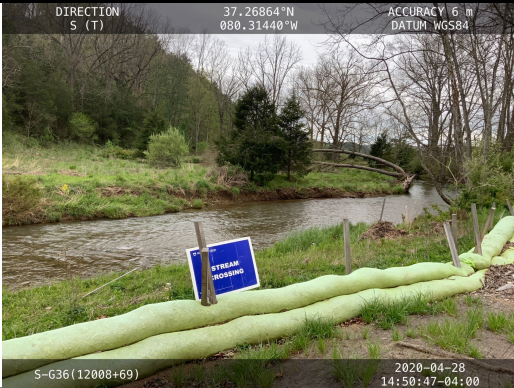
Pic 5 Desc.	Stream banks, ECDs, and signage are in acceptable condition.		Pic 6 Desc.	Stream banks and ECDs are in acceptable condition.

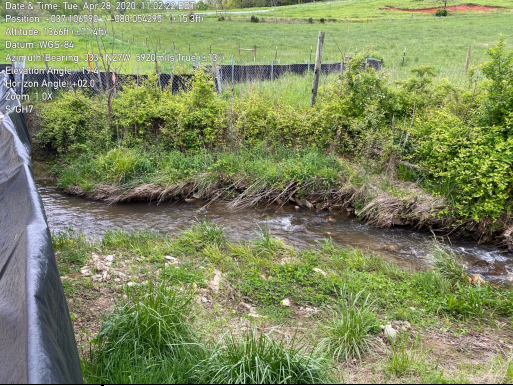
<p>Date & Time: Tue, Apr 28, 2020, 11:02:22 EDT Position: +037.148534° / -080.052193° (+30.50) Altitude: 1365ft (+35.5m) Datum: WGS-84 Azimuth/Bearing: 133° N27W 9920mils True (+13°) Elevation Angle: +11.9° Horizon Angle: +02.0° Zoom: 1.0X S-GH7</p>			
GPS Location	See photo for coordinates.		GPS Location	See photo for coordinates.	
Field Station#	13190+00		Field Station#	13309+25	
Pic 1 Desc.	MVP-AR-29 ECDs along access road in acceptable condition, cattle in adjacent field, gap installed in SSF for landowner.		Pic 2 Desc.	S-GH7, upstream of equipment bridge, no changes noted to stream bed or banks, deposition of native material under bridge.

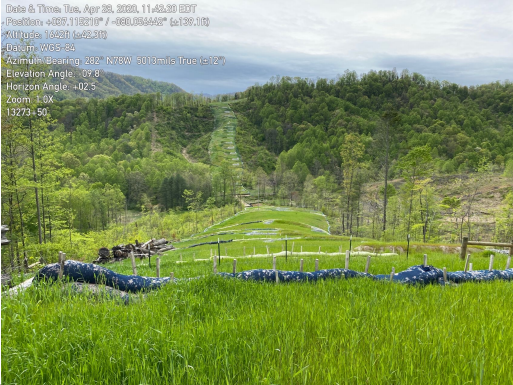
<p>Date & Time: Tue, Apr 28, 2020, 11:45:30 EDT Position: +037.118210° / -080.054455° (+30.10) Altitude: 1420ft (+36.20) Datum: WGS-84 Azimuth/Bearing: 282° N28W 5013mils True (+12°) Elevation Angle: +09.8° Horizon Angle: +02.5° Zoom: 1.0X 13273+50</p>			
GPS Location	See photo for coordinates.		GPS Location	See photo for coordinates.	
Field Station#	13289+25		Field Station#	13273+50	
Pic 3 Desc.	ROW stable, moderate to good vegetative cover noted across LOD, perimeter controls functioning acceptably.		Pic 4 Desc.	ROW stable, moderate to good vegetative cover noted across LOD, perimeter controls functioning acceptably.

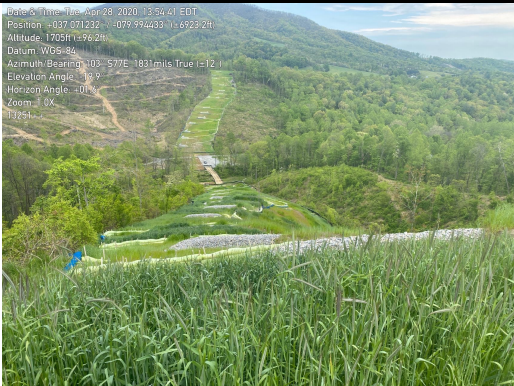
GPS Location	See photo for coordinates.		GPS Location	See photo for coordinates.	
Field Station#	13251+00		Field Station#	13211+00	
Pic 5 Desc.	Good vegetative cover noted across LOD, permanent waterbars and CFS extensions stable.		Pic 6 Desc.	Good vegetative cover noted across LOD, permanent waterbars and CFS extensions stable.

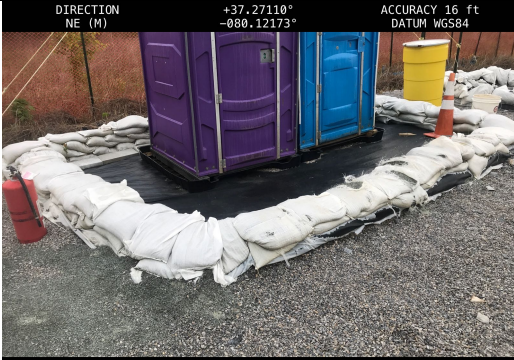
GPS Location	MVP-LY-049 See photo for gps data		GPS Location	MVP-LY-049 See photo for gps data	
Field Station#	+0		Field Station#	+0	
Pic 1 Desc.	Condition of trays and containment under toilets. Looking NE.		Pic 2 Desc.	No loose trash around south dumpsters. Looking SE.

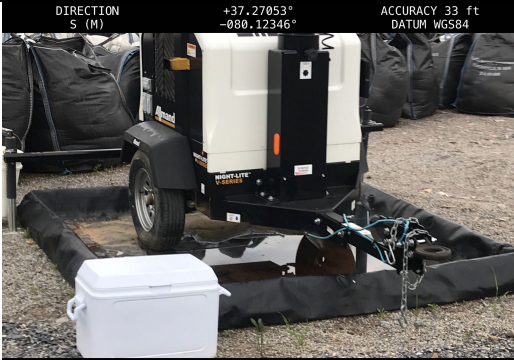
GPS Location	MVP-LY-049 See photo for gps data		GPS Location	MVP-LY-049 See photo for gps data	
Field Station#	+0		Field Station#	+0	
Pic 3 Desc.	Condition of containment under light plant. Looking S.		Pic 4 Desc.	Condition of temporary trash transfer pit. Looking W.

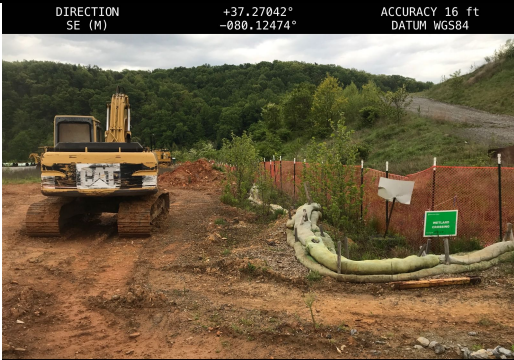
GPS Location	MVP-LY-049 See photo for gps data		GPS Location	MVP-LY-049 See photo for gps data	
Field Station#	+0		Field Station#	+0	
Pic 5 Desc.	Landowner disturbance and equipment parked next to compost filter sock and feature. No impacts. Looking SE.		Pic 6 Desc.	Condition of compost filter sock along north LOD. Looking E.

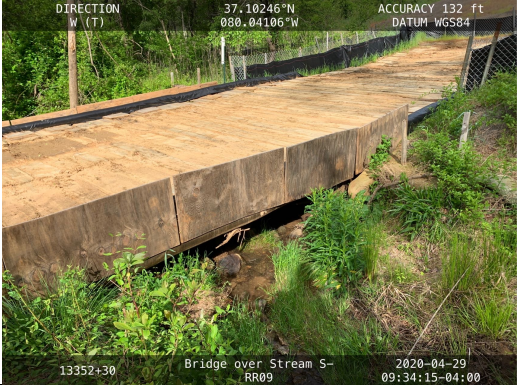
GPS Location	See photo for gps location data.		GPS Location	See photo for gps location data.	
Field Station#	13352+30		Field Station#	13352+23	
Pic 7 Desc.	photo shows the bridge over stream S-RR09.		Pic 8 Desc.	Photo shows stream S-RR09 downstream from the ROW.

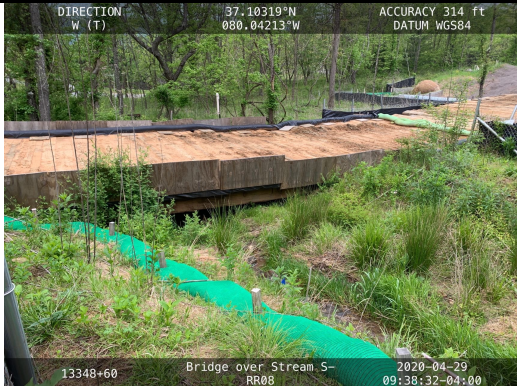
GPS Location	See photo for gps location data.		GPS Location	See photo for gps location data.	
Field Station#	13348+60		Field Station#	13348+46	
Pic 9 Desc.	Photo shows the bridge over stream S-RR08.		Pic 10 Desc.	Photo shows stream S-RR08 downstream from the ROW.

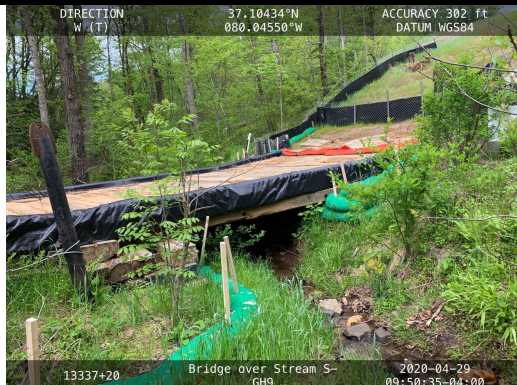
GPS Location	See photo for gps location data.		GPS Location	See photo for gps location data.	
Field Station#	13337+20		Field Station#	13337+13	
Pic 11 Desc.	Photo shows the bridge over stream S-GH09.		Pic 12 Desc.	Photo shows stream S-GH09 downstream from the ROW.

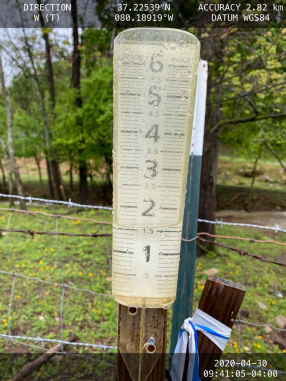
GPS Location	See photo	GPS Location	See photo		
Field Station#	12544+06	Field Station#	12543+00		
Pic 1 Desc.	1.6 inches of precipitation accumulated in the rain gauge at Yellow Finch Road overnight.	Pic 2 Desc.	Plastic sheeting intact and effective.

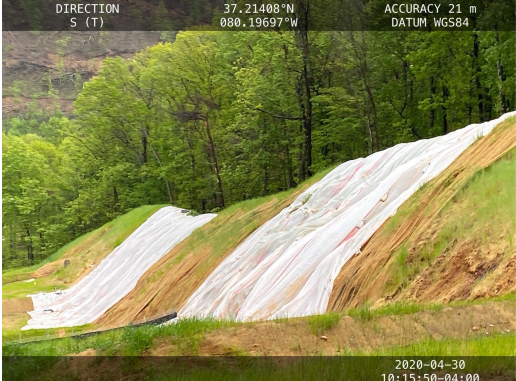
GPS Location	See photo	GPS Location	See photo		
Field Station#	12529+00	Field Station#	12519+41		
Pic 3 Desc.	Plastic sheeting intact and effective.	Pic 4 Desc.	Stream S-EF19, facing south

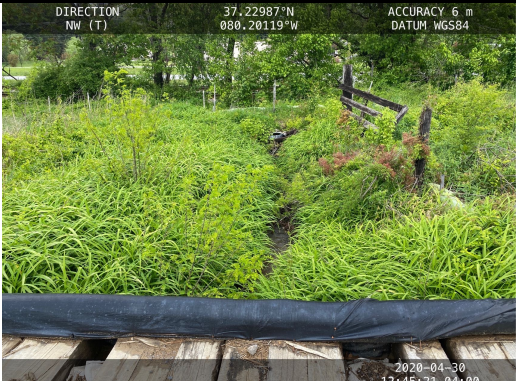
GPS Location	See photo	GPS Location	See photo		
Field Station#	12455+21	Field Station#	12444+94		
Pic 5 Desc.	Stream S-CD12, facing northwest, downstream	Pic 6 Desc.	Stream S-I1, facing west, upstream
