Visual Site Inspection Report

Project Name	H-600 Pipeline Spread H	AFE	124300138	Spread	H-600 Pipeline Spread H
Contractor	Precision			Report #	9138
Inspector	Tammy Kruizenga			Date/Time	4/6/2020 6:21 AM
Permit #	TBD	Inspection Type	VA SWPP	Station Begin	12005+00
State	VA	Inspection Area	Partial	Station End	12119+17
County	Montgomery	Ground	Wet	Temperature (°F)	70.00
Municipality	N/A	Weather	Light Rain	Rain Gauge (in)	0.00
				Rain Accumulation Time (days)	1.00

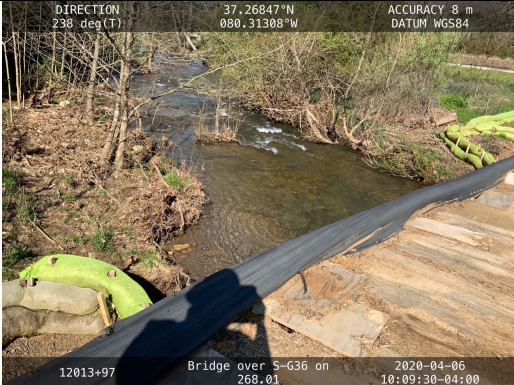
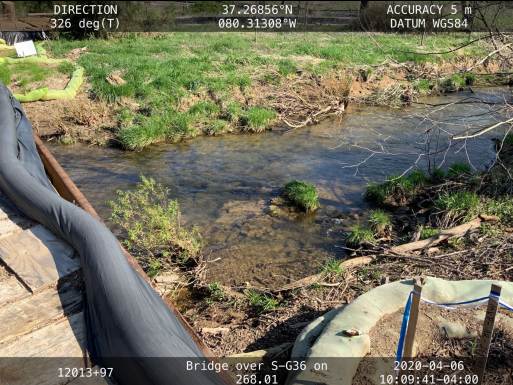
GPS Location	See photo GPS for location		GPS Location	See photo GPS for location	
Field Station#	12013+97		Field Station#	12013+97	
Pic 1 Desc.	ECDs surrounding stream are in acceptable condition. Stream free of turbidity.		Pic 2 Desc.	ECDs surrounding stream are in acceptable condition. Stream free of turbidity.

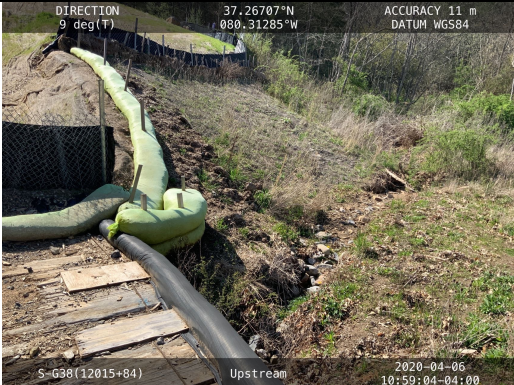
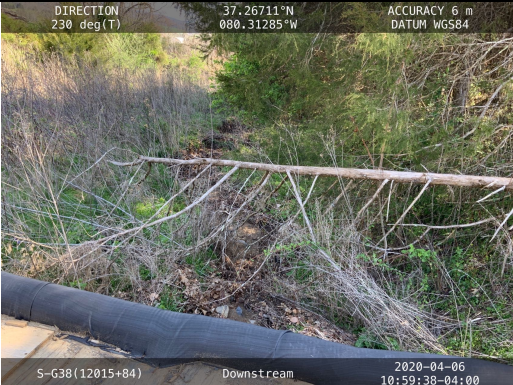
GPS Location	See photo GPS for location		GPS Location	See photo GPS for location	
Field Station#	12015+84		Field Station#	12015+84	
Pic 3 Desc.	ECDs surrounding stream are in acceptable condition. Stream is dry.		Pic 4 Desc.	ECDs surrounding stream are in acceptable condition. Stream is dry.

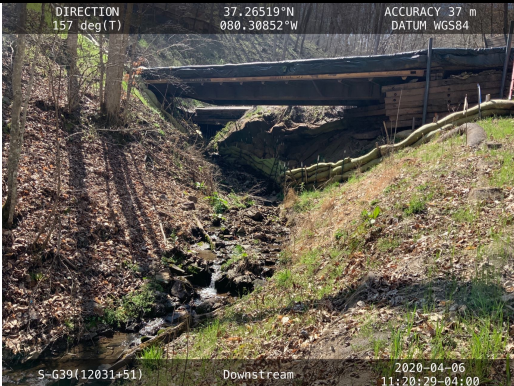
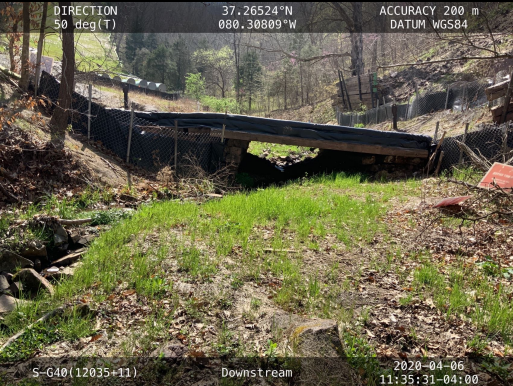
GPS Location	See photo GPS for location		GPS Location	See photo GPS for location	
Field Station#	12031+51		Field Station#	12035+11	
Pic 5 Desc.	ECDs surrounding stream are in acceptable condition. Stream free of turbidity.		Pic 6 Desc.	ECDs surrounding stream are in acceptable condition. Stream free of turbidity.

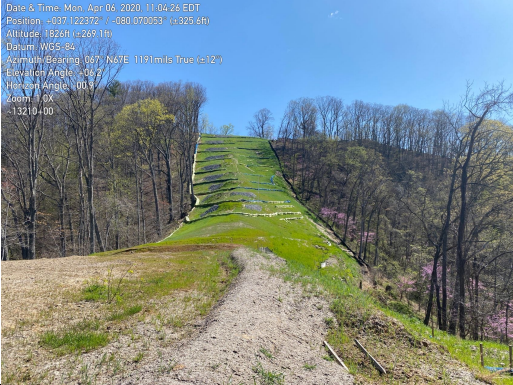
<p>Date & Time: Mon, Apr 06, 2020, 11:04:28 EDT Position: +037.122372 / -080.076033 / +13229.6ft Altitude: 1520ft / +269.1m Datum: WGS 84 Azimuth: Bearing: 167, N46E, 1191mils True (+12) Elevation Angle: +06.2 Horizon Angle: +00.3 Zoom: 1.0x 13210+00</p>											
GPS Location				See photo for coordinates.				GPS Location				See photo for coordinates.			
Field Station#				13207+00				Field Station#				13210+00			
Pic 1 Desc.				ROW temporarily stabilized, vegetation noted consistently across ROW.				Pic 2 Desc.				Start of permanently restored ROW, permanent waterbars stable, CFS expansions also stable, vegetation noted across LOD.

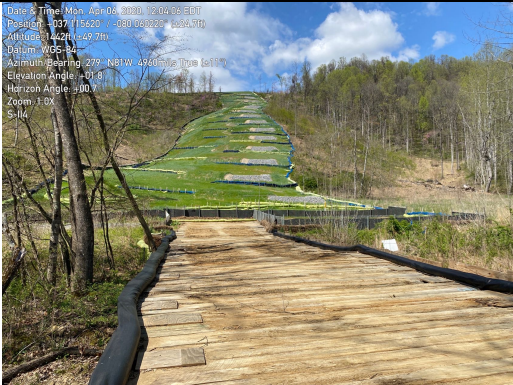
<p>Date & Time: Mon, Apr 06, 2020, 12:10:03 EDT Position: +037.115620 / -080.069226 / +13543.1ft Altitude: 1420ft / +269.7m Datum: WGS 84 Azimuth: Bearing: 279, N69W, 4940mils True (+11) Elevation Angle: +11.1 Horizon Angle: +10.7 Zoom: 1.0x S-II4</p>											
GPS Location				See photo for coordinates.				GPS Location				See photo for coordinates.			
Field Station#				13260+60				Field Station#				13260+60			
Pic 3 Desc.				S-II4, ECDs functioning acceptably, no environmental issues noted at stream crossing.				Pic 4 Desc.				CIS of S-II4, ROW permanently restored, permanent waterbars and CFS extensions stable, acceptable vegetative cover across LOD.

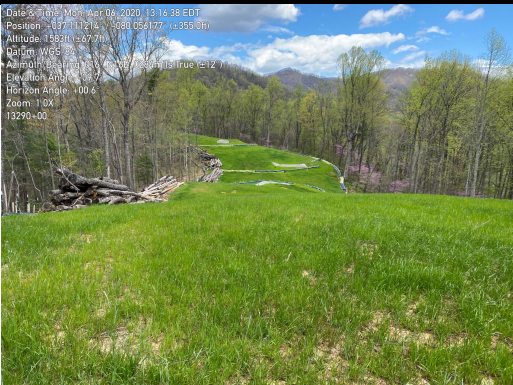
<p>Date & Time: Mon, Apr 06, 2020, 13:16:38 EDT Position: +037.123307 / -080.050177 / +13301.0ft Altitude: 1520ft / +269.1m Datum: WGS 84 Azimuth: Bearing: 167, N46E, 1191mils True (+12) Elevation Angle: +06.2 Horizon Angle: +00.3 Zoom: 1.0x 13290+00</p>											
GPS Location				See photo for coordinates.				GPS Location				See photo for coordinates.			
Field Station#				13301+00				Field Station#				13290+00			
Pic 5 Desc.				Good vegetative cover noted across permanently restored LOD.				Pic 6 Desc.				Permanent waterbars stable, perimeter controls functioning acceptably.

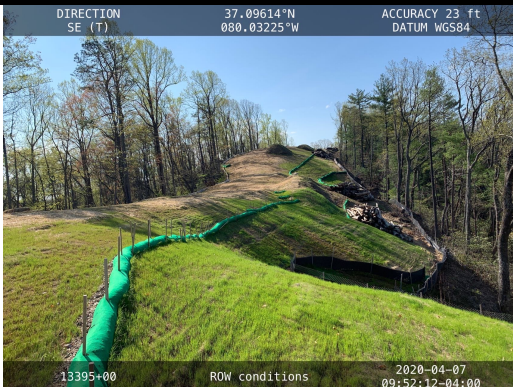
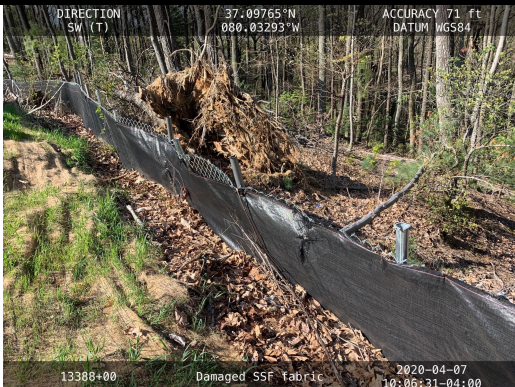
DIRECTION SE (T)		37.09614°N 080.03225°W		ACCURACY 23 ft DATUM WGS84	
13395+00		ROW conditions		2020-04-07 09:52:12-04:00	
GPS Location		See photo for gps location data.			
Field Station#		13395+00			
Pic 1 Desc.		Photo shows the ROW condition from about 13395+00 to 13340+00.

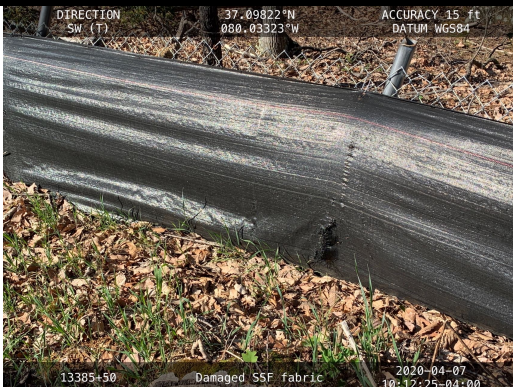
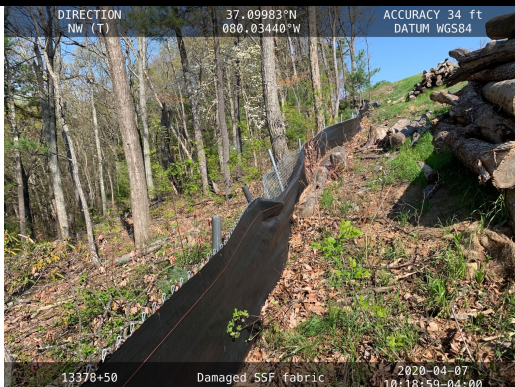
DIRECTION Sw (T)		37.09822°N 080.03323°W		ACCURACY 15 ft DATUM WGS84	
13385+50		Damaged SSF fabric		2020-04-07 10:12:25-04:00	
GPS Location		See photo for gps location data.			
Field Station#		13385+50			
Pic 3 Desc.		Photo shows the damaged SSF fabric at about 13385+50.			
DIRECTION NW (T)		37.09983°N 080.03440°W		ACCURACY 34 ft DATUM WGS84	
13378+50		Damaged SSF fabric		2020-04-07 10:18:59-04:00	
GPS Location		See photo for gps location data.			
Field Station#		13378+50			
Pic 4 Desc.		Photo shows the damaged SSF fabric at about 13378+50.

E&S BMPs	Compliance Level	Corrective Action	Corrective Time Frame	Date Repaired
Compost Filter Sock	Acceptable			
Equipment Bridge	Acceptable			
Silt Fence (Filter Fabric Fence)	Acceptable			
Silt Fence (Reinforced Filter Fabric Fence)	Communication	Replace damaged SSF fabric	48 Hours	4/8/2020
Sump Pit	Acceptable

7. Identify all remedial measures that have been taken since the previous inspection was conducted. The following mitigation measures were performed in this area since the last SWPPP inspection: 13414+50: damaged SSF fabric was replaced					
Comments (Reference above questions as appropriate.) I arrived on the ROW near Cahas Mountain Road this morning at 7:30 am. The inspection team did not meet today due to the potential spread of the Coronavirus. No measurable rainfall was recorded at the nearest rain gauge (Cahas Mountain Road) within the last 24 hours. I performed a SWPPP inspection of the ROW to observe conditions of the ROW, ECDs, stream crossings and general ROW condition between stations 13315+00 and 13416+00. The stream crossings observed included S-GH15, S-GH14, S-GH11, S-GH9, S-RR08, S-RR09, S-RR11, S-IJ1, S-IN2, and S-IJ3. The ROW from station 13315+00 to 13342+00 has been temporarily stabilized with seed, ProGanics Dual and Flexterra. Currently the vegetative growth in this areas is less than 40%. The ROW between 13342+00 and 13416+00 has been temporarily stabilized with seed and erosion control blanket. The vegetative growth in this area is less than 20%. The section of SSF between about stations 13378+00 and 13388+00 has been damaged, likely by wind. The SSF fabric in this area has multiple small holes and has been pulled loose from the fence in a few places. I informed the contractor and included this on today's punch list. No additional environmental issues, off-ROW sediment or stream impacts were observed during this SWPPP inspection.

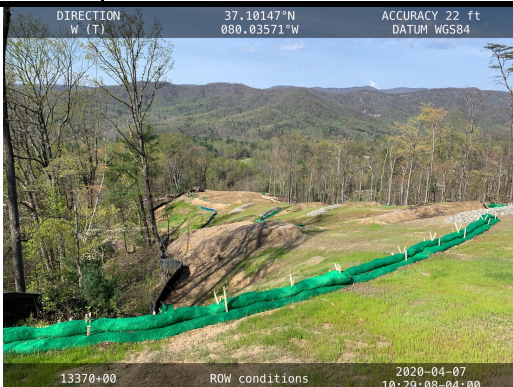
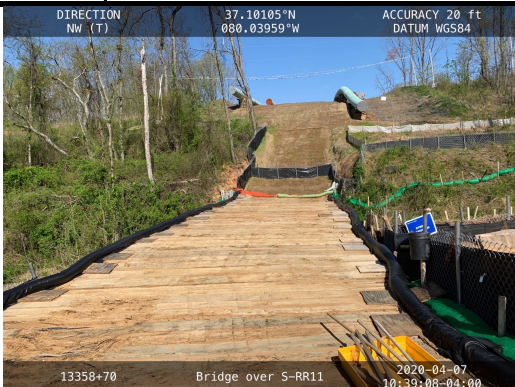
DIRECTION W (T)		37.10147°N 080.03571°W		ACCURACY 22 ft DATUM WGS84	
13370+00		ROW conditions		2020-04-07 10:29:08-04:00	
GPS Location		See photo for gps location data.			
Field Station#		13370+00			
Pic 5 Desc.		Photo shows the ROW condition from about 13366+00 to 13370+00.			
DIRECTION NW (T)		37.10105°N 080.03959°W		ACCURACY 20 ft DATUM WGS84	
13358+70		Bridge over S-RR11		2020-04-07 10:39:08-04:00	
GPS Location		See photo for gps location data.			
Field Station#		13358+70			
Pic 6 Desc.		Photo shows the bridge over stream S-RR11.

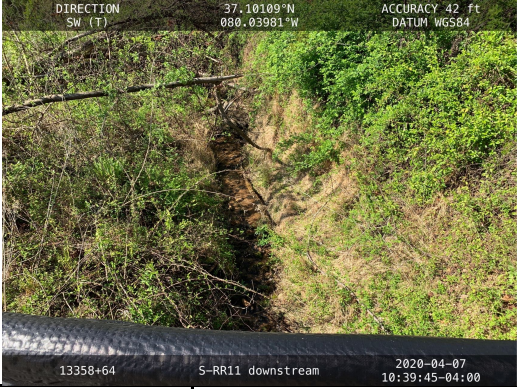
GPS Location	See photo for gps location data.		GPS Location	See photo for gps location data.	
Field Station#	13358+64		Field Station#	13352+30	
Pic 7 Desc.	Photo shows stream S-RR11 downstream from the ROW.		Pic 8 Desc.	Photo shows the bridge over stream S-RR09.

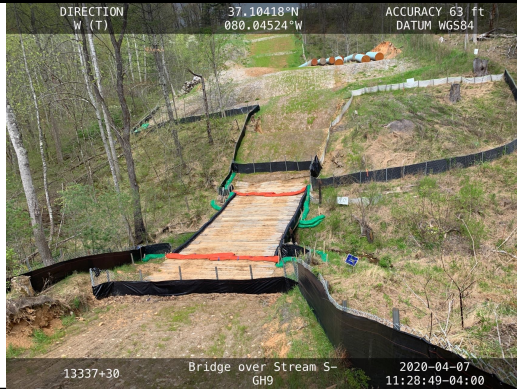
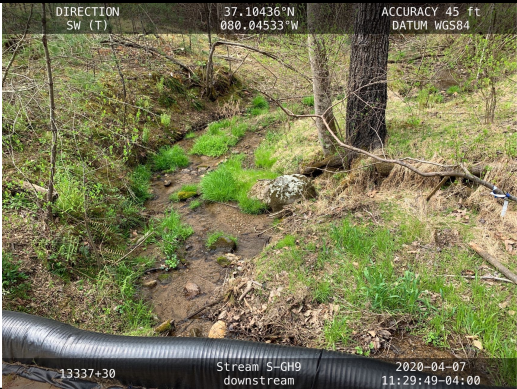
GPS Location	See photo for gps location data.		GPS Location	See photo for gps location data.	
Field Station#	13337+30		Field Station#	13337+13	
Pic 11 Desc.	Photo shows the bridge over stream S-GH9.		Pic 12 Desc.	Photo shows stream S-GH9 downstream from the ROW.

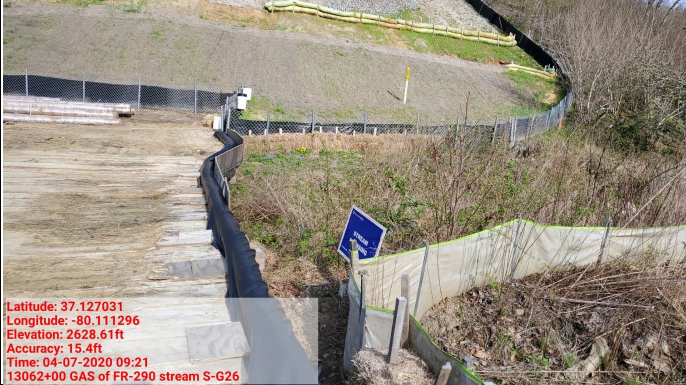
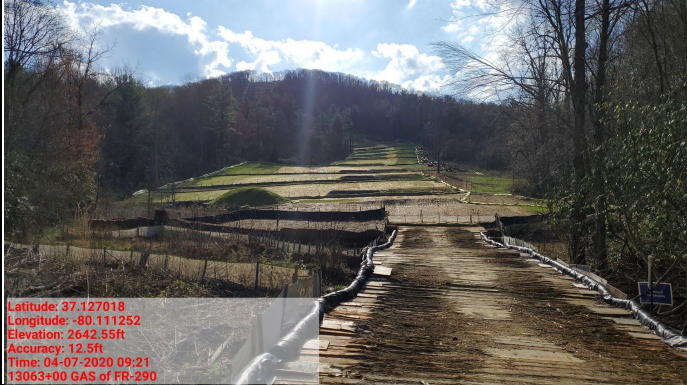
GPS Location	See pic for GPS location		GPS Location	See pic for GPS location	
Field Station#	13062+00		Field Station#	13063+00	
Pic 13 Desc.	No stream impacts observed at stream S-G26.		Pic 14 Desc.	Good vegetation growth throughout the area on the CIS and the GAS of FR-290.	
Insert image here			Insert image here		
GPS Location			GPS Location		
Field Station#			Field Station#		
Pic 15 Desc.			Pic 16 Desc.		
Insert image here			Insert image here		
GPS Location			GPS Location		
Field Station#			Field Station#		
Pic 17 Desc.			Pic 18 Desc.

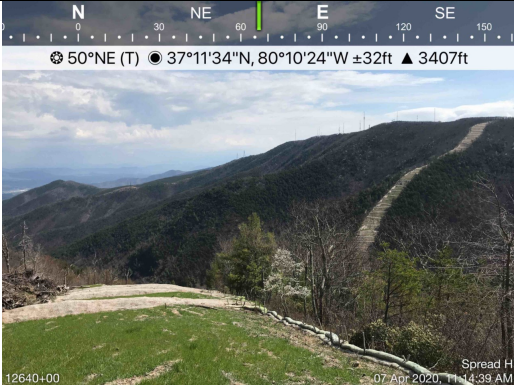
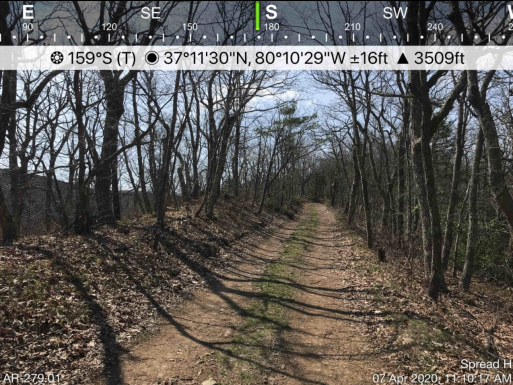
GPS Location	See photo		GPS Location	See photo	
Field Station#	12640+00		Field Station#	279+01	
Pic 1 Desc.	Start of Inspection area, Vegetation is mature and uniform and controls are in good condition.		Pic 2 Desc.	AR-279.01 in acceptable condition.

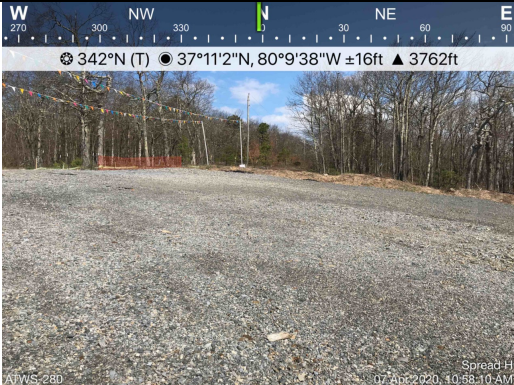
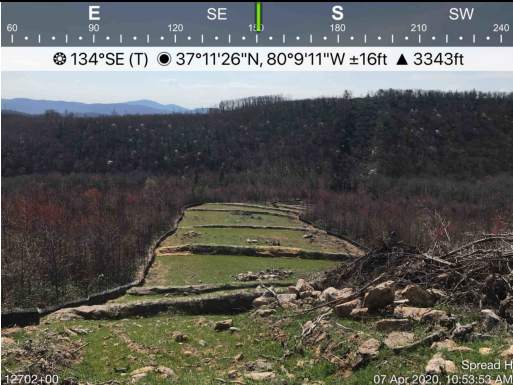
GPS Location	See photo		GPS Location	See photo	
Field Station#	2+80		Field Station#	12702+00	
Pic 3 Desc.	ATWS-280 remains inactive and controls are in acceptable condition.		Pic 4 Desc.	Waterbars and end treatments on the GAS of Honeysuckle in good condition.

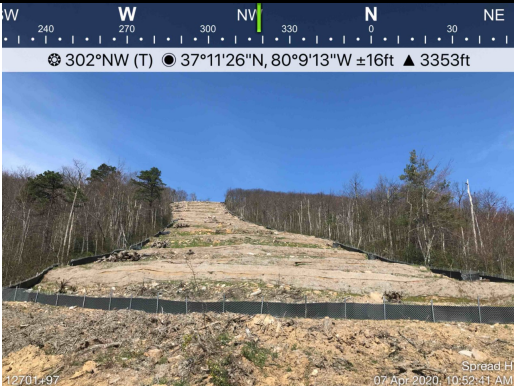
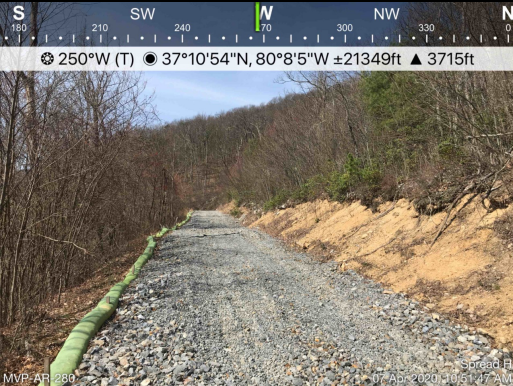
GPS Location	See photo		GPS Location	See photo	
Field Station#	12701+97		Field Station#	2+80	
Pic 5 Desc.	SSF controls in good condition.		Pic 6 Desc.	Controls are in place and functioning on AR-280

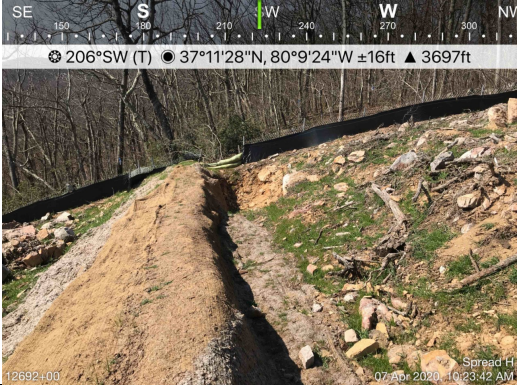
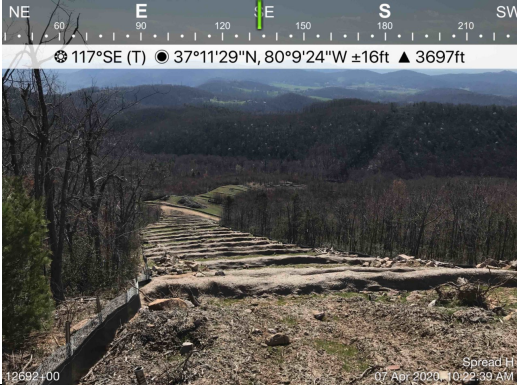
GPS Location	See photo		GPS Location	See photo	
Field Station#	12692+00		Field Station#	12692+00	
Pic 7 Desc.	Waterbar stabilized and in acceptable condition, sump holding minimal water and functioning.		Pic 8 Desc.	Controls along this slope are in place and functioning.

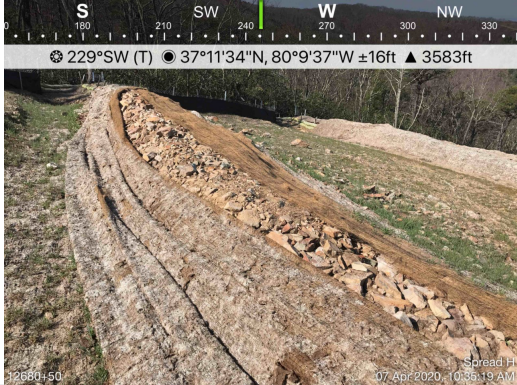
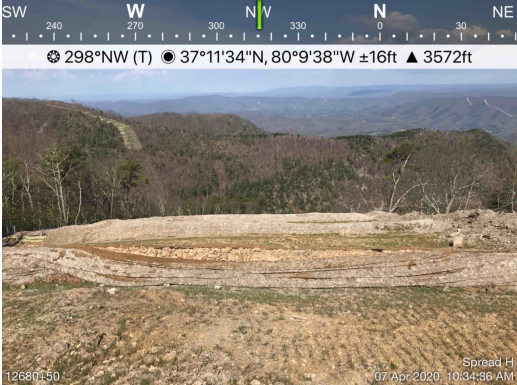
GPS Location	See photo		GPS Location	See photo	
Field Station#	12680+50		Field Station#	12680+50	
Pic 9 Desc.	Erosion control blanketing has become loose on this waterbar. Monitor and repair as necessary.		Pic 10 Desc.	Loose erosion control blanketing. Material beneath the blanketing is compacted and there is no immediate issue as a result.

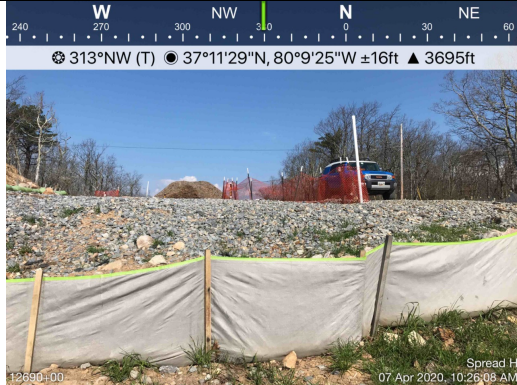
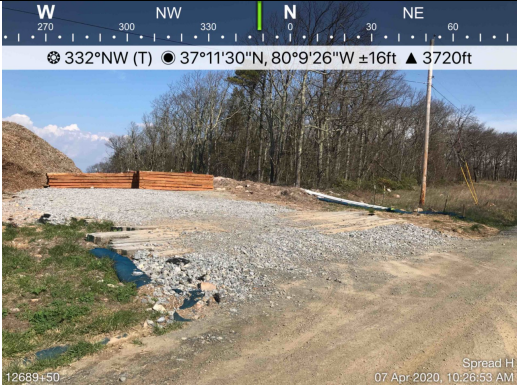
GPS Location	See photo		GPS Location	See photo	
Field Station#	12690+00		Field Station#	12689+50	
Pic 11 Desc.	SF fence controls in acceptable condition.		Pic 12 Desc.	Rock CE and Timber matting in acceptable condition.

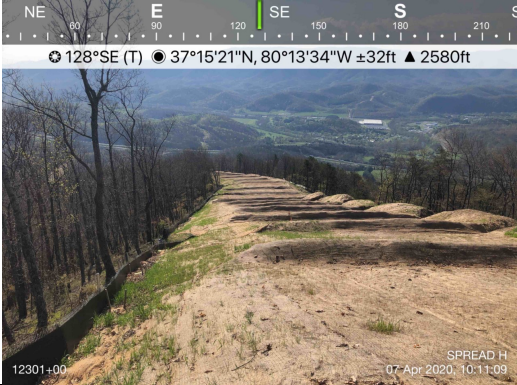
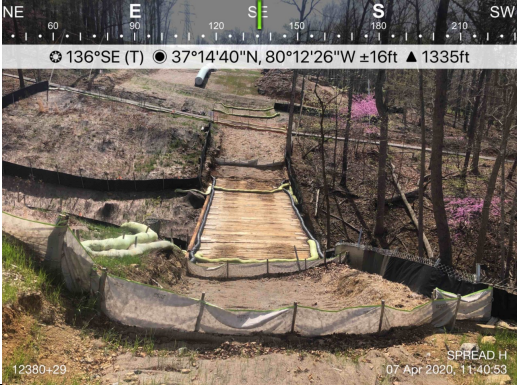
GPS Location	see photo		GPS Location	see photo	
Field Station#	12301+00		Field Station#	12380+20	
Pic 7 Desc.	Slope leading to I-81 in good condition with controls in place.		Pic 8 Desc.	Controls in place and functioning at this stream crossing.

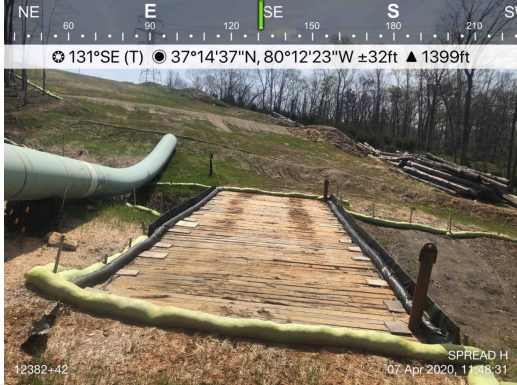
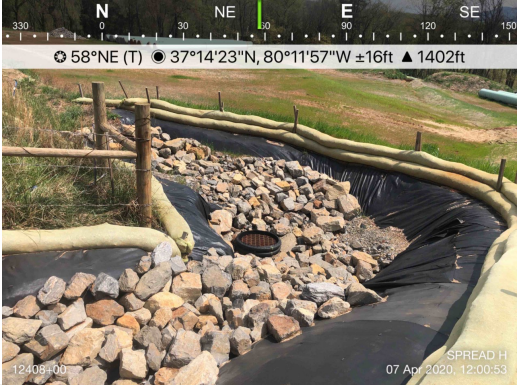
GPS Location	see photo		GPS Location	see photo	
Field Station#	12382+42		Field Station#	12408+00	
Pic 9 Desc.	Equipment bridge in good condition at drainage crossing.		Pic 10 Desc.	CWD functioning at MLV-027.

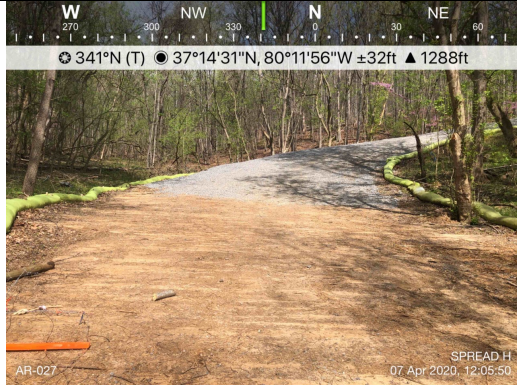
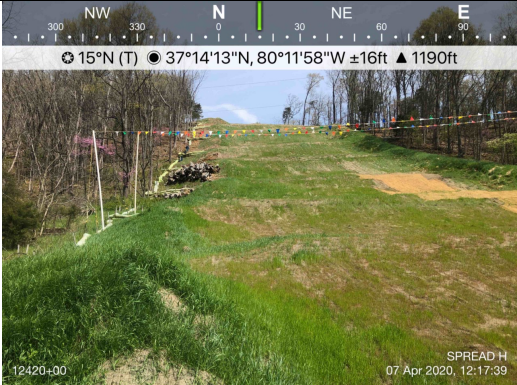
GPS Location	see photo		GPS Location	see photo	
Field Station#	0+27		Field Station#	12420+00	
Pic 11 Desc.	AR-027 in good condition.		Pic 12 Desc.	Slope on the CIS of the railroad tracks in good condition.

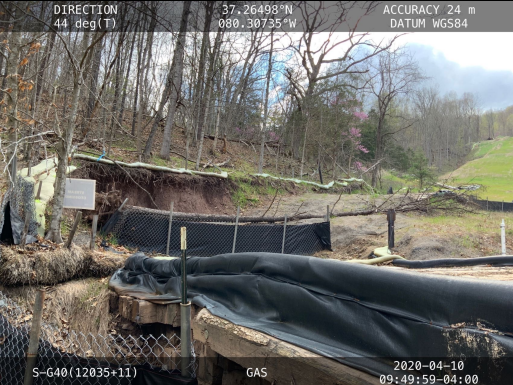
<p>DIRECTION 44 deg(T) 37.26498°N 080.30735°W ACCURACY 24 m DATUM WGS84</p> <p>S-G40(12035+11) GAS 2020-04-10 09:49:59-04:00</p>			
GPS Location	See photo GPS for location		GPS Location	See photo GPS for location	
Field Station#	12013+97		Field Station#	12035+11	
Pic 1 Desc.	Stream is free of turbidity.		Pic 2 Desc.	ECDs surrounding this stream are functioning adequately at this time.

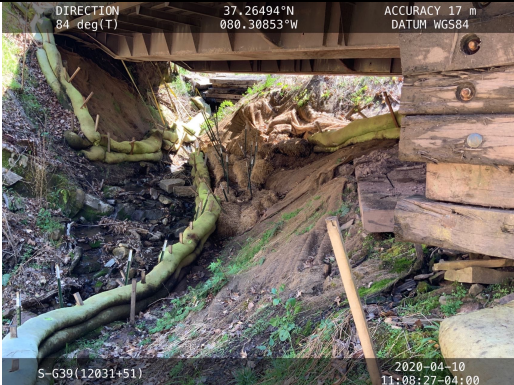
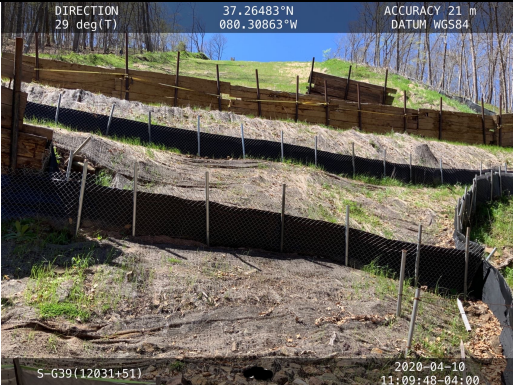
Field Station#	12031+51		Field Station#	12031+51	
Pic 3 Desc.	ECDs surrounding this stream are functioning adequately at this time.		Pic 4 Desc.	ECDs on the CIS of this stream are functioning adequately at this time.

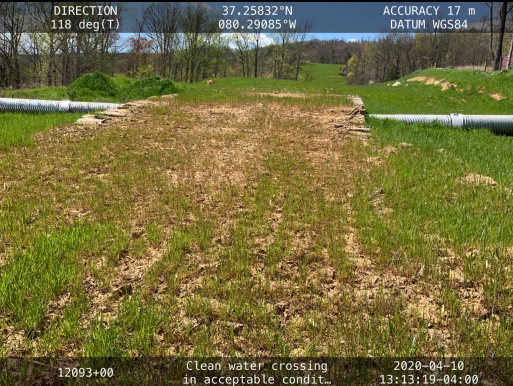
<p>DIRECTION 118 deg(T) 37.25832°N 080.29085°W ACCURACY 17 m DATUM WGS84</p> <p>12093+00 Clean water crossing in acceptable condit... 2020-04-10 13:13:19-04:00</p>			
GPS Location	See photo GPS for location		GPS Location	See photo GPS for location	
Field Station#	12031+51		Field Station#	12093+00	
Pic 5 Desc.	ECDs surrounding this stream are functioning adequately at this time.		Pic 6 Desc.	Clean water crossing is in acceptable condition.

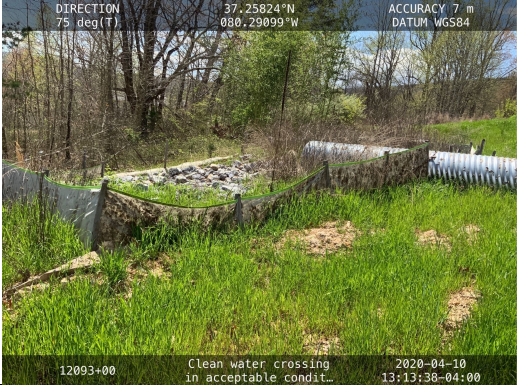
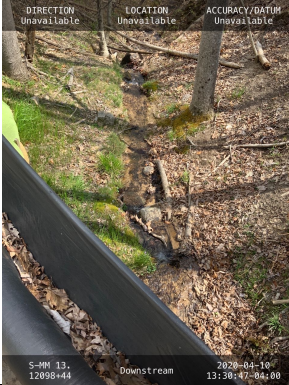
GPS Location	See photo GPS for location	GPS Location	See photo GPS for location		
Field Station#	12093+00	Field Station#	12098+44		
Pic 7 Desc.	Clean water crossing is in acceptable condition.	Pic 8 Desc.	Stream is free of turbidity.

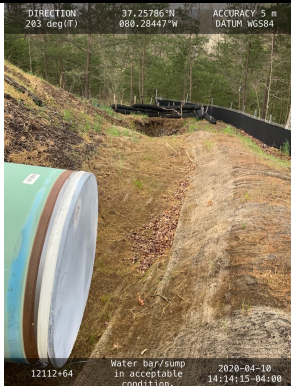
GPS Location	See photo GPS for location	GPS Location			
Field Station#	12112+64	Field Station#			
Pic 9 Desc.	Water bar and sump are in acceptable condition and functioning properly.	Pic 10 Desc.

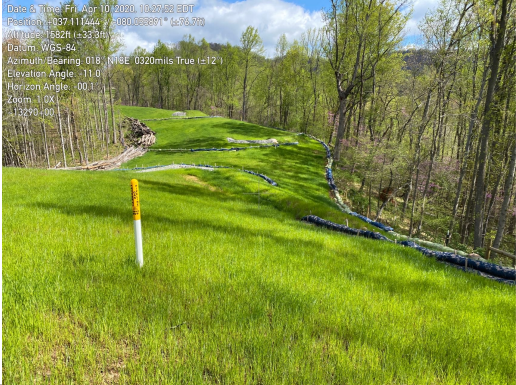
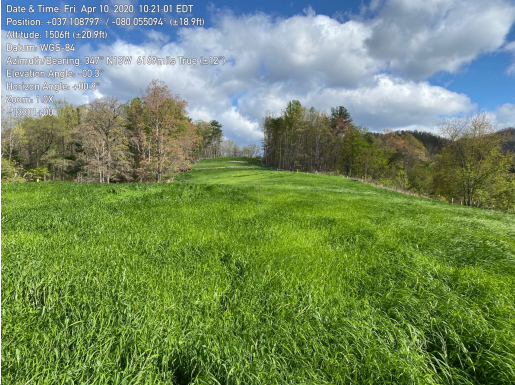
GPS Location	See photo for coordinates.		GPS Location	See photo for coordinates.	
Field Station#	13290+00		Field Station#	13300+00	
Pic 3 Desc.	ROW restored with good vegetative cover, permanent waterbars stable, ECDs functioning acceptably.		Pic 4 Desc.	ROW restored with good vegetative cover, ECDs functioning acceptably.
