Visual Site Inspection Report

Project Name	H-600 Pipeline Spread I	AFE	124300139	Spread	H-600 Pipeline Spread I
Contractor	Precision			Report #	10855
Inspector	Charles Head			Date/Time	5/14/2020 2:34 PM
Permit #	TBD	Inspection Type	VA SWPP	Station Begin	13784+35
State	VA	Inspection Area	Partial	Station End	14171+36
County	Franklin	Ground	Dry	Temperature (°F)	72.00
Municipality	N/A	Weather	Sunny	Rain Gauge (in)	0.00
				Rain Accumulation Time (days)	6.00

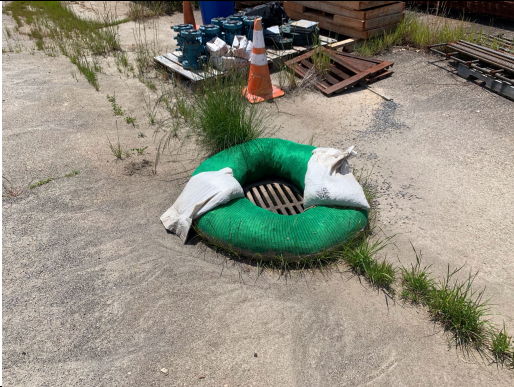
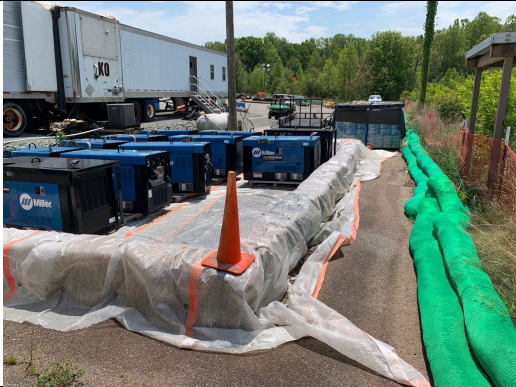
GPS Location 000000000000		GPS Location 000000000000			
Field Station# 0000+00		Field Station# 0000+00			
Pic 1 Desc. Inlet protection for parking lot drains in good condition		Pic 2 Desc. Secondary containment structure near storage building in acceptable condition

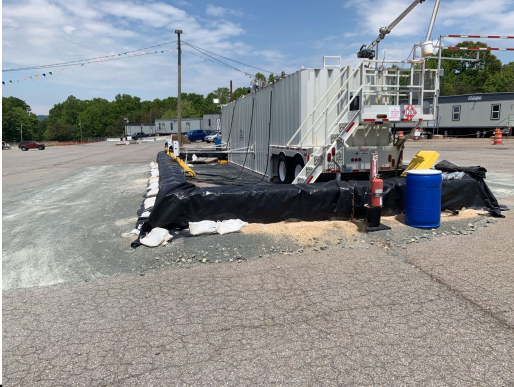
GPS Location 000000000000		GPS Location 000000000000			
Field Station# 0000+00		Field Station# 0000+00			
Pic 3 Desc. Secondary containment structure for fuel cell in compliance		Pic 4 Desc. RCE at gravel yard in acceptable condition			
 		Insert image here			
GPS Location 000000000000		GPS Location			
Field Station# 0000+00		Field Station#			
Pic 5 Desc. Perimeter ECD's on west side of gravel yard in good condition.		Pic 6 Desc.

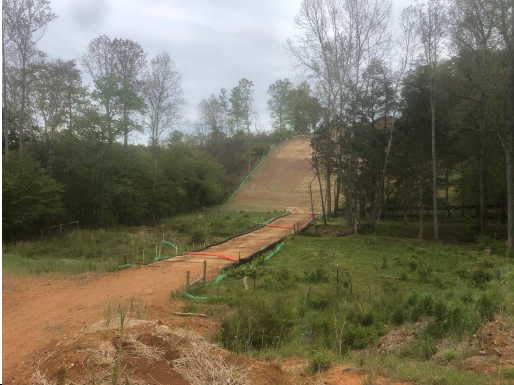
GPS Location	1	GPS Location	2		
Field Station#	15168+49	Field Station#	15175+00		
Pic 1 Desc.	Equipment bridge and surrounding ECD's functional and in good condition at S-C7.	Pic 2 Desc.	Permanent vegetation area between Rock Creek Rd and Star Land Dr.

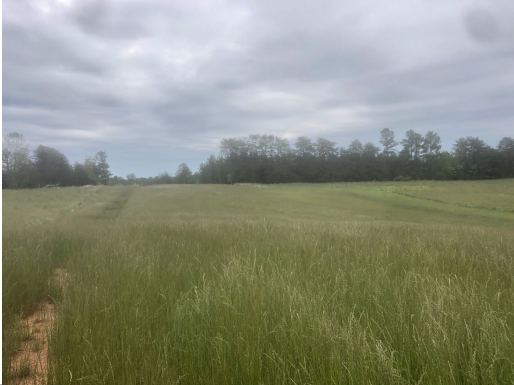
GPS Location	3	GPS Location	4		
Field Station#	15190+00	Field Station#	15222+00		
Pic 3 Desc.	Permanent vegetation area CIS Star Land Dr.	Pic 4 Desc.	Permanent vegetation area GAS Grassland Dr. All ECD's in place and functional.

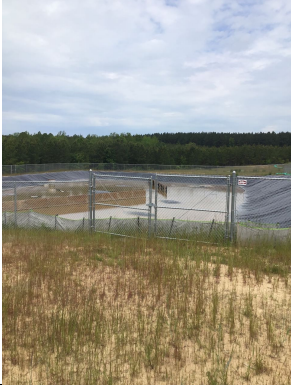
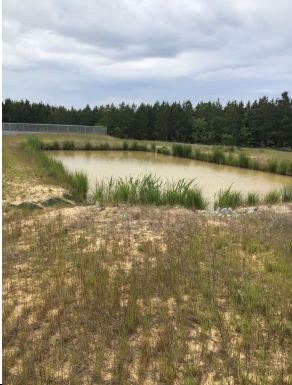
GPS Location	O	GPS Location	O		
Field Station#	00+00	Field Station#	00+00		
Pic 1 Desc.	Observing storm water pond at Transco.	Pic 2 Desc.	Observing sediment basin.
