# Visual Site Inspection Report

<b>Project Name</b>	H-600 Pipeline Spread I	<b>AFE</b>	124300139	<b>Spread</b>	H-600 Pipeline Spread I
<b>Contractor</b>	Precision	<b>Report #</b>	7162		
<b>Inspector</b>	Logan Box	<b>Date/Time</b>	1/7/2020 4:24 PM		
<b>Permit #</b>	TBD	<b>Inspection Type</b>	VA SWPP	<b>Station Begin</b>	13670+00
<b>State</b>	VA	<b>Inspection Area</b>	Partial	<b>Station End</b>	13784+35
<b>County</b>	Franklin	<b>Ground</b>	Wet	<b>Temperature (°F)</b>	32.00
<b>Municipality</b>	N/A	<b>Weather</b>	Snow/Sleet	<b>Rain Gauge (in)</b>	0.00
				<b>Rain Accumulation Time (days)</b>	0.00

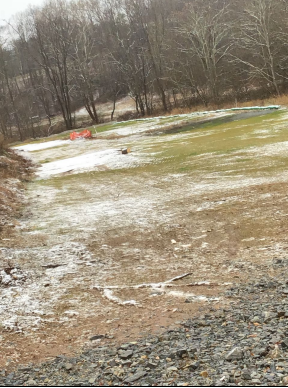
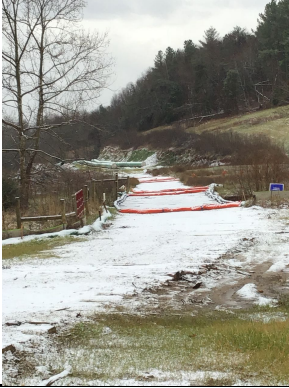
<b>GPS Location</b>	00000	<b>GPS Location</b>	0000		
<b>Field Station#</b>	13750+00	<b>Field Station#</b>	13692+61		
<b>Pic 1 Desc.</b>	Row photo during sleet/snow events	<b>Pic 2 Desc.</b>	Row photo during sleet/snow events

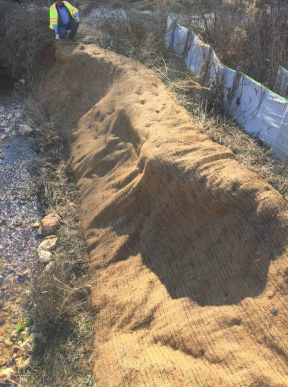
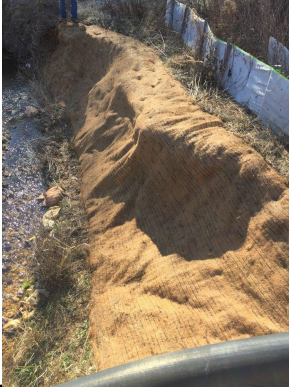
<b>GPS Location</b>	00000	<b>GPS Location</b>	0000		
<b>Field Station#</b>	13678+71	<b>Field Station#</b>	13678+71		
<b>Pic 3 Desc.</b>	Contractor installed new Erosion blanket to the banks of stream to repair old weathered blanket	<b>Pic 4 Desc.</b>	Contractor installed new Erosion blanket to the banks of stream to repair old weathered blanket		
Insert image here			Insert image here		
<b>GPS Location</b>		<b>GPS Location</b>			
<b>Field Station#</b>		<b>Field Station#</b>			
<b>Pic 5 Desc.</b>		<b>Pic 6 Desc.</b>

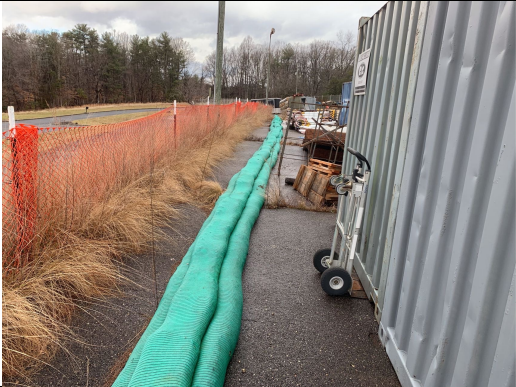
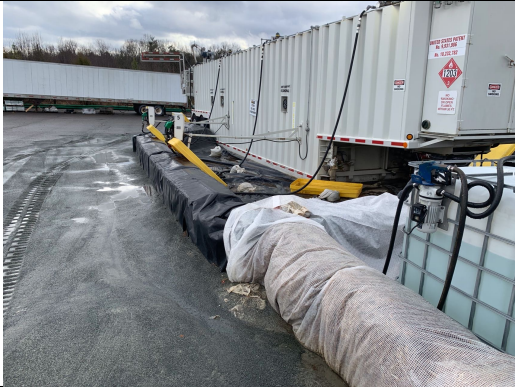
<b>GPS Location</b>	0000000000	<b>GPS Location</b>	0000000000		
<b>Field Station#</b>	0000+00	<b>Field Station#</b>	0000+00		
<b>Pic 1 Desc.</b>	Perimeter ECD's on west side of paved yard in good condition	<b>Pic 2 Desc.</b>	Secondary containment structure for fuel cell in compliance

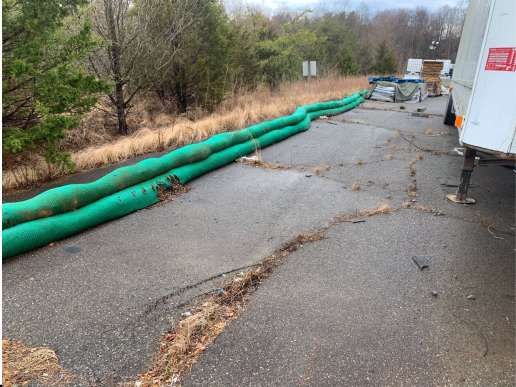
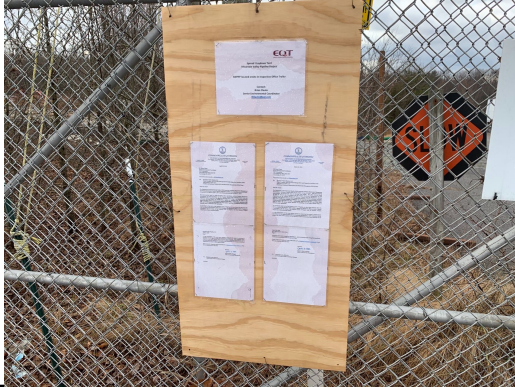
<b>GPS Location</b>	0000000000	<b>GPS Location</b>	0000000000		
<b>Field Station#</b>	0000+00	<b>Field Station#</b>	0000+00		
<b>Pic 3 Desc.</b>	Perimeter ECD's need maintenance hole in CFS needs repaired on south end of paved yard.	<b>Pic 4 Desc.</b>	General Construction permits posted t main entrance of the paved yard.

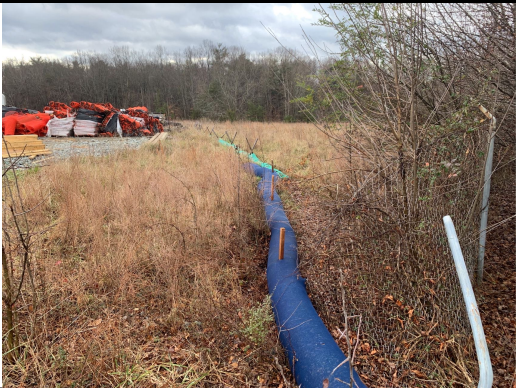
Insert image here			
<b>GPS Location</b>	0000000000	<b>GPS Location</b>			
<b>Field Station#</b>	0000+00	<b>Field Station#</b>			
<b>Pic 5 Desc.</b>	Perimeter ECD's in good condition on north end of gravel yard.	<b>Pic 6 Desc.</b>

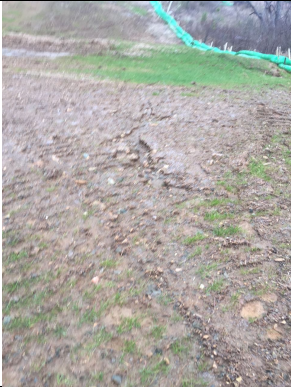
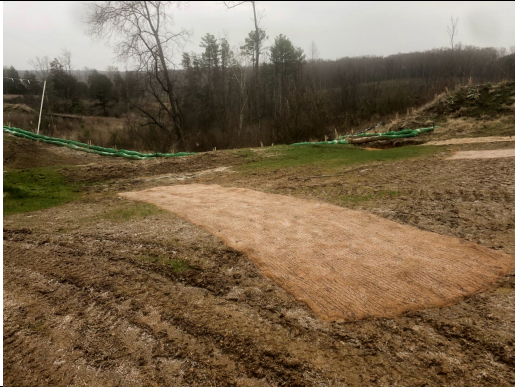
<b>GPS Location</b>	1	<b>GPS Location</b>	2		
<b>Field Station#</b>	14997+00	<b>Field Station#</b>	14997+00		
<b>Pic 1 Desc.</b>	Rill erosion occurring down ROW	<b>Pic 2 Desc.</b>	Contractor repaired rill erosion and installed Curlex to help curb future erosion

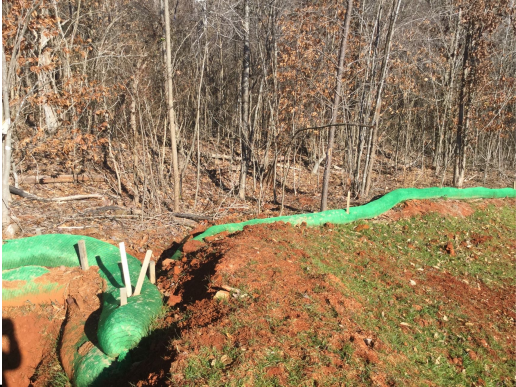
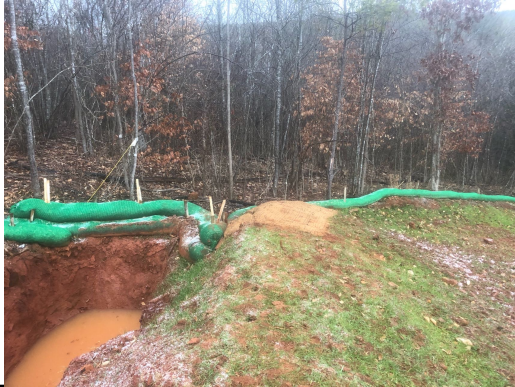
<b>GPS Location</b>	3	<b>GPS Location</b>	4		
<b>Field Station#</b>	15023+00	<b>Field Station#</b>	15023+00		
<b>Pic 3 Desc.</b>	Water bar eroding around end treatment and sediment overtopping perimeter CFS	<b>Pic 4 Desc.</b>	Ent treatment reset, Curlex installed, and sediment moved away from perimeter CFS

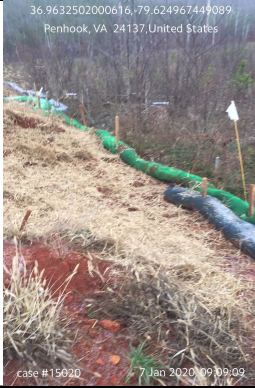
<b>GPS Location</b>	5	<b>GPS Location</b>	6		
<b>Field Station#</b>	15020+75	<b>Field Station#</b>	15020+75		
<b>Pic 5 Desc.</b>	Perimeter CFS missing	<b>Pic 6 Desc.</b>	Contractor installed new section of perimeter CFS and stabilized surrounding area

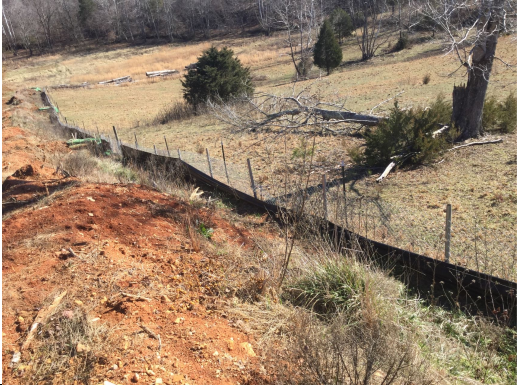
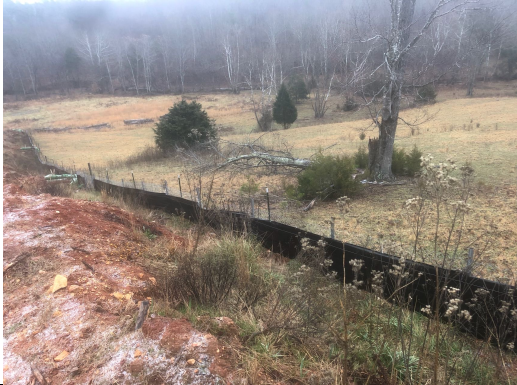
<b>GPS Location</b>	7	<b>GPS Location</b>	8		
<b>Field Station#</b>	15038+00	<b>Field Station#</b>	15038+00		
<b>Pic 7 Desc.</b>	SSF fabric separated from chain link fence and lying on ground		<b>Pic 8 Desc.</b>	Contractor repaired damage to SSF	
Insert image here			Insert image here		
<b>GPS Location</b>		<b>GPS Location</b>			
<b>Field Station#</b>		<b>Field Station#</b>			
<b>Pic 9 Desc.</b>			<b>Pic 10 Desc.</b>		
Insert image here			Insert image here		
<b>GPS Location</b>		<b>GPS Location</b>			
<b>Field Station#</b>		<b>Field Station#</b>			
<b>Pic 11 Desc.</b>			<b>Pic 12 Desc.</b>

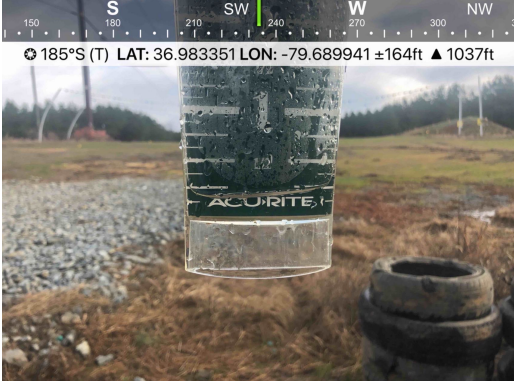
<b>GPS Location</b>	0	<b>GPS Location</b>	0		
<b>Field Station#</b>	14311+57	<b>Field Station#</b>	14758+16		
<b>Pic 1 Desc.</b>	Rain gauge at Indian Cave Road 0.25"	<b>Pic 2 Desc.</b>	Rain gauge at Farm View Road 0.35"

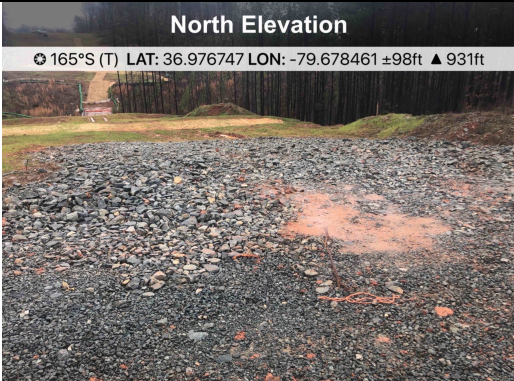
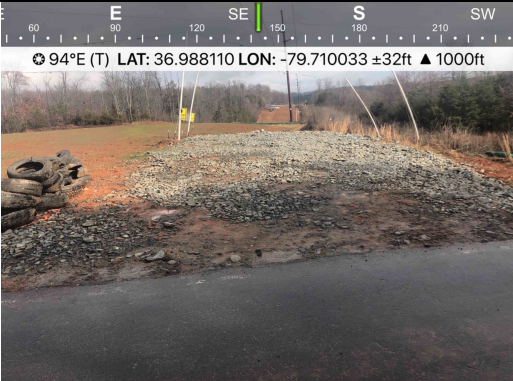
<b>GPS Location</b>	0	<b>GPS Location</b>	0		
<b>Field Station#</b>	14802+19	<b>Field Station#</b>	14694+77		
<b>Pic 3 Desc.</b>	RCE clean at access road MVP-FR-323	<b>Pic 4 Desc.</b>	RCE clean at Jacks Creek Road

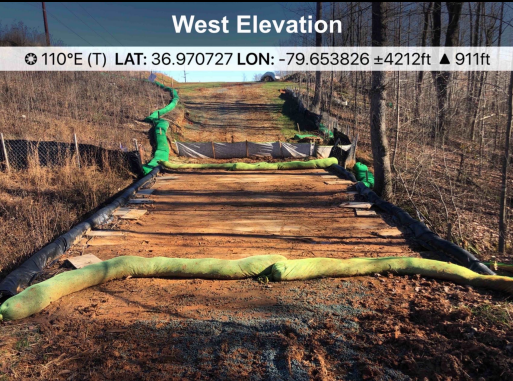
<b>GPS Location</b>	0	<b>GPS Location</b>	0		
<b>Field Station#</b>	14870+43	<b>Field Station#</b>	4881+54		
<b>Pic 5 Desc.</b>	Equipment bridge clean at steam S-SS8	<b>Pic 6 Desc.</b>	Equipment bridge clean at stream S-CD8
