Visual Site Inspection Report

Project Name	H-600 Pipeline Spread I	AFE	124300139	Spread	H-600 Pipeline Spread I
Contractor	Precision			Report #	6259
Inspector	Ben Davenport			Date/Time	12/2/2019 5:00 PM
Permit #	TBD	Inspection Type	VA SWPP	Station Begin	14694+77
State	VA	Inspection Area	Partial	Station End	15142+66
County	Franklin/Pittsylvania	Ground	Muddy	Temperature (°F)	45.00
Municipality	Chatham	Weather	Cloudy	Rain Gauge (in)	1.70
				Rain Accumulation Time (days)	4.00

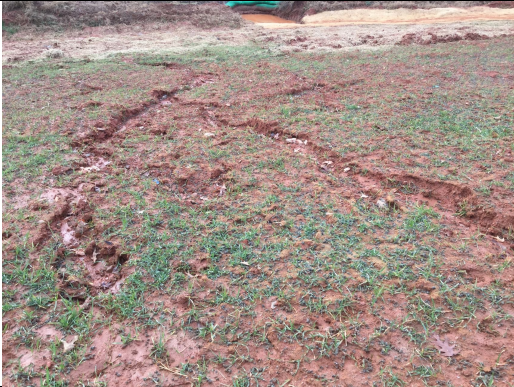
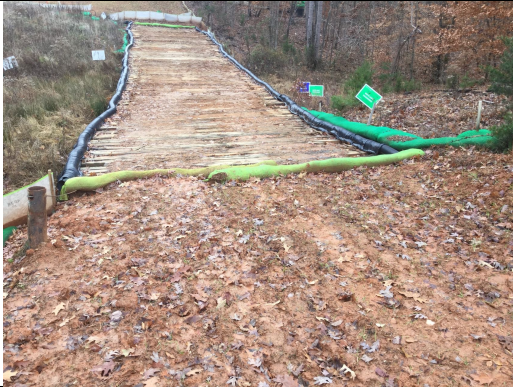
GPS Location	1	GPS Location	2		
Field Station#	14697+50	Field Station#	14716+50		
Pic 1 Desc.	Erosion channel forming down ROW and requires maintenance		Pic 2 Desc.	Maintenance required on bridge wattles (more than half full of sediment)

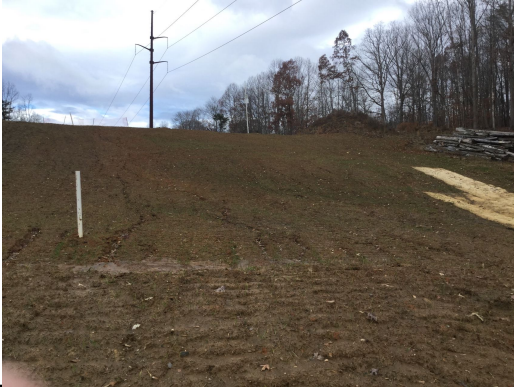
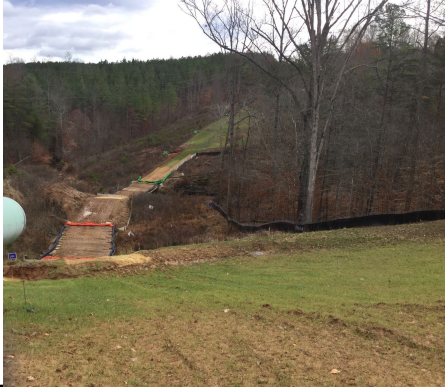
GPS Location	3	GPS Location	4		
Field Station#	14722+00	Field Station#	14726+00		
Pic 3 Desc.	Slope needs reseeded and stabilized		Pic 4 Desc.	View of vegetation growing along ROW with ECD's in place and functional

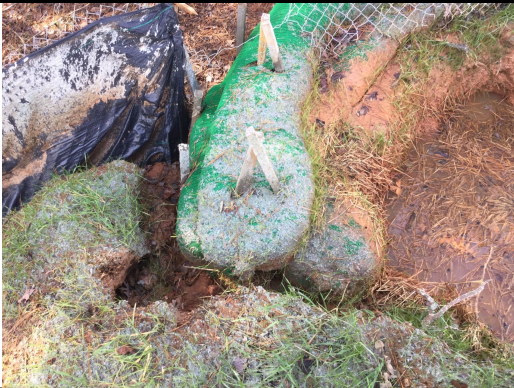
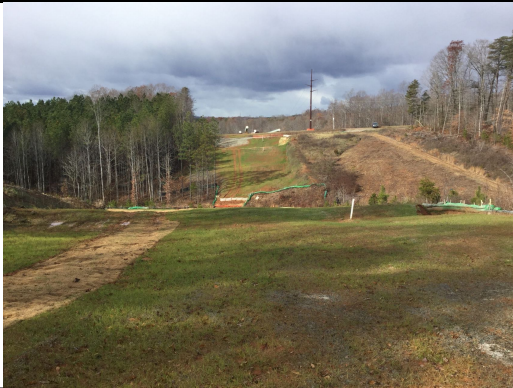
GPS Location	5	GPS Location	6		
Field Station#	14803+00	Field Station#	14809+00		
Pic 5 Desc.	Water/sediment eroding around end treatment and undermining SSF		Pic 6 Desc.	View of vegetation growing along ROW with ECD's in place and functional

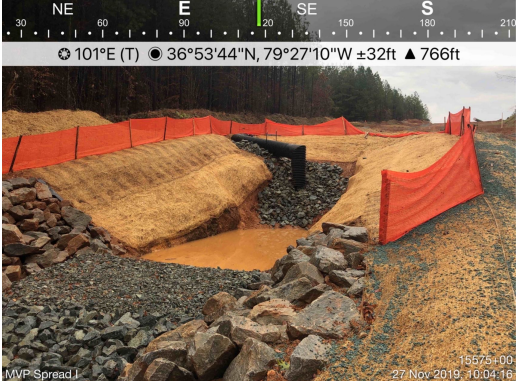
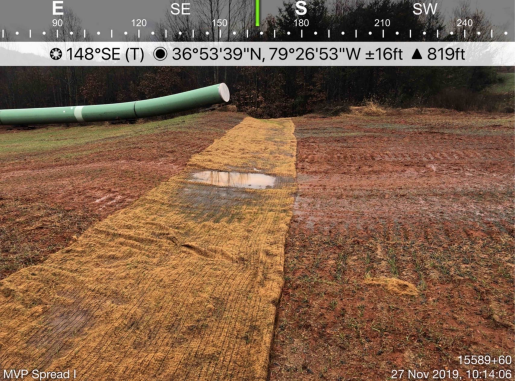
GPS Location	0	GPS Location	0		
Field Station#	15575+00	Field Station#	15589+60		
Pic 1 Desc.	Rock filter is acceptable	Pic 2 Desc.	Erosion control blanket is acceptable

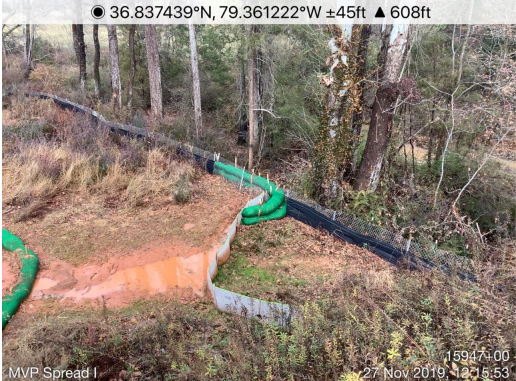
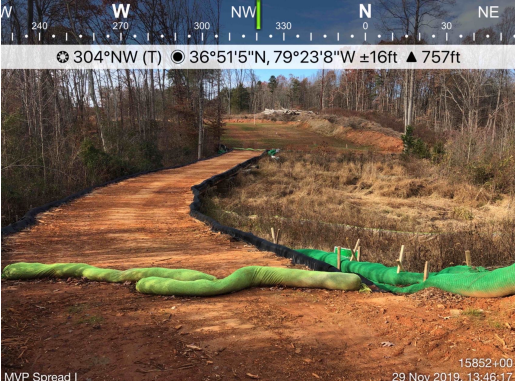
GPS Location	0	GPS Location	0		
Field Station#	15947+00	Field Station#	15852+00		
Pic 3 Desc.	P1 silt fence is acceptable	Pic 4 Desc.	Equipment bridge is acceptable

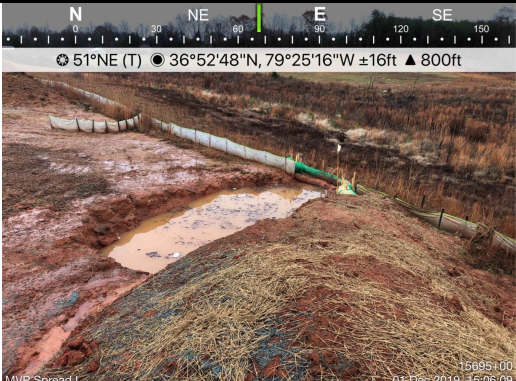
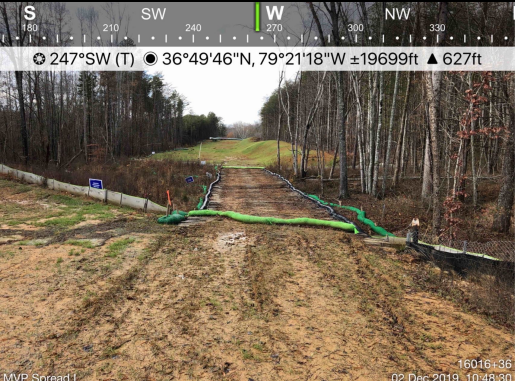
GPS Location	0	GPS Location	0		
Field Station#	15695+00	Field Station#	16016+36		
Pic 5 Desc.	Waterbar end treatment is acceptable	Pic 6 Desc.	Equipment bridge is acceptable

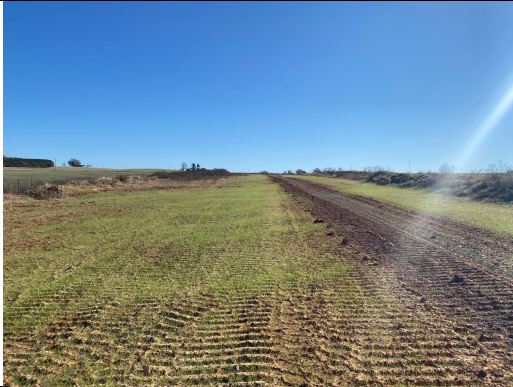
GPS Location	0	GPS Location	0		
Field Station#	15363+50	Field Station#	15505+00		
Pic 1 Desc.	Curlex installed to alleviate erosion issues.	Pic 2 Desc.	Travel lane stabilized behind maintenance process. Good vegetation growing along ROW.

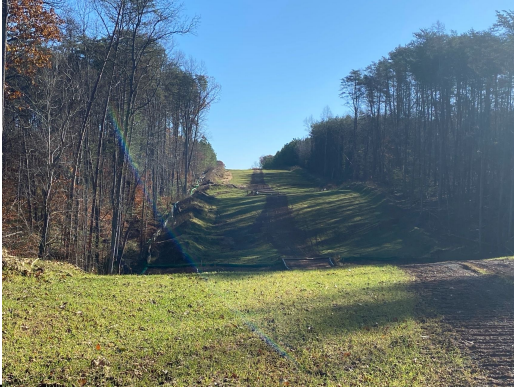
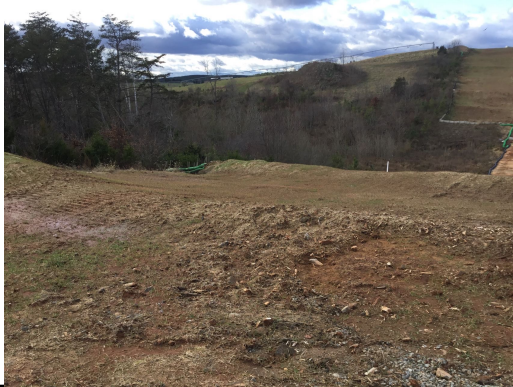
GPS Location	0	GPS Location	0		
Field Station#	15390+00	Field Station#	15350+00		
Pic 3 Desc.	Travel lane stabilized behind maintenance process. Good vegetation growing along ROW.	Pic 4 Desc.	Temporary vegetation beginning to die off due to poor soil conditions. No soil amendments were applied during seeding process.		
Insert image here		Insert image here			
GPS Location		GPS Location			
Field Station#		Field Station#			
Pic 5 Desc.		Pic 6 Desc.

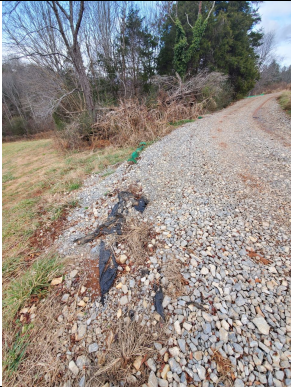
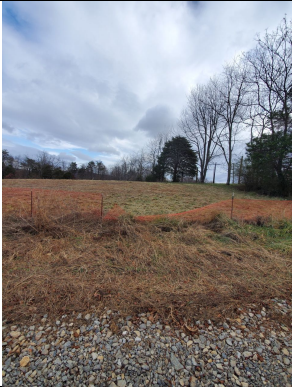
GPS Location	00000	GPS Location	0000		
Field Station#	13784+35	Field Station#	13784+35		
Pic 1 Desc.	CFS and geo tech on edge of access rd , added to the punch list to be removed	Pic 2 Desc.	Safety fence damaged from land owner mowing

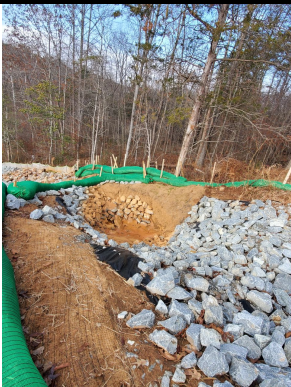
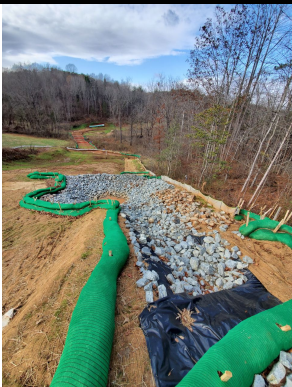
GPS Location	00000	GPS Location	0000		
Field Station#	13782+33	Field Station#	13782+33		
Pic 3 Desc.	Functioning sump pit at the Brick Church access rd, added to the punch list	Pic 4 Desc.	Photo showing functioning sump pit and rock lined channel at the Brick Church access rd		
Insert image here			Insert image here		
GPS Location		GPS Location			
Field Station#		Field Station#			
Pic 5 Desc.		Pic 6 Desc.

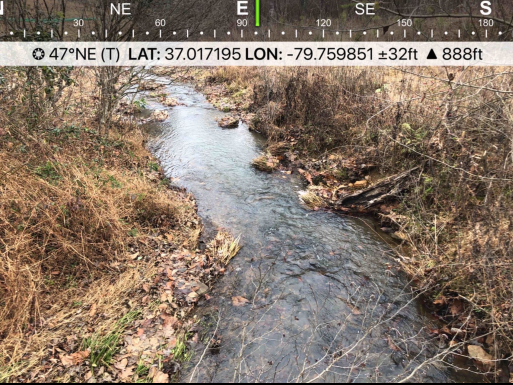
GPS Location	0	GPS Location	0		
Field Station#	14476+00	Field Station#	14496+58		
Pic 5 Desc.	Temporary stabilization	Pic 6 Desc.	Downstream side of stream S-G20

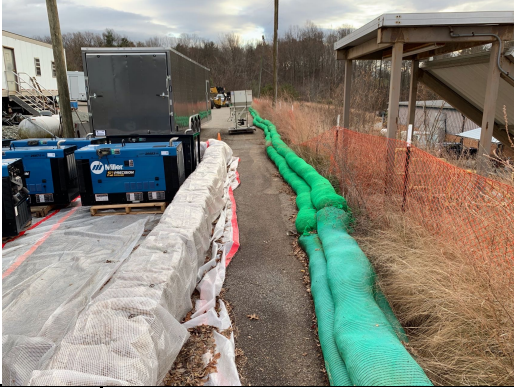
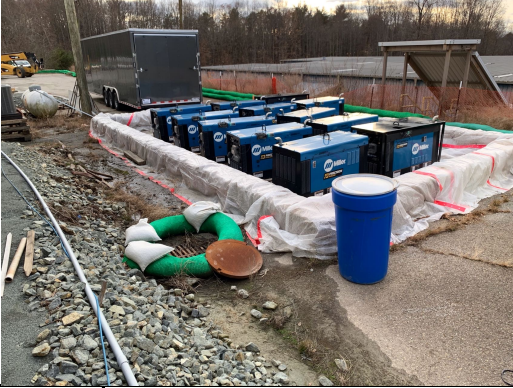
GPS Location 0000000000		GPS Location 0000000000			
Field Station# 0000+00		Field Station# 0000+00			
Pic 1 Desc. Perimeter ECD's in good condition on west side of paved yard		Pic 2 Desc. Secondary containment structure and inlet protection for parking lot drain near storage building in acceptable condition.

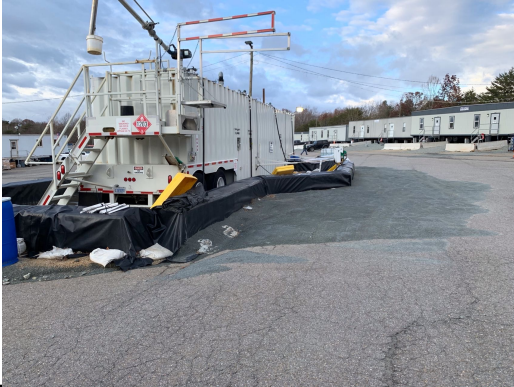
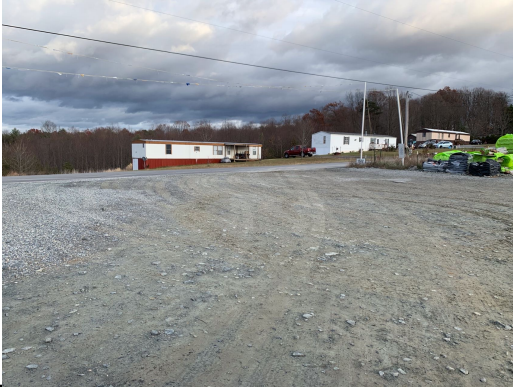
GPS Location 0000000000		GPS Location 0000000000			
Field Station# 0000+00		Field Station# 0000+00			
Pic 3 Desc. Secondary containment structure for fuel cell in compliance		Pic 4 Desc. RCE at gravel yard in good condition.			
Insert image here		Insert image here			
GPS Location		GPS Location			
Field Station#		Field Station#			
Pic 5 Desc.		Pic 6 Desc.

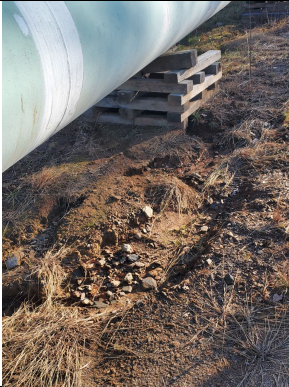
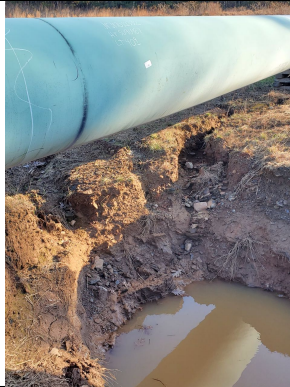
GPS Location	00000	GPS Location	00000		
Field Station#	13710+00	Field Station#	13710+00		
Pic 1 Desc.	Erosion under pipe , could cause skids to wash out, sent in for punch list		Pic 2 Desc.	Erosion under pipe at sump pit

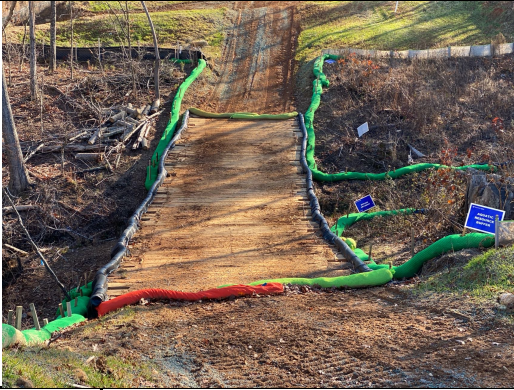
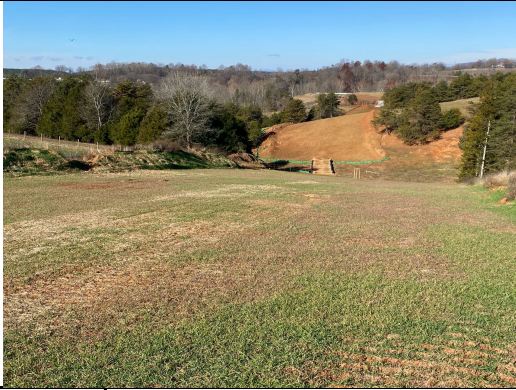
GPS Location	0	GPS Location	0		
Field Station#	15562+68	Field Station#	15335+00		
Pic 1 Desc.	All ECDs at stream crossing S-CC10 are in good working condition.		Pic 2 Desc.	Temporary vegetation growing well along stabilized ROW.

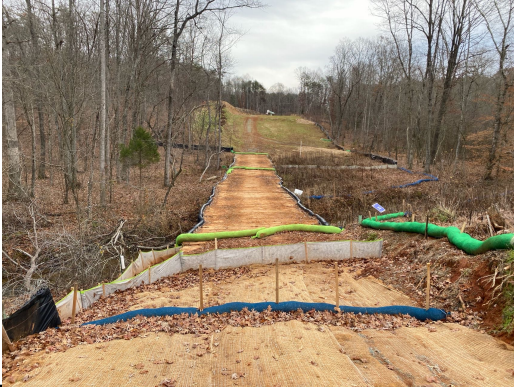
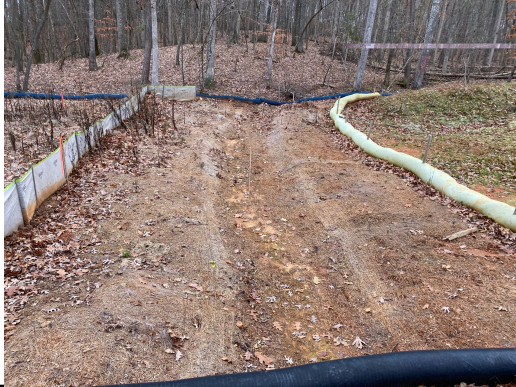
GPS Location	0	GPS Location	0		
Field Station#	15425+00	Field Station#	15460+50		
Pic 3 Desc.	All ECDs at stream crossing S-G4 are in good working condition.		Pic 4 Desc.	CWD drainage feature in good working condition.	
Insert image here			Insert image here		
GPS Location		GPS Location			
Field Station#		Field Station#			
Pic 5 Desc.		Pic 6 Desc.

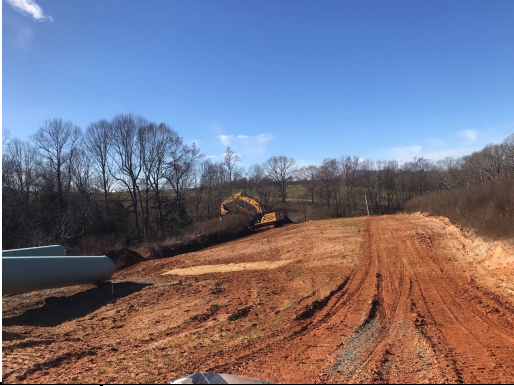
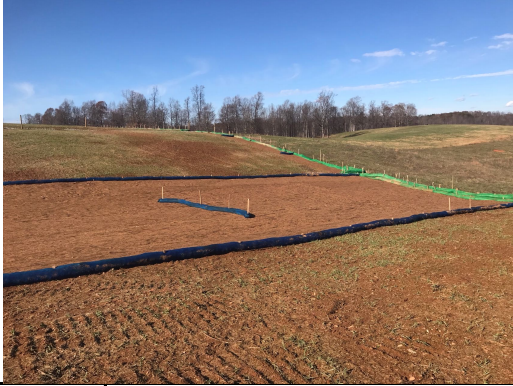
GPS Location	0	GPS Location	0		
Field Station#	14282+13	Field Station#	14274+00		
Pic 1 Desc.	Approximately 14282+13. Crews repairing erosion rills and digging sump per punch list.		Pic 2 Desc.	Approximately 14274+00. Erosion control blanket and CFS installed per red line.

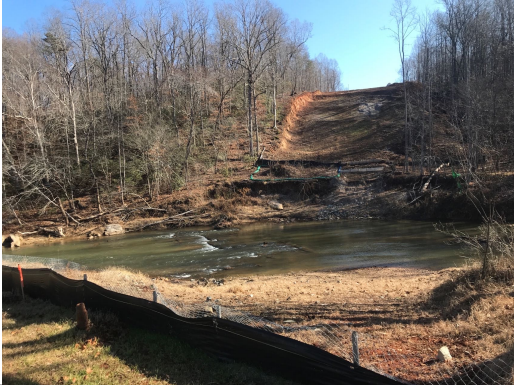
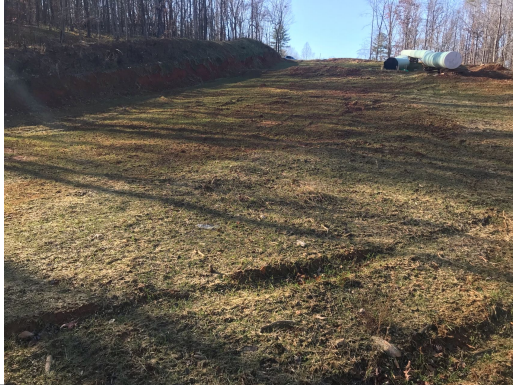
GPS Location	0	GPS Location	0		
Field Station#	14249+65	Field Station#	14225+00		
Pic 3 Desc.	Approximately 14249+65. Overview of stream crossing at stream S-F11.		Pic 4 Desc.	Approximately 14225+00. ROW temporarily seeded and stabilized in this area. Winter vegetation growing.	
Insert image here			Insert image here		
GPS Location		GPS Location			
Field Station#		Field Station#			
Pic 5 Desc.		Pic 6 Desc.

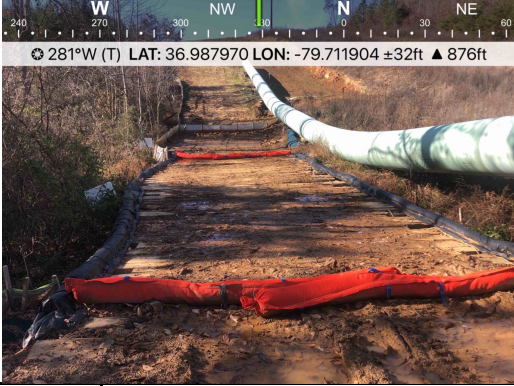
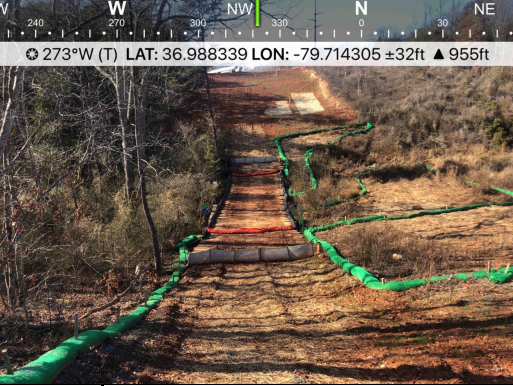
GPS Location	0	GPS Location	0		
Field Station#	14689+36	Field Station#	4680+37		
Pic 1 Desc.	Equipment bridge clean at stream S-H34	Pic 2 Desc.	Equipment bridge clean at stream S-H36

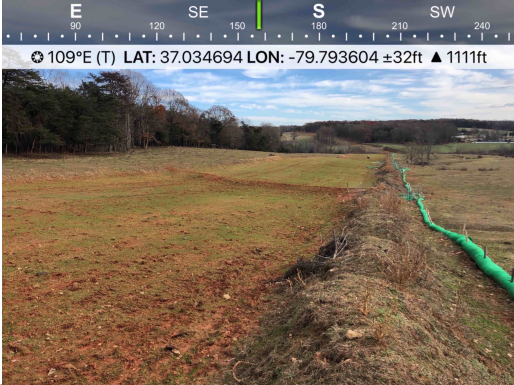
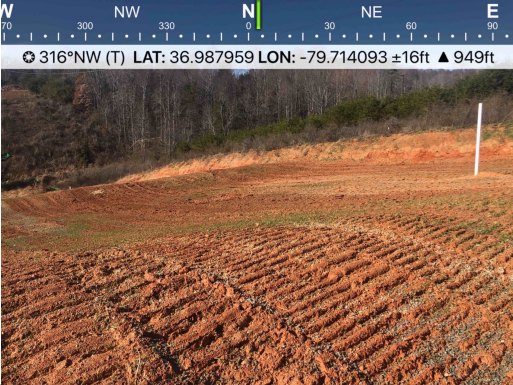
GPS Location	0	GPS Location	0		
Field Station#	14380+00	Field Station#	14685+00		
Pic 3 Desc.	Temporary stabilization on the GAS of Golden View Road	Pic 4 Desc.	Temporary stabilization on the CIS of Jacks Creek Road

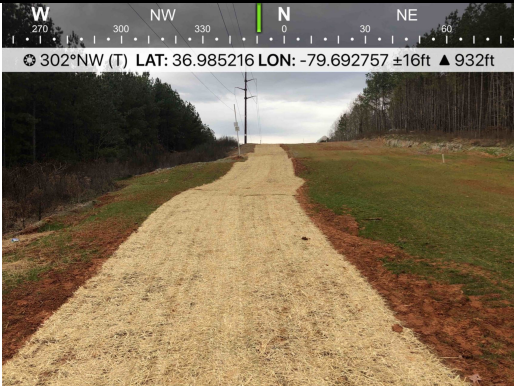
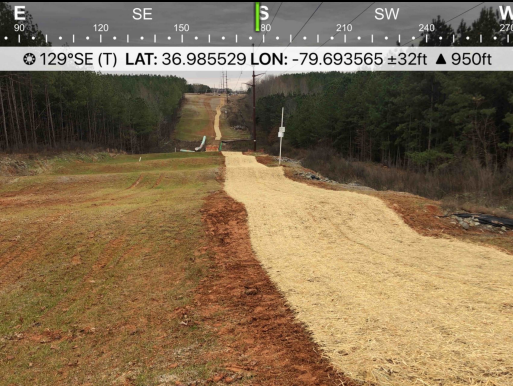
GPS Location	0	GPS Location	0		
Field Station#	14755+00	Field Station#	14740+00		
Pic 5 Desc.	Third party contractor seeding and stabilizing travel lane once work was completed	Pic 6 Desc.	Third party contractor seeding and stabilizing travel lane once work was completed
