# Visual Site Inspection Report

<b>Project Name</b>	H-600 Pipeline Spread I	<b>AFE</b>	124300139	<b>Spread</b>	H-600 Pipeline Spread I
<b>Contractor</b>	Precision			<b>Report #</b>	6886
<b>Inspector</b>	Justin Burch			<b>Date/Time</b>	12/24/2019 8:33 AM
<b>Permit #</b>	TBD	<b>Inspection Type</b>	VA SWPP	<b>Station Begin</b>	14928+52
<b>State</b>	VA	<b>Inspection Area</b>	Full	<b>Station End</b>	15296+00
<b>County</b>	Franklin	<b>Ground</b>	Damp	<b>Temperature (°F)</b>	60.00
<b>Municipality</b>	N/A	<b>Weather</b>	Sunny	<b>Rain Gauge (in)</b>	0.00
				<b>Rain Accumulation Time (days)</b>	6.00

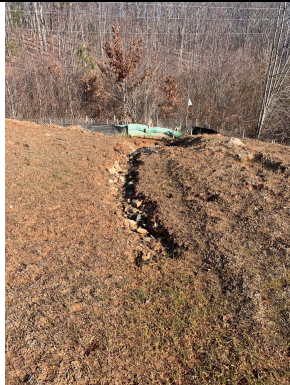
<b>GPS Location</b>	O	<b>GPS Location</b>	O		
<b>Field Station#</b>	15582+00	<b>Field Station#</b>	15582+50		
<b>Pic 1 Desc.</b>	Observing ECD's performing as they should.	<b>Pic 2 Desc.</b>	Observing ECD's performing as they should.

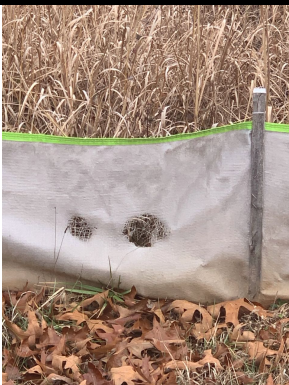
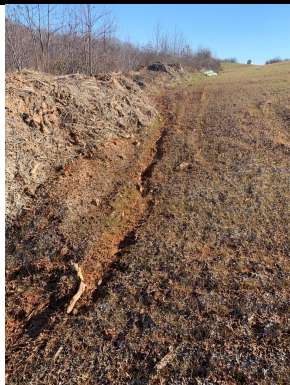
<b>GPS Location</b>	O	<b>GPS Location</b>	O		
<b>Field Station#</b>	15828+00	<b>Field Station#</b>	15877+00		
<b>Pic 3 Desc.</b>	Observing the Contractor performing ECD maintenance.	<b>Pic 4 Desc.</b>	Observing water bar that requires maintenance.

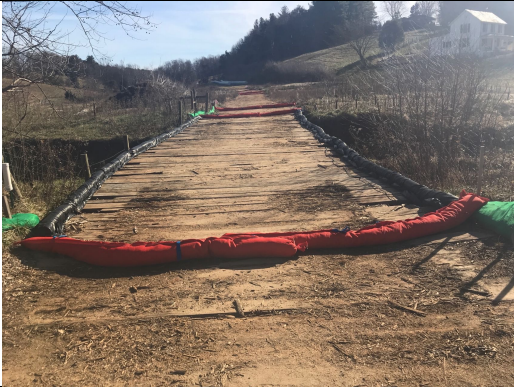
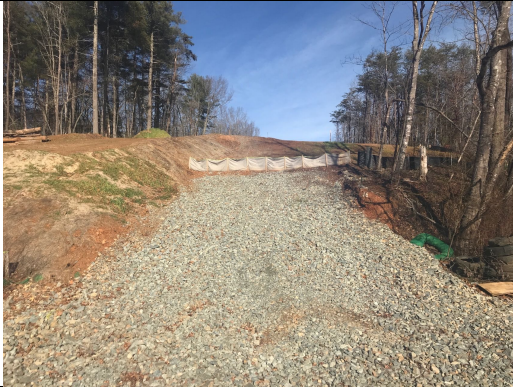
<b>GPS Location</b>	0	<b>GPS Location</b>	0		
<b>Field Station#</b>	13692+70	<b>Field Station#</b>	13748+00		
<b>Pic 1 Desc.</b>	Approximately 13692+70. Overview of stream crossing and equipment bridge at stream S-E28.		<b>Pic 2 Desc.</b>	Approximately 13748+00. REC installed and maintained.

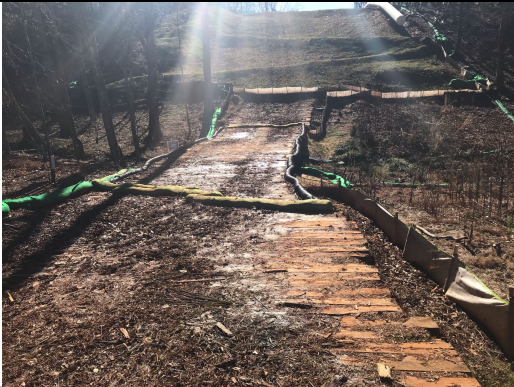
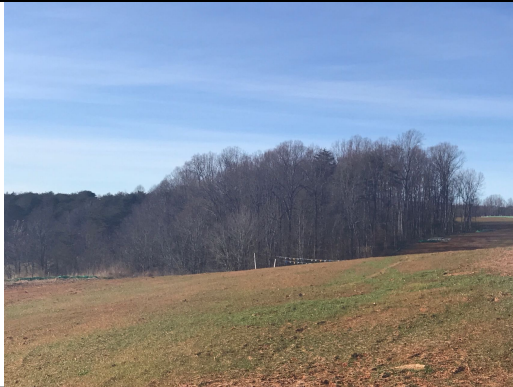
<b>GPS Location</b>	0	<b>GPS Location</b>	0		
<b>Field Station#</b>	14050+28	<b>Field Station#</b>	14130+00		
<b>Pic 3 Desc.</b>	Approximately 14050+28. Overview of stream crossing and equipment bridge at stream S-YZ4.		<b>Pic 4 Desc.</b>	Approximately 14130+00. ROW temporarily seeded and stabilized in this area. Winter vegetation growing.	
Insert image here			Insert image here		
<b>GPS Location</b>		<b>GPS Location</b>			
<b>Field Station#</b>		<b>Field Station#</b>			
<b>Pic 5 Desc.</b>		<b>Pic 6 Desc.</b>

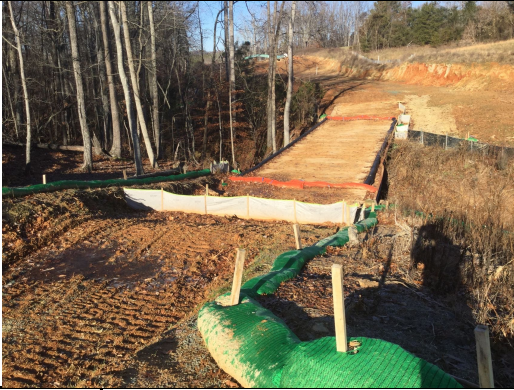
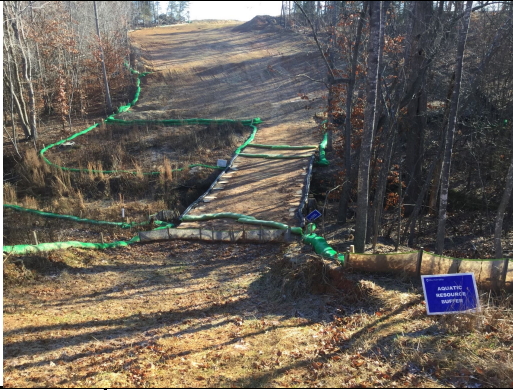
<b>GPS Location</b>	1	<b>GPS Location</b>	2		
<b>Field Station#</b>	15056+00	<b>Field Station#</b>	15072+86		
<b>Pic 1 Desc.</b>	P1 silt fence installed at base of hill to prevent sediment from going into stream	<b>Pic 2 Desc.</b>	Bridge crossing at S-G11 with all ECD's in place and functional

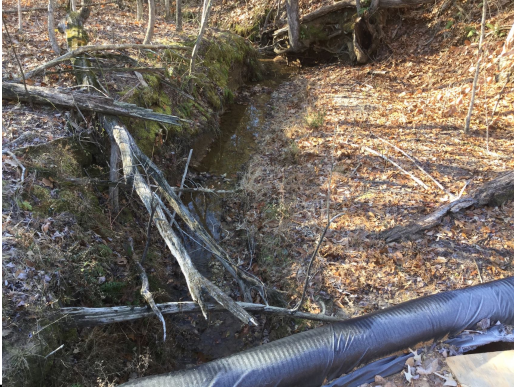
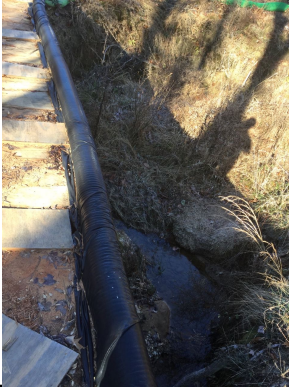
<b>GPS Location</b>	3	<b>GPS Location</b>	4		
<b>Field Station#</b>	15072+86	<b>Field Station#</b>	15072+86		
<b>Pic 3 Desc.</b>	Downstream view of S-G11	<b>Pic 4 Desc.</b>	Upstream view of S-G11		
Insert image here			Insert image here		
<b>GPS Location</b>		<b>GPS Location</b>			
<b>Field Station#</b>		<b>Field Station#</b>			
<b>Pic 5 Desc.</b>		<b>Pic 6 Desc.</b>

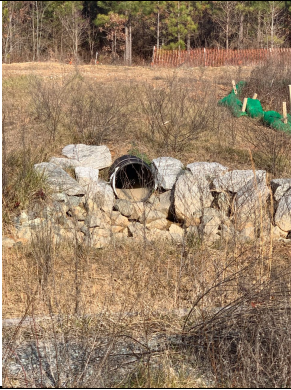
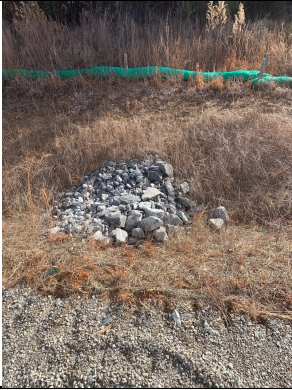
<b>GPS Location</b>	O	<b>GPS Location</b>	O		
<b>Field Station#</b>	00+00	<b>Field Station#</b>	00+00		
<b>Pic 1 Desc.</b>	Observing outlet and outlet protection.	<b>Pic 2 Desc.</b>	Observing rock check dam.

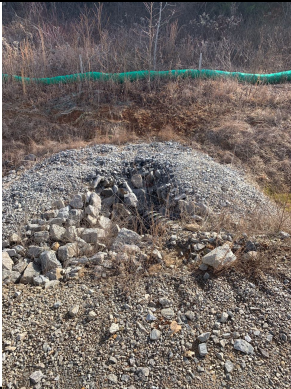
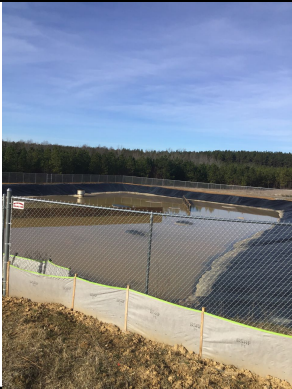
<b>GPS Location</b>	O	<b>GPS Location</b>	O		
<b>Field Station#</b>	00+00	<b>Field Station#</b>	00+00		
<b>Pic 3 Desc.</b>	Observing outlet and outlet protection.	<b>Pic 4 Desc.</b>	Observing storm water pond at Transco.		
Insert image here			Insert image here		
<b>GPS Location</b>		<b>GPS Location</b>			
<b>Field Station#</b>		<b>Field Station#</b>			
<b>Pic 5 Desc.</b>		<b>Pic 6 Desc.</b>
