Visual Site Inspection Report

Project Name	H-600 Pipeline Spread I	AFE	124300139	Spread	H-600 Pipeline Spread I	
Contractor	Precision			Report #	6967	
Inspector	Glenn Mike Renfro			Date/Time	12/31/2019 7:08 PM	
Permit #	TBD	Inspection Type	VA SWPP	Station Begin	0000+00	
State	VA	Inspection Area	Full	Station End	0000+00	
County	Franklin	Ground	Wet	Temperature (°F)	58.00	
Municipality	N/A	Weather	Light Rain	Rain Gauge (in)	0.40	
				Rain Accumulation Time (days)	6.00

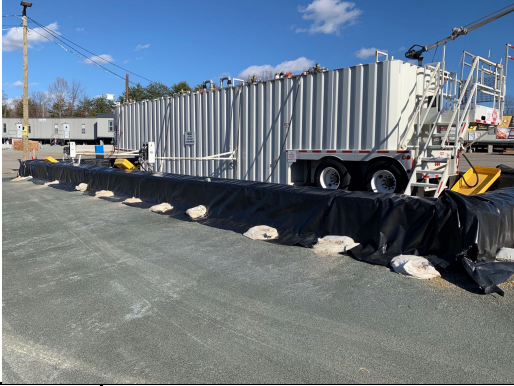
GPS Location	0000000000	GPS Location	0000000000		
Field Station#	0000+00	Field Station#	0000+00		
Pic 1 Desc.	Secondary containment structure for fuel cell in compliance	Pic 2 Desc.	Inlet protection for parking lot drain and perimeter ECD's at paved yard in good condition

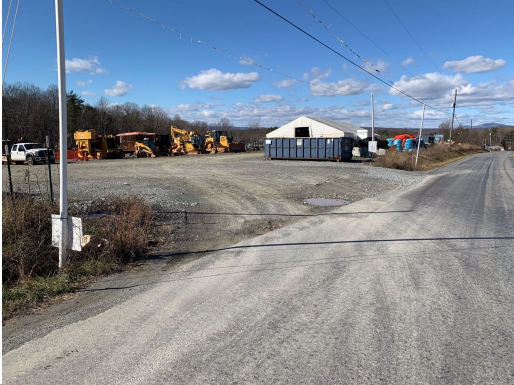
GPS Location	0000000000	GPS Location	0000000000		
Field Station#	0000+00	Field Station#	0000+00		
Pic 3 Desc.	RCE at gravel yard in good condition	Pic 4 Desc.	Perimeter ECD's on west side of gravel yard in good condition		
Insert image here		Insert image here			
GPS Location		GPS Location			
Field Station#		Field Station#			
Pic 5 Desc.		Pic 6 Desc.

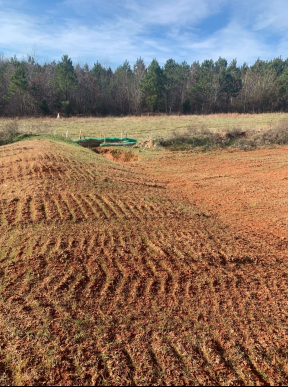
GPS Location	O	GPS Location	O		
Field Station#	15900+00	Field Station#	15880+00		
Pic 1 Desc.	Observing water bar performing as it should.	Pic 2 Desc.	Observing sump and end treatment.

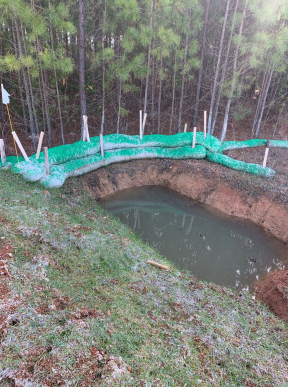
GPS Location	O	GPS Location	O		
Field Station#	15810+00	Field Station#	15780+00		
Pic 3 Desc.	Observing sump and end treatment.	Pic 4 Desc.	Observing water bar performing as it should.		
Insert image here			Insert image here		
GPS Location		GPS Location			
Field Station#		Field Station#			
Pic 5 Desc.		Pic 6 Desc.

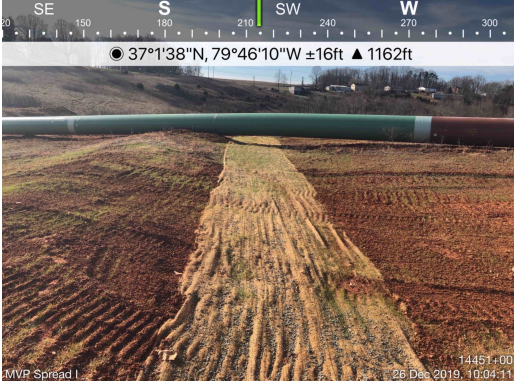
GPS Location	0	GPS Location	0		
Field Station#	14451+00	Field Station#	14447+00		
Pic 1 Desc.	Waterbar and ECB on the CIS of Webster Road	Pic 2 Desc.	Waterbar end treatment is acceptable

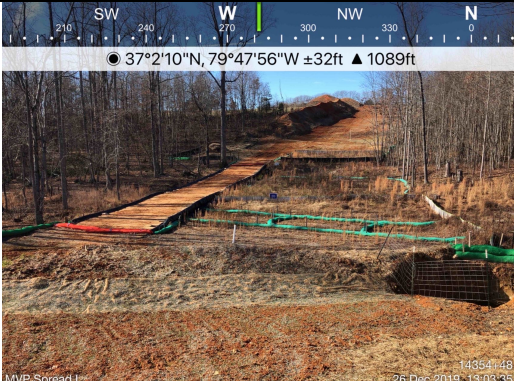
GPS Location	0	GPS Location	0		
Field Station#	14354+48	Field Station#	14532+00		
Pic 3 Desc.	Equipment bridge looking west	Pic 4 Desc.	Clean water diversion plunge pool is acceptable

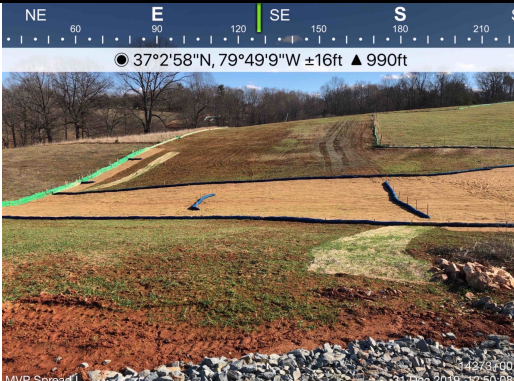
GPS Location	0	GPS Location	0		
Field Station#	14273+00	Field Station#	14279+00		
Pic 5 Desc.	Erosion control blanket looking east	Pic 6 Desc.	Equipment bridge is acceptable

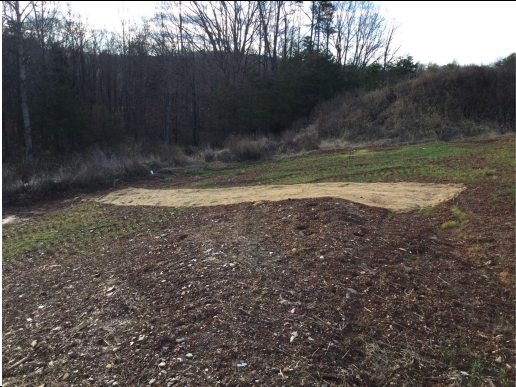
GPS Location	1		GPS Location	2	
Field Station#	14930+00		Field Station#	15092+95	
Pic 1 Desc.	Curlex installed to help curb erosion occurring on slope		Pic 2 Desc.	Bridge crossing and ECD's at S-G9 functional.

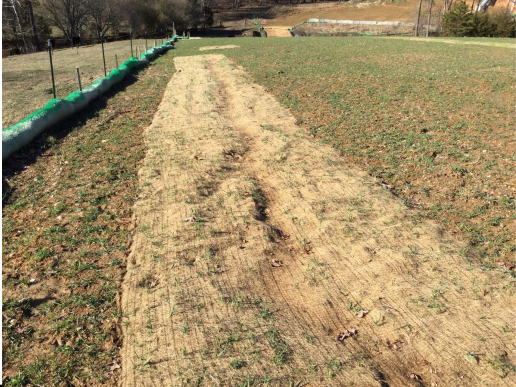
GPS Location	3		GPS Location	4	
Field Station#	15097+00		Field Station#	15112+50	
Pic 3 Desc.	Erosion occurring underneath Curlex. Will continue to monitor.		Pic 4 Desc.	Area overseeded now has vegetation growing in once bare spot

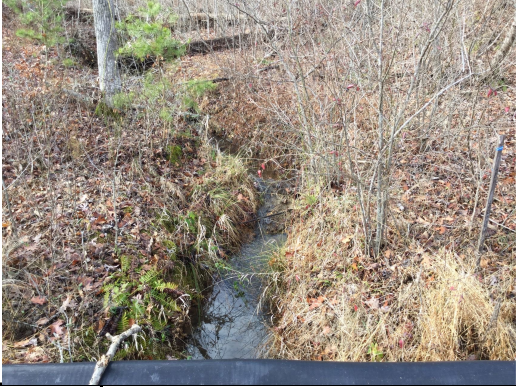
GPS Location	5		GPS Location	6	
Field Station#	15126+40		Field Station#	15126+40	
Pic 5 Desc.	Upstream view of S-A6		Pic 6 Desc.	Downstream view of S-A6

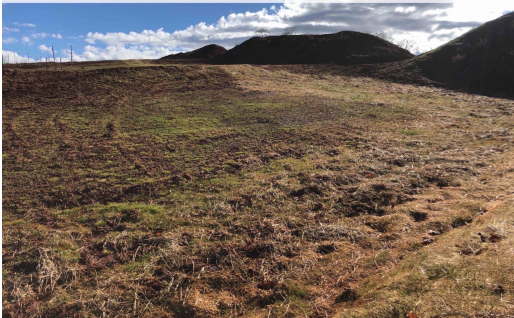
GPS Location	0	GPS Location	0		
Field Station#	14585+00	Field Station#	14582+85		
Pic 1 Desc.	Temporary stabilization	Pic 2 Desc.	Equipment bridge clean at stream S-E17		
North East Elevation ☉ 216°SW (T) LAT: 36.987649 LON: -79.717012 ±32ft ▲ 959ft

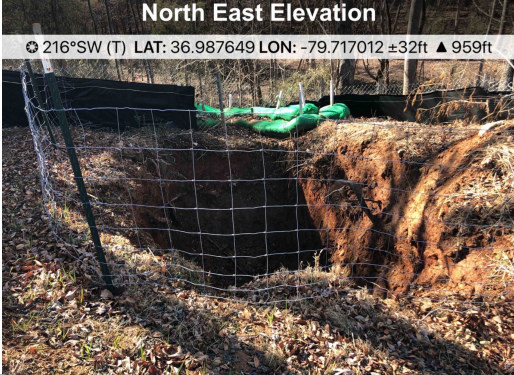
GPS Location	0	GPS Location	0		
Field Station#	14660+00	Field Station#	14673+10		
Pic 3 Desc.	Sump pit functioning as intended	Pic 4 Desc.	Equipment bridge clean at stream S-H37		
North Elevation ☉ 185°S (T) LAT: 36.987905 LON: -79.715145 ±16ft ▲ 928ft

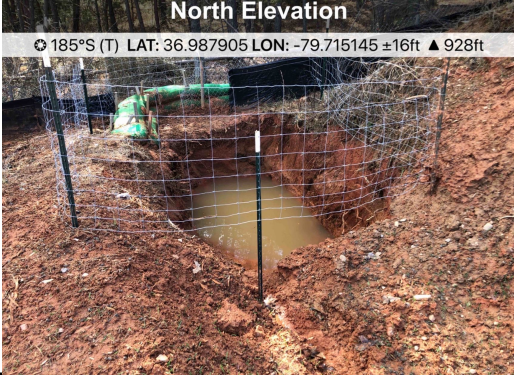
Field Station#	14680+00	Field Station#	14680+37		
Pic 5 Desc.	Sump pit functioning as intended	Pic 6 Desc.	Equipment bridge clean at stream S-H36
