Visual Site Inspection Report

Project Name	H-600 Pipeline Spread I		AFE	124300139	Spread	H-600 Pipeline Spread I	
Contractor	Precision				Report #	6584	
Inspector	Ben Davenport				Date/Time	12/12/2019 5:00 PM	
Permit #	TBD	Inspection Type	VA SWPP		Station Begin	14928+52	
State	VA	Inspection Area	Partial		Station End	15296+00	
County	Franklin/Pittsylvania	Ground	Muddy		Temperature (°F)	42.00	
Municipality	Chatham	Weather	Sunny		Rain Gauge (in)	0.00	
					Rain Accumulation Time (days)	0.00

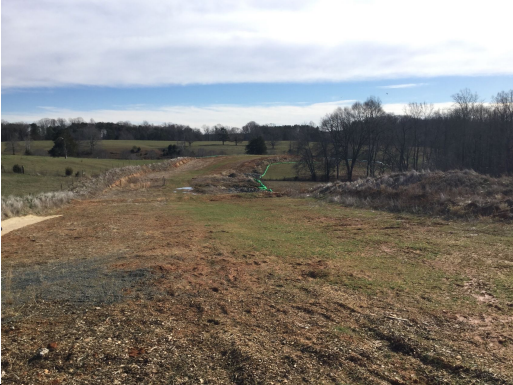
GPS Location	1		GPS Location	2	
Field Station#	15022+00		Field Station#	15082+00	
Pic 1 Desc.	View of stabilized ROW with ECD's in place and functional		Pic 2 Desc.	View of stabilized ROW with ECD's in place and functional

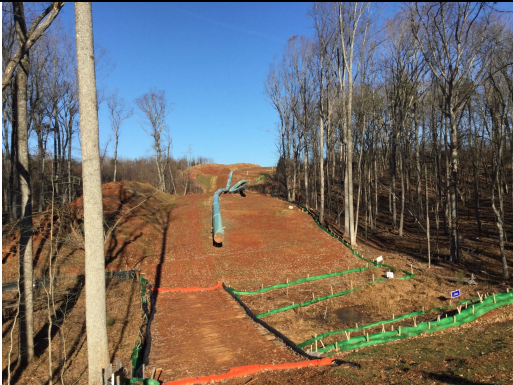
GPS Location	3		GPS Location	4	
Field Station#	15128+00		Field Station#	15141+00	
Pic 3 Desc.	View of stabilized ROW with ECD's in place and functional		Pic 4 Desc.	View of stabilized ROW with ECD's in place and functional

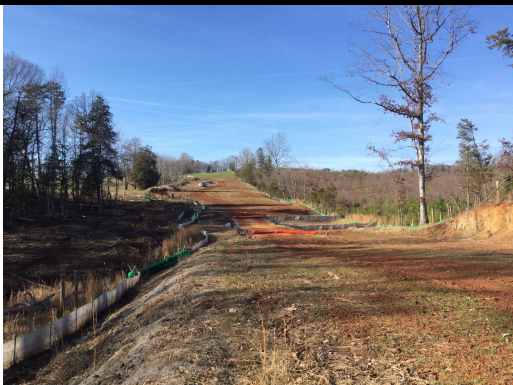
GPS Location	5		GPS Location	6	
Field Station#	15152+00		Field Station#	15170+00	
Pic 5 Desc.	View of stabilized ROW with ECD's in place and functional		Pic 6 Desc.	View of stabilized ROW with ECD's in place and functional

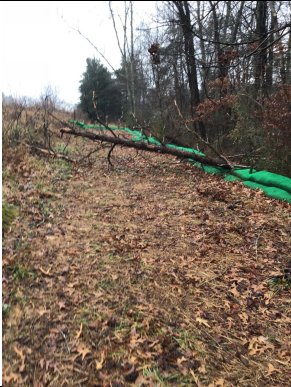
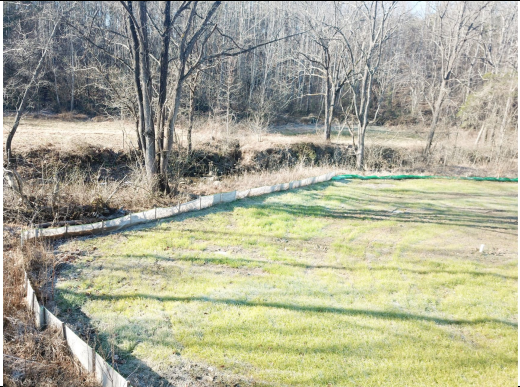
GPS Location	00000	GPS Location	00000		
Field Station#	13784+32	Field Station#	13755+48		
Pic 1 Desc.	Tree fell on CFS during rain events, no damage was done to the CFS , added to punch list to have tree removed.		Pic 2 Desc.	Inspected ECDs at stream crossing and monitored vegetation growth

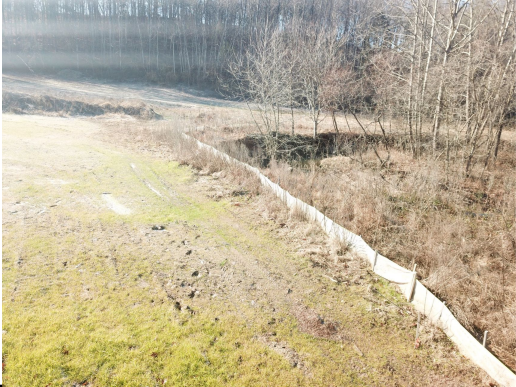
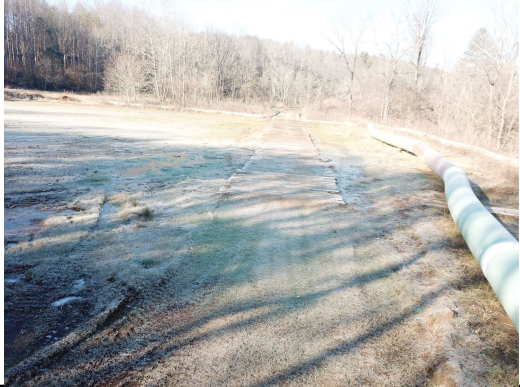
GPS Location	00000	GPS Location	00000		
Field Station#	13755+73	Field Station#	13760+00		
Pic 3 Desc.	Inspected ECDs at stream crossing.		Pic 4 Desc.	Photo showing vegetation	
Insert image here			Insert image here		
GPS Location		GPS Location			
Field Station#		Field Station#			
Pic 5 Desc.			Pic 6 Desc.

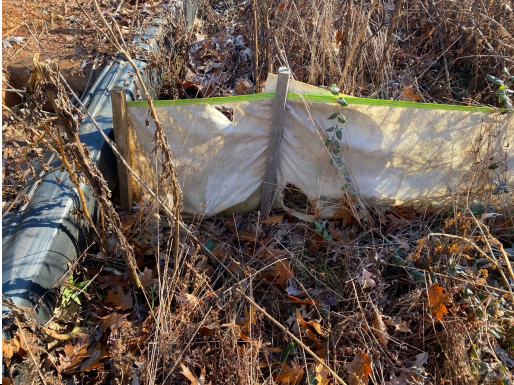
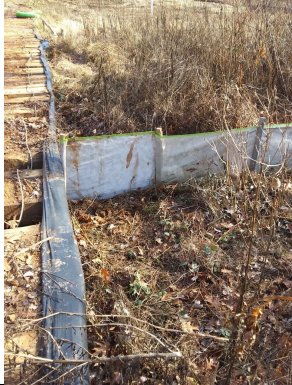
GPS Location	0	GPS Location	0		
Field Station#	15427+50	Field Station#	15427+50		
Pic 1 Desc.	Replace damaged P1 fence at buffer zone.	Pic 2 Desc.	P1 fence replaced during maintenance process.

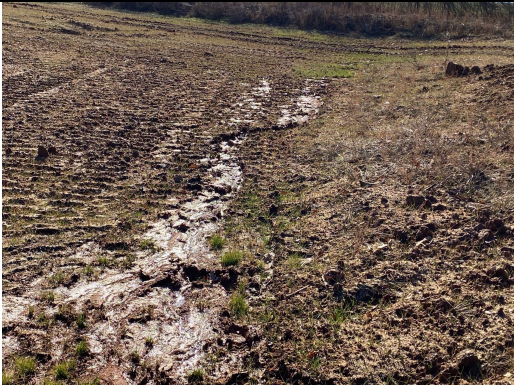
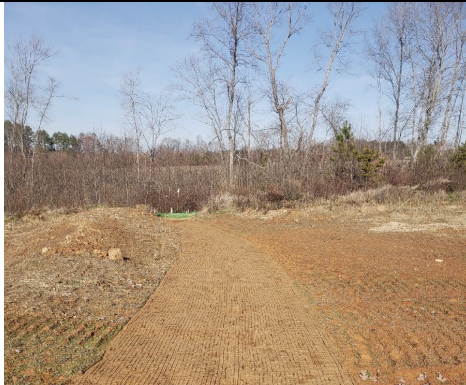
GPS Location	0	GPS Location	0		
Field Station#	15463+50	Field Station#	15463+50		
Pic 3 Desc.	Erosion occurring along breaker. Curlex recommended.	Pic 4 Desc.	Curlex installed along breaker during maintenance process.		
Insert image here			Insert image here		
GPS Location		GPS Location			
Field Station#		Field Station#			
Pic 5 Desc.		Pic 6 Desc.

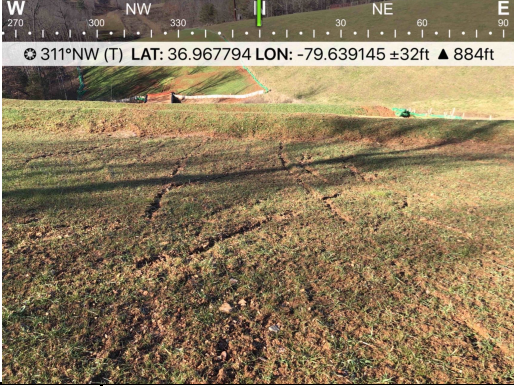
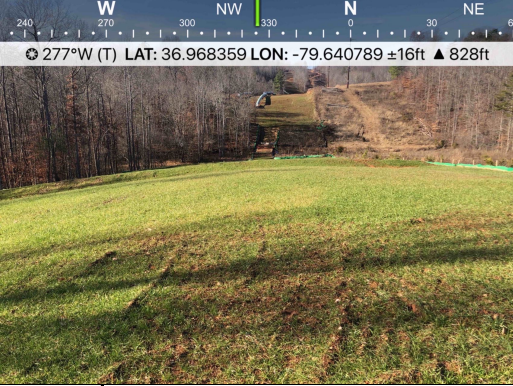
GPS Location	0	GPS Location	0		
Field Station#	14925+00	Field Station#	4910+00		
Pic 1 Desc.	Rill erosion starting to form and will be monitored		Pic 2 Desc.	Temporary stabilization

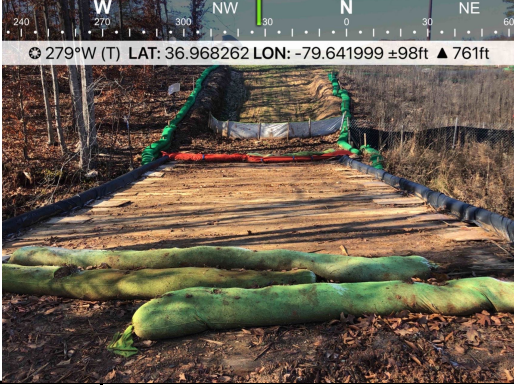
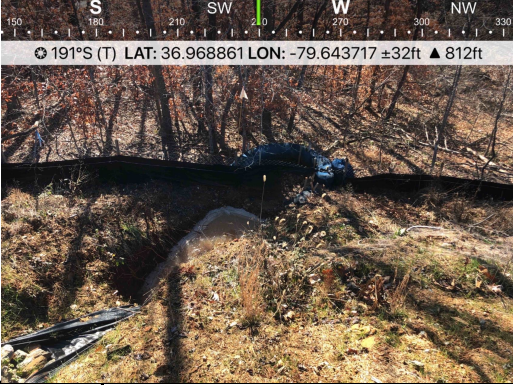
GPS Location	0	GPS Location	0		
Field Station#	4916+26	Field Station#	14902+00		
Pic 3 Desc.	Equipment bridge clean at stream S-G16		Pic 4 Desc.	Sump pit to spec

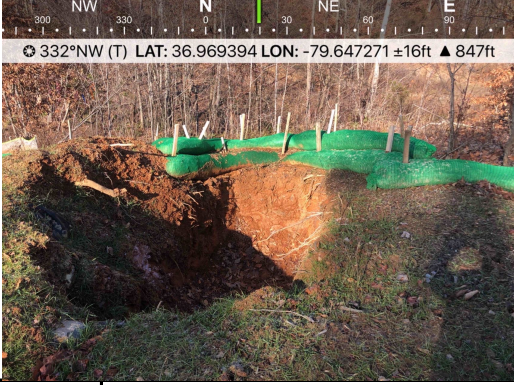
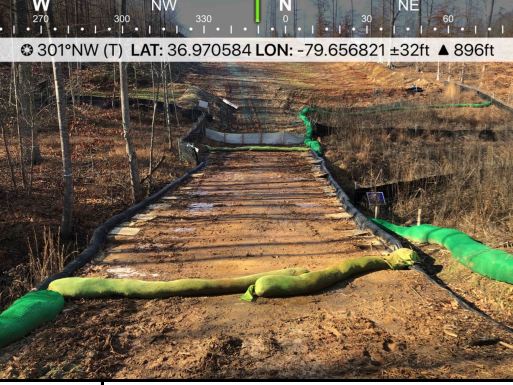
GPS Location	0	GPS Location	0		
Field Station#	14895+00	Field Station#	14870+43		
Pic 5 Desc.	Sump pit to spec		Pic 6 Desc.	Equipment bridge clean at stream S-SS8
