Visual Site Inspection Report

Project Name	H-600 Pipeline Spread I	AFE	124300139	Spread	H-600 Pipeline Spread I
Contractor	Precision			Report #	8129
Inspector	Justin Burch			Date/Time	2/10/2020 12:20 PM
Permit #	TBD	Inspection Type	VA SWPP	Station Begin	14171+36
State	VA	Inspection Area	Full	Station End	14546+75
County	Franklin	Ground	Wet	Temperature (°F)	53.00
Municipality	N/A	Weather	Light Rain	Rain Gauge (in)	0.00
				Rain Accumulation Time (days)	1.00

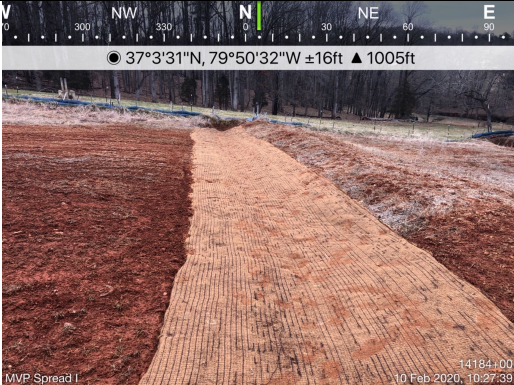
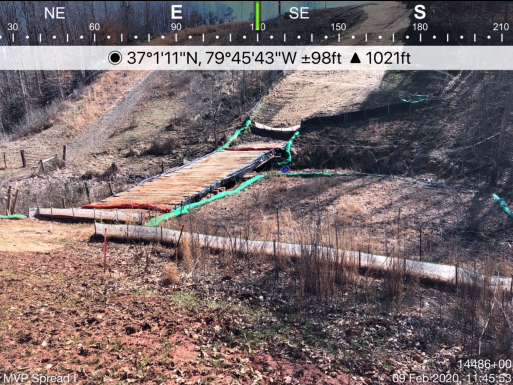
GPS Location	0	GPS Location	0		
Field Station#	14184+00	Field Station#	14486+00		
Pic 1 Desc.	Curlex was installed in Waterbar flow line	Pic 2 Desc.	Equipment bridge in acceptable condition

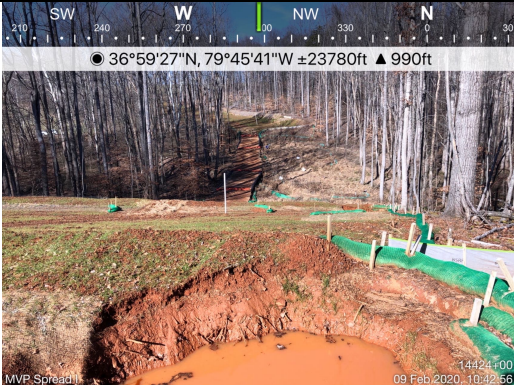
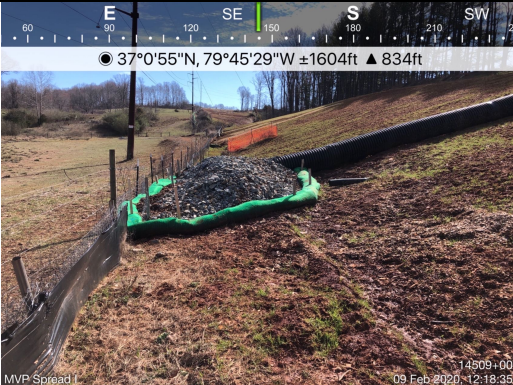
GPS Location	0	GPS Location	0		
Field Station#	14424+00	Field Station#	14509+00		
Pic 3 Desc.	Waterbar end treatment in acceptable condition	Pic 4 Desc.	Clean water diversion pipe in acceptable condition		
Insert image here		Insert image here			
GPS Location		GPS Location			
Field Station#		Field Station#			
Pic 5 Desc.		Pic 6 Desc.

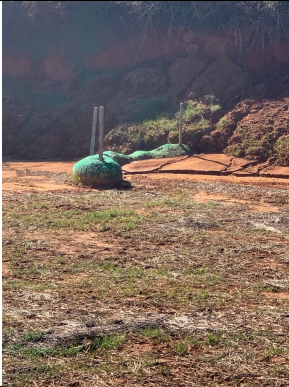
GPS Location	O	GPS Location	O		
Field Station#	15997+00	Field Station#	15998+00		
Pic 1 Desc.	Observing CFS that requires maintenance.	Pic 2 Desc.	Observing CFS That Requires Maintenance.

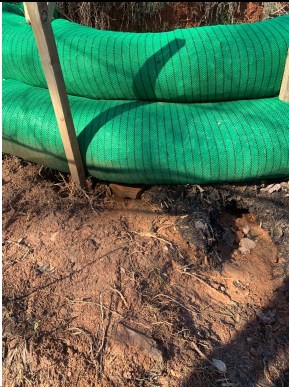
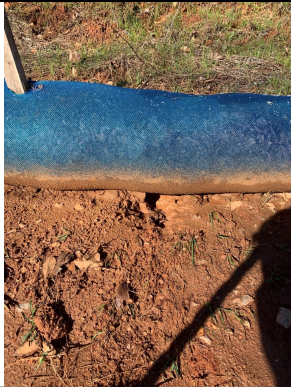
GPS Location	O	GPS Location	O		
Field Station#	15976+00	Field Station#	15976+00		
Pic 3 Desc.	Observing end treatment that requires maintenance.	Pic 4 Desc.	Observing CFS that requires maintenance.

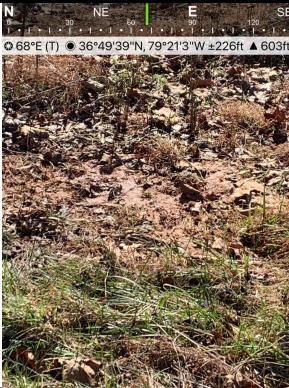
GPS Location	O	GPS Location	O		
Field Station#	15999+00	Field Station#	15587+00		
Pic 5 Desc.	Observing sediment off row.	Pic 6 Desc.	Observing sediment off row.

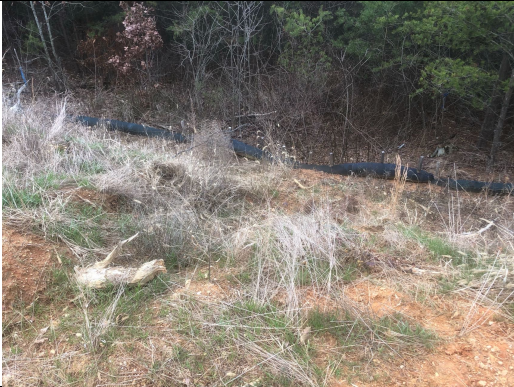
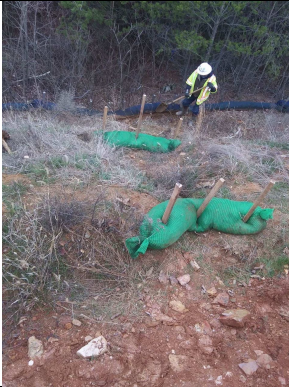
GPS Location	1	GPS Location	2		
Field Station#	14943+50	Field Station#	14943+50		
Pic 1 Desc.	Channeling occurring down backside of diversion berm. Perimeter CFS more than half full as a result.		Pic 2 Desc.	Contractor installed CFS check dams and performed maintenance on perimeter CFS per punch list item.

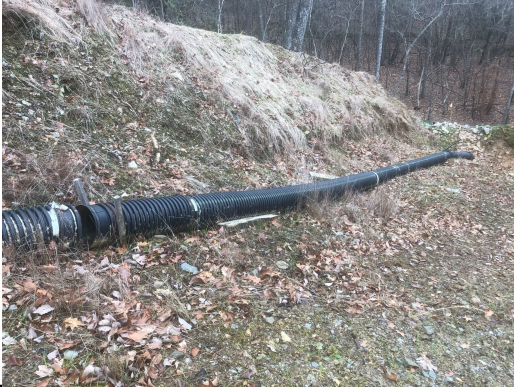
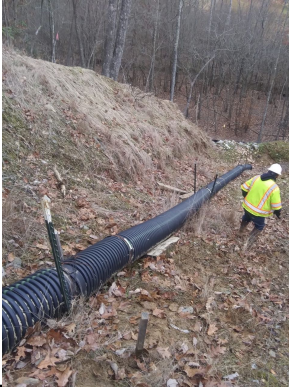
GPS Location	3	GPS Location	4		
Field Station#	14953+00	Field Station#	14953+00		
Pic 3 Desc.	Drain tile detached causing water to channel down ROW instead of into sump pit.		Pic 4 Desc.	Contractor corrected issue per punch list item.

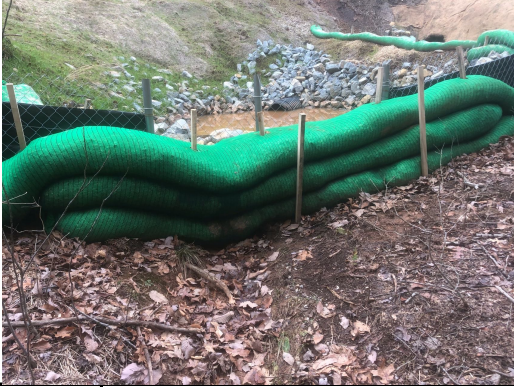
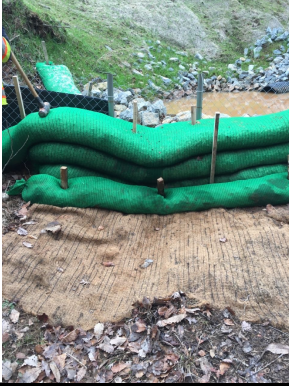
GPS Location	5	GPS Location	6		
Field Station#	14975+00	Field Station#	14975+00		
Pic 5 Desc.	Triple stack at perimeter of ROW below plunge pool undermining.		Pic 6 Desc.	Contractor repaired undermining triple stack and installed erosion control blanket to help curb further issues.

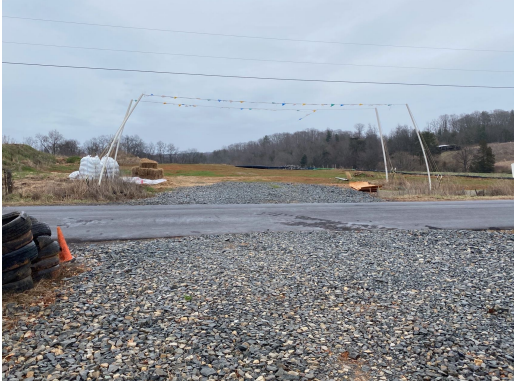
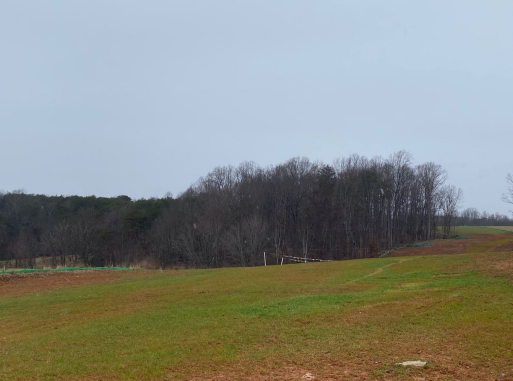
GPS Location	0	GPS Location	0		
Field Station#	13958+31	Field Station#	14130+00		
Pic 1 Desc.	Approximately 13958+31. RCEs and road crossing.		Pic 2 Desc.	Approximately 14130+00. Overview of ROW. ROW temporarily stabilized and has winter vegetation growing.

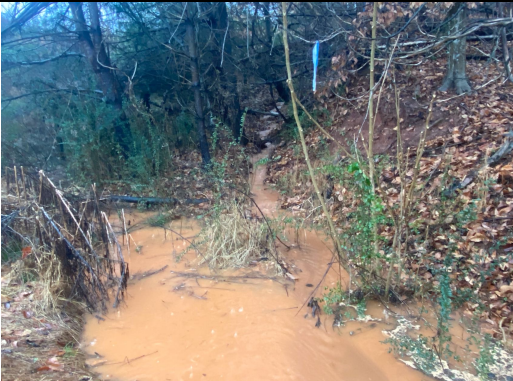
GPS Location	0	GPS Location	0		
Field Station#	13998+15	Field Station#	13997+00		
Pic 3 Desc.	Approximately 13998+15. Overview of stream crossing, equipment bridge and ECDs at stream S-KL36.		Pic 4 Desc.	Approximately 13997+00. Sediment laden water flowing from beyond LOD along edge of ROW and into S-KL36.	
Insert image here			Insert image here		
GPS Location		GPS Location			
Field Station#		Field Station#			
Pic 5 Desc.			Pic 6 Desc.

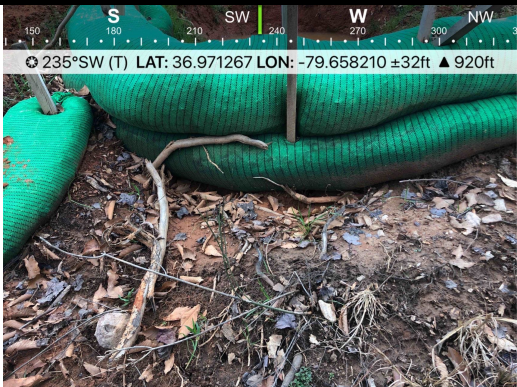
GPS Location	0	GPS Location	0		
Field Station#	14868+00	Field Station#	14870+43		
Pic 1 Desc.	CFS undermined at end treatment	Pic 2 Desc.	Equipment bridge clean at stream S-SS8

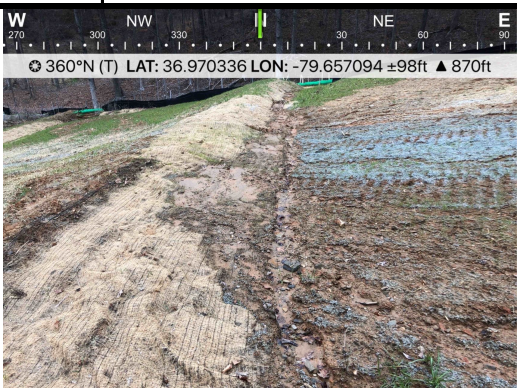
GPS Location	0	GPS Location	0		
Field Station#	14872+00	Field Station#	14876+00		
Pic 3 Desc.	Sediment building up in throat of water bar	Pic 4 Desc.	CFS undermined at end treatment

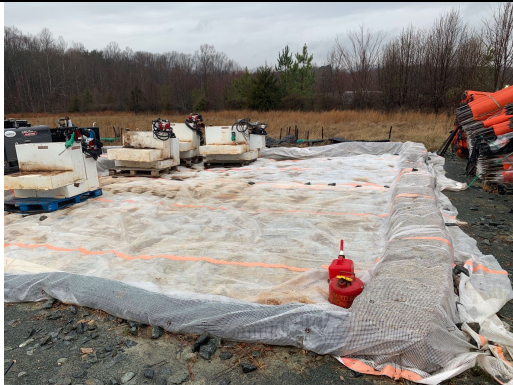
GPS Location	000000000	GPS Location	000000000		
Field Station#	0000+00	Field Station#	0000+00		
Pic 3 Desc.	Inlet protection for parking lot drain on south end of paved yard functioning properly.	Pic 4 Desc.	Issue from previous inspection addressed by contractor (plastic liner needs repair).

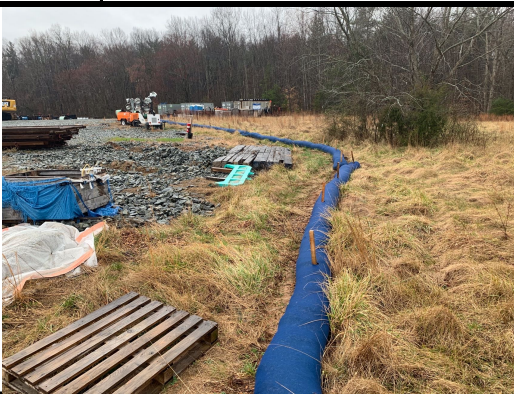
Insert image here			
GPS Location	000000000	GPS Location			
Field Station#	0000+00	Field Station#			
Pic 5 Desc.	Perimeter ECD's on north end of gravel yard in good condition.	Pic 6 Desc.

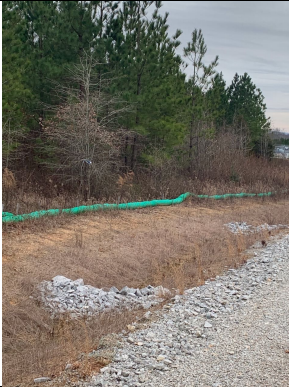
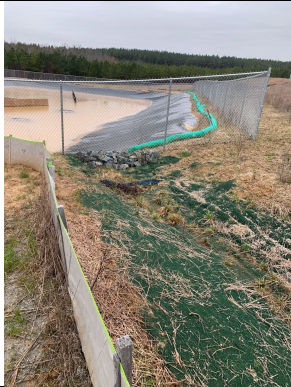
GPS Location	O	GPS Location	O		
Field Station#	00+00	Field Station#	00+00		
Pic 1 Desc.	Observing rock check dam.	Pic 2 Desc.	Observing stabilized channel and ECD's performing as they should.

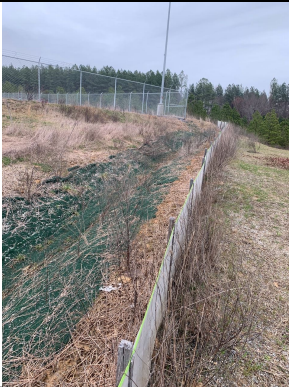
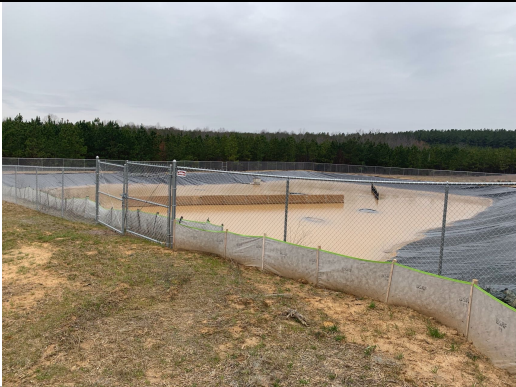
GPS Location	O	GPS Location	O		
Field Station#	00+00	Field Station#	00+00		
Pic 3 Desc.	Observing stabilized channel.	Pic 4 Desc.	Observing storm water pond at Transco.		
Insert image here			Insert image here		
GPS Location		GPS Location			
Field Station#		Field Station#			
Pic 5 Desc.		Pic 6 Desc.
