Visual Site Inspection Report

Project Name	H-600 Pipeline Spread I	AFE	124300139	Spread	H-600 Pipeline Spread I	
Contractor	Precision			Report #	8171	
Inspector	Glenn Mike Renfro			Date/Time	2/20/2020 2:10 AM	
Permit #	TBD	Inspection Type	VA SWPP	Station Begin	0000+00	
State	VA	Inspection Area	Full	Station End	0000+00	
County	Franklin	Ground	Dry	Temperature (°F)	39.00	
Municipality	N/A	Weather	Cloudy	Rain Gauge (in)	0.00	
				Rain Accumulation Time (days)	6.00

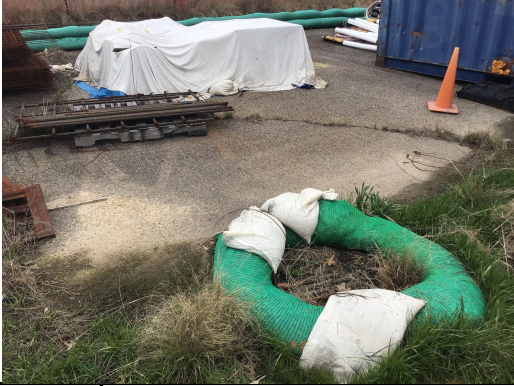
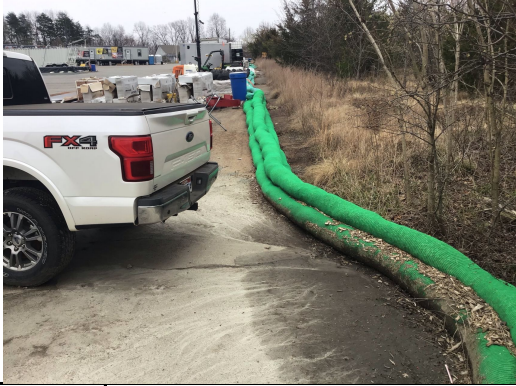
GPS Location 000000000		GPS Location 00000000000			
Field Station# 0000+00		Field Station# 0000+00			
Pic 1 Desc. Inlet protection on north end on paved yard in good condition.		Pic 2 Desc. Perimeter ECD's on southwest corner of paved yard in good condition

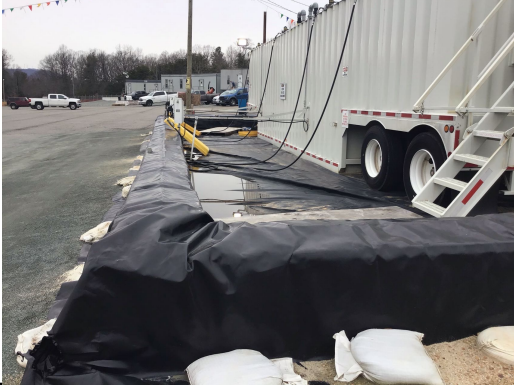
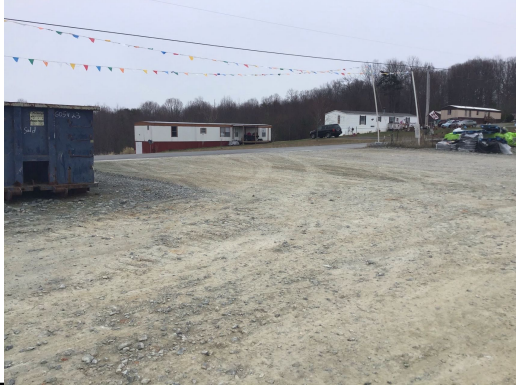
GPS Location 0000000000		GPS Location 0000000000			
Field Station# 0000+00		Field Station# 0000+00			
Pic 3 Desc. Secondary containment structure for fuel cell in compliance		Pic 4 Desc. RCE at gravel yard in acceptable condition.

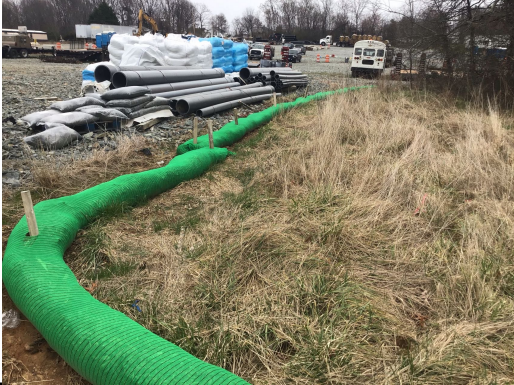
Insert image here			
GPS Location 000000000		GPS Location			
Field Station# 0000+00		Field Station#			
Pic 5 Desc. Perimeter ECD's on west side of gravel yard in good condition.		Pic 6 Desc.

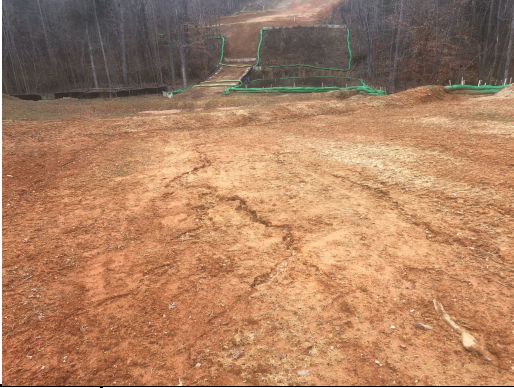
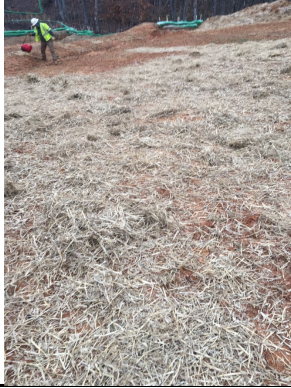
GPS Location	1	GPS Location	2		
Field Station#	15075+00	Field Station#	15075+00		
Pic 1 Desc.	Erosion channels forming down ROW need repaired and stabilized		Pic 2 Desc.	Contractor repaired erosion rills and stabilized area per punch list item

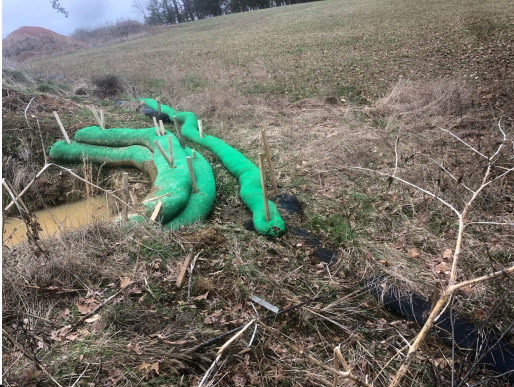
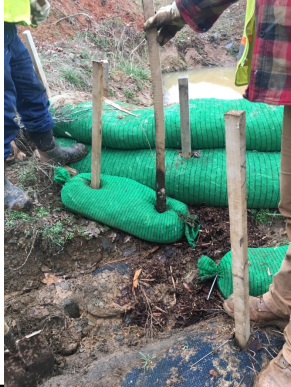
GPS Location	3	GPS Location	4		
Field Station#	15107+50	Field Station#	15107+50		
Pic 3 Desc.	Triple stack undermining and perimeter CFS more than half full. Maintenance required.		Pic 4 Desc.	Contractor performing environmental maintenance per punch list item.

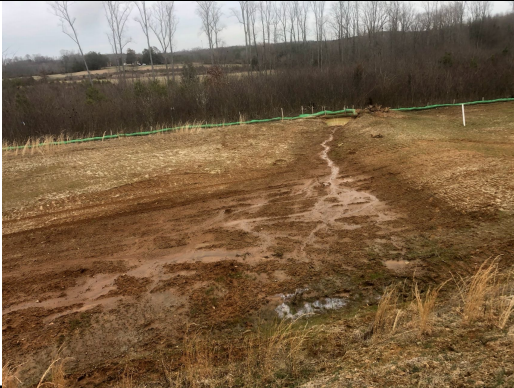
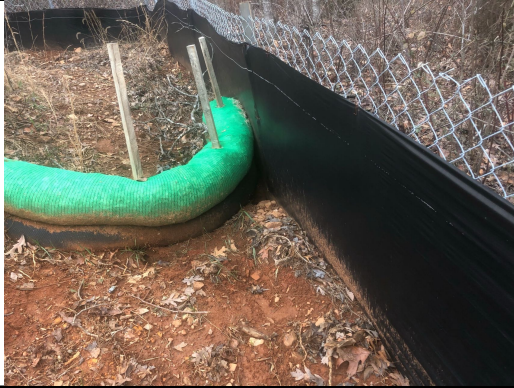
GPS Location	5	GPS Location	6		
Field Station#	15122+83	Field Station#	15126+95		
Pic 5 Desc.	Erosion channel forming in throat of water bar. Recommend Curlex and also stabilize travel lane in area.		Pic 6 Desc.	CFS check dam undermining and requires maintenance.

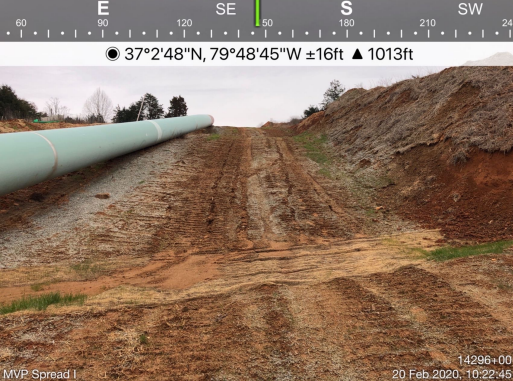
GPS Location	0	GPS Location	0		
Field Station#	14297+00	Field Station#	14296+00		
Pic 1 Desc.	Rill Erosion is occurring; recommend installing erosion control blanket		Pic 2 Desc.	Rill Erosion is occurring; recommend installing erosion control blanket

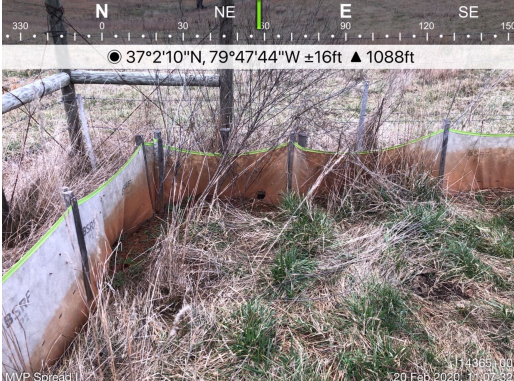
GPS Location	0	GPS Location	0		
Field Station#	14365+00	Field Station#	14430+00		
Pic 3 Desc.	Hole in P1 silt fence		Pic 4 Desc.	Equipment bridge in acceptable condition

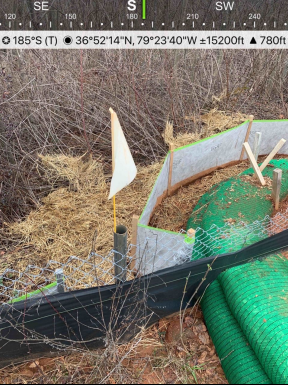
GPS Location	O	GPS Location	O		
Field Station#	15853+00	Field Station#	15848+00		
Pic 1 Desc.	Observing location where sediment was removed from off row and additional ECD's were installed.		Pic 2 Desc.	Observing location where sediment was removed from off row and additional ECD's were installed.

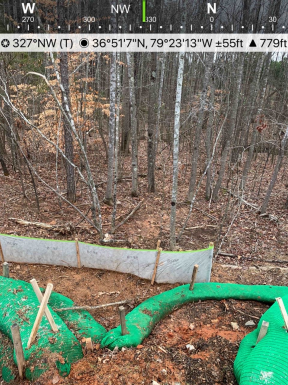
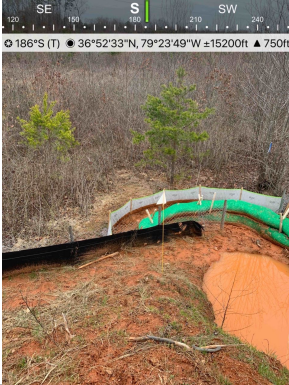
GPS Location	O	GPS Location	O		
Field Station#	15847+00	Field Station#	15860+00		
Pic 3 Desc.	Observing location where sediment was removed from off row and additional ECD's were installed.		Pic 4 Desc.	Observing location where sediment was removed from off row and additional ECD's were installed.	
Insert image here			Insert image here		
GPS Location		GPS Location			
Field Station#		Field Station#			
Pic 5 Desc.			Pic 6 Desc.

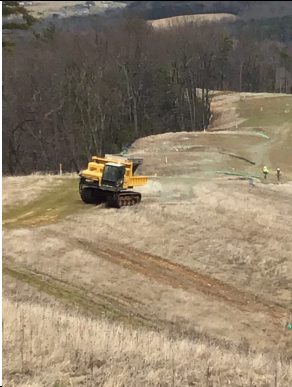
GPS Location	0000	GPS Location	0000		
Field Station#	13440+00	Field Station#	13470+00		
Pic 1 Desc.	Crew making repairs to damaged CFS	Pic 2 Desc.	Environmental crew installing earth guard and seed

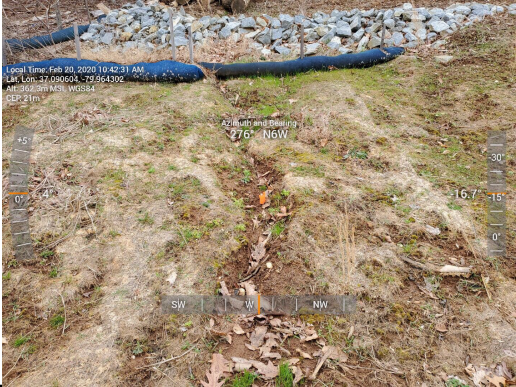
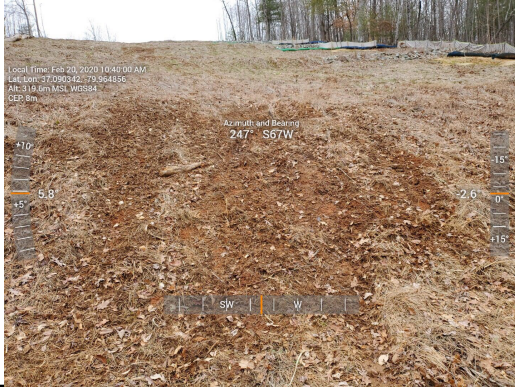
GPS Location	0000	GPS Location	0000		
Field Station#	13633+40	Field Station#	13632+00		
Pic 3 Desc.	Small erosion channel caused from undermined CFS	Pic 4 Desc.	Area on hill side that needs stabilized, added to the punch list		
Insert image here		Insert image here			
GPS Location		GPS Location			
Field Station#		Field Station#			
Pic 5 Desc.		Pic 6 Desc.

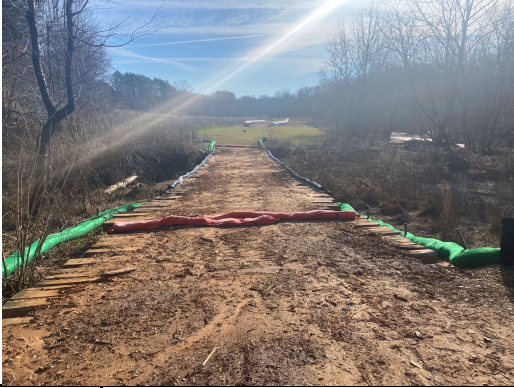
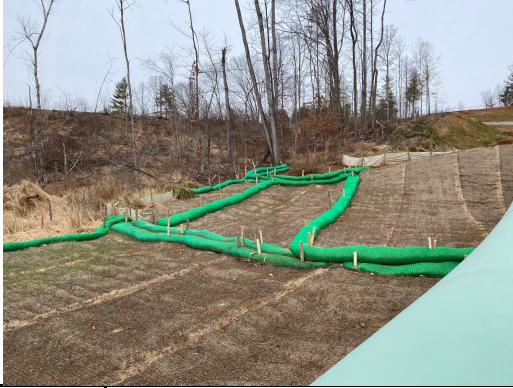
GPS Location	0	GPS Location	0		
Field Station#	13862+80	Field Station#	13999+00		
Pic 1 Desc.	Approximately 13862+80. Overview of stream crossing, equipment bridge and ECDs at stream crossing S-C17.		Pic 2 Desc.	Approximately 13999+00. Overview of ECDs installed for adjacent pond overflow.

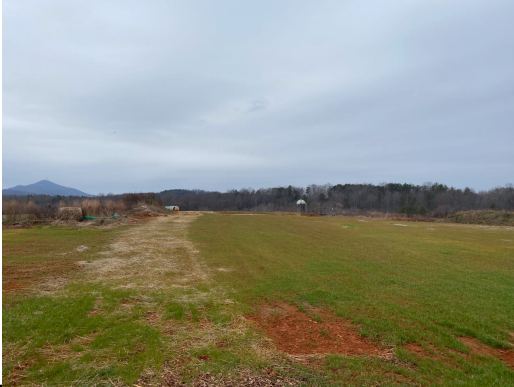
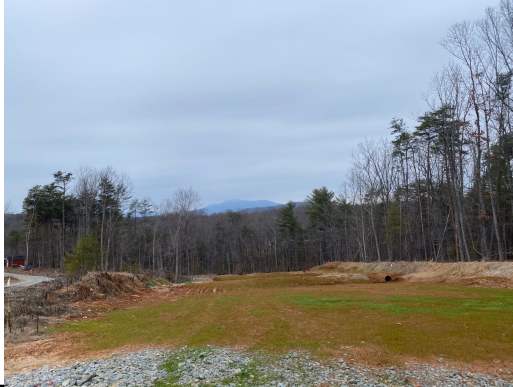
GPS Location	0	GPS Location	0		
Field Station#	14168+00	Field Station#	14061+00		
Pic 3 Desc.	Approximately 14168+00. Overview of ROW. ROW temporarily stabilized and has winter vegetation growing.		Pic 4 Desc.	Approximately 14061+00. Overview of ROW. ROW temporarily stabilized and has winter vegetation growing.	
Insert image here			Insert image here		
GPS Location		GPS Location			
Field Station#		Field Station#			
Pic 5 Desc.		Pic 6 Desc.

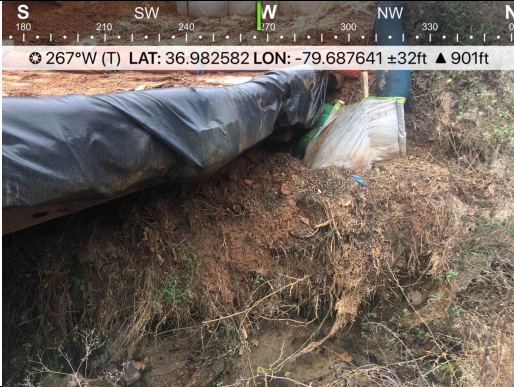
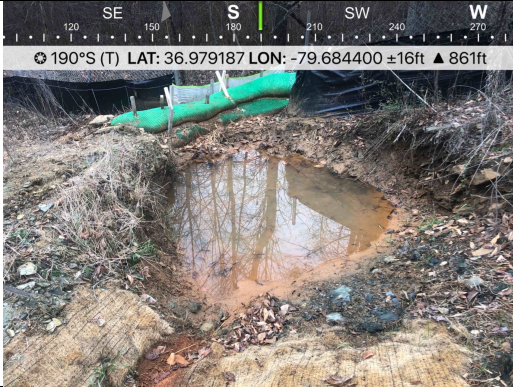
GPS Location	0	GPS Location	0		
Field Station#	14766+11	Field Station#	14782+00		
Pic 1 Desc.	North side of bridge at stream S-MM44 requires additional ECDs		Pic 2 Desc.	Sump pit over 50% full and needs cleaned out

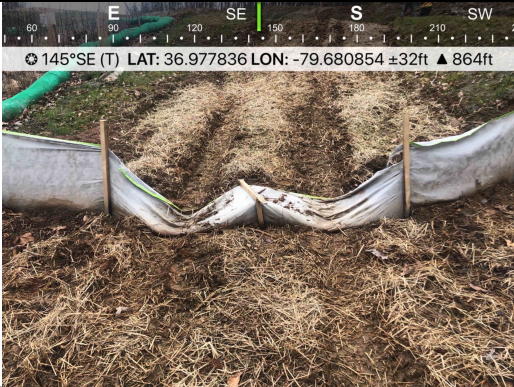
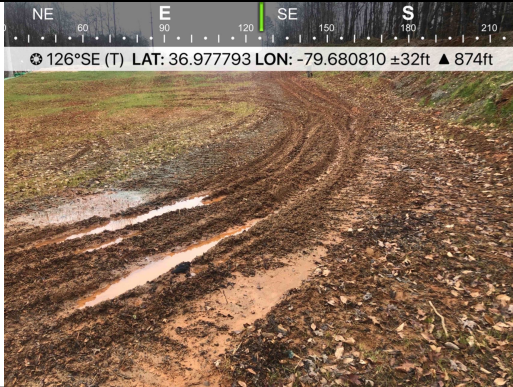
GPS Location	0	GPS Location	0		
Field Station#	14793+78	Field Station#	14795+00		
Pic 3 Desc.	Damage due to travel land and P1 silt fence on both sides of stream S-H24		Pic 4 Desc.	Third party damage to travel land requires stabilization from 14795+00 to 14802+00

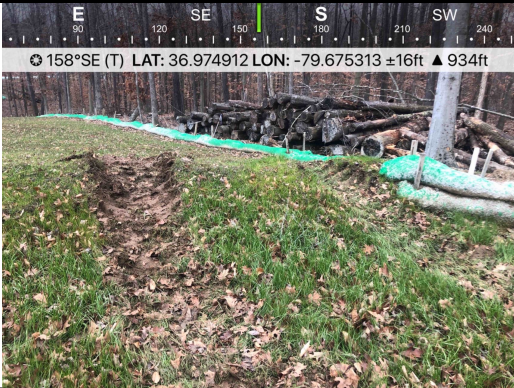
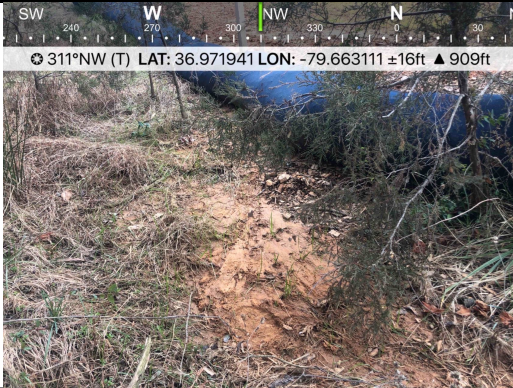
GPS Location	0	GPS Location	0		
Field Station#	14810+50	Field Station#	14853+30		
Pic 5 Desc.	Damage to water bar by third party logging company		Pic 6 Desc.	CFS undermined allowing sediment to pass through

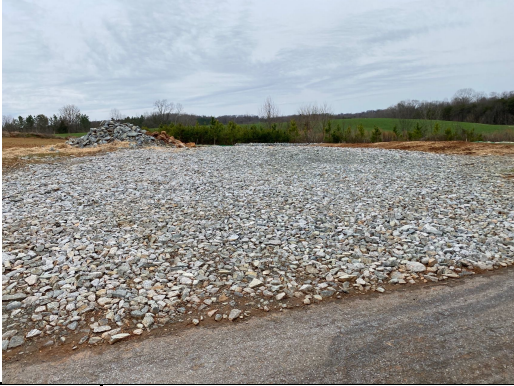
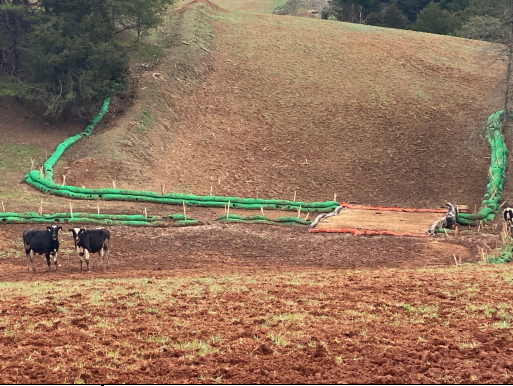
GPS Location	0	GPS Location	0		
Field Station#	15371+00	Field Station#	15327+00		
Pic 1 Desc.	RCE at Snowberry Rd in good working condition.	Pic 2 Desc.	Livestock continues to damage ECDs along ROW.

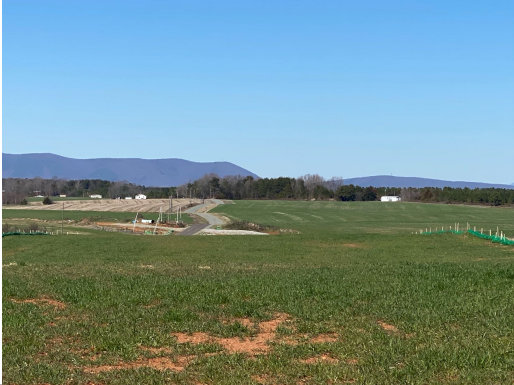
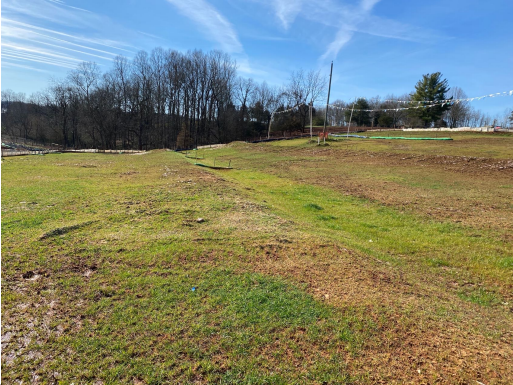
GPS Location	0	GPS Location	0		
Field Station#	15490+00	Field Station#	15298+00		
Pic 3 Desc.	Vegetation along ROW growing well.	Pic 4 Desc.	Vegetation along ROW growing well.		
Insert image here			Insert image here		
GPS Location		GPS Location			
Field Station#		Field Station#			
Pic 5 Desc.		Pic 6 Desc.

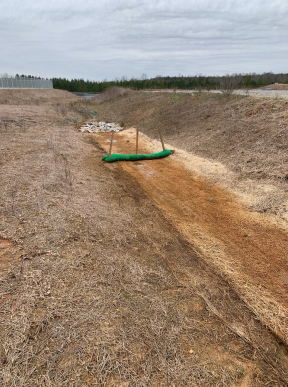
GPS Location	O	GPS Location	O		
Field Station#	00+00	Field Station#	00+00		
Pic 3 Desc.	Observing ECD's performing as they should.	Pic 4 Desc.	Observing ECD's performing as they should.		
Insert image here			Insert image here		
GPS Location		GPS Location			
Field Station#		Field Station#			
Pic 5 Desc.		Pic 6 Desc.
