Visual Site Inspection Report

Project Name	H-600 Pipeline Spread I	AFE	124300139	Spread	H-600 Pipeline Spread I
Contractor	Precision	Report #	8625		
Inspector	Ben Davenport	Date/Time	2/26/2020 5:00 PM		
Permit #	TBD	Inspection Type	VA SWPP	Station Begin	14928+52
State	VA	Inspection Area	Partial	Station End	15296+00
County	Franklin/Pittsylvania	Ground	Muddy	Temperature (°F)	58.00
Municipality	Chatham	Weather	Sunny	Rain Gauge (in)	0.00
				Rain Accumulation Time (days)	0.00

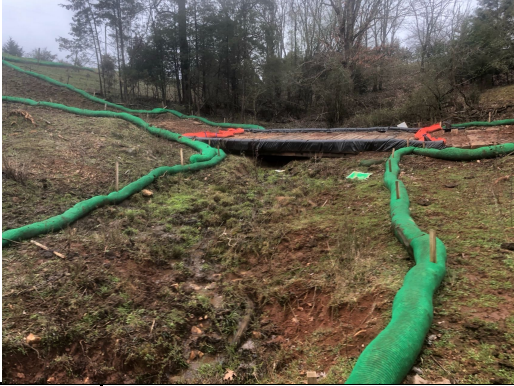
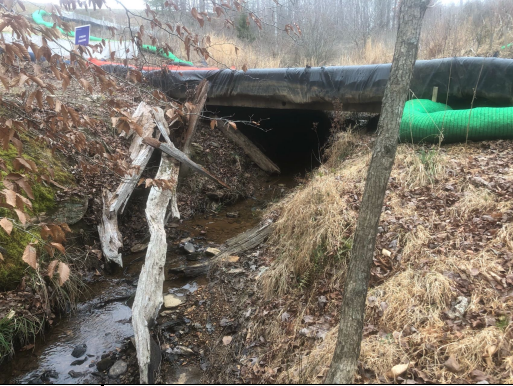
GPS Location	1	GPS Location	2		
Field Station#	14991+62	Field Station#	14932+89		
Pic 1 Desc.	Equipment crossing over S-D7/W-MM17 in good condition. No issues with ECD's around stream and resource buffer.		Pic 2 Desc.	Equipment crossing over S-G15 in good condition. No issues with ECD's around stream and resource buffer.

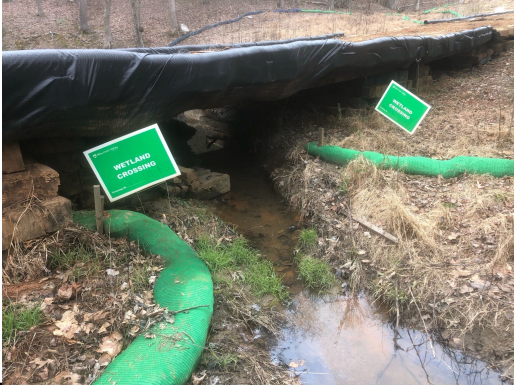
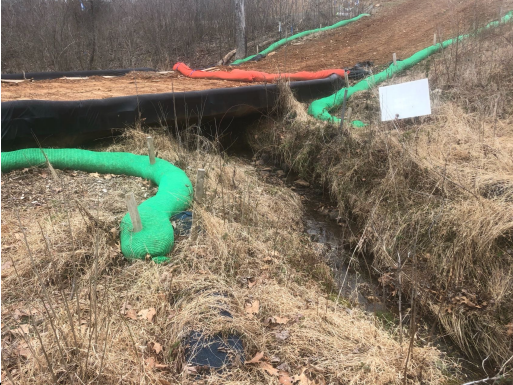
GPS Location	3	GPS Location	4		
Field Station#	15103+45	Field Station#	15126+40		
Pic 3 Desc.	Equipment crossing over S-G8 in good condition. No issues with ECD's around stream and resource buffer.		Pic 4 Desc.	Equipment crossing over S-A6 in good condition. No issues with ECD's around stream and resource buffer.

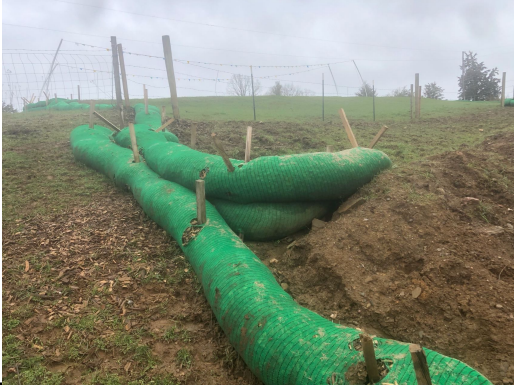
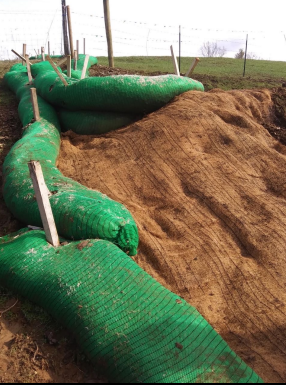
GPS Location	5	GPS Location	6		
Field Station#	14992+25	Field Station#	14992+25		
Pic 5 Desc.	CFS triple stack undermining and sediment accumulating in corner of CFS. Maintenance required.		Pic 6 Desc.	Contractor corrected undermining issue and installed erosion control blanket to help prevent further issues.

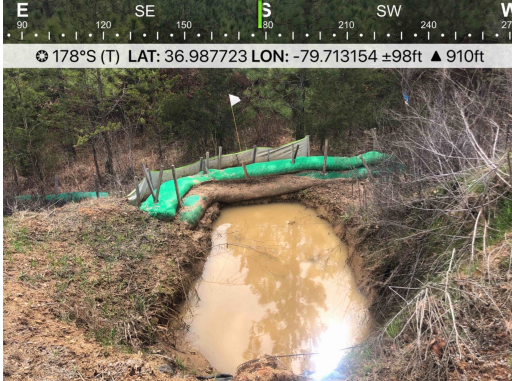
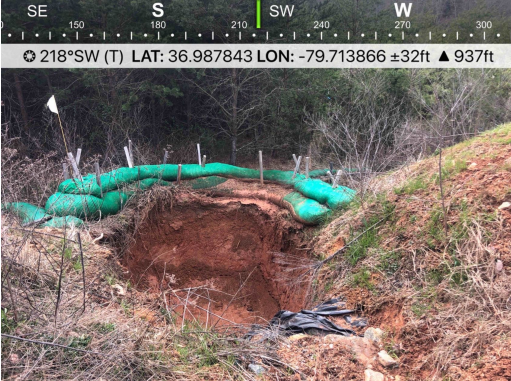
GPS Location	0		GPS Location	0	
Field Station#	14685+00		Field Station#	14684+00	
Pic 1 Desc.	CFS on end treatment needs to be cleaned so that it filters correctly		Pic 2 Desc.	CFS on end treatment needs to be cleaned so that it filters correctly

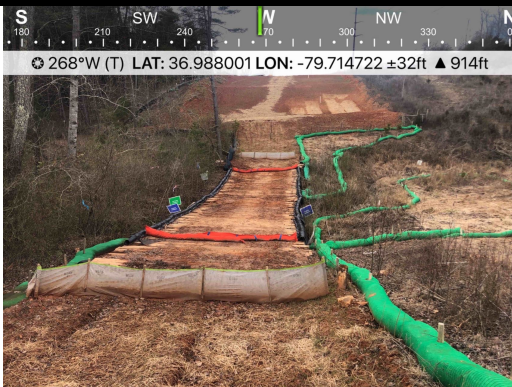
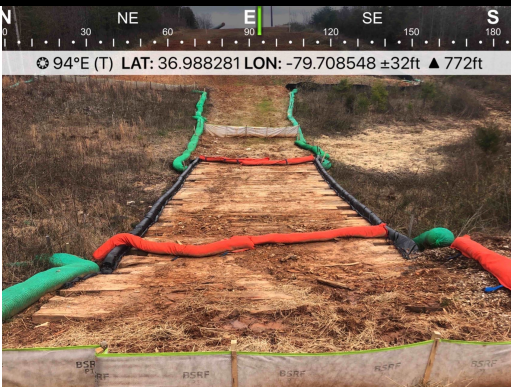
GPS Location	0		GPS Location	0	
Field Station#	14680+37		Field Station#	14700+70	
Pic 3 Desc.	Equipment bridge clean at stream S-H36		Pic 4 Desc.	Equipment bridge clean at stream S-H32

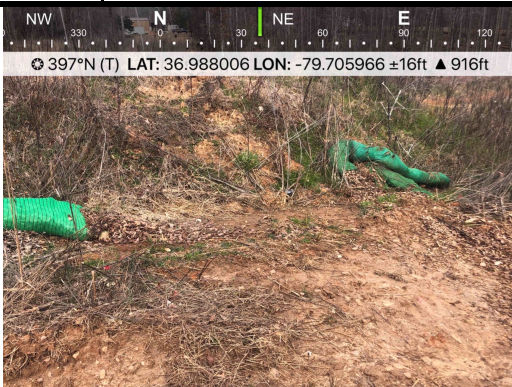
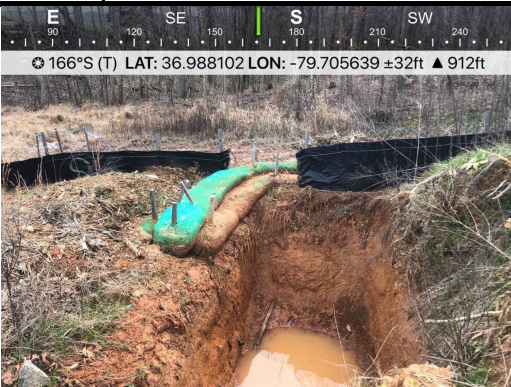
GPS Location	0		GPS Location	0	
Field Station#	14707+50		Field Station#	14708+50	
Pic 5 Desc.	Perimeter CFS damaged and needs to be replaced		Pic 6 Desc.	CFS on end treatment needs to be cleaned so that it filters correctly

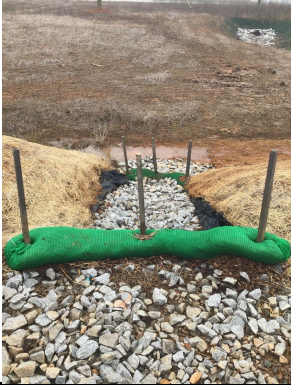
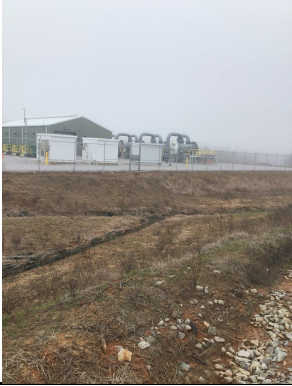
GPS Location	O	GPS Location	O		
Field Station#	00+00	Field Station#	00+00		
Pic 1 Desc.	Observing ECD's performing as they should.	Pic 2 Desc.	Observing drainage channels.

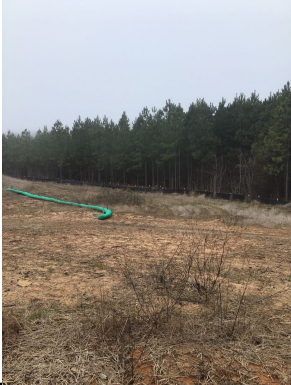
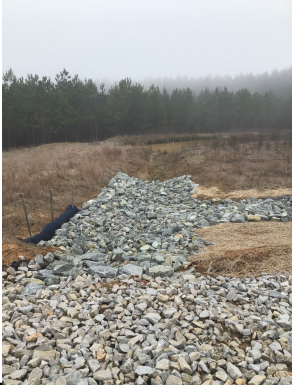
GPS Location	O	GPS Location	O		
Field Station#	00+00	Field Station#	00+00		
Pic 3 Desc.	Observing ECD's performing as they should.	Pic 4 Desc.	Observing ECD's performing as they should.		
Insert image here			Insert image here		
GPS Location		GPS Location			
Field Station#		Field Station#			
Pic 5 Desc.		Pic 6 Desc.
