Visual Site Inspection Report

Project Name	H-600 Pipeline Spread I	AFE	124300139	Spread	H-600 Pipeline Spread I
Contractor	Precision			Report #	8765
Inspector	Ben Davenport			Date/Time	3/3/2020 5:00 PM
Permit #	TBD	Inspection Type	VA SWPP	Station Begin	14928+52
State	VA	Inspection Area	Partial	Station End	15296+00
County	Franklin/Pittsylvania	Ground	Wet	Temperature (°F)	58.00
Municipality	Chatham	Weather	Light Rain	Rain Gauge (in)	0.00
				Rain Accumulation Time (days)	0.00

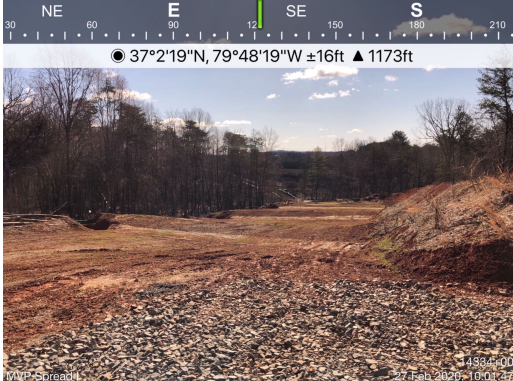
GPS Location	0		GPS Location	0	
Field Station#	14334+00		Field Station#	13365+00	
Pic 1 Desc.	Waterbars in acceptable condition		Pic 2 Desc.	P1 silt fence that was repaired by the contractor

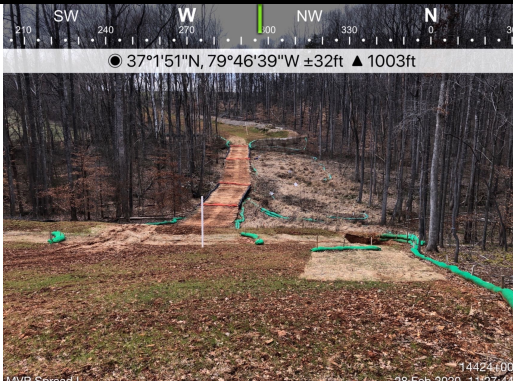
GPS Location	0		GPS Location	0	
Field Station#	14424+00		Field Station#	14514+00	
Pic 3 Desc.	Equipment bridges in acceptable condition		Pic 4 Desc.	Clean water diversion pipe in acceptable condition

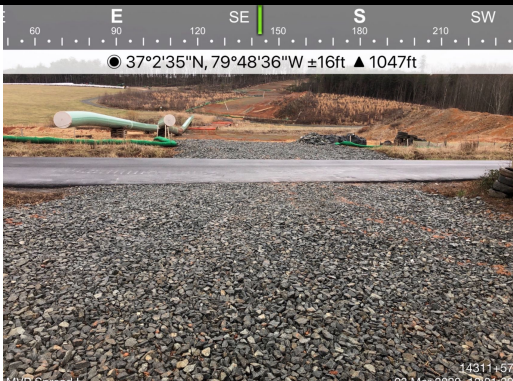
GPS Location	0		GPS Location	0	
Field Station#	14311+57		Field Station#	14334+40	
Pic 5 Desc.	Rock construction entrance in acceptable condition at Farm View Road		Pic 6 Desc.	Waterbar end treatment in acceptable condition

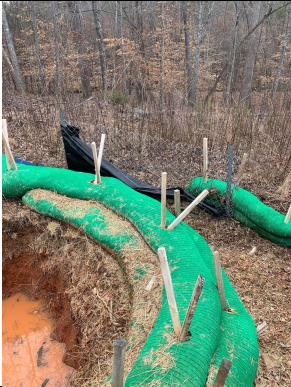
GPS Location	O	GPS Location	O		
Field Station#	15708+35	Field Station#	15781+00		
Pic 1 Desc.	Observing SSF that requires maintenance.	Pic 2 Desc.	Observing cfs that requires maintenance.

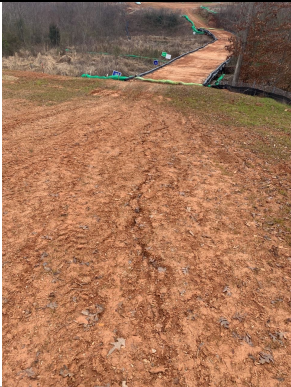
GPS Location	O	GPS Location	O		
Field Station#	15851+38	Field Station#	15860+00		
Pic 3 Desc.	Observing minor erosion rills.	Pic 4 Desc.	Observing undermined end treatment.

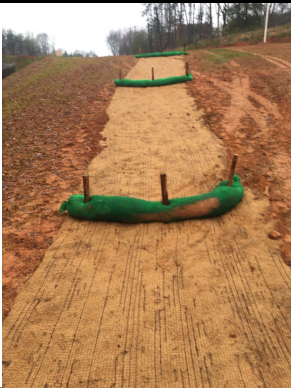
GPS Location	O	GPS Location	O		
Field Station#	15851+38	Field Station#	15781+00		
Pic 5 Desc.	Observing stabilized erosion rills.	Pic 6 Desc.	Observing ECD's performing as they should.

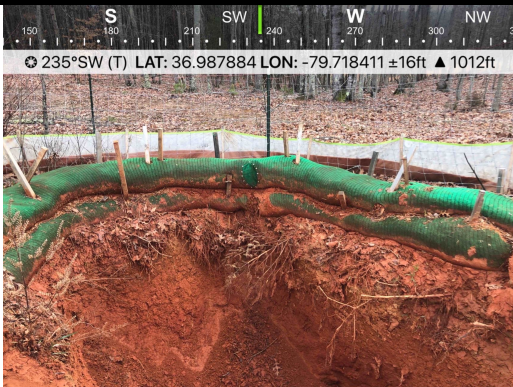
GPS Location	0	GPS Location	0		
Field Station#	14671+00	Field Station#	14673+50		
Pic 1 Desc.	CFS on end treatment has a hole that needs repair and needs to be cleaned out		Pic 2 Desc.	Hole in P1 silt fence due to cattle on tract

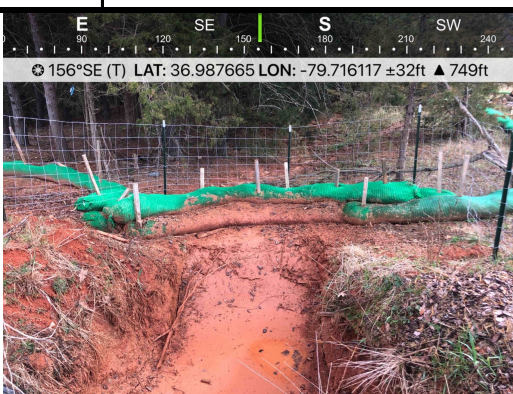
GPS Location	0	GPS Location	0		
Field Station#	14677+00	Field Station#	14678+00		
Pic 3 Desc.	CFS on end treatment needs to be cleaned so that it filters correctly		Pic 4 Desc.	CFS on end treatment needs to be cleaned so that it filters correctly

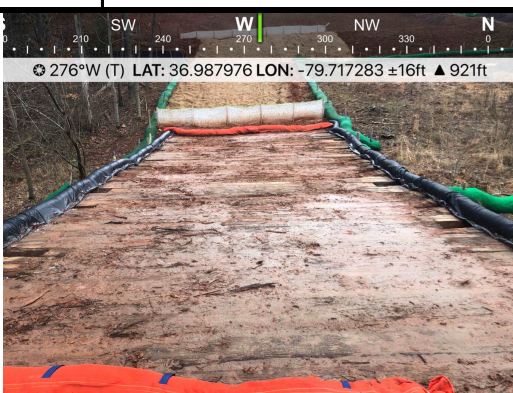
GPS Location	0	GPS Location	0		
Field Station#	14673+10	Field Station#	14680+37		
Pic 5 Desc.	Equipment bridge clean at stream S-H37		Pic 6 Desc.	Equipment bridge clean at stream S-H36

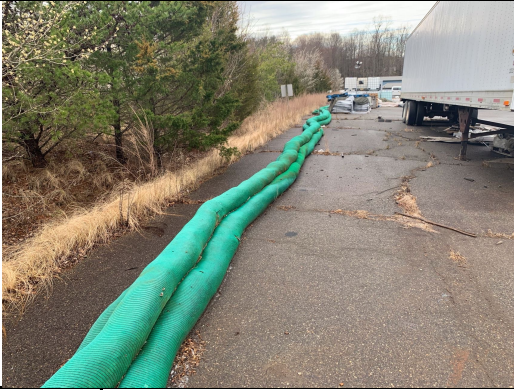
GPS Location	0000000000	GPS Location	0000000000		
Field Station#	0000+00	Field Station#	0000+00		
Pic 1 Desc.	Perimeter ECD's on south end of paved yard in good condition	Pic 2 Desc.	Secondary containment structure for fuel cell in compliance

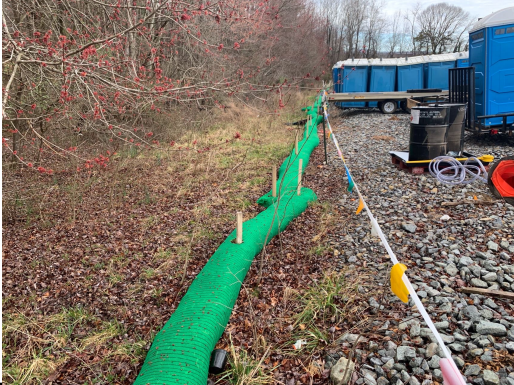
GPS Location	0000000000	GPS Location	0000000000		
Field Station#	0000+00	Field Station#	0000+00		
Pic 3 Desc.	Perimeter ECD's on west side of gravel yard in good condition	Pic 4 Desc.	RCE at gravel yard in acceptable condition.		
Insert image here			Insert image here		
GPS Location		GPS Location			
Field Station#		Field Station#			
Pic 5 Desc.		Pic 6 Desc.

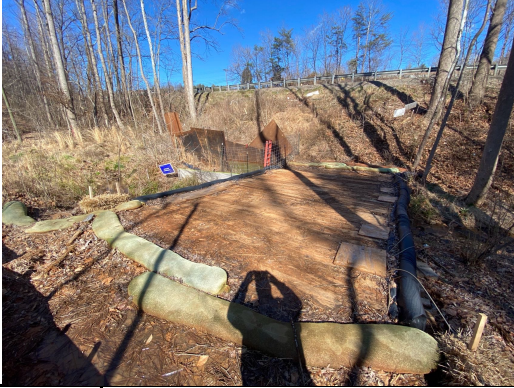
GPS Location	0	GPS Location	0		
Field Station#	14009+20	Field Station#	13888+63		
Pic 1 Desc.	Approximately 14009+20. Overview of stream crossing, equipment bridge and ECDs at stream S-KL38.		Pic 2 Desc.	Approximately 13888+63. Overview of wetland crossing, equipment bridge and ECDs at wetland W-CD5.

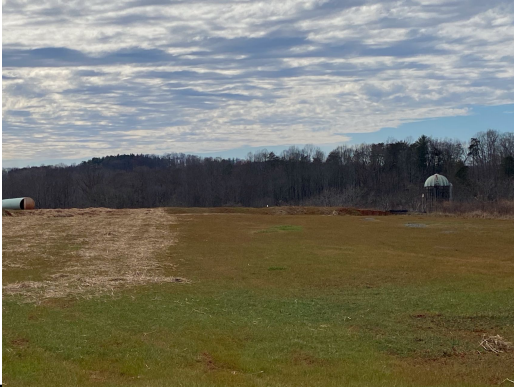
GPS Location	0	GPS Location	0		
Field Station#	14168+00	Field Station#	13880+00		
Pic 3 Desc.	Approximately 14168+00. Overview of ROW. ROW temporarily stabilized and has winter vegetation growing.		Pic 4 Desc.	Approximately 13880+00. Overview of ROW. ROW temporarily stabilized and has winter vegetation growing.	
Insert image here			Insert image here		
GPS Location		GPS Location			
Field Station#		Field Station#			
Pic 5 Desc.		Pic 6 Desc.
