Visual Site Inspection Report

Project Name	H-600 Pipeline Spread I	AFE	124300139	Spread	H-600 Pipeline Spread I
Contractor	Precision			Report #	9612
Inspector	Ben Davenport			Date/Time	3/31/2020 5:00 PM
Permit #	TBD	Inspection Type	VA SWPP	Station Begin	14928+52
State	VA	Inspection Area	Partial	Station End	15296+00
County	Franklin/Pittsylvania	Ground	Wet	Temperature (°F)	49.00
Municipality	Chatham	Weather	Heavy Rain	Rain Gauge (in)	0.00
				Rain Accumulation Time (days)	0.00

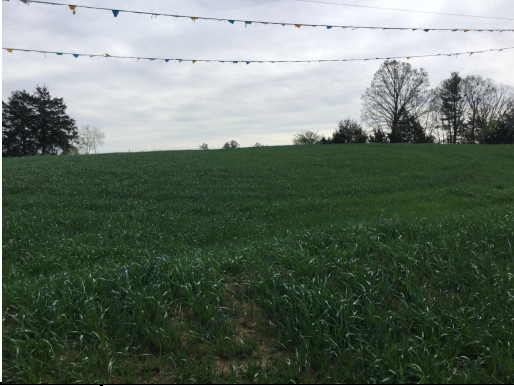
GPS Location	1	GPS Location	2		
Field Station#	14995+00	Field Station#	15105+00		
Pic 1 Desc.	Permanent vegetation approximately 4-6" tall GAS Snow Creek Rd	Pic 2 Desc.	New row of P1 silt fence installed per punch list item

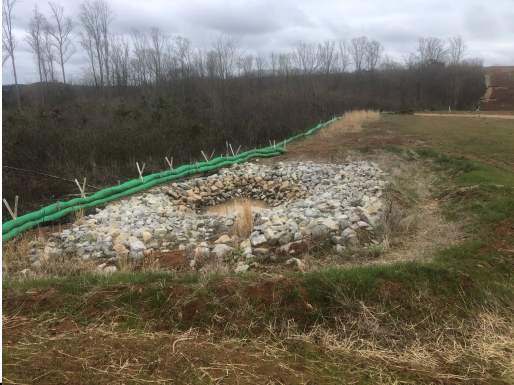
GPS Location	3	GPS Location	4		
Field Station#	15122+00	Field Station#	15145+00		
Pic 3 Desc.	Plunge pool in good condition and performing intended function	Pic 4 Desc.	Permanent vegetation approximately 6" tall GAS Rock Creek Rd

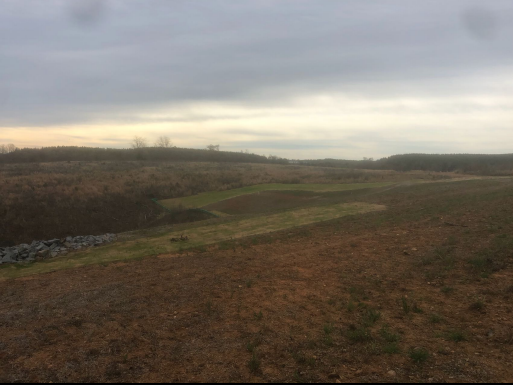
GPS Location	5	GPS Location	6		
Field Station#	15202+00	Field Station#	15257+00		
Pic 5 Desc.	Curlex installed and vegetation growing to curb further erosion issues	Pic 6 Desc.	Area at HDD exit where ditch subsidence was fixed, Curlex installed, vegetation growing

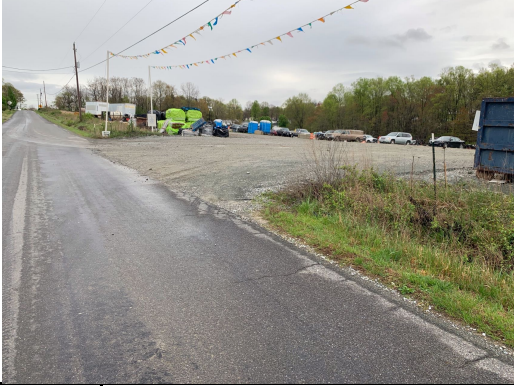
GPS Location	0000000000	GPS Location	0000000000		
Field Station#	0000+00	Field Station#	0000+00		
Pic 1 Desc.	RCE at gravel yard in good condition.	Pic 2 Desc.	Inlet protection and perimeter ECD's on west side of paved yard in acceptable condition.

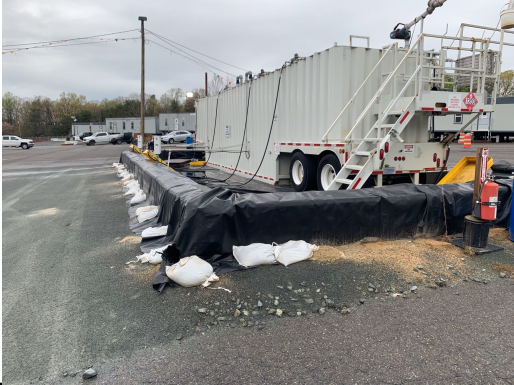
GPS Location	0000000000	GPS Location	0000000000		
Field Station#	0000+00	Field Station#	000000+00		
Pic 3 Desc.	Secondary containment structure for fuel cell in compliance	Pic 4 Desc.	Secondary containment structure on south end of paved yard needs edges of plastic liner secured.

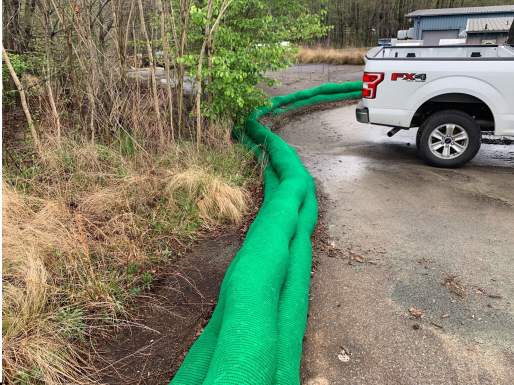
Insert image here			
GPS Location	0000000000	GPS Location			
Field Station#	0000+00	Field Station#			
Pic 5 Desc.	Perimeter ECD's on southwest corner of paved yard in good condition.	Pic 6 Desc.

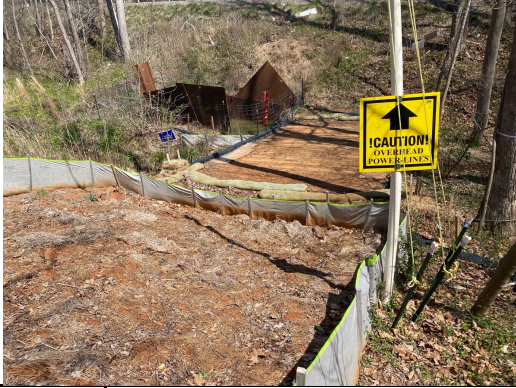
GPS Location	0	GPS Location	0		
Field Station#	13834+34	Field Station#	14009+20		
Pic 1 Desc.	Approximately 13834+34. Overview of stream crossing, equipment bridge and ECDs at stream S-C14.		Pic 2 Desc.	Approximately 14009+20. Overview of stream crossing, equipment bridge and ECDs at stream S-KL38.

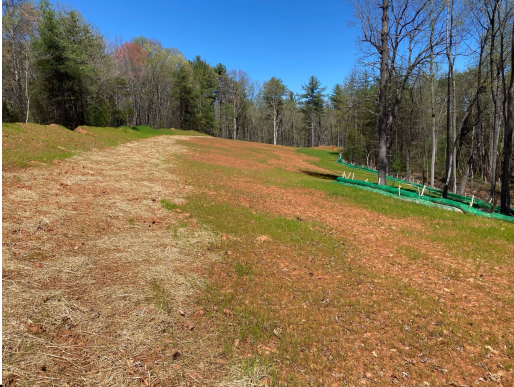
GPS Location	0	GPS Location	0		
Field Station#	14026+75	Field Station#	13855+00		
Pic 3 Desc.	Approximately 14026+75. Overview of ROW. ROW temporarily stabilized and has winter vegetation growing.		Pic 4 Desc.	Approximately 13855+00. Overview of ROW. ROW temporarily stabilized and has winter vegetation growing.	
Insert image here			Insert image here		
GPS Location		GPS Location			
Field Station#		Field Station#			
Pic 5 Desc.		Pic 6 Desc.

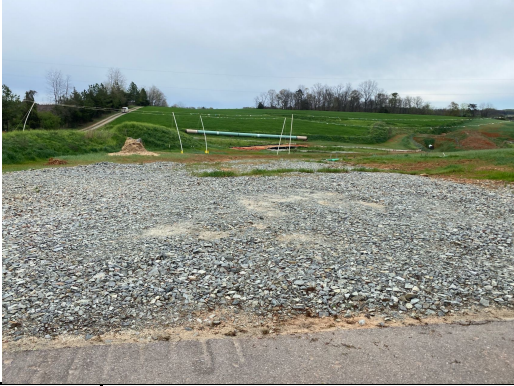
GPS Location	0	GPS Location	0		
Field Station#	15296+00	Field Station#	15600+00		
Pic 1 Desc.	Oxford Rd RCE.	Pic 2 Desc.	Stream crossing S-CC3

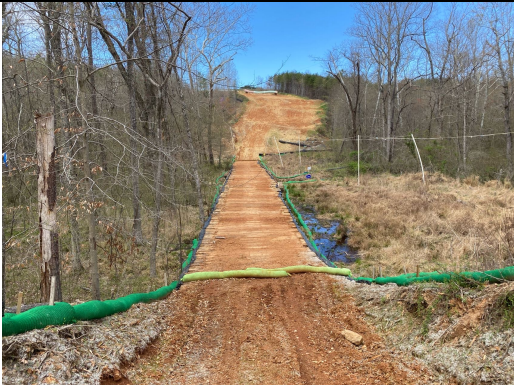
GPS Location	0	GPS Location	0		
Field Station#	15596+50	Field Station#	15365+00		
Pic 3 Desc.	Stream crossing S-CC1	Pic 4 Desc.	Vegetation growth in section where final cleanup has been performed.

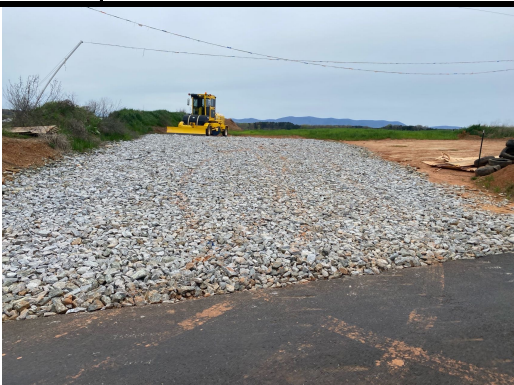
Insert image here			
GPS Location	0	GPS Location			
Field Station#	15496+00	Field Station#			
Pic 5 Desc.	Climax Rd RCE	Pic 6 Desc.

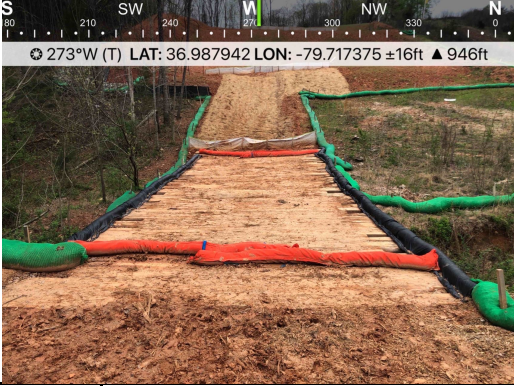
GPS Location	0	GPS Location	0		
Field Station#	14673+10	Field Station#	14676+00		
Pic 1 Desc.	Equipment bridge clean at stream S-H37	Pic 2 Desc.	Perimeter CFS functioning as intended

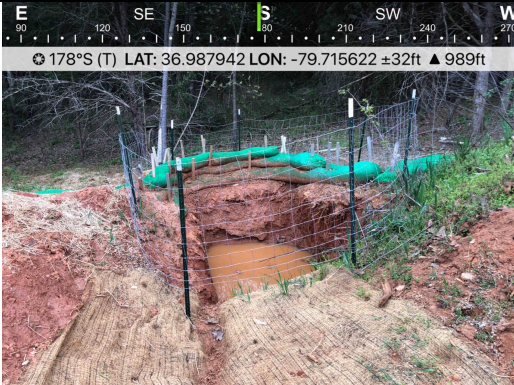
GPS Location	0	GPS Location	0		
Field Station#	14677+00	Field Station#	14680+37		
Pic 3 Desc.	Sump pit functioning as intended	Pic 4 Desc.	Equipment bridge clean as stream S-H36

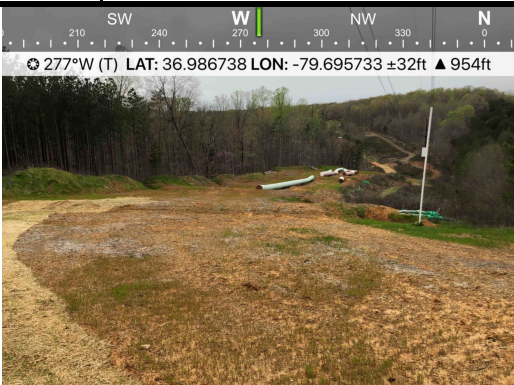
GPS Location	0	GPS Location	0		
Field Station#	14740+00	Field Station#	14745+00		
Pic 5 Desc.	Temporary stabilization	Pic 6 Desc.	Sump pit functioning as intended

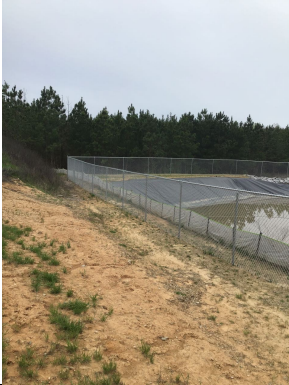
GPS Location	O	GPS Location	O		
Field Station#	00+00	Field Station#	00+00		
Pic 1 Desc.	Observing ECD's performing as they should	Pic 2 Desc.	Observing storm water pond.

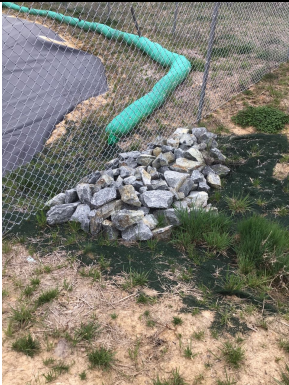
GPS Location	O	GPS Location	O		
Field Station#	00+00	Field Station#	00+00		
Pic 3 Desc.	Observing ECD's performing as they should.	Pic 4 Desc.	Observing ECD's performing as they should.		
Insert image here			Insert image here		
GPS Location		GPS Location			
Field Station#		Field Station#			
Pic 5 Desc.		Pic 6 Desc.
