# Visual Site Inspection Report

<b>Project Name</b>	H-600 Pipeline Spread I	<b>AFE</b>	124300139	<b>Spread</b>	H-600 Pipeline Spread I
<b>Contractor</b>	Precision			<b>Report #</b>	8965
<b>Inspector</b>	Charles Head			<b>Date/Time</b>	3/9/2020 9:34 AM
<b>Permit #</b>	TBD	<b>Inspection Type</b>	VA SWPP	<b>Station Begin</b>	13784+35
<b>State</b>	VA	<b>Inspection Area</b>	Partial	<b>Station End</b>	14171+36
<b>County</b>	Franklin	<b>Ground</b>	Dry	<b>Temperature (°F)</b>	65.00
<b>Municipality</b>	N/A	<b>Weather</b>	Sunny	<b>Rain Gauge (in)</b>	0.00
				<b>Rain Accumulation Time (days)</b>	6.00

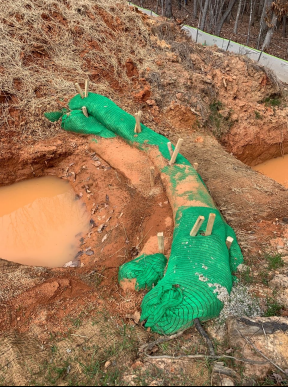
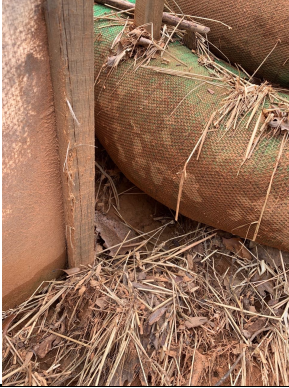
<b>GPS Location</b>	O	<b>GPS Location</b>	O		
<b>Field Station#</b>	15750+80	<b>Field Station#</b>	15751+00		
<b>Pic 1 Desc.</b>	Observing end treatment that requires maintenance.	<b>Pic 2 Desc.</b>	Observing undermined end treatment.

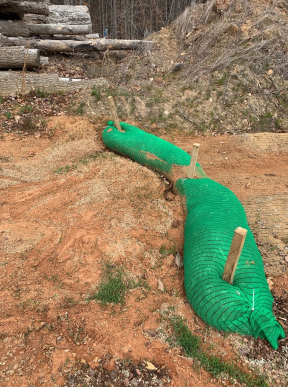
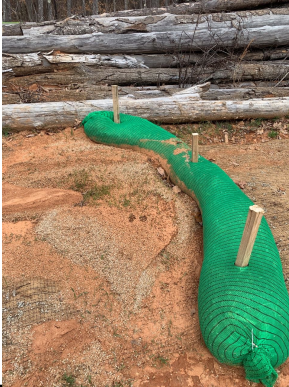
<b>GPS Location</b>	O	<b>GPS Location</b>	O		
<b>Field Station#</b>	15750+00	<b>Field Station#</b>	15749+80		
<b>Pic 3 Desc.</b>	Observing cfs that requires maintenance.	<b>Pic 4 Desc.</b>	Observing cfs that requires maintenance.		
Insert image here			Insert image here		
<b>GPS Location</b>		<b>GPS Location</b>			
<b>Field Station#</b>		<b>Field Station#</b>			
<b>Pic 5 Desc.</b>		<b>Pic 6 Desc.</b>

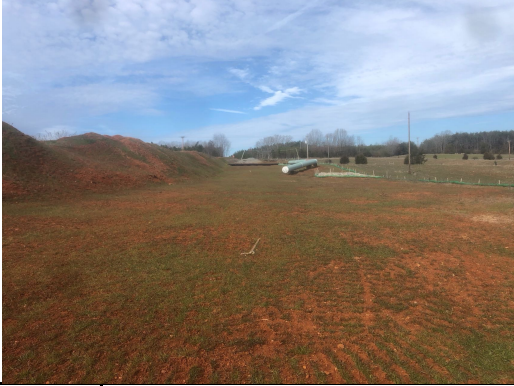
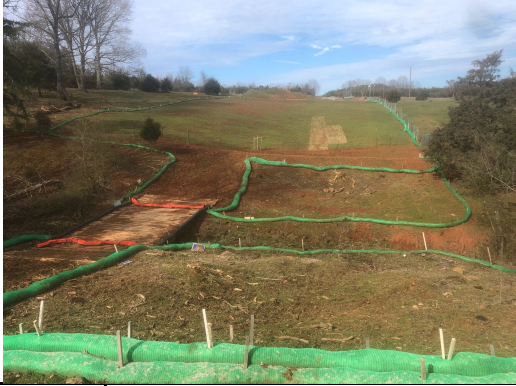
<b>GPS Location</b>	1	<b>GPS Location</b>	2		
<b>Field Station#</b>	14984+00	<b>Field Station#</b>	14992+00		
<b>Pic 1 Desc.</b>	View of temporary stabilization along ROW and spoil pile. No issues observed.		<b>Pic 2 Desc.</b>	Bridge and ECD's at stream crossing in good condition. No issues observed.

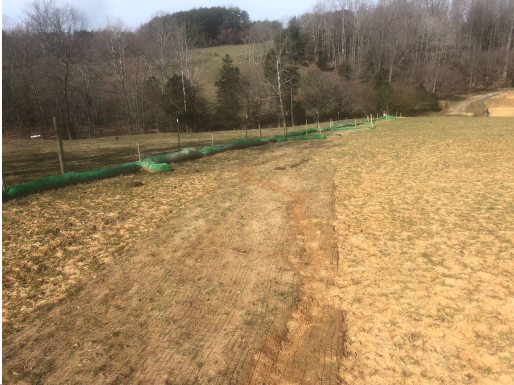
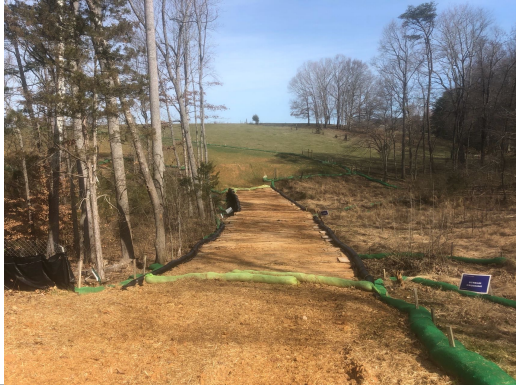
<b>GPS Location</b>	3	<b>GPS Location</b>	4		
<b>Field Station#</b>	15095+00	<b>Field Station#</b>	15104+28		
<b>Pic 3 Desc.</b>	Erosion beginning to occur underneath installed erosion control blanket. Will monitor for signs of worsening.		<b>Pic 4 Desc.</b>	Bridge and ECD's at stream crossing in good condition. No issues observed.

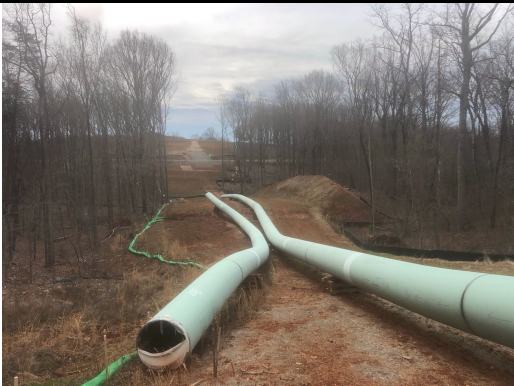
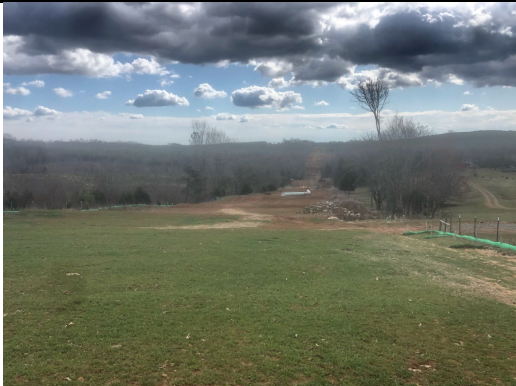
<b>GPS Location</b>	5	<b>GPS Location</b>	6		
<b>Field Station#</b>	15136+00	<b>Field Station#</b>	15152+00		
<b>Pic 5 Desc.</b>	ROW stabilized with vegetation and pellets. Pipe sections on skids. No issues observed.		<b>Pic 6 Desc.</b>	ROW in area switching from permanent to temporary stabilization. No issues observed.

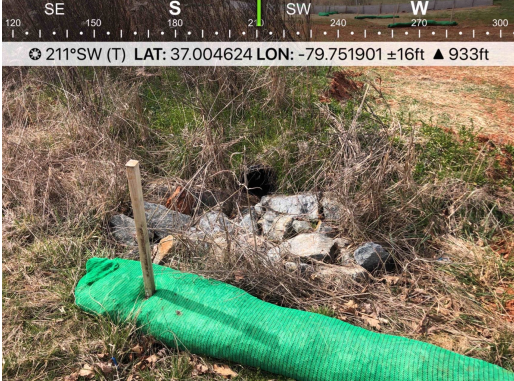
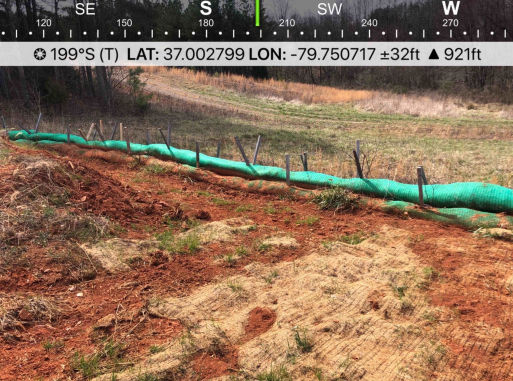
<b>GPS Location</b>	0	<b>GPS Location</b>	0		
<b>Field Station#</b>	14550+00	<b>Field Station#</b>	14559+00		
<b>Pic 1 Desc.</b>	CWD inlet pipe clean and functioning as intended	<b>Pic 2 Desc.</b>	Perimeter CFS functioning as intended

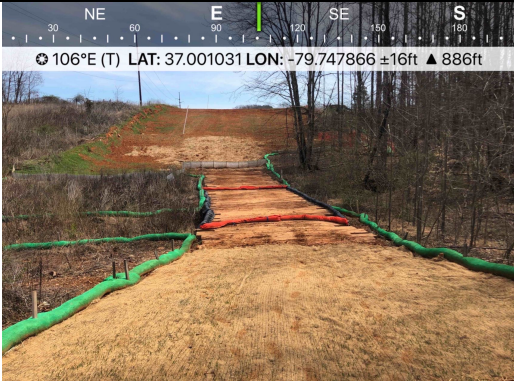
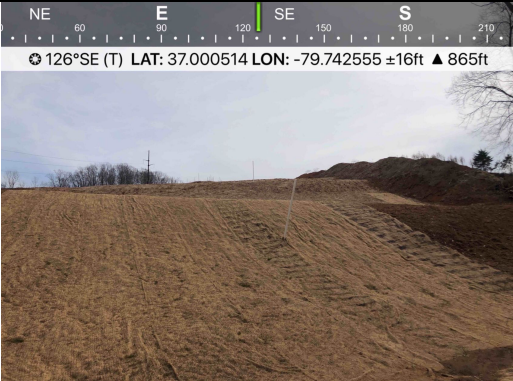
<b>GPS Location</b>	0	<b>GPS Location</b>	0		
<b>Field Station#</b>	14568+10	<b>Field Station#</b>	14587+00		
<b>Pic 3 Desc.</b>	Equipment bridge clean at stream S-E18	<b>Pic 4 Desc.</b>	Temporary stabilization on slope functioning as intended

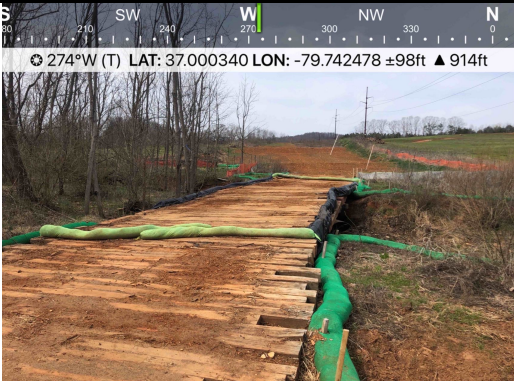
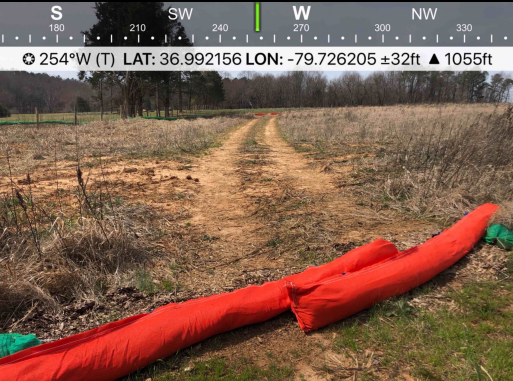
<b>GPS Location</b>	0	<b>GPS Location</b>	0		
<b>Field Station#</b>	14582+85	<b>Field Station#</b>	14641+00		
<b>Pic 5 Desc.</b>	Equipment bridge clean at stream S-E17	<b>Pic 6 Desc.</b>	Perimeter CFS fixed so that land owner can access field without damaging ECDs

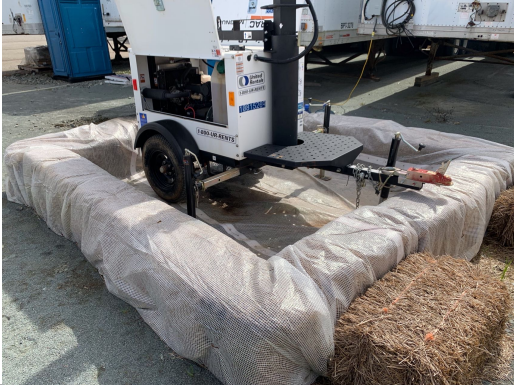
<b>GPS Location</b>	0000000000	<b>GPS Location</b>	0000000000		
<b>Field Station#</b>	0000+00	<b>Field Station#</b>	0000+00		
<b>Pic 1 Desc.</b>	Secondary containment structure for fuel cell in compliance	<b>Pic 2 Desc.</b>	Perimeter ECD's on west side of paved yard in good condition.

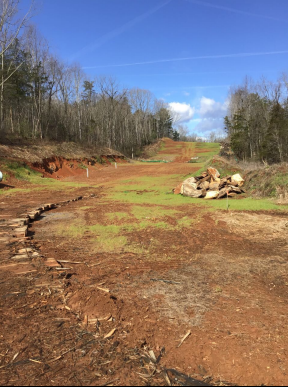
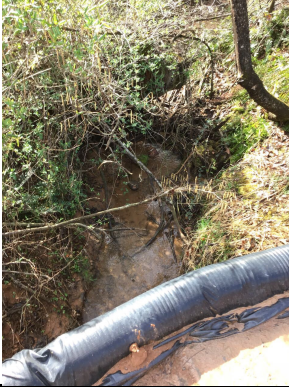
<b>GPS Location</b>	0000	<b>GPS Location</b>	0000		
<b>Field Station#</b>	13781+50	<b>Field Station#</b>	13781+64		
<b>Pic 1 Desc.</b>	Row photo showing vegetation	<b>Pic 2 Desc.</b>	Stream crossing photo facing upstream

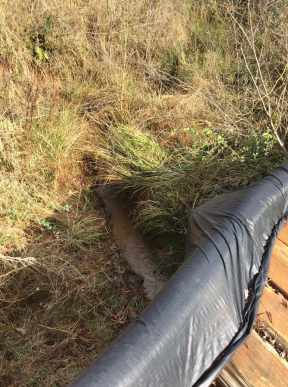
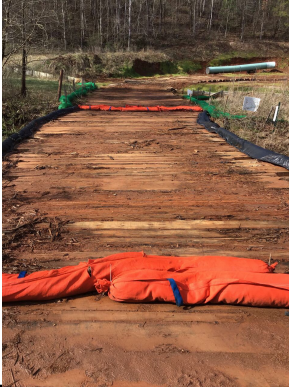
<b>GPS Location</b>	00000	<b>GPS Location</b>	0000		
<b>Field Station#</b>	13781+64	<b>Field Station#</b>	13781+65		
<b>Pic 3 Desc.</b>	Stream crossing photo facing downstream	<b>Pic 4 Desc.</b>	Observed ECDs and equipment bridge across streams		
Insert image here			Insert image here		
<b>GPS Location</b>		<b>GPS Location</b>			
<b>Field Station#</b>		<b>Field Station#</b>			
<b>Pic 5 Desc.</b>		<b>Pic 6 Desc.</b>

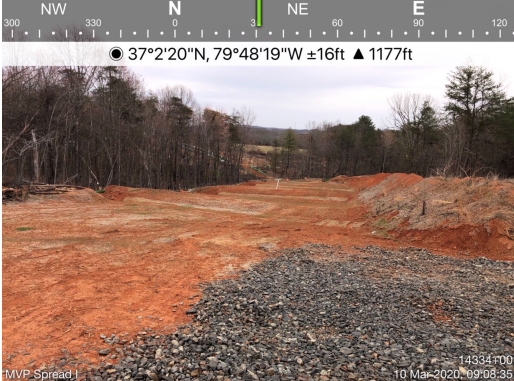
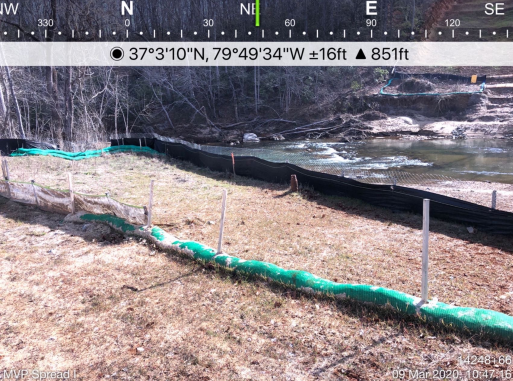
<b>GPS Location</b>	0	<b>GPS Location</b>	0		
<b>Field Station#</b>	14334+00	<b>Field Station#</b>	14248+66		
<b>Pic 1 Desc.</b>	Waterbars in acceptable condition		<b>Pic 2 Desc.</b>	Super silt fence at Blackwater River in acceptable condition

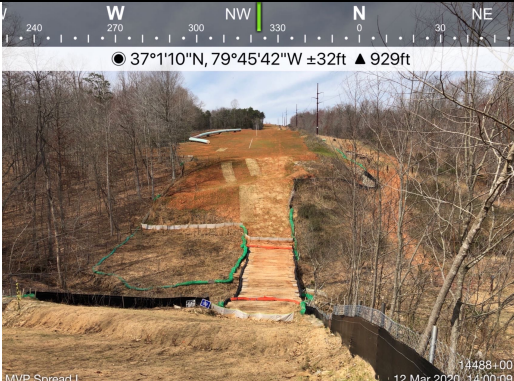
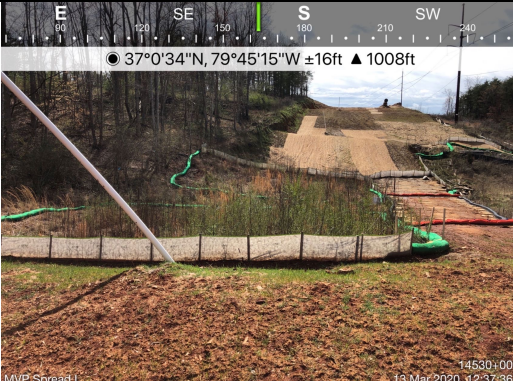
<b>GPS Location</b>	0	<b>GPS Location</b>	0		
<b>Field Station#</b>	14488+00	<b>Field Station#</b>	14530+00		
<b>Pic 3 Desc.</b>	Equipment bridge in acceptable condition		<b>Pic 4 Desc.</b>	P1 silt fence in acceptable condition	
Insert image here		Insert image here			
<b>GPS Location</b>		<b>GPS Location</b>			
<b>Field Station#</b>		<b>Field Station#</b>			
<b>Pic 5 Desc.</b>		<b>Pic 6 Desc.</b>

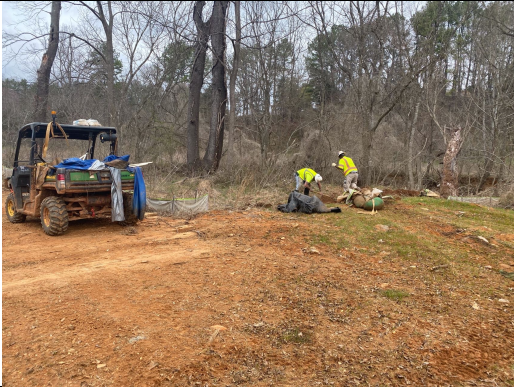
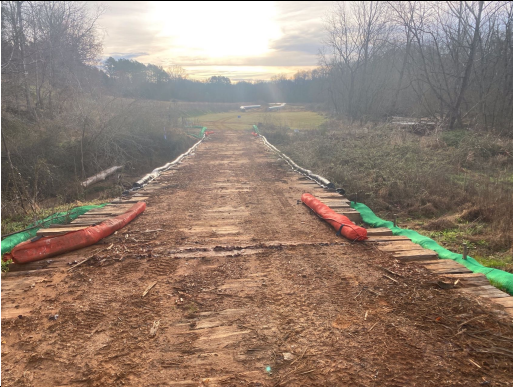
<b>GPS Location</b>	0	<b>GPS Location</b>	0		
<b>Field Station#</b>	13876+25	<b>Field Station#</b>	13862+80		
<b>Pic 1 Desc.</b>	Approximately 13876+25. Crews replacing damaged P-1.		<b>Pic 2 Desc.</b>	Approximately 13862+80. Overview of stream crossing, equipment bridge and ECDs at stream S-C17.

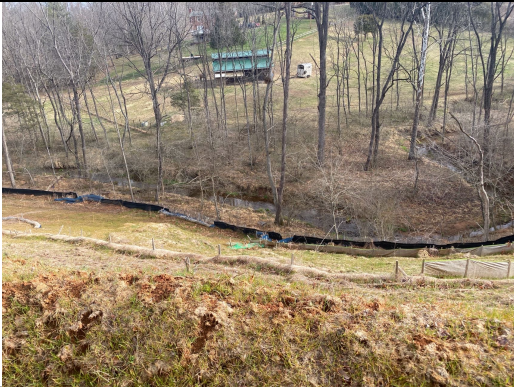
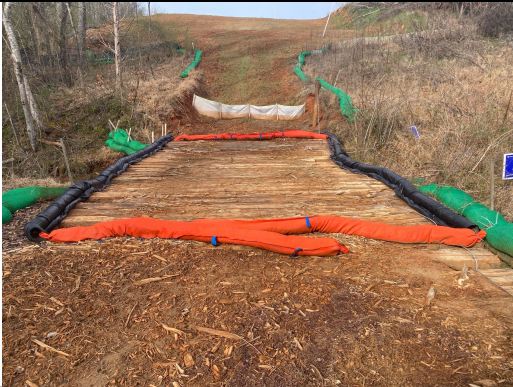
<b>GPS Location</b>	0	<b>GPS Location</b>	0		
<b>Field Station#</b>	13817+00	<b>Field Station#</b>	13805+70		
<b>Pic 3 Desc.</b>	Approximately 13817+00. Over of ROW. ROW temporarily stabilized and has winter vegetation growing. ECDs installed and appear to be functioning correctly at time of		<b>Pic 4 Desc.</b>	Approximately 13805+70. Overview of stream crossing, equipment bridge and ECDs at stream S-D20.	
Insert image here			Insert image here		
<b>GPS Location</b>		<b>GPS Location</b>

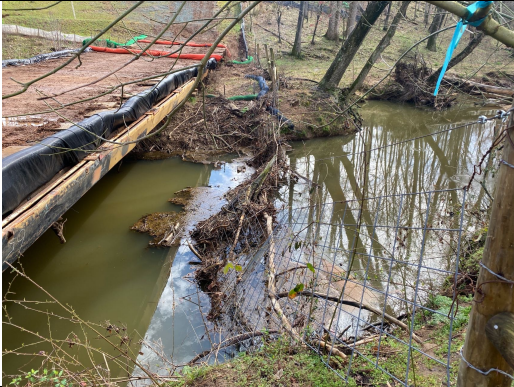
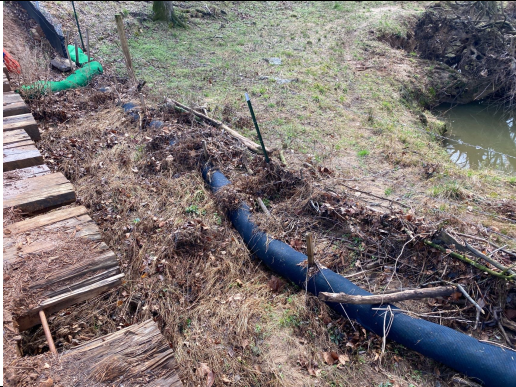
<b>GPS Location</b>	0	<b>GPS Location</b>	0		
<b>Field Station#</b>	15314+30	<b>Field Station#</b>	15314+30		
<b>Pic 1 Desc.</b>	Debris build up along landowner fence across stream S-C4.	<b>Pic 2 Desc.</b>	Reinstall CFS. Moved by stormwater.

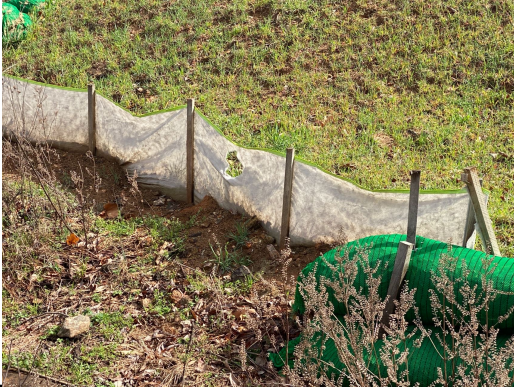
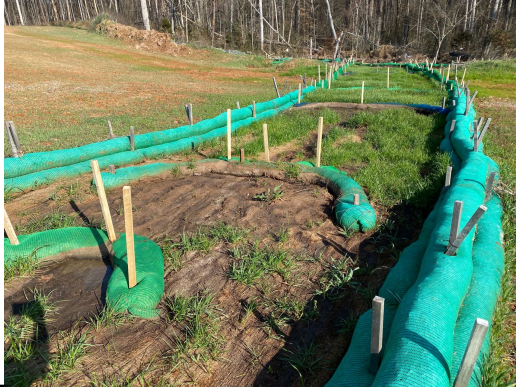
<b>GPS Location</b>	P	<b>GPS Location</b>	0		
<b>Field Station#</b>	15315+00	<b>Field Station#</b>	15372+00		
<b>Pic 3 Desc.</b>	Replace damaged P1 fence.	<b>Pic 4 Desc.</b>	Replace CFS in natural drainage feature.

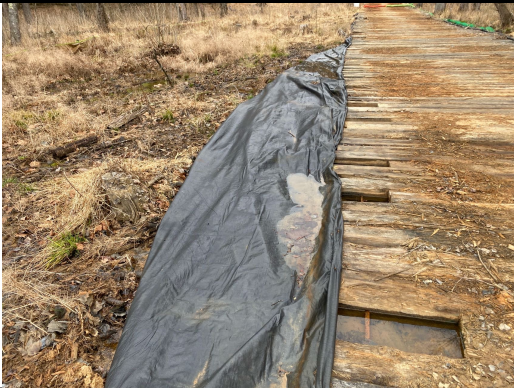
Insert image here			
<b>GPS Location</b>	0	<b>GPS Location</b>			
<b>Field Station#</b>	15666+50	<b>Field Station#</b>			
<b>Pic 5 Desc.</b>	Reinstall geotech under mats.	<b>Pic 6 Desc.</b>

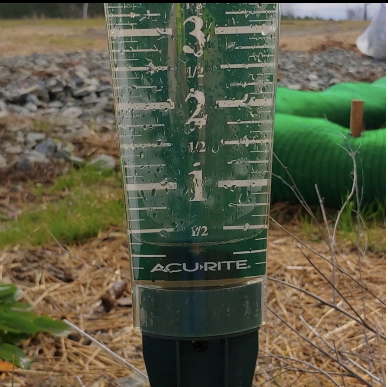
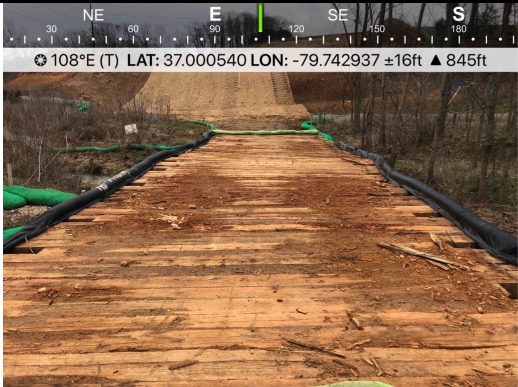
GPS Location 0	
	Field Station# 14758+16		Field Station# 14582+85	Pic 2 Desc. Equipment bridge clean at stream S-E17	
	Pic 1 Desc. Rain gauge at Indian Cave Road 0.4"

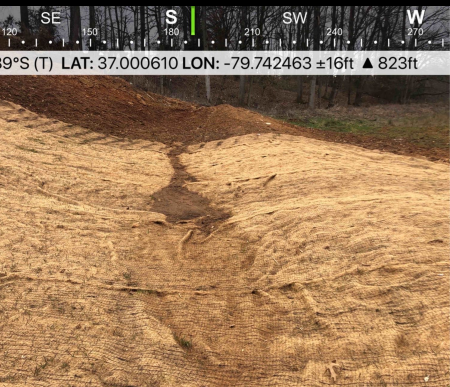
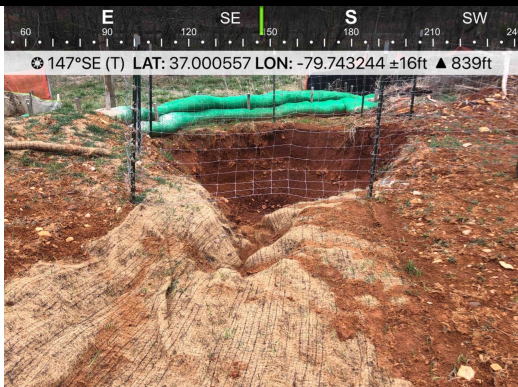
GPS Location 0	
	Field Station# 14585+00		Field Station# 14591+00	Pic 4 Desc. Sum pit functioning as intended	
	Pic 3 Desc. Erosion forming in water bar flow path. Will continue to monitor.

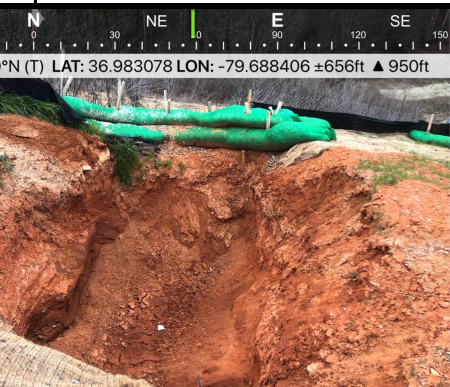
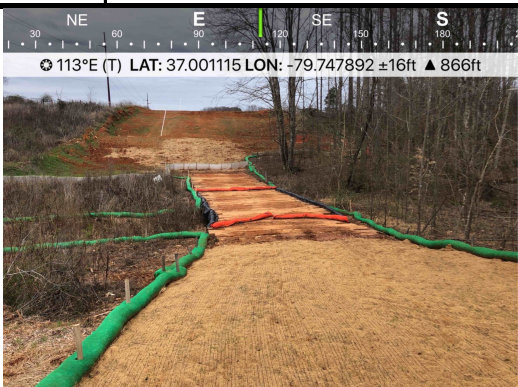
GPS Location 0	
	Field Station# 14560+00		Field Station# 14568+10	Pic 6 Desc. Equipment bridge clean at stream S-E18	
	Pic 5 Desc. Sump pit functioning as intended

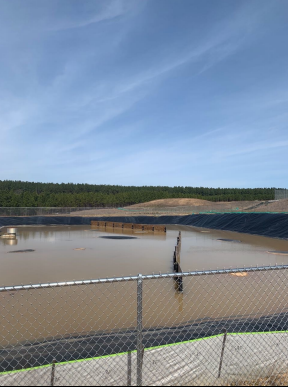
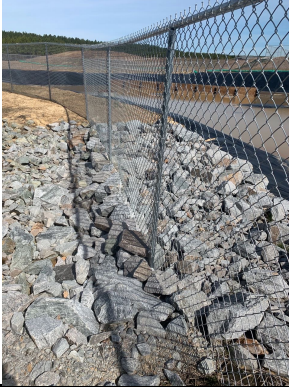
<b>GPS Location</b>	O	<b>GPS Location</b>	O		
<b>Field Station#</b>	00+00	<b>Field Station#</b>	00+00		
<b>Pic 1 Desc.</b>	Observing storm water pond at Transco.	<b>Pic 2 Desc.</b>	Observing rock overflow.

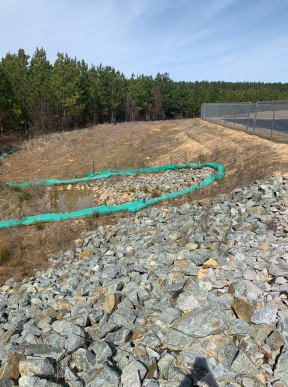
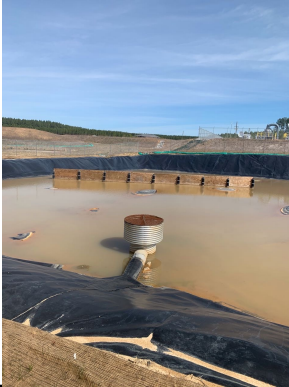
<b>GPS Location</b>	O	<b>GPS Location</b>	O		
<b>Field Station#</b>	00+00	<b>Field Station#</b>	00+00		
<b>Pic 3 Desc.</b>	Observing rock overflow.	<b>Pic 4 Desc.</b>	Observing storm water pond at Transco.		
Insert image here			Insert image here		
<b>GPS Location</b>		<b>GPS Location</b>			
<b>Field Station#</b>		<b>Field Station#</b>			
<b>Pic 5 Desc.</b>		<b>Pic 6 Desc.</b>

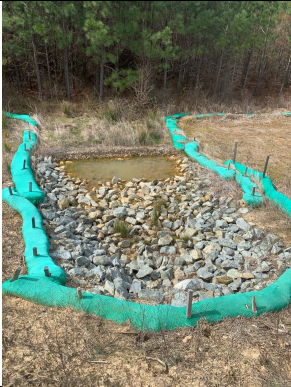
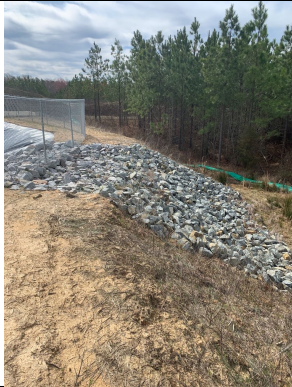
<b>GPS Location</b>	O	<b>GPS Location</b>	O		
<b>Field Station#</b>	00+00	<b>Field Station#</b>	00+00		
<b>Pic 1 Desc.</b>	Observing rock drain.	<b>Pic 2 Desc.</b>	Observing emergency overflow.

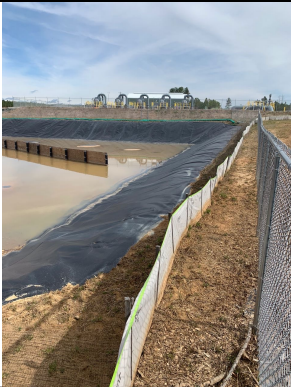
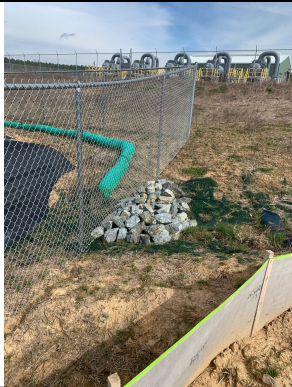
<b>GPS Location</b>	O	<b>GPS Location</b>	O		
<b>Field Station#</b>	00+00	<b>Field Station#</b>	00+00		
<b>Pic 3 Desc.</b>	Observing ECD's and storm water pond.	<b>Pic 4 Desc.</b>	Observing ECD's performing as they should.		
<p style="text-align: center;">Insert image here</p>			<p style="text-align: center;">Insert image here</p>		
<b>GPS Location</b>		<b>GPS Location</b>			
<b>Field Station#</b>		<b>Field Station#</b>			
<b>Pic 5 Desc.</b>		<b>Pic 6 Desc.</b>
