Visual Site Inspection Report

Project Name	H-600 Pipeline Spread I	AFE	124300139	Spread	H-600 Pipeline Spread I
Contractor	Precision			Report #	10033
Inspector	Charles Head			Date/Time	4/16/2020 4:09 PM
Permit #	TBD	Inspection Type	VA SWPP	Station Begin	13784+35
State	VA	Inspection Area	Partial	Station End	14171+36
County	Franklin	Ground	Damp	Temperature (°F)	50.00
Municipality	N/A	Weather	Sunny	Rain Gauge (in)	3.55
				Rain Accumulation Time (days)	6.00

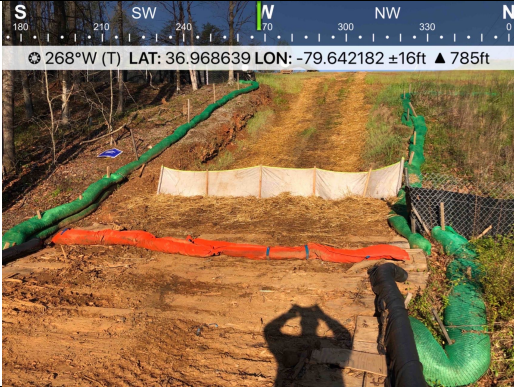
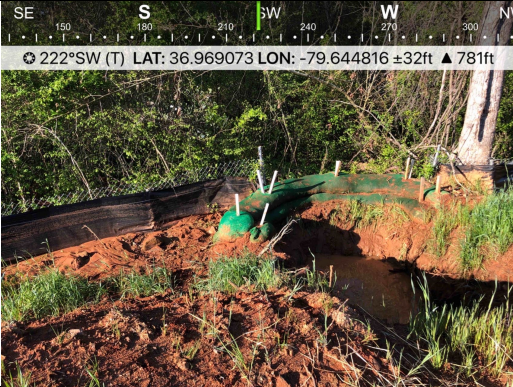
GPS Location	0	GPS Location	0		
Field Station#	14915+96	Field Station#	14908+00		
Pic 1 Desc.	Bridge cleaned off and new P1 silt fence installed that had washed out at stream S-G16	Pic 2 Desc.	SSF reattached and CFS on end treatment cleaned off

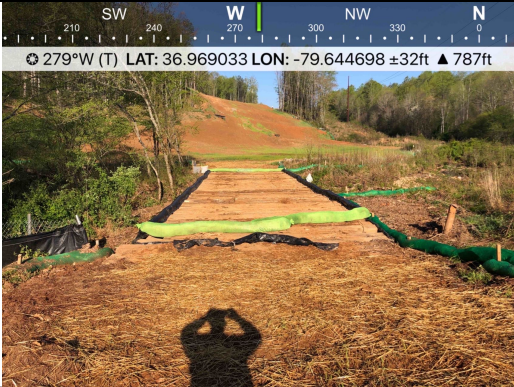
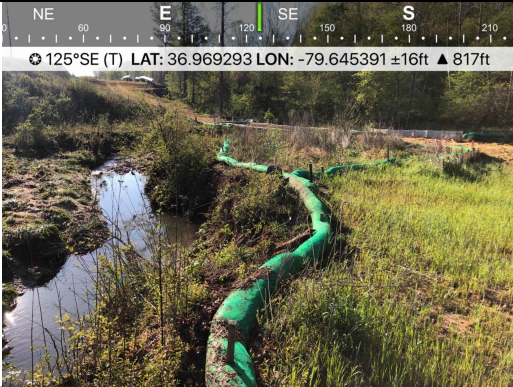
GPS Location	0	GPS Location	0		
Field Station#	14907+70	Field Station#	14907+30		
Pic 3 Desc.	Bridge at stream S-DD3 rebuilt that shifted due to high water	Pic 4 Desc.	Perimeter CFS reinstalled that washed into stream due to high water

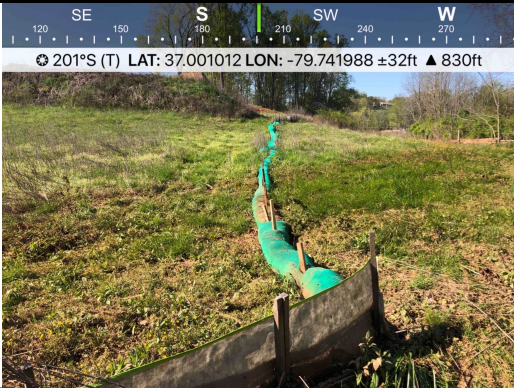
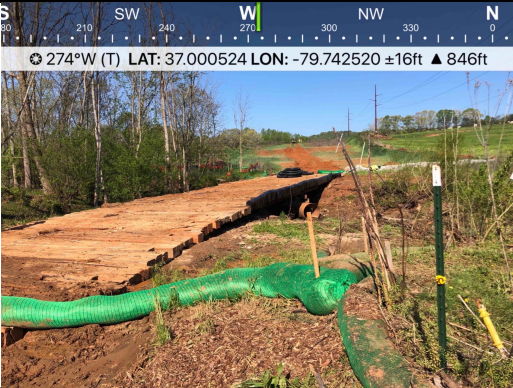
GPS Location	0	GPS Location	0		
Field Station#	14583+00	Field Station#	14582+85		
Pic 5 Desc.	Perimeter CFS reinstalled that washed out due to high water	Pic 6 Desc.	Bridge at stream S-E17 being rebuilt that washed out due to high water

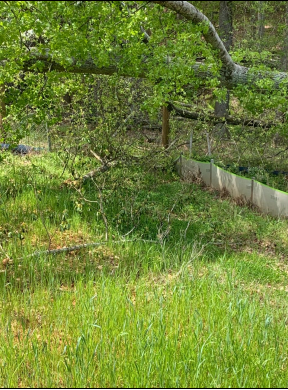
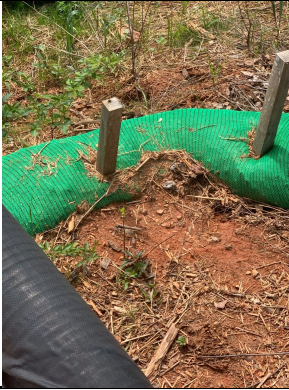
GPS Location	O		GPS Location	O	
Field Station#	15987+80		Field Station#	15868+50	
Pic 1 Desc.	Observing ECD's that require maintenance.		Pic 2 Desc.	Observing CFS that requires maintenance.

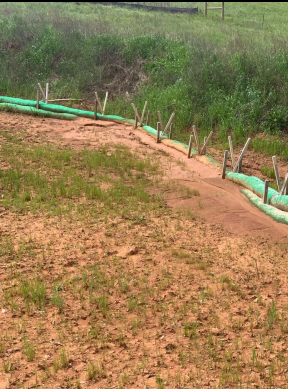
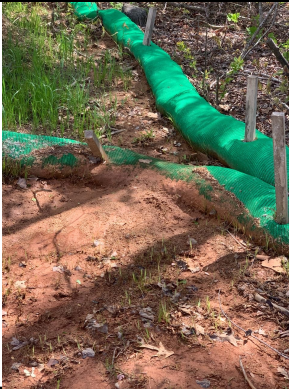
GPS Location	O		GPS Location	O	
Field Station#	15930+00		Field Station#	15841+00	
Pic 3 Desc.	Observing CFS that requires maintenance.		Pic 4 Desc.	Observing CFS that requires maintenance.	
Insert image here			Insert image here		
GPS Location			GPS Location		
Field Station#			Field Station#		
Pic 5 Desc.			Pic 6 Desc.

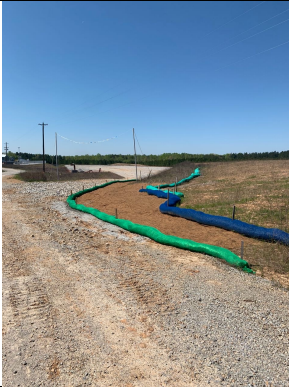
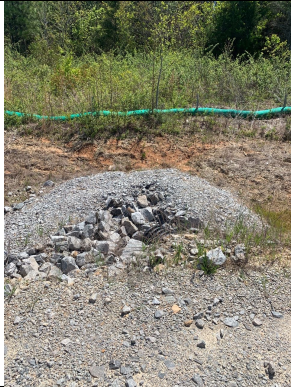
GPS Location	O	GPS Location	O		
Field Station#	00+00	Field Station#	00+00		
Pic 1 Desc.	Observing ECD's performing as they should.	Pic 2 Desc.	Observing outlet and outlet protection.

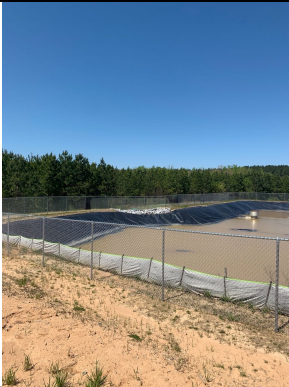
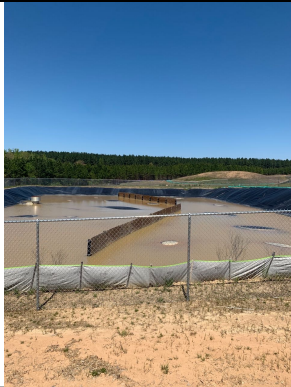
GPS Location	O	GPS Location	O		
Field Station#	00+00	Field Station#	00+00		
Pic 3 Desc.	Observing storm water pond.	Pic 4 Desc.	Observing storm water pond.		
Insert image here			Insert image here		
GPS Location		GPS Location			
Field Station#		Field Station#			
Pic 5 Desc.		Pic 6 Desc.
