# Visual Site Inspection Report

<b>Project Name</b>	H-600 Pipeline Spread I	<b>AFE</b>	124300139	<b>Spread</b>	H-600 Pipeline Spread I
<b>Contractor</b>	Precision			<b>Report #</b>	10462
<b>Inspector</b>	Charles Head			<b>Date/Time</b>	4/28/2020 2:21 PM
<b>Permit #</b>	TBD	<b>Inspection Type</b>	VA SWPP	<b>Station Begin</b>	13784+35
<b>State</b>	VA	<b>Inspection Area</b>	Partial	<b>Station End</b>	14171+36
<b>County</b>	Franklin	<b>Ground</b>	Damp	<b>Temperature (°F)</b>	65.00
<b>Municipality</b>	N/A	<b>Weather</b>	Cloudy	<b>Rain Gauge (in)</b>	1.55
				<b>Rain Accumulation Time (days)</b>	6.00

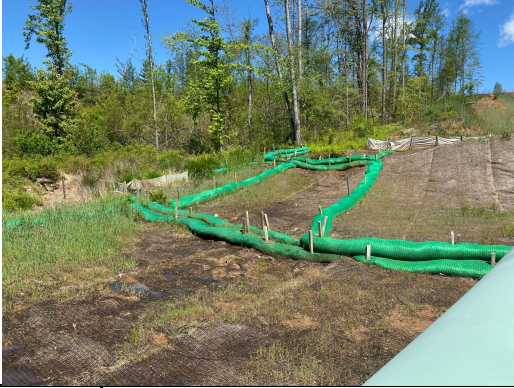
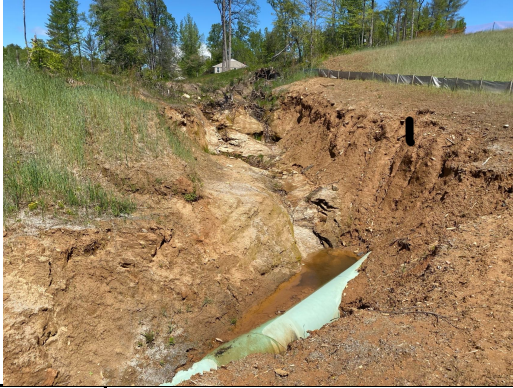
<b>GPS Location</b>	0	<b>GPS Location</b>	0		
<b>Field Station#</b>	13999+00	<b>Field Station#</b>	14000+00		
<b>Pic 1 Desc.</b>	Approximately 13999+00. Overview of ECDs installed to filter and slow adjacent pond overflow.		<b>Pic 2 Desc.</b>	Approximately 14000+00. View of area that adjacent pond overflow path enters the LOD. Adjacent pond overflow is minor after the last rain event.

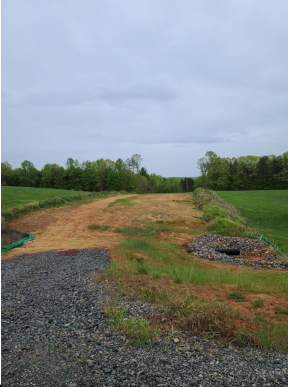
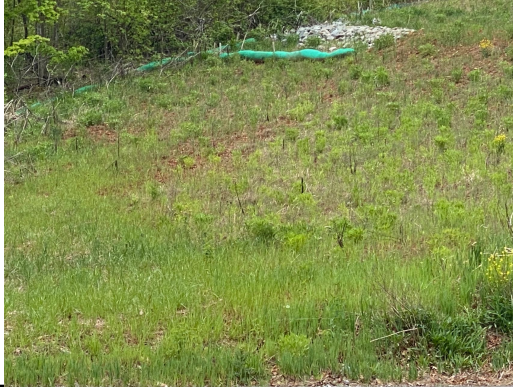
<b>GPS Location</b>	0	<b>GPS Location</b>	0		
<b>Field Station#</b>	14133+00	<b>Field Station#</b>	14017+50		
<b>Pic 3 Desc.</b>	Approximately 14133+00. Overview of ROW. ROW temporarily stabilized and has winter vegetation growing. RCE appears to be installed and functioning correctly at time of		<b>Pic 4 Desc.</b>	Approximately 14017+50. Overview of ROW. ROW temporarily stabilized and has winter and permanent vegetation growing.

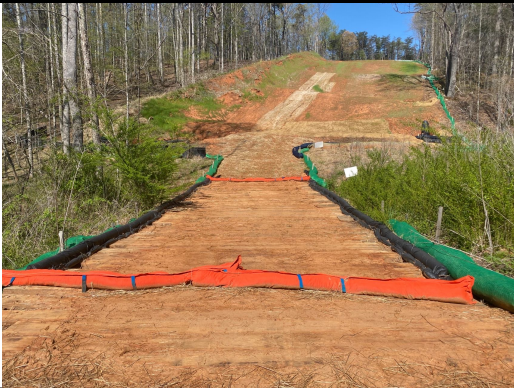
Insert image here			
<b>GPS Location</b>	0	<b>GPS Location</b>			
<b>Field Station#</b>	14157+55	<b>Field Station#</b>			
<b>Pic 5 Desc.</b>	Approximately 14157+55. Overview of stream crossing, equipment bridge and ECDs at stream S-KL51.		<b>Pic 6 Desc.</b>

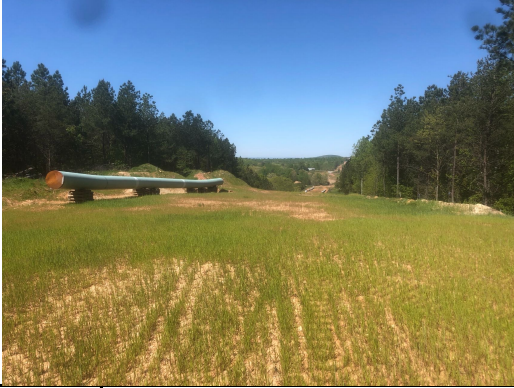
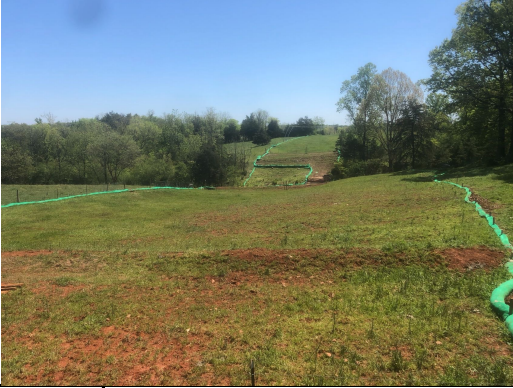
<b>GPS Location</b>	1	<b>GPS Location</b>	2		
<b>Field Station#</b>	14958+00	<b>Field Station#</b>	14987+00		
<b>Pic 1 Desc.</b>	Sparse temporary vegetation growing along ROW. Perimeter ECD's in place and functional.		<b>Pic 2 Desc.</b>	Permanent vegetation growing along ROW. Perimeter ECD's in place and functional. Water bars in good condition.

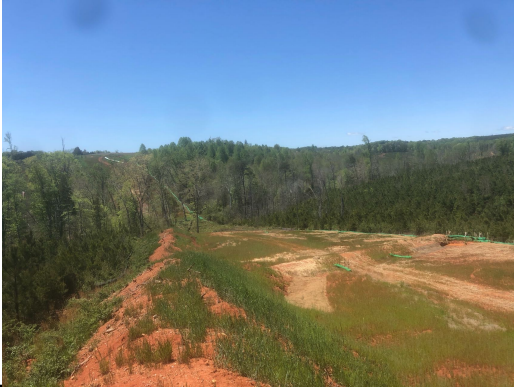
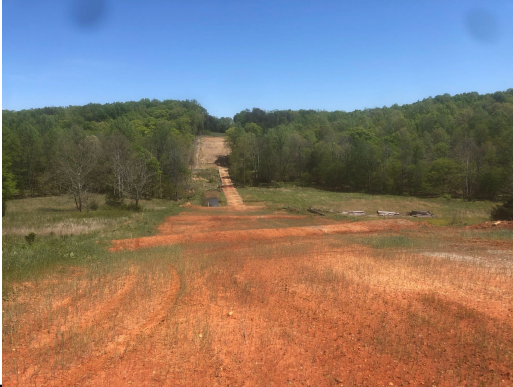
<b>GPS Location</b>	3	<b>GPS Location</b>	4		
<b>Field Station#</b>	15031+00	<b>Field Station#</b>	15037+00		
<b>Pic 3 Desc.</b>	Spoil pile stabilized. View of ROW with installed ECD's to help curb erosion channeling occurring in throats of water bars.		<b>Pic 4 Desc.</b>	Sparse temporary vegetation growing along ROW. Perimeter ECD's in place and functional.

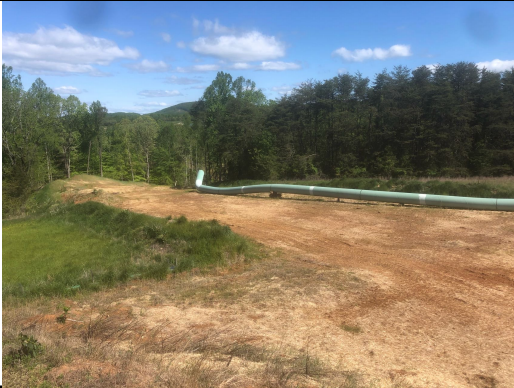
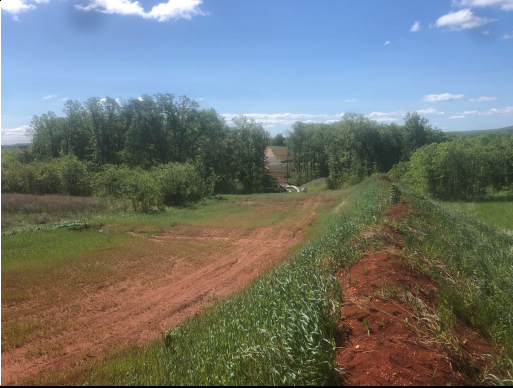
<b>Pic 5 Desc.</b>	Sparse temporary vegetation growing along ROW. Perimeter ECD's in place and functional.		<b>Pic 6 Desc.</b>	Sparse temporary vegetation growing along ROW. Perimeter ECD's in place and functional. Spoil pile stabilized.

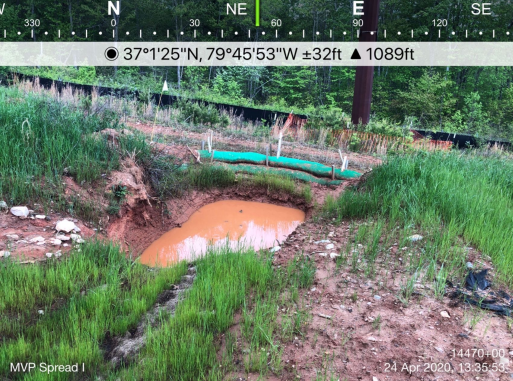
<b>GPS Location</b>	0	<b>GPS Location</b>	0		
<b>Field Station#</b>	14361+00	<b>Field Station#</b>	14470+00		
<b>Pic 1 Desc.</b>	Waterbar in acceptable condition		<b>Pic 2 Desc.</b>	Waterbar end treatment in acceptable condition

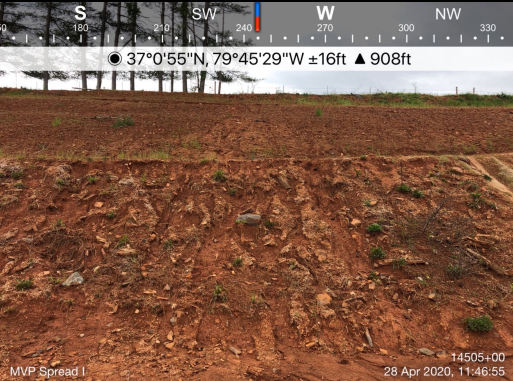
<b>GPS Location</b>	0	<b>GPS Location</b>	0		
<b>Field Station#</b>	14509+50	<b>Field Station#</b>	14505+00		
<b>Pic 5 Desc.</b>	CFS is undermined		<b>Pic 6 Desc.</b>	Rill erosion greater than 6" in depth on side slope

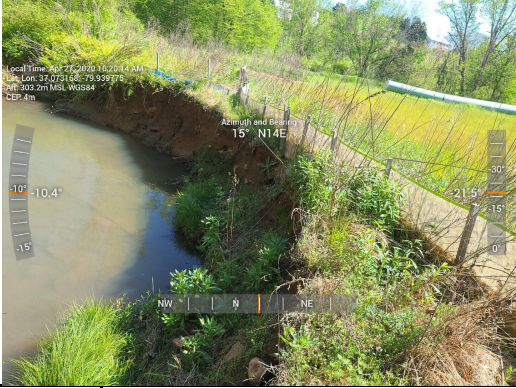
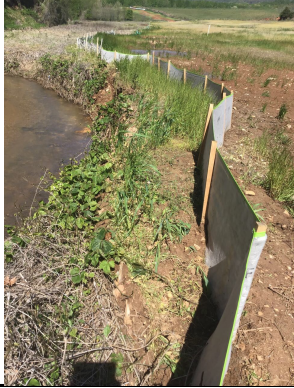
<b>GPS Location</b>	0000	<b>GPS Location</b>	00000		
<b>Field Station#</b>	13755+71	<b>Field Station#</b>	13678+00		
<b>Pic 1 Desc.</b>	Stream bank washing due to storm water , recommended moving P1 further back onto row , added to the punch list		<b>Pic 2 Desc.</b>	Inspected area of P1 that was recently moved back further on the LOD due to the stream bank washing during storm events

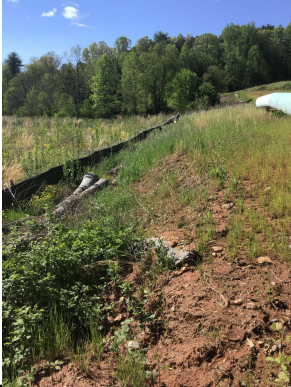
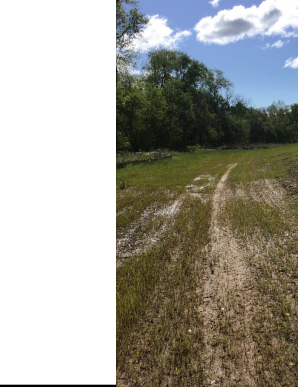
<b>GPS Location</b>	0000	<b>GPS Location</b>	0000		
<b>Field Station#</b>	13765+00	<b>Field Station#</b>	13760+00		
<b>Pic 3 Desc.</b>	Monitored ECDs while checking row.		<b>Pic 4 Desc.</b>	Row photo showing vegetation	
Insert image here			Insert image here		
<b>GPS Location</b>		<b>GPS Location</b>			
<b>Field Station#</b>		<b>Field Station#</b>			
<b>Pic 5 Desc.</b>			<b>Pic 6 Desc.</b>

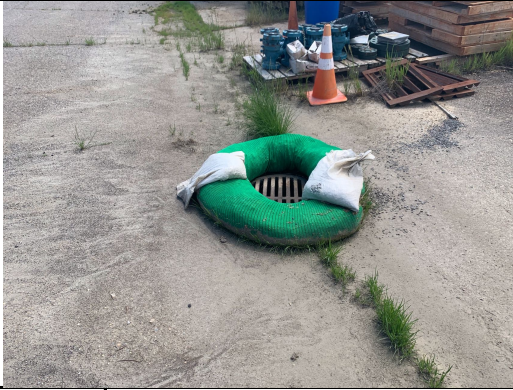
<b>GPS Location</b>	0000000000	<b>GPS Location</b>	0000000000		
<b>Field Station#</b>	0000+00	<b>Field Station#</b>	0000+00		
<b>Pic 1 Desc.</b>	Perimeter ECD's on west side of paved yard in good condition	<b>Pic 2 Desc.</b>	Inlet protection for parking lot drains in the paved in acceptable condition.

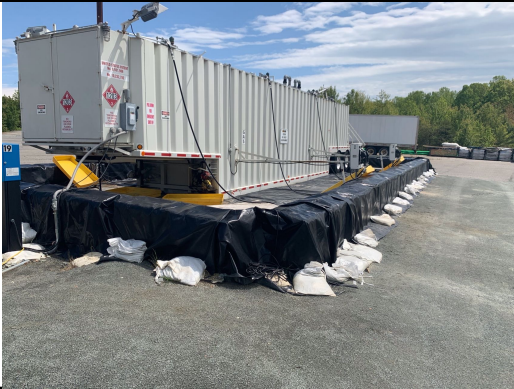
<b>GPS Location</b>	0000000000	<b>GPS Location</b>	0000000000		
<b>Field Station#</b>	0000+00	<b>Field Station#</b>	0000+00		
<b>Pic 3 Desc.</b>	Secondary containment structure for fuel cell in compliance	<b>Pic 4 Desc.</b>	Perimeter ECD's on west end of gravel yard.

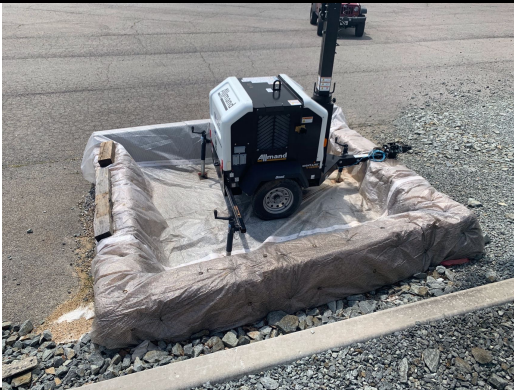
Insert image here			
<b>GPS Location</b>	0000000000	<b>GPS Location</b>			
<b>Field Station#</b>	0000+00	<b>Field Station#</b>			
<b>Pic 5 Desc.</b>	Secondary containment structure for light plant near office.	<b>Pic 6 Desc.</b>

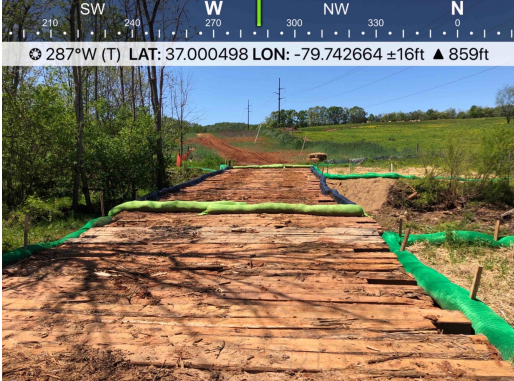
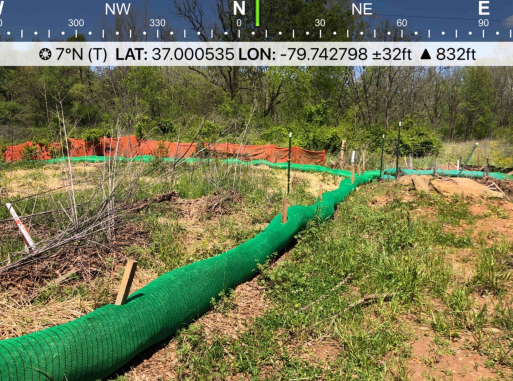
<b>GPS Location</b>	0	<b>GPS Location</b>	0		
<b>Field Station#</b>	14582+85	<b>Field Station#</b>	14583+60		
<b>Pic 1 Desc.</b>	Bridge at stream S-E17 clean and new ECDs installed	<b>Pic 2 Desc.</b>	New ECDs installed on stream banks on stream S-E17

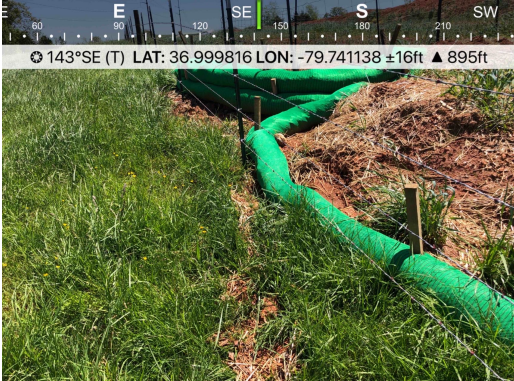
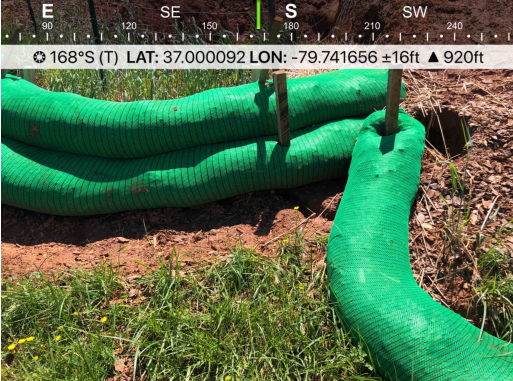
<b>GPS Location</b>	0	<b>GPS Location</b>	0		
<b>Field Station#</b>	14587+00	<b>Field Station#</b>	14585+00		
<b>Pic 3 Desc.</b>	CFS on end treatment and perimeter CFS undermining	<b>Pic 4 Desc.</b>	CFS on end treatment undermined

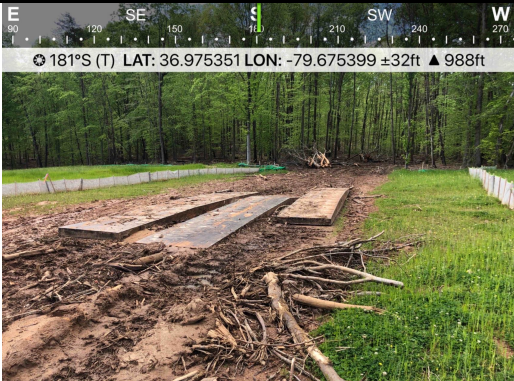
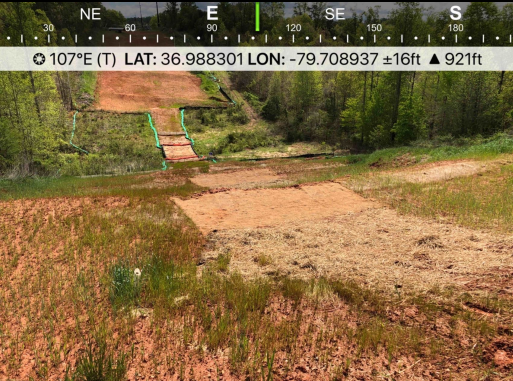
<b>GPS Location</b>	0	<b>GPS Location</b>	0		
<b>Field Station#</b>	14812+00	<b>Field Station#</b>	14698+00		
<b>Pic 5 Desc.</b>	Third party logging contractor crossing the right of way. ECDs are in place	<b>Pic 6 Desc.</b>	Water bars rebuilt to spec and curlex installed

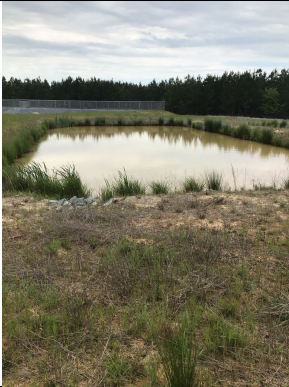
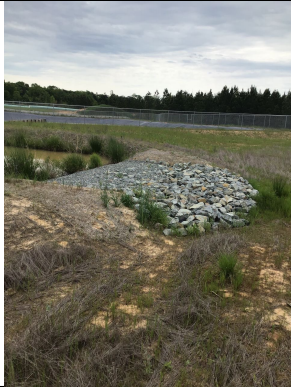
<b>GPS Location</b>	O	<b>GPS Location</b>	O		
<b>Field Station#</b>	00+00	<b>Field Station#</b>	00+00		
<b>Pic 1 Desc.</b>	Observing sediment basin.	<b>Pic 2 Desc.</b>	Observing overflow.

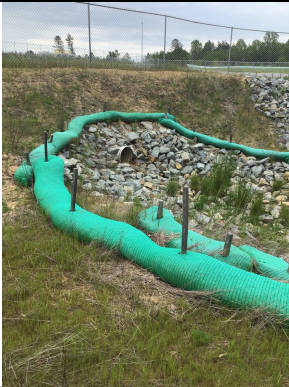
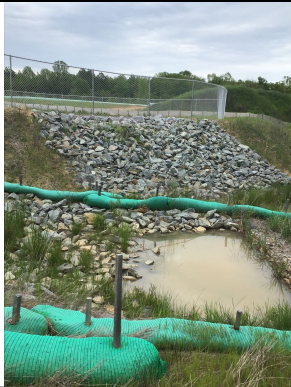
<b>GPS Location</b>	O	<b>GPS Location</b>	O		
<b>Field Station#</b>	00+00	<b>Field Station#</b>	00+00		
<b>Pic 3 Desc.</b>	Observing outlet and outlet protection.	<b>Pic 4 Desc.</b>	Observing emergency overflow at the storm water pond.		
Insert image here			Insert image here		
<b>GPS Location</b>		<b>GPS Location</b>			
<b>Field Station#</b>		<b>Field Station#</b>			
<b>Pic 5 Desc.</b>		<b>Pic 6 Desc.</b>
