Visual Site Inspection Report

Project Name	H-600 Pipeline Spread I	AFE	124300139	Spread	H-600 Pipeline Spread I
Contractor	Precision			Report #	9739
Inspector	Ben Davenport			Date/Time	4/6/2020 5:00 PM
Permit #	TBD	Inspection Type	VA SWPP	Station Begin	14928+55
State	VA	Inspection Area	Partial	Station End	15296+00
County	Franklin/Pittsylvania	Ground	Dry	Temperature (°F)	75.00
Municipality	Chatham	Weather	Sunny	Rain Gauge (in)	4.00
				Rain Accumulation Time (days)	0.90

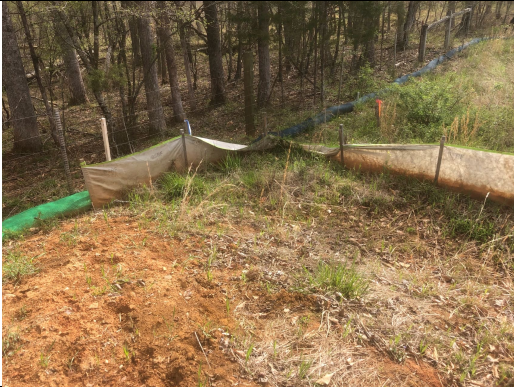
GPS Location	1	GPS Location	2		
Field Station#	15168+00	Field Station#	15168+00		
Pic 1 Desc.	Repair damaged P1 silt fence in corner of ROW	Pic 2 Desc.	Contractor corrected issue upon punch list identification

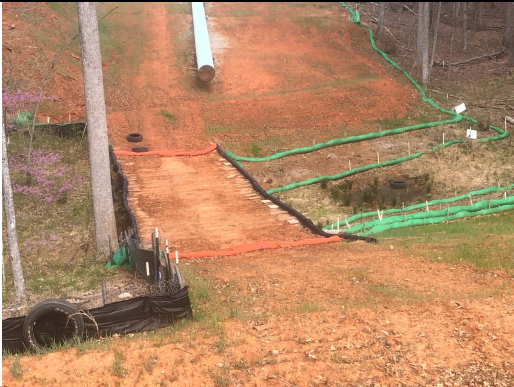
GPS Location	3	GPS Location	4		
Field Station#	15141+00	Field Station#	15141+00		
Pic 3 Desc.	Move all tires out of stream crossing and ROW back to road crossing	Pic 4 Desc.	Contractor corrected issue upon punch list identification

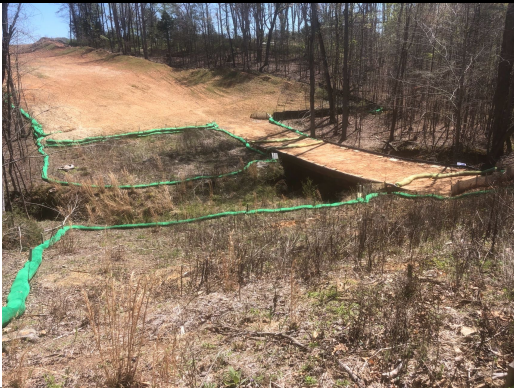
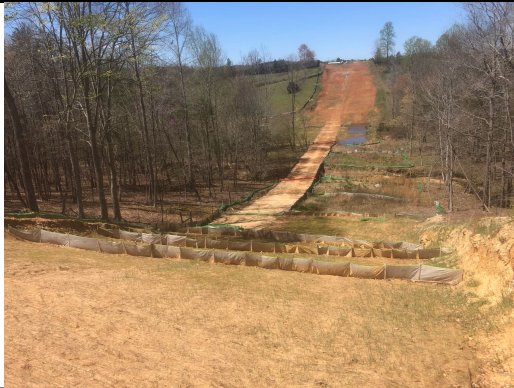
GPS Location	5	GPS Location	6		
Field Station#	15072+86	Field Station#	15145+00		
Pic 5 Desc.	All ECD's in resource buffer and equipment bridge crossing in good condition	Pic 6 Desc.	All ECD's in resource buffer and equipment bridge crossing in good condition

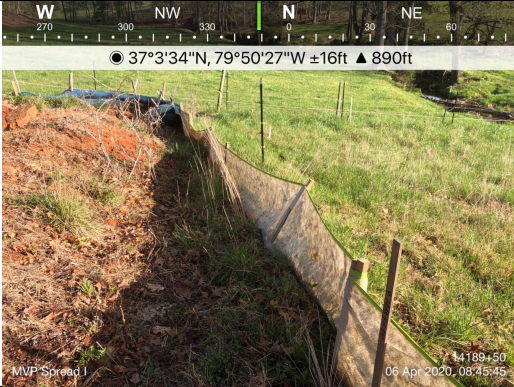
GPS Location	0	GPS Location	0		
Field Station#	14189+50	Field Station#	14189+50		
Pic 1 Desc.	Stake is broken on P1 silt fence	Pic 2 Desc.	P1 silt fence has holes in it .

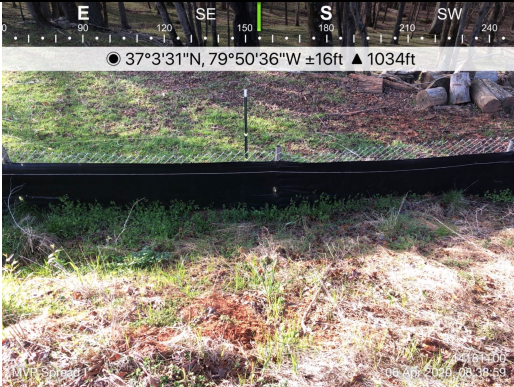
GPS Location	0	GPS Location	0		
Field Station#	14181+00	Field Station#	14323+00		
Pic 3 Desc.	Super silt fence has holes in it .	Pic 4 Desc.	CFS in acceptable condition

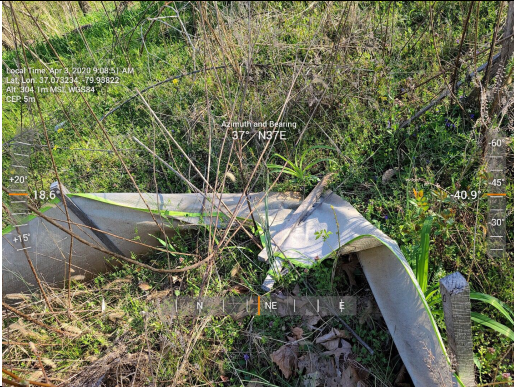
GPS Location	0000	GPS Location	00000		
Field Station#	13760+20	Field Station#	13758+00		
Pic 1 Desc.	P1 requires maintenance, added to the punch list for repairs.	Pic 2 Desc.	Row photo showing vegetation and where a land owner has been riding ATV's on the row.

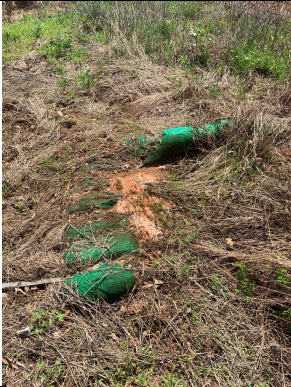
GPS Location	O	GPS Location	O		
Field Station#	15940+00	Field Station#	15936+00		
Pic 1 Desc.	Observing CFS that requires maintenance.	Pic 2 Desc.	Observing sump and end treatment.

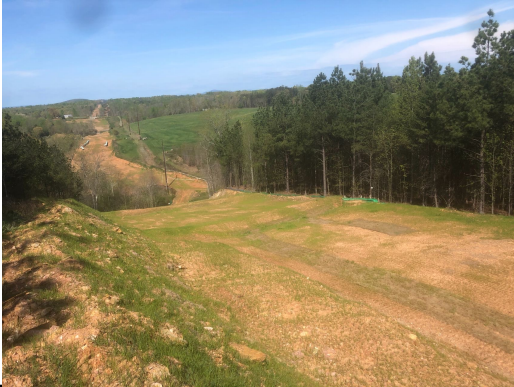
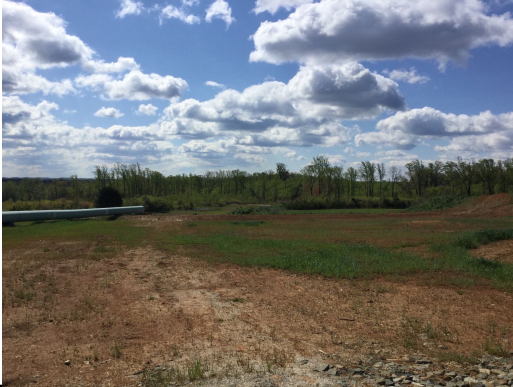
GPS Location	3	GPS Location	4		
Field Station#	14958+00	Field Station#	15118+00		
Pic 3 Desc.	Temporary vegetation area and sparse growth in areas. Will continue to monitor.	Pic 4 Desc.	Temporary vegetation area and sparse growth in areas. Will continue to monitor.
