Visual Site Inspection Report

Project Name	H-600 Pipeline Spread I	AFE	124300139	Spread	H-600 Pipeline Spread I
Contractor	Precision			Report #	11093
Inspector	Logan Box			Date/Time	5/20/2020 4:31 PM
Permit #	TBD	Inspection Type	VA SWPP	Station Begin	13670+00
State	VA	Inspection Area	Partial	Station End	13784+35
County	Franklin	Ground	Wet	Temperature (°F)	50.00
Municipality	N/A	Weather	Light Rain	Rain Gauge (in)	4.60
				Rain Accumulation Time (days)	6.00

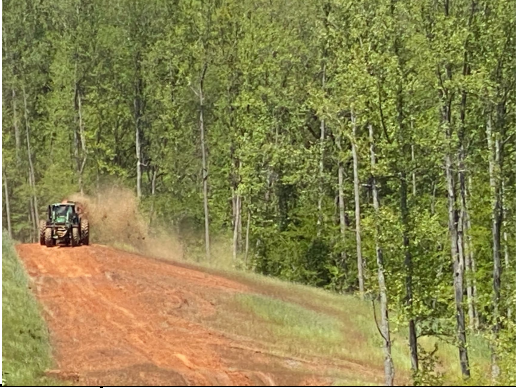
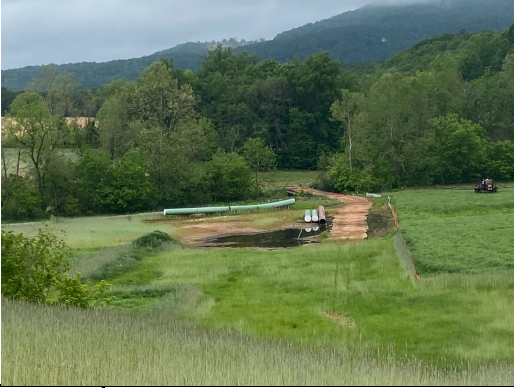
GPS Location	0	GPS Location	0		
Field Station#	13845+00	Field Station#	13910+00		
Pic 1 Desc.	Approximately 13845+00. Contractor blowing straw mulch.	Pic 2 Desc.	Approximately 13910+00. Overview of ROW. ROW temporarily stabilized and has winter vegetation growing.

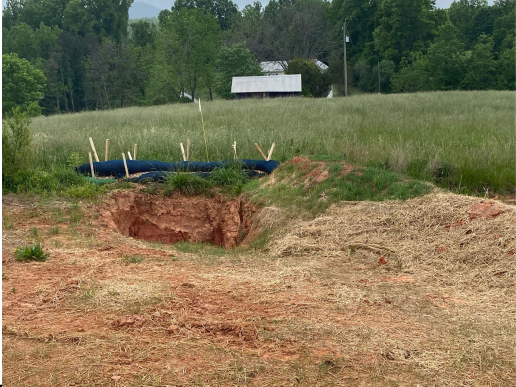
Insert image here			
GPS Location	0	GPS Location	0		
Field Station#	14128+50	Field Station#	14016+00		
Pic 3 Desc.	Approximately 14128+50. Water bar and sump installed and appear to be functioning correctly at time of inspection.	Pic 4 Desc.	Approximately 14016+00. Overview of ROW. ROW temporarily stabilized and has permanent and winter vegetation growing.		
Insert image here		Insert image here			
GPS Location		GPS Location			
Field Station#		Field Station#			
Pic 5 Desc.		Pic 6 Desc.

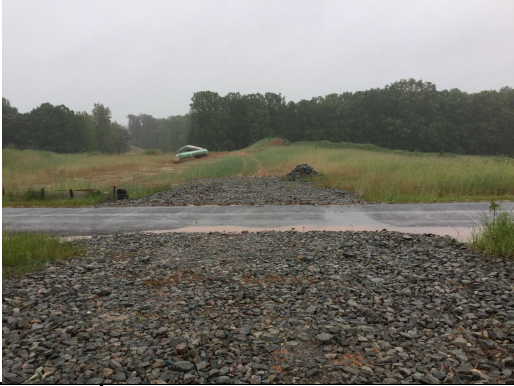
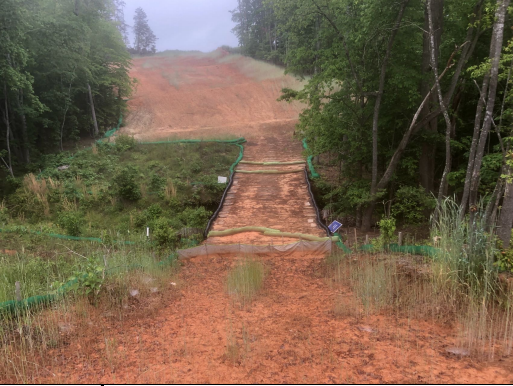
GPS Location	1	GPS Location	2		
Field Station#	15063+85	Field Station#	15072+86		
Pic 1 Desc.	RCE in good condition at Armstrong Rd		Pic 2 Desc.	Equipment bridge and surrounding ECD's in place and functional at S-G11. Limited vegetation on ROW which could lead to erosion issues after heavy rain event.

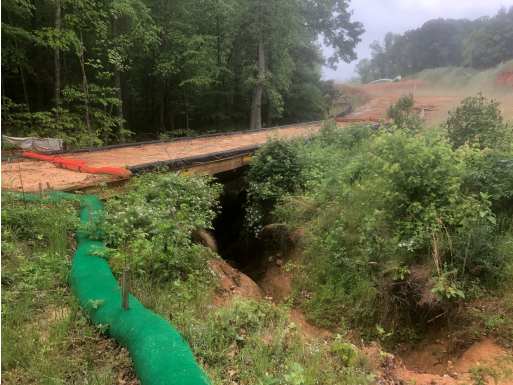
GPS Location	3	GPS Location	4		
Field Station#	15072+86	Field Station#	15055+84		
Pic 3 Desc.	Equipment bridge and surrounding ECD's in place and functional at S-G11		Pic 4 Desc.	Equipment bridge and surrounding ECD's in place and functional at S-D2-EPH

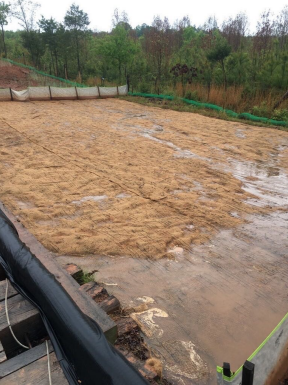
GPS Location	5	GPS Location	6		
Field Station#	15162+00	Field Station#	15159+00		
Pic 5 Desc.	Erosion control blanket reinstalled in CWD natural drainage area per punch list item		Pic 6 Desc.	P1 silt fence installed behind sumps to prevent sediment runoff off ROW during heavy rain event

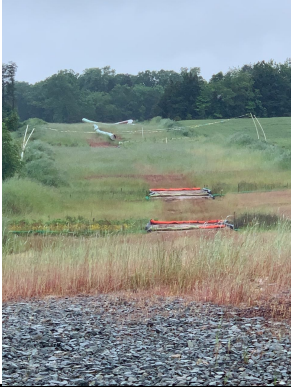
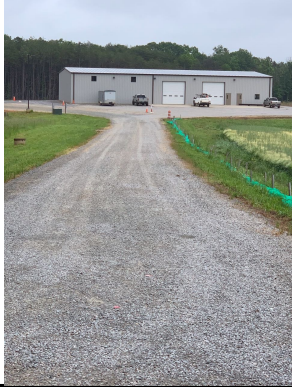
GPS Location	O	GPS Location	O		
Field Station#	15775+00	Field Station#	15834+92		
Pic 1 Desc.	Observing temporary vegetation and ECD's performing as they should during the rain event.	Pic 2 Desc.	Observing access road.

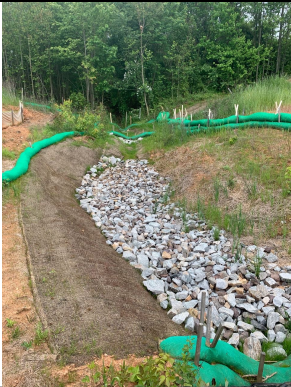
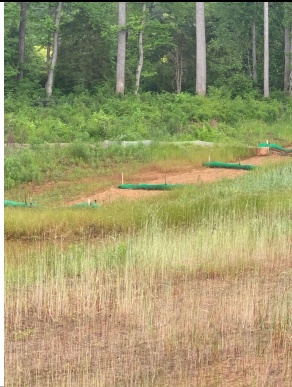
GPS Location	O	GPS Location	O		
Field Station#	15866+00	Field Station#	15945+00		
Pic 3 Desc.	Observing ECD's performing as they should.	Pic 4 Desc.	Observing ECD's performing as they should during the rain event.		
Insert image here			Insert image here		
GPS Location		GPS Location			
Field Station#		Field Station#			
Pic 5 Desc.		Pic 6 Desc.

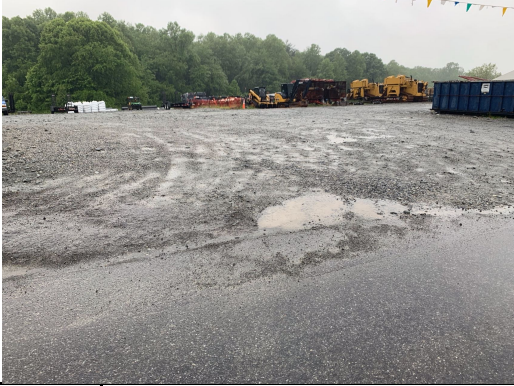
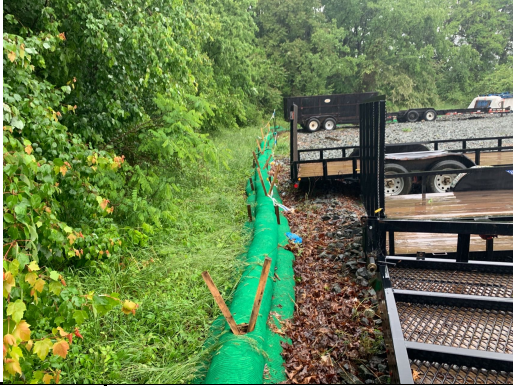
GPS Location 000000000000		GPS Location 000000000000			
Field Station# 0000+00		Field Station# 0000+00			
Pic 1 Desc. RCE at gravel yard in good condition		Pic 2 Desc. Perimeter ECD's on west side of gravel yard in good condition

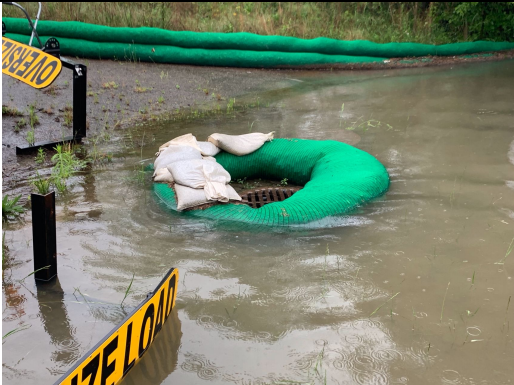
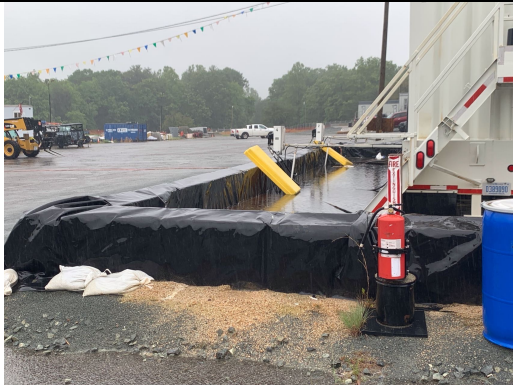
GPS Location 000000000000		GPS Location 000000000000			
Field Station# 0000+00		Field Station# 0000+00			
Pic 3 Desc. Inlet protection for parking lot drain on south end of paved yard in good condition		Pic 4 Desc. Secondary containment structure for fuel cell in compliance.

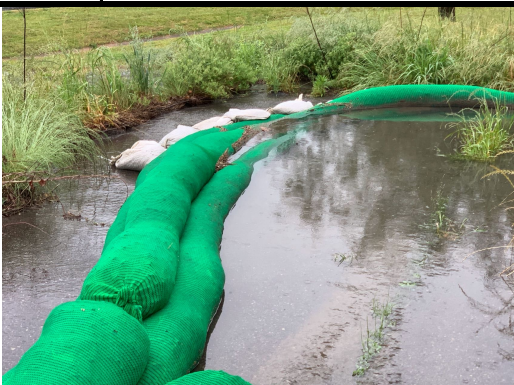
Insert image here			
GPS Location 000000000000		GPS Location			
Field Station# 0000+00		Field Station#			
Pic 5 Desc. Triple stack CFS on northwest corner of paved yard needs maintenance.		Pic 6 Desc.

7. Identify all remedial measures that have been taken since the previous inspection was conducted.					
Comments (Reference above questions as appropriate.)					
Performed SWPPP inspection of Spread I main laydown yard in Rocky Mount, Va. The site has received 5" of rainfall since the last inspection. All perimeter ECD's were inspected and a issue was observed on the northwest corner of paved yard with triple stack CFS needing re-stacked and repositioned, it has been moved due to water flow. The inlet protection for parking lot drains in the paved yard were in good condition. All secondary containment structures were found to be in compliance at the time of inspection. The RCE at the gravel yard was found to be in acceptable condition. The General Construction permits and contact information are posted at the main entrance of the paved yard as required. Any issues observed during the inspection were placed on the punch list and given to the contractor to address.

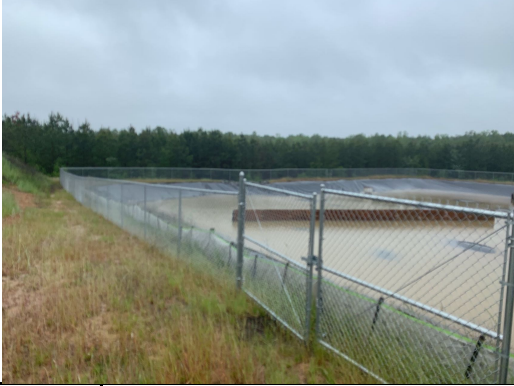
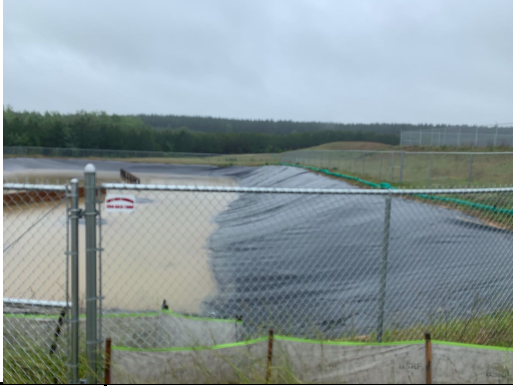
GPS Location	O	GPS Location	O		
Field Station#	00+00	Field Station#	00+00		
Pic 1 Desc.	Observing storm water pond and ECD's performing as they should during the rain event.	Pic 2 Desc.	Observing storm water pond and ECD's performing as they should during the rain event.

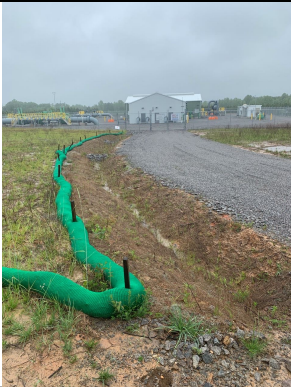
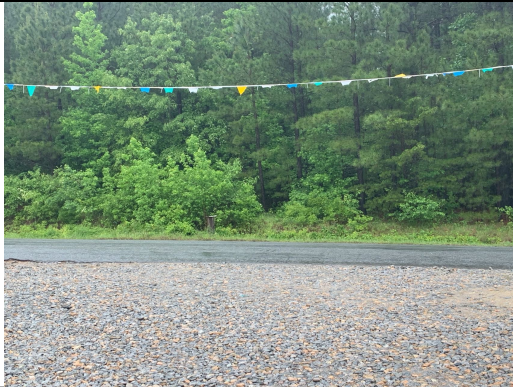
GPS Location	O	GPS Location	O		
Field Station#	00+00	Field Station#	00+00		
Pic 3 Desc.	Observing ECD's performing as they should during the rain event.	Pic 4 Desc.	Observing RCE at Transco.		
Insert image here			Insert image here		
GPS Location		GPS Location			
Field Station#		Field Station#			
Pic 5 Desc.		Pic 6 Desc.
