Visual Site Inspection Report

Project Name	H-600 Pipeline Spread I	AFE	124300139	Spread	H-600 Pipeline Spread I
Contractor	Precision			Report #	11294
Inspector	Charles Head			Date/Time	5/27/2020 1:51 PM
Permit #	TBD	Inspection Type	VA SWPP	Station Begin	13784+35
State	VA	Inspection Area	Partial	Station End	14171+36
County	Franklin	Ground	Muddy	Temperature (°F)	72.00
Municipality	N/A	Weather	Cloudy	Rain Gauge (in)	5.80
				Rain Accumulation Time (days)	6.00

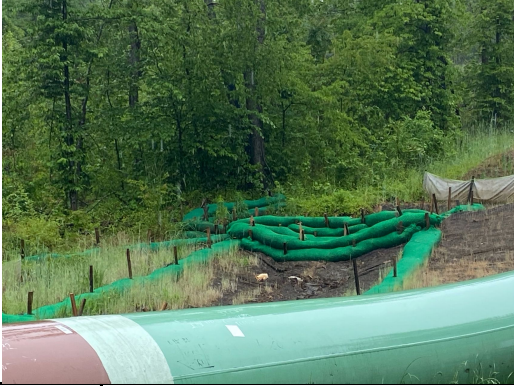
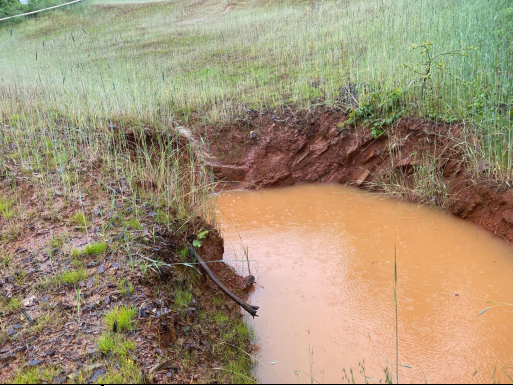
GPS Location	0	GPS Location	0		
Field Station#	13999+00	Field Station#	14008+00		
Pic 1 Desc.	Approximately 13999+00. Overview of flow path of adjacent pond overflow. Minimal flow across ROW at time of inspection.		Pic 2 Desc.	Approximately 14008+00. Overview of ROW, water and sump. ROW temporarily stabilized and has temporary vegetation growing. Water bar and sump installed and appear to be

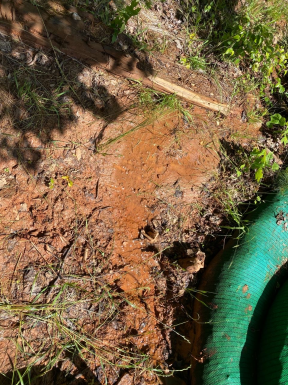
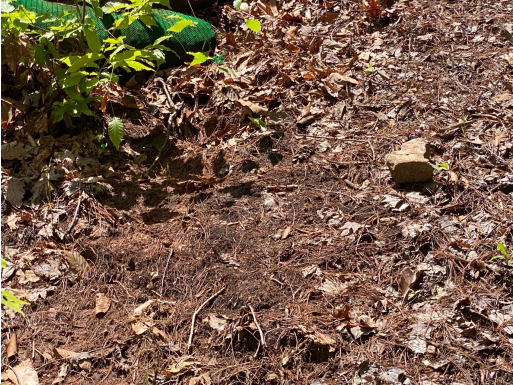
GPS Location	0	GPS Location	0		
Field Station#	14032+88	Field Station#	14048+70		
Pic 3 Desc.	Approximately 14032+88. Area behind sump and CFS end treatment is eroding beyond LOD due to heavy rains and causing sediment pockets downhill.		Pic 4 Desc.	Approximately 14048+70. Area behind sump and CFS end treatment is eroding beyond LOD due to heavy rains and causing sediment pockets downhill.

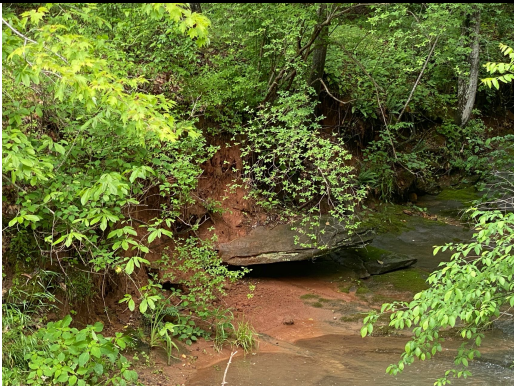
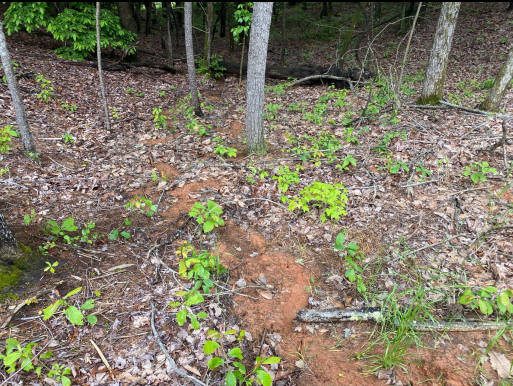
Field Station#	14105+26	Field Station#	14071+00		
Pic 5 Desc.	Approximately 14105+26. Bank of stream KL41 has sloughed off depositing a large amount of soil onto stream bank and into stream approximately 40 feet upstream and		Pic 6 Desc.	Approximately 14071+00. Due to heavy rains the out behind the CWD plunge pool is starting to cause erosion beyond the LOD.

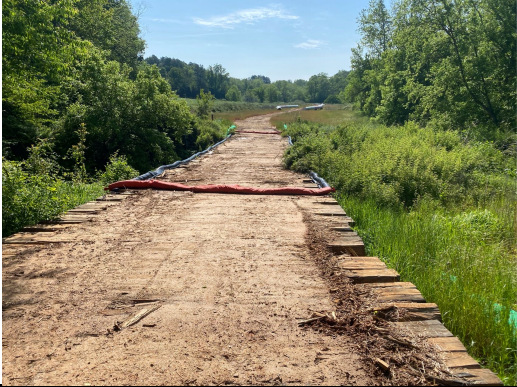
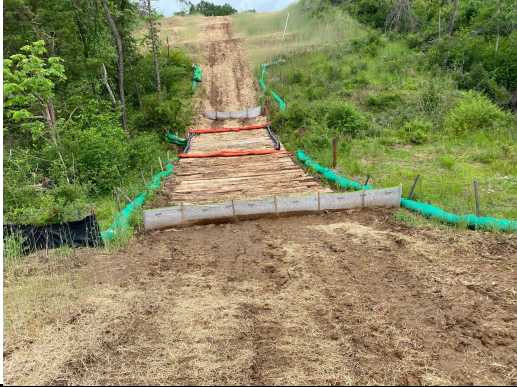
GPS Location	0	GPS Location	0		
Field Station#	13862+80	Field Station#	13805+70		
Pic 7 Desc.	Approximately 13862+80. Overview of stream crossing, equipment bridge and ECDs at stream S-C17.		Pic 8 Desc.	Approximately 13805+70. Overview of stream crossing, equipment bridge and ECDs at stream S-D20.

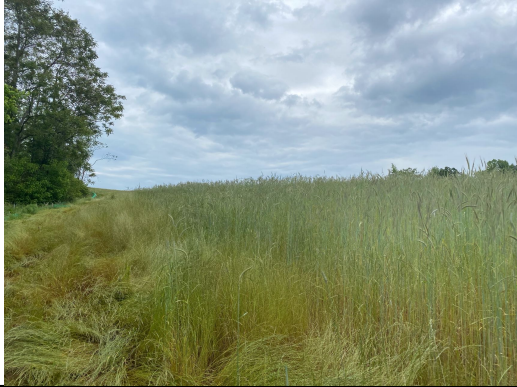
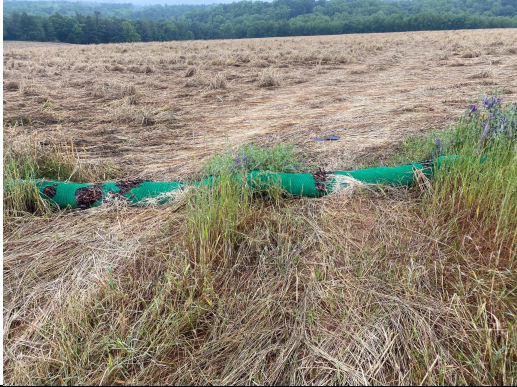
GPS Location	0	GPS Location	0		
Field Station#	14161+00	Field Station#	13939+50		
Pic 9 Desc.	Approximately 14161+00. Overview of ROW. ROW temporarily stabilized and has temporary vegetation growing.		Pic 10 Desc.	Approximately 13939+50. CFS at LOD damaged in multiple places by third party.

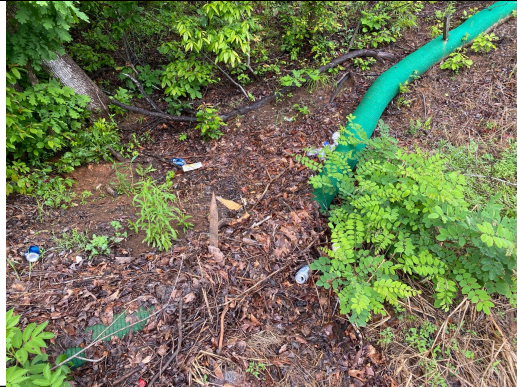
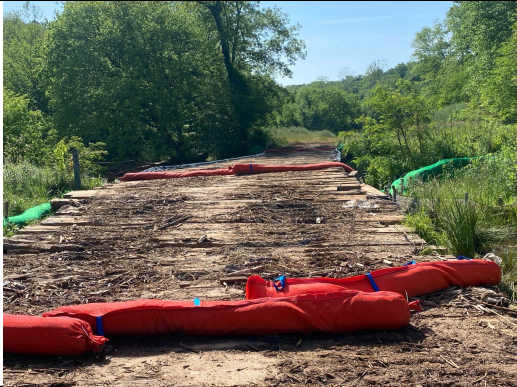
GPS Location	0	GPS Location	0		
Field Station#	14013+00	Field Station#	13875+44		
Pic 11 Desc.	Approximately 14013+00. CFS displaced by water flowing onto ROW.		Pic 12 Desc.	Approximately 13875+44. Overview of stream crossing, equipment bridge and ECDs at stream S-CD6.

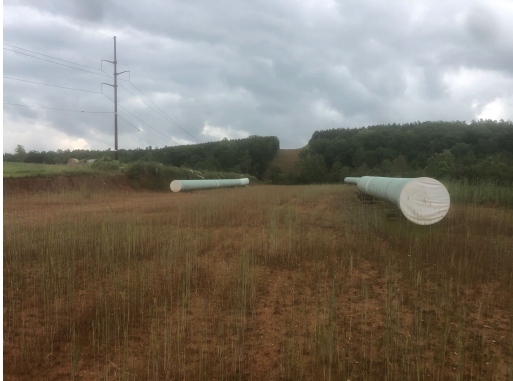
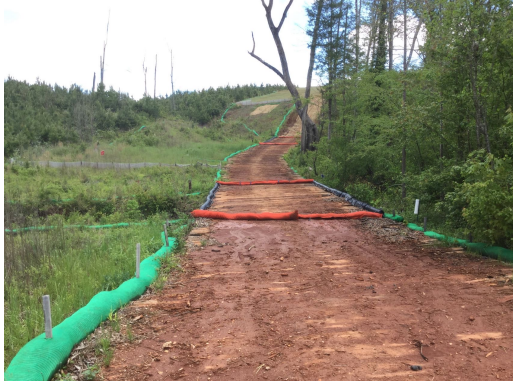
GPS Location	1	GPS Location	2		
Field Station#	14946+00	Field Station#	15027+00		
Pic 1 Desc.	Pipe sections on skids. Sparse temporary vegetation growing along ROW. Many bare spots.		Pic 2 Desc.	Equipment bridge and surrounding ECD's in place and functional at streams S-D3 and S-D4.

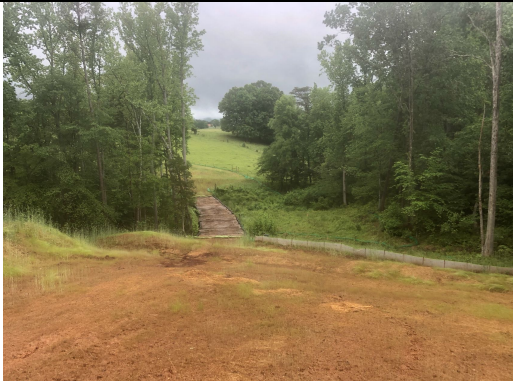
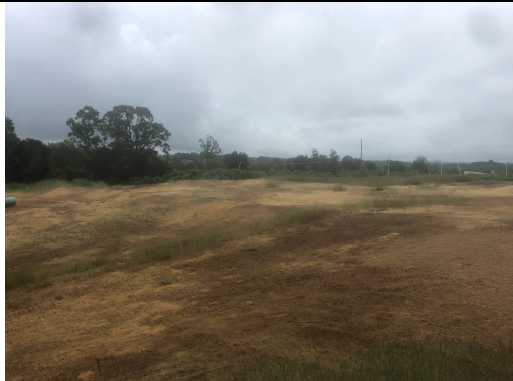
GPS Location	3	GPS Location	4		
Field Station#	15105+00	Field Station#	15110+00		
Pic 3 Desc.	Slope overlooking streams S-G8 and S-Q15. Area is stabilized. Equipment bridge and surrounding ECD's in place and functional.		Pic 4 Desc.	Extra work space CIS Museville Rd. Area stabilized with straw mulch but limited vegetative growth observed. Will continue to monitor area.

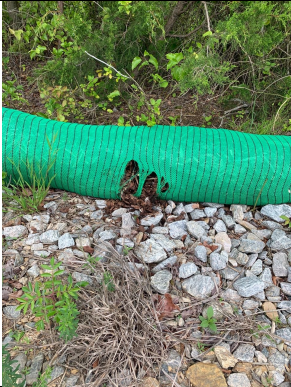
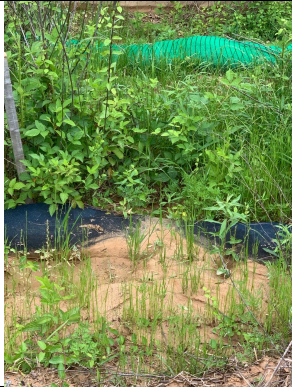
GPS Location	O	GPS Location	O		
Field Station#	16024+00	Field Station#	16025+00		
Pic 1 Desc.	Observing CFS that required maintenance.	Pic 2 Desc.	Observing CFS that required maintenance.

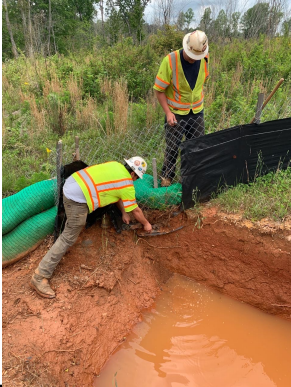
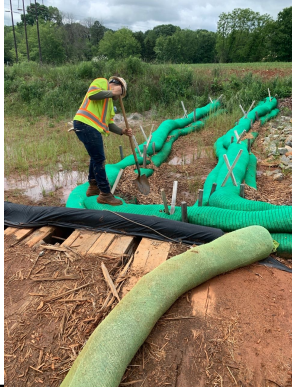
GPS Location	O	GPS Location	O		
Field Station#	15707+00	Field Station#	15837+00		
Pic 3 Desc.	Observing the Contractor repairing punch list items.	Pic 4 Desc.	Observing the Contractor repairing punch list items.		
Insert image here			Insert image here		
GPS Location		GPS Location			
Field Station#		Field Station#			
Pic 5 Desc.		Pic 6 Desc.

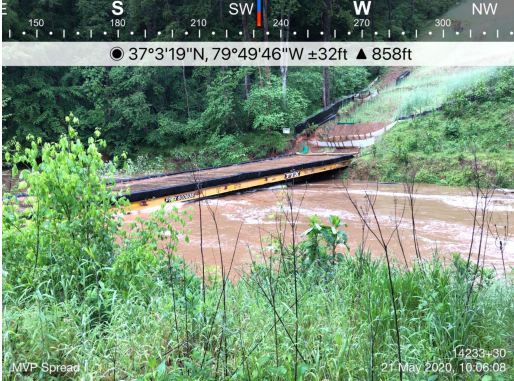
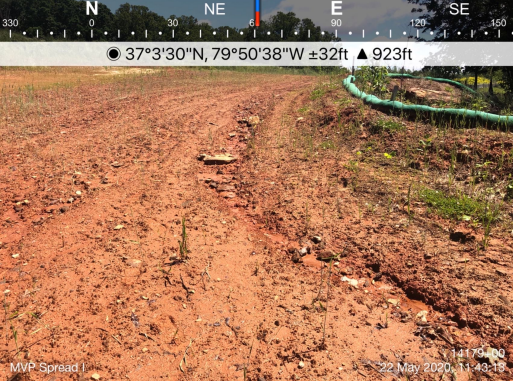
GPS Location	0	GPS Location	0		
Field Station#	14233+30	Field Station#	14179+00		
Pic 1 Desc.	Equipment bridge in acceptable condition		Pic 2 Desc.	Erosion over 6" deep was subsequently repaired, seeded and Curlex was installed and in acceptable condition

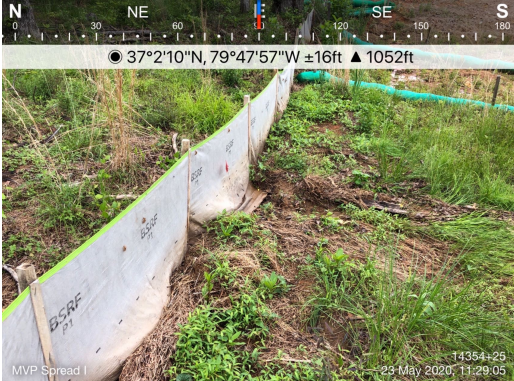
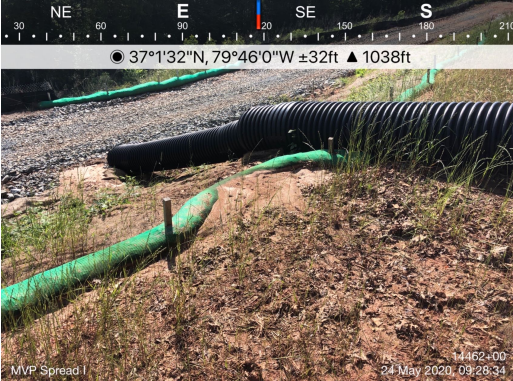
GPS Location	0	GPS Location	0		
Field Station#	14354+25	Field Station#	14462+00		
Pic 3 Desc.	P1 silt fence was undermined and was subsequently repaired and in acceptable condition		Pic 4 Desc.	CFS was full of sediment and was subsequently cleaned out and in acceptable condition.

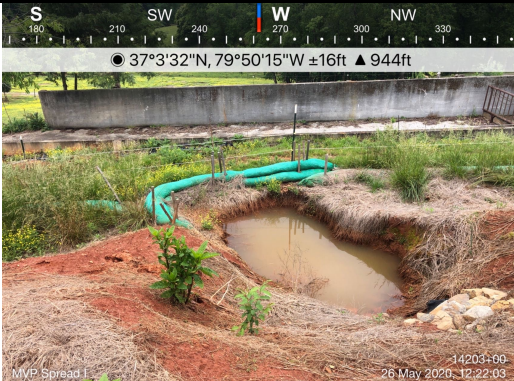
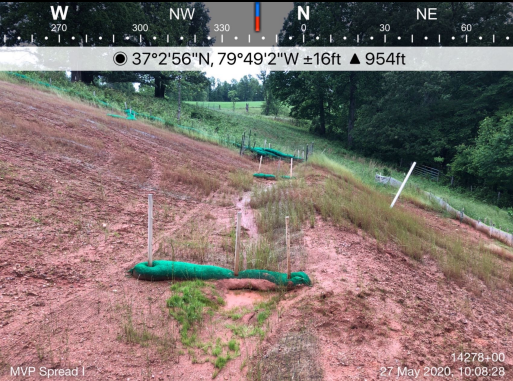
GPS Location	0	GPS Location	0		
Field Station#	14203+00	Field Station#	14278+00		
Pic 5 Desc.	Waterbar end treatment in acceptable condition		Pic 6 Desc.	Waterbar in acceptable condition

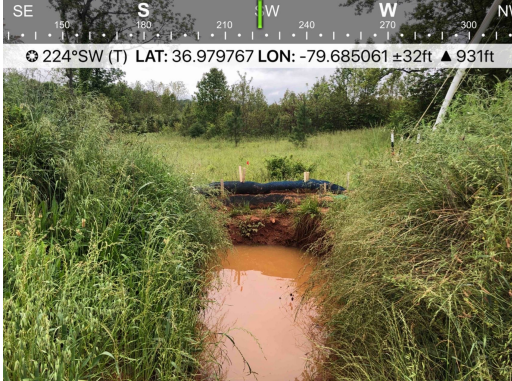
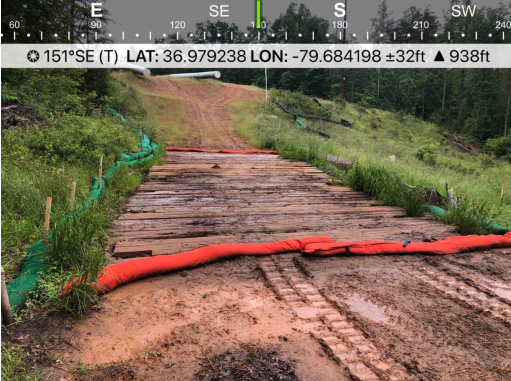
GPS Location	0	GPS Location	0		
Field Station#	14778+00	Field Station#	14782+25		
Pic 1 Desc.	CFS on end treatment cleaned off and functioning properly	Pic 2 Desc.	Mats fixed on equipment bridge at stream S-MM48 that shifted due to heavy rainfall

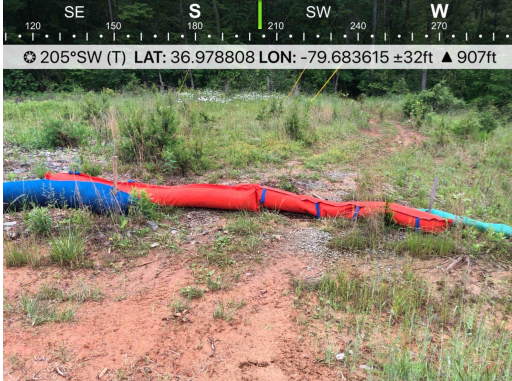
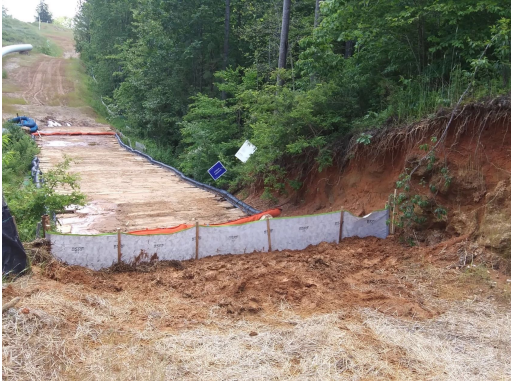
GPS Location	0	GPS Location	0		
Field Station#	14785+30	Field Station#	14766+00		
Pic 3 Desc.	Perimeter CFS replaced that was damaged due to land owner crossing with ATV	Pic 4 Desc.	P1 silt fence replaced at stream S-MM44

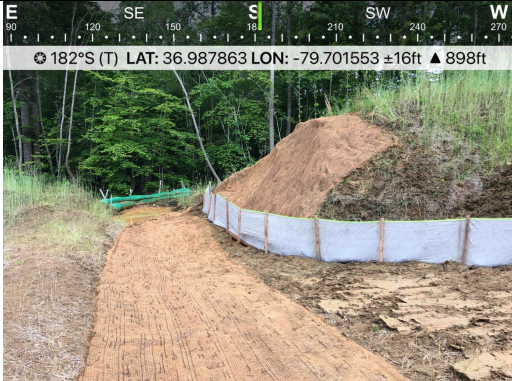
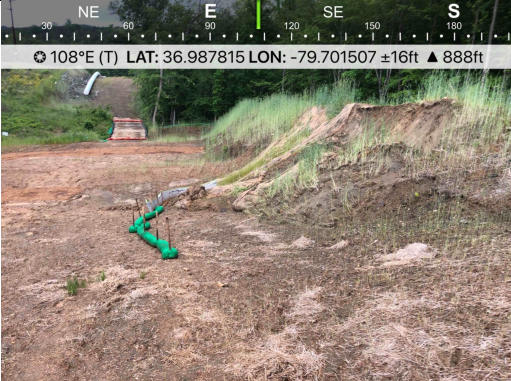
GPS Location	0	GPS Location	0		
Field Station#	14721+00	Field Station#	14721+50		
Pic 5 Desc.	Cut sloughed off and temporarily fixed and maintained until conditions allow equipment	Pic 6 Desc.	Cut sloughed off and temporarily fixed and maintained until conditions allow equipment

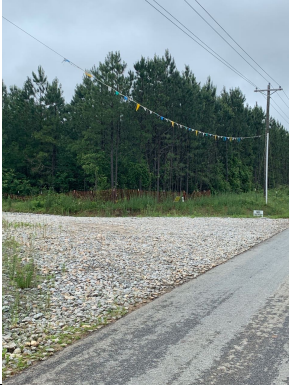
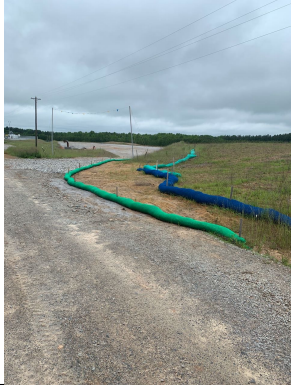
GPS Location	O	GPS Location	O		
Field Station#	00+00	Field Station#	00+00		
Pic 1 Desc.	Observing RCE at Transco.	Pic 2 Desc.	Observing ECD's performing as they should.

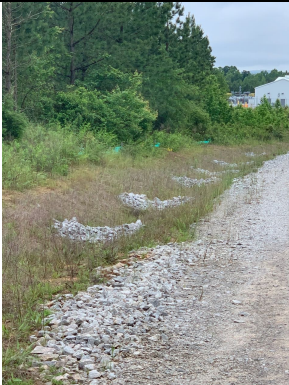
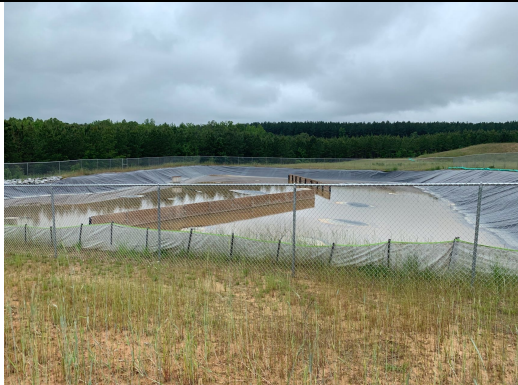
GPS Location	O	GPS Location	O		
Field Station#	00+00	Field Station#	00+00		
Pic 3 Desc.	Observing rock check dams performing as they should.	Pic 4 Desc.	Observing storm water pond.		
Insert image here			Insert image here		
GPS Location		GPS Location			
Field Station#		Field Station#			
Pic 5 Desc.		Pic 6 Desc.
