## Visual Site Inspection Report

<b>Project Name</b>	H-600 Pipeline Spread G	<b>AFE</b>	124300137	<b>Spread</b>	H-600 Pipeline Spread G
<b>Contractor</b>	Precision			<b>Report #</b>	11860
<b>Inspector</b>	Jared Saunders			<b>Date/Time</b>	6/15/2020 2:41 PM
<b>Permit #</b>	TBD	<b>Inspection Type</b>	VA SWPP	<b>Station Begin</b>	12005+00
<b>State</b>	VA	<b>Inspection Area</b>	Partial	<b>Station End</b>	12005+00
<b>County</b>	Giles	<b>Ground</b>	Muddy	<b>Temperature (°F)</b>	60.00
<b>Municipality</b>	N/A	<b>Weather</b>	Light Rain	<b>Rain Gauge (in)</b>	1.20
				<b>Rain Accumulation Time (days)</b>	1.00

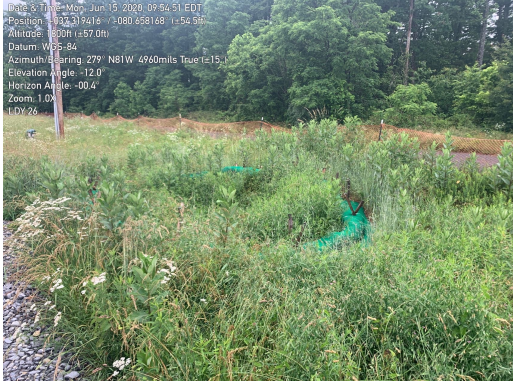
GPS Location	See photo for GPS location.		GPS Location	See photo for GPS location.	
Field Station#	12005+00		Field Station#	12005+00	
Pic 1 Desc.	Triple stack compost filter sock in place around drainage.		Pic 2 Desc.	Dumpsters being utilized for trash management.

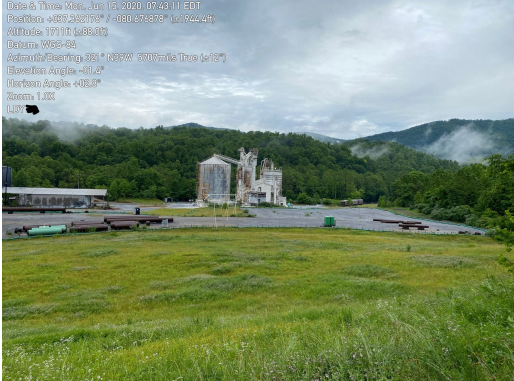
<b>GPS Location</b>	1	<b>GPS Location</b>	2		
<b>Field Station#</b>	12005+00	<b>Field Station#</b>	12005+00		
<b>Pic 1 Desc.</b>	Overview of the lower section of LDY 29 (1).		<b>Pic 2 Desc.</b>	Overview of the lower section of LDY 29 (2).

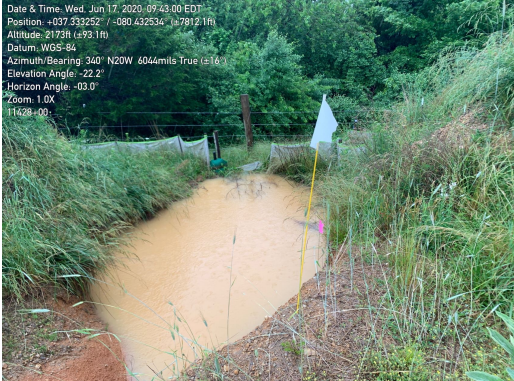
GPS Location	See photo for GPS location.		GPS Location	See photo for GPS location.	
Field Station#	11489+00		Field Station#	11428+00	
Pic 3 Desc.	Rain gauge at Stevers Gap Road reads 1.5 inches.		Pic 4 Desc.	Priority one silt fence stake broken at end treatment.

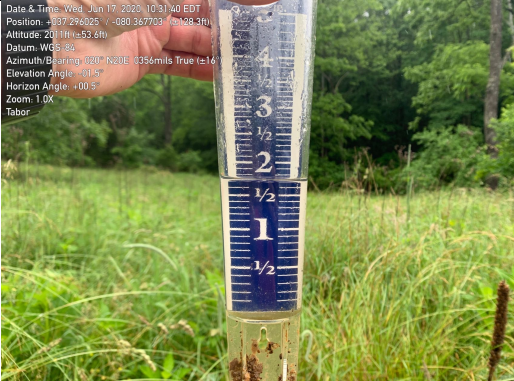
Pic 5 Desc.	Priority one silt fence stake broken at end treatment.		Pic 6 Desc.	Rain gauge at Mount Tabor Road reads 1.7 inches.

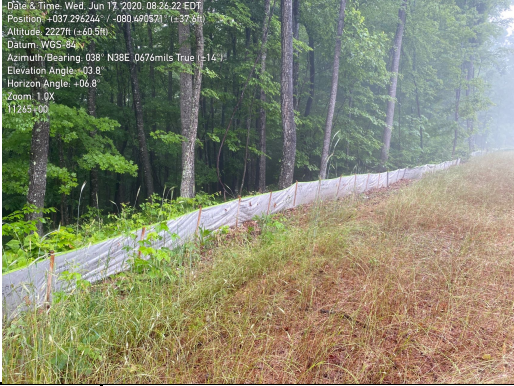
<b>GPS Location</b>	1	<b>GPS Location</b>	2		
<b>Field Station#</b>	11265+00	<b>Field Station#</b>	11286+00		
<b>Pic 1 Desc.</b>	Perimeter controls functional.		<b>Pic 2 Desc.</b>	Perimeter controls functional.

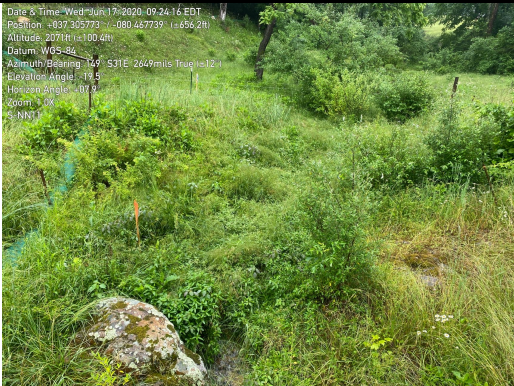
<b>GPS Location</b>	5	<b>GPS Location</b>	6		
<b>Field Station#</b>	11352+97	<b>Field Station#</b>	11331+00		
<b>Pic 5 Desc.</b>	S-NN11 and controls.		<b>Pic 6 Desc.</b>	VDOT road construction on and off RoW disturbance along AR 256.02.

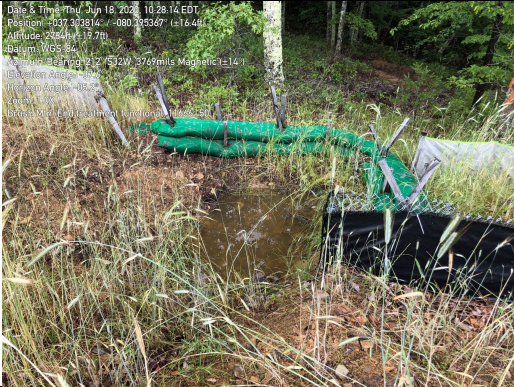
<b>GPS Location</b>	On photo	<b>GPS Location</b>	On photo		
<b>Field Station#</b>	11666+50	<b>Field Station#</b>	11663+00		
<b>Pic 1 Desc.</b>	End treatments in place and effective	<b>Pic 2 Desc.</b>	End treatments and perimeter controls functional

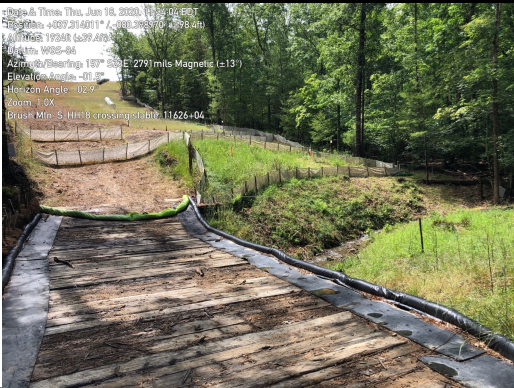
<b>GPS Location</b>	On photo	<b>GPS Location</b>	On photo		
<b>Field Station#</b>	11626+04	<b>Field Station#</b>	11614+20		
<b>Pic 5 Desc.</b>	S-HH18 crossing stable with environmental controls in place	<b>Pic 6 Desc.</b>	S-RR14 crossing stable with environmental controls in place

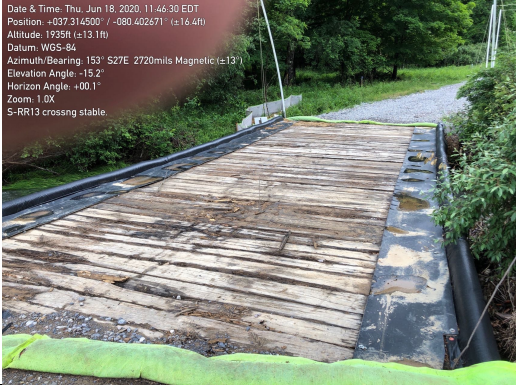
<p><small>Date &amp; Time: Thu, Jun 18, 2020, 11:46:30 EDT Position: +037.314500° / -080.402671° (±14.4ft) Altitude: 1935ft (±13.1ft) Datum: WGS-84 Azimuth/Bearing: 159° S27E 2720mils Magnetic (±13°) Elevation Angle: -15.2° Horizon Angle: +00.1° Zoom: 1.0X S-RR13 crossing stable</small></p>
