## Visual Site Inspection Report

<b>Project Name</b>	H-600 Pipeline Spread G	<b>AFE</b>	124300137	<b>Spread</b>	H-600 Pipeline Spread G
<b>Contractor</b>	Precision			<b>Report #</b>	12061
<b>Inspector</b>	Chris Burns			<b>Date/Time</b>	6/22/2020 1:52 PM
<b>Permit #</b>	TBD	<b>Inspection Type</b>	VA SWPP	<b>Station Begin</b>	11023+80
<b>State</b>	VA	<b>Inspection Area</b>	Partial	<b>Station End</b>	11064+53
<b>County</b>	Giles	<b>Ground</b>	Wet	<b>Temperature (°F)</b>	80.00
<b>Municipality</b>	N/A	<b>Weather</b>	Cloudy	<b>Rain Gauge (in)</b>	0.45
				<b>Rain Accumulation Time (days)</b>	1.00

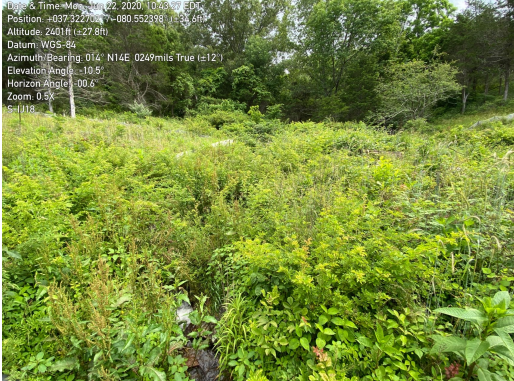
<b>GPS Location</b>	1	<b>GPS Location</b>	2		
<b>Field Station#</b>	11025+50	<b>Field Station#</b>	11034+00		
<b>Pic 1 Desc.</b>	S-IJ18.	<b>Pic 2 Desc.</b>	Section of RoW showing conditions and controls.

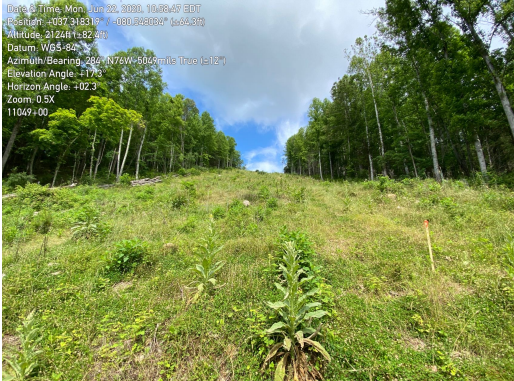
<b>GPS Location</b>	3	<b>GPS Location</b>	4		
<b>Field Station#</b>	11049+00	<b>Field Station#</b>	11050+10		
<b>Pic 3 Desc.</b>	Section of RoW showing conditions and controls.	<b>Pic 4 Desc.</b>	S-IJ16B/S-IJ17 and controls.

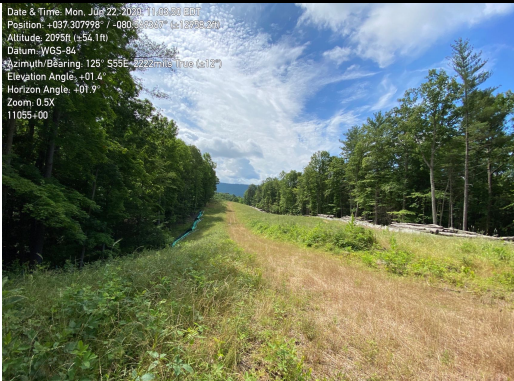
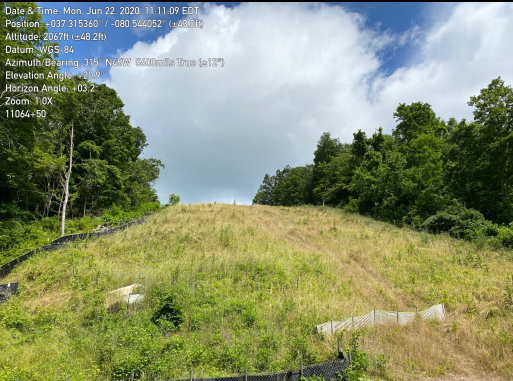
<b>GPS Location</b>	5	<b>GPS Location</b>	6		
<b>Field Station#</b>	11055+00	<b>Field Station#</b>	11064+50		
<b>Pic 5 Desc.</b>	Section of RoW showing conditions and controls.	<b>Pic 6 Desc.</b>	Section of RoW showing conditions and controls.

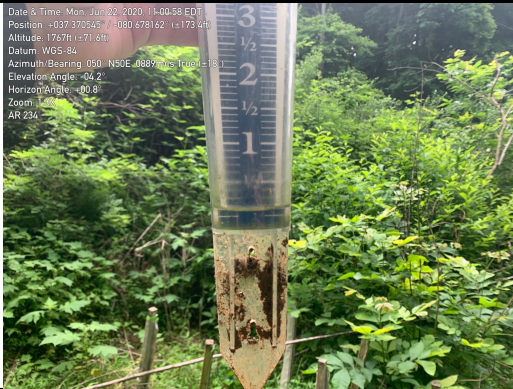
<p>Date &amp; Time: Mon Jun 22, 2020 11:00:58 EDT Position: +037.372542° / -080.678162° (+173.4ft) Altitude: 1757ft (+171.6ft) Datum: WGS-84 Azimuth/Bearing: 050° NSOE 089mils True (+15.1°) Elevation Angle: -04.2° Horizon Angle: -02.8° Zoom: 1.0X AR 234</p>		<p>Date &amp; Time: Mon Jun 22, 2020 11:12:50 EDT Position: +037.3953112° / -080.620178° (+17454.4ft) Altitude: 2159ft (+199.4ft) Datum: WGS-84 Azimuth/Bearing: 095° S85E 1689mils True (+15.1°) Elevation Angle: -05.8° Horizon Angle: -03.2° Zoom: 1.0X 10712+50 S-G33</p>			
<b>GPS Location</b>		See photo for GPS location.			
<b>Field Station#</b>		12005+00			
<b>Pic 1 Desc.</b>		Rain gauge at AR 234 reads 0.2 inches.

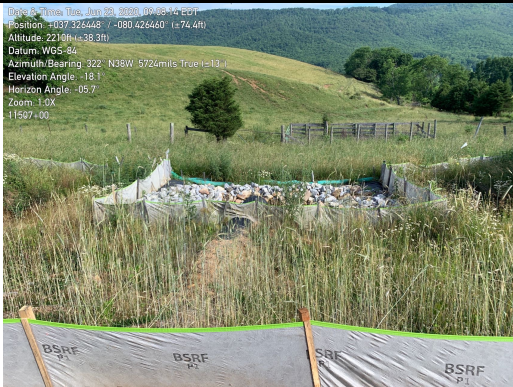
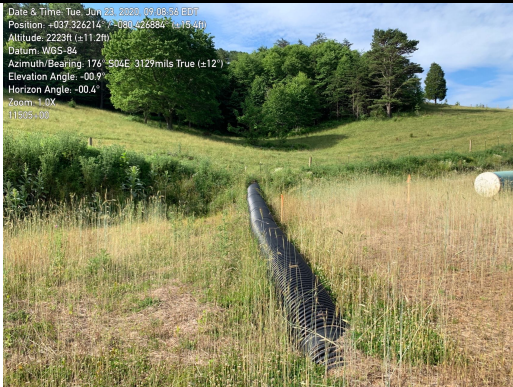
GPS Location	See photo for GPS location.		GPS Location	See photo for GPS location.	
Field Station#	11507+00		Field Station#	11505+00	
Pic 1 Desc.	Clean water diversion pipe and plunge pool in place.		Pic 2 Desc.	Clean water diversion pipe and clean water diversion berm in place.

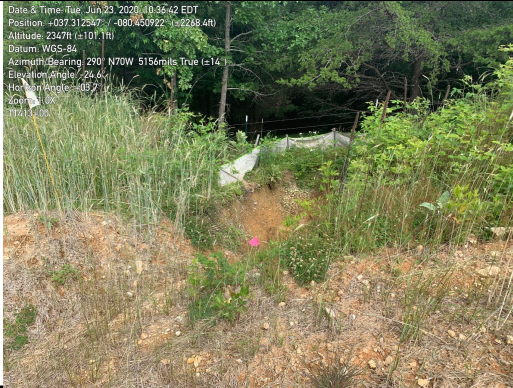
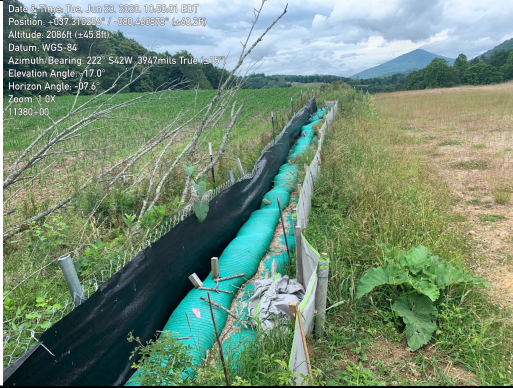
GPS Location	See photo for GPS location.		GPS Location	See photo for GPS location.	
Field Station#	11413+00		Field Station#	113800+00	
Pic 5 Desc.	Priority one silt fence stake broken.		Pic 6 Desc.	Triple barrier ECDs in place at off ROW karst feature.

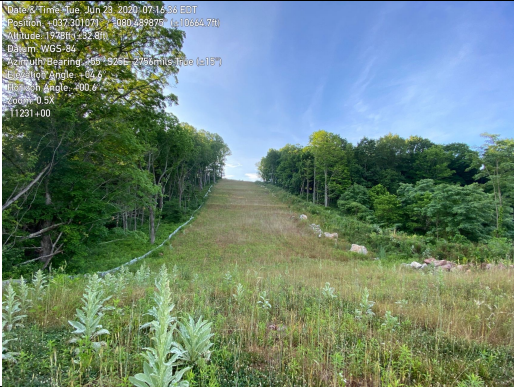
<b>GPS Location</b>	1	<b>GPS Location</b>	2		
<b>Field Station#</b>	11231+00	<b>Field Station#</b>	11215+00		
<b>Pic 1 Desc.</b>	Section of RoW showing conditions and controls.	<b>Pic 2 Desc.</b>	Perimeter controls functional.

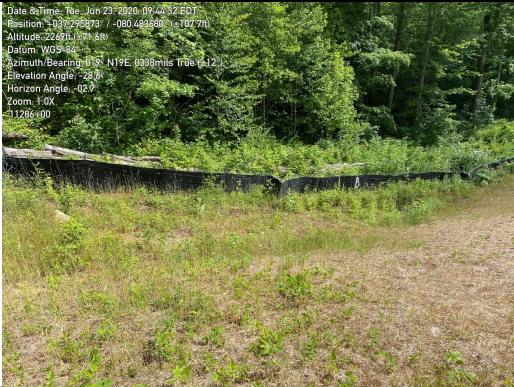
<b>GPS Location</b>	3	<b>GPS Location</b>	4		
<b>Field Station#</b>	11286+00	<b>Field Station#</b>	11292+80		
<b>Pic 3 Desc.</b>	Perimeter controls functional.	<b>Pic 4 Desc.</b>	S-MM18 and controls.

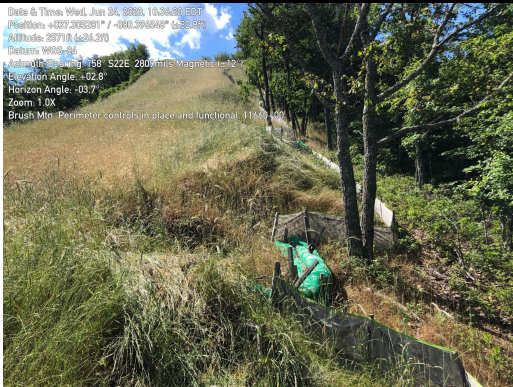
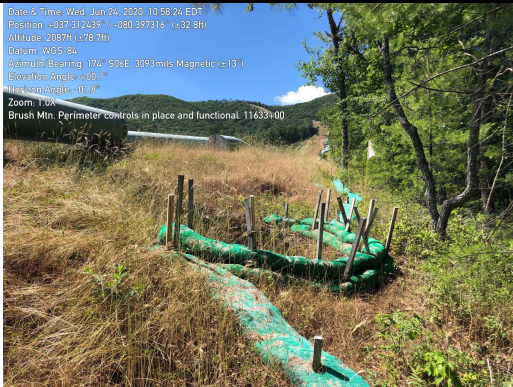
GPS Location	On photo		GPS Location	On photo	
Field Station#	11660+00		Field Station#	11633+00	
Pic 1 Desc.	Perimeter controls in place and functional		Pic 2 Desc.	Perimeter controls in place and functional

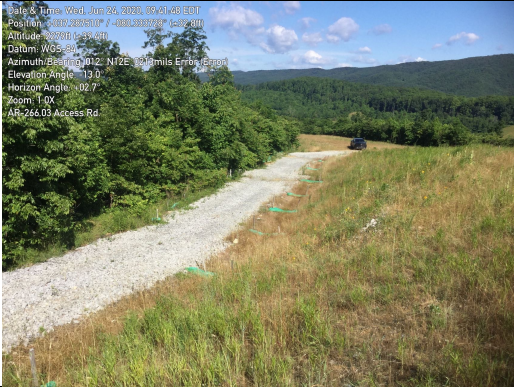
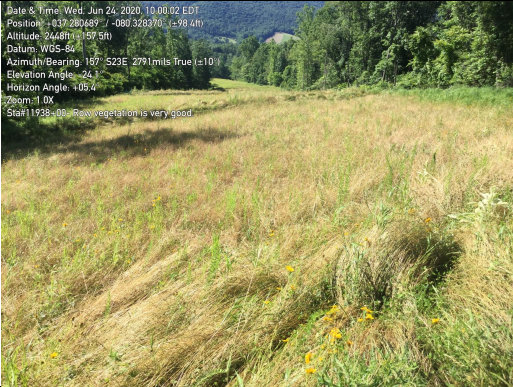
<b>GPS Location</b>	See photo GPS	<b>GPS Location</b>	See photo GPS		
<b>Field Station#</b>	11900+00	<b>Field Station#</b>	11938+00		
<b>Pic 1 Desc.</b>	AR-266.03- Access road & ECD's are in acceptable condition	<b>Pic 2 Desc.</b>	Row vegetation is very good

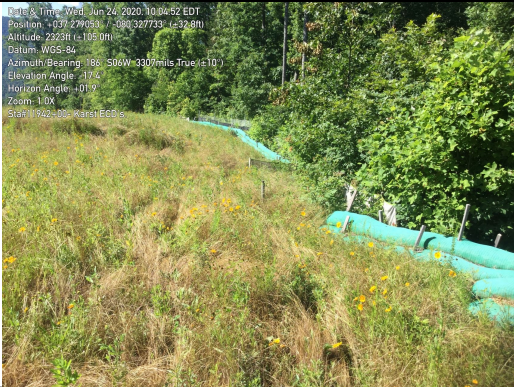
<b>GPS Location</b>	See photo GPS	<b>GPS Location</b>	See photo GPS		
<b>Field Station#</b>	11942+00	<b>Field Station#</b>	11954+00		
<b>Pic 3 Desc.</b>	Karst ECD's	<b>Pic 4 Desc.</b>	Level spreader

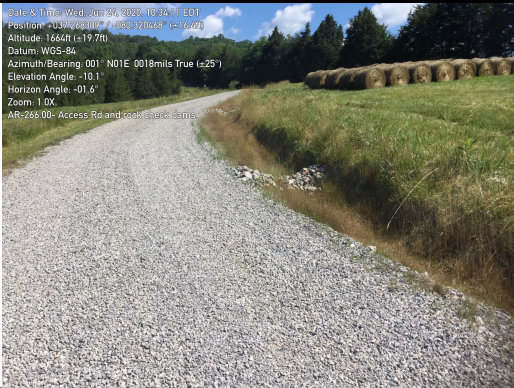
<b>GPS Location</b>	See photo GPS	<b>GPS Location</b>	See photo GPS		
<b>Field Station#</b>	11988+00	<b>Field Station#</b>	11989+00		
<b>Pic 5 Desc.</b>	AR- 266.00- Access road and rock check dams are in acceptable condition.	<b>Pic 6 Desc.</b>	Catawba rain gauge reading- 0.10"
