Visual Site Inspection Report

Project Name	H-600 Pipeline Spread G	AFE	124300137	Spread	H-600 Pipeline Spread G
Contractor	Precision			Report #	11653
Inspector	Rob Robertson			Date/Time	6/8/2020 12:46 PM
Permit #	TBD	Inspection Type	VA SWPP	Station Begin	11600+01
State	VA	Inspection Area	Full	Station End	11670+00
County	Montgomery	Ground	Dry	Temperature (°F)	74.00
Municipality	N/A	Weather	Sunny	Rain Gauge (in)	0.00
				Rain Accumulation Time (days)	1.00

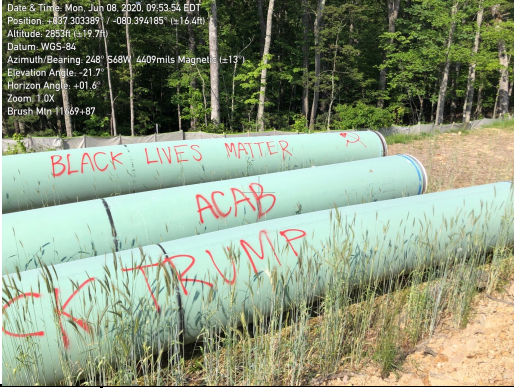
GPS Location	On photo	GPS Location	On photo		
Field Station#	11669+87	Field Station#	11669+50		
Pic 1 Desc.	Graffiti painted on pipe over weekend.	Pic 2 Desc.	Graffiti painted on pipe over weekend.		
<p>Date & Time: Mon, Jun 08, 2020, 10:03:29 EDT Position: +037.309770, -080.594902 (+16.4ft) Altitude: 2822ft (+157.7ft) Datum: WGS-84 Azimuth/Bearing: 289° S40W 3911mils Magnetic (+13°) Elevation Angle: -02.3° Horizon Angle: +01.6° Zoom: 1.0X Brush Min: 11669+50</p>

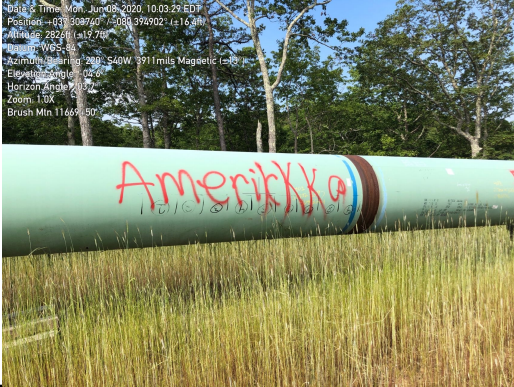
GPS Location	On photo	GPS Location	On photo		
Field Station#	11669+50	Field Station#	11659+00		
Pic 3 Desc.	Graffiti painted on pipe over weekend.	Pic 4 Desc.	End treatments are in place and functional.		
<p>Date & Time: Mon, Jun 08, 2020, 10:44:11 EDT Position: +037.311470, -080.597372 (+16.4ft) Altitude: 2004ft (+157.7ft) Datum: WGS-84 Azimuth/Bearing: 229° N51W 5316mils Magnetic (+13°) Elevation Angle: +01.5° Horizon Angle: -00.5° Zoom: 1.0X Brush Min: ROW stable 11629+00</p>

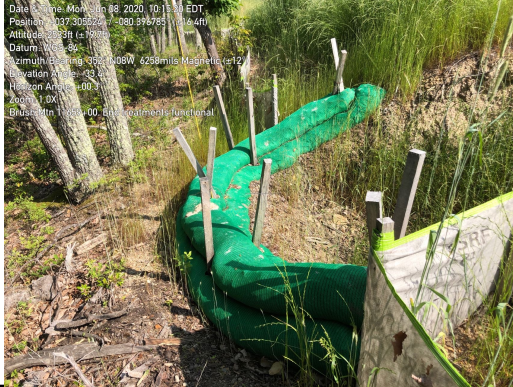
<p>Date & Time: Mon, Jun 08, 2020, 10:11:14 EDT Position: +037.305227, -080.594785 (+16.4ft) Altitude: 2822ft (+157.7ft) Datum: WGS-84 Azimuth/Bearing: 209° S40W 4288mils Magnetic (+12°) Elevation Angle: -02.3° Horizon Angle: +00.3° Zoom: 1.0X Brush Min: 11669+00. End treatments functional</p>

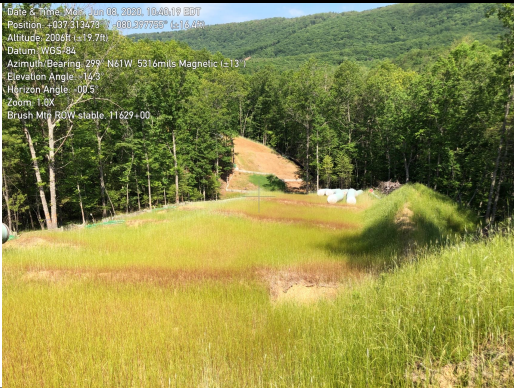
GPS Location	On photo	GPS Location	On photo		
Field Station#	11629+00	Field Station#	11626+04		
Pic 5 Desc.	ROW stable. Slope breakers functional. ECDs in place.	Pic 6 Desc.	S-HH18 crossing stable.

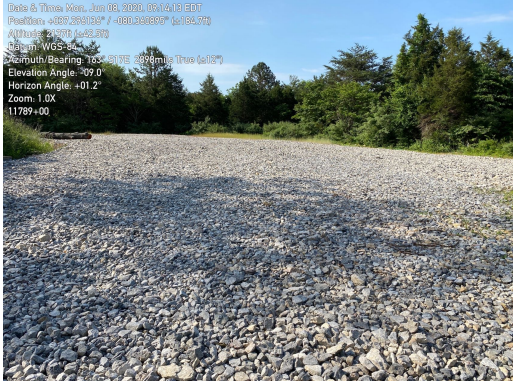
GPS Location				1		GPS Location				2			
Field Station#				11789+00		Field Station#				11798+00			
Pic 1 Desc.				RCE on this South side of Mt Tabor rd.				Pic 2 Desc.				Section of restored RoW showing conditions and controls.

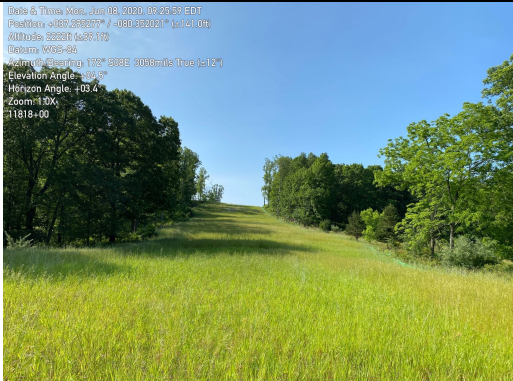
GPS Location				3		GPS Location				4			
Field Station#				11818+00		Field Station#				11845+00			
Pic 3 Desc.				Section of restored RoW showing conditions and controls.				Pic 4 Desc.				Section of restored RoW showing conditions and controls.

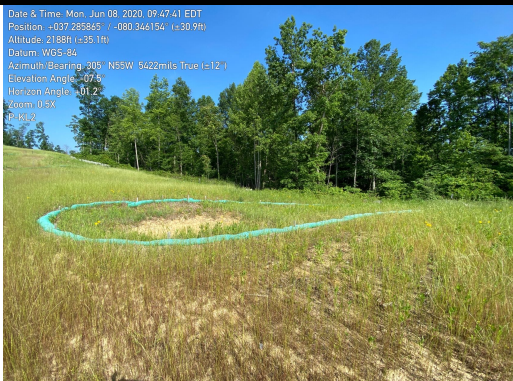
GPS Location				5		GPS Location				6			
Field Station#				11863+65		Field Station#				11899+00			
Pic 5 Desc.				P-KL2 and controls.				Pic 6 Desc.				Section of restored RoW showing conditions and controls.

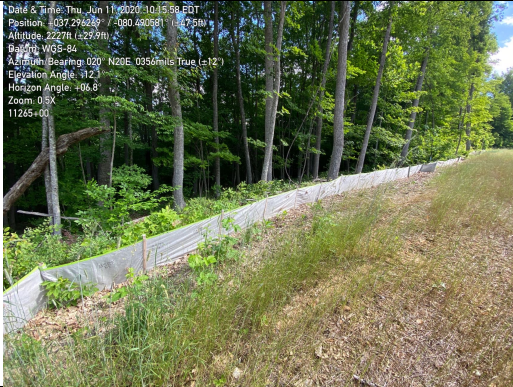
GPS Location	1		GPS Location	2	
Field Station#	11265+00		Field Station#	11286+00	
Pic 1 Desc.	Perimeter controls functional.		Pic 2 Desc.	Perimeter controls functional.

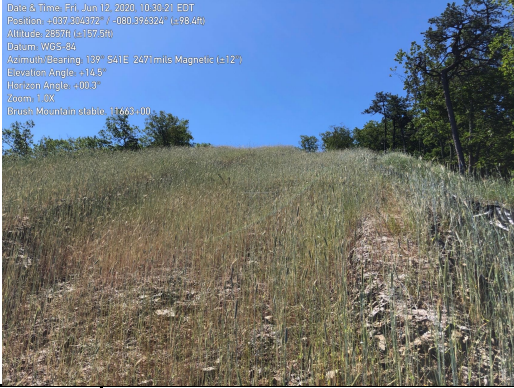
GPS Location	On photo	GPS Location	On photo		
Field Station#	11663+00	Field Station#	11663+00		
Pic 1 Desc.	ROW is currently stable.	Pic 2 Desc.	End treatments were checked and found functional and in good condition.

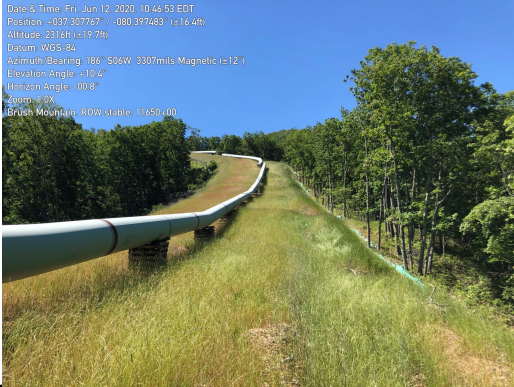
GPS Location	On photo	GPS Location	On photo		
Field Station#	11650+00	Field Station#	11636+00		
Pic 3 Desc.	ROW is currently stable. ECDs are in place and functioning as designed.	Pic 4 Desc.	Sumps and end treatments have worked to control runoff and sediment transport.

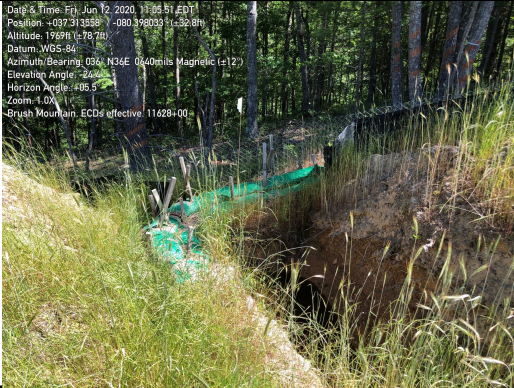
GPS Location	On photo	GPS Location	On photo		
Field Station#	11628+00	Field Station#	11626+04		
Pic 5 Desc.	Perimeter controls in place and in good condition.	Pic 6 Desc.	Resource crossing S-HH18 is stable. ECDs in place. No impact.
