# Visual Site Inspection Report

<b>Project Name</b>	H-600 Pipeline Spread G	<b>AFE</b>	124300137	<b>Spread</b>	H-600 Pipeline Spread G
<b>Contractor</b>	Precision			<b>Report #</b>	12821
<b>Inspector</b>	Chris Burns			<b>Date/Time</b>	7/20/2020 8:14 AM
<b>Permit #</b>	TBD	<b>Inspection Type</b>	VA SWPP	<b>Station Begin</b>	11023+80
<b>State</b>	VA	<b>Inspection Area</b>	Partial	<b>Station End</b>	11064+53
<b>County</b>	Giles	<b>Ground</b>	Dry	<b>Temperature (°F)</b>	92.00
<b>Municipality</b>	N/A	<b>Weather</b>	Sunny	<b>Rain Gauge (in)</b>	0.00
				<b>Rain Accumulation Time (days)</b>	1.00

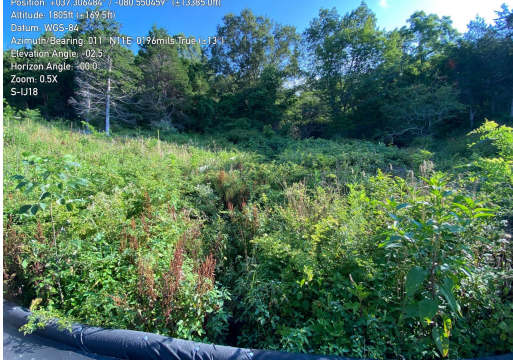
GPS Location				1				GPS Location				2			
Field Station#				11025+50				Field Station#				11034+00			
Pic 1 Desc.				S-IJ18.				Pic 2 Desc.				Section of RoW showing conditions and controls.			
<p>Date &amp; Time: Mon Jul 20, 2020 09:02:40 EDT Position: +037.110139° / -080.540086° (-137.1th) Altitude: 2124ft (+9.4ft) Datum: WGS-84 Azimuth/Bearing: 285° N74W 508mils True (+12.1) Elevation Angle: +03.2° Horizon Angle: -00.9° Zoom: 0.5X 11049+00</p>

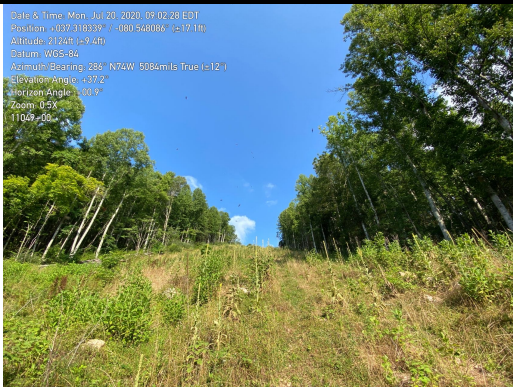
GPS Location				3				GPS Location				4			
Field Station#				11049+00				Field Station#				11050+10			
Pic 3 Desc.				Section of RoW showing conditions and controls.				Pic 4 Desc.				S-IJ16B/S-IJ17 showing conditions and controls.			
<p>Date &amp; Time: Mon Jul 20, 2020 09:05:50 EDT Position: +037.308772° / -080.550502° (-13337.00) Altitude: 2092ft (+135.8ft) Datum: WGS-84 Azimuth/Bearing: 165° S14E 3531mils True (+12.1) Elevation Angle: +01.3° Horizon Angle: -00.1° Zoom: 0.5X 11055+00</p>

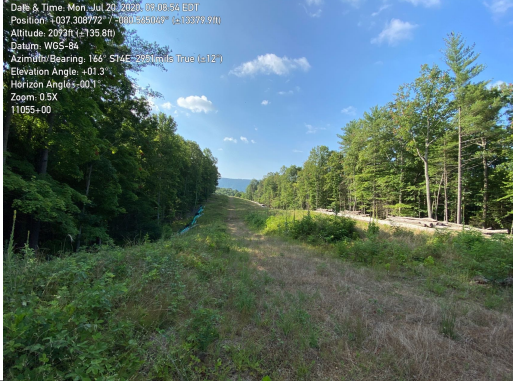
GPS Location				5				GPS Location				6			
Field Station#				11055+00				Field Station#				11064+50			
Pic 5 Desc.				Section of RoW showing conditions and controls.				Pic 6 Desc.				Section of RoW showing conditions and controls.

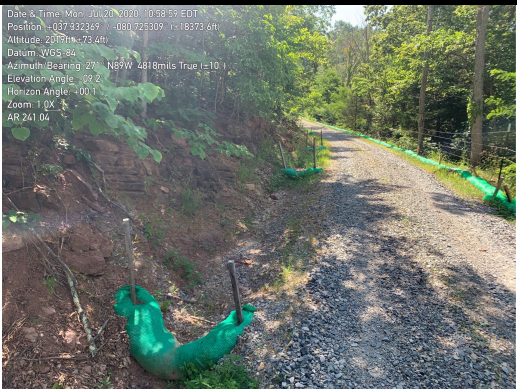
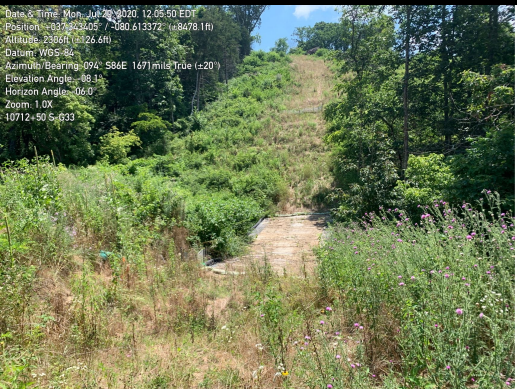
<b>GPS Location</b>	See photo for GPS location.		<b>GPS Location</b>	See photo for GPS location.	
<b>Field Station#</b>	10710+00		<b>Field Station#</b>	10712+50	
<b>Pic 1 Desc.</b>	Compost filter sock checks in place along access road 241.04 bar ditch.		<b>Pic 2 Desc.</b>	Sensitive resource buffer in place at stream S-G33.

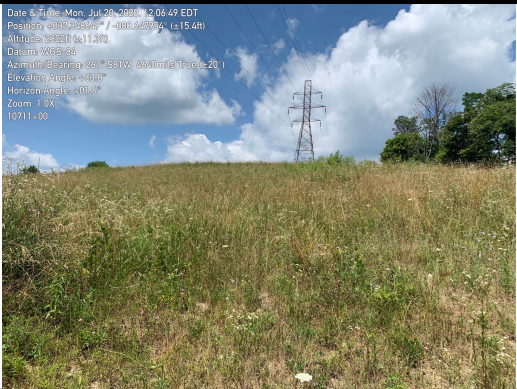
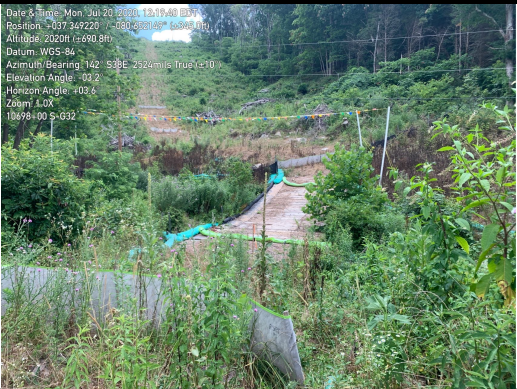
<b>GPS Location</b>	See photo for GPS location.		<b>GPS Location</b>	See photo for GPS location.	
<b>Field Station#</b>	10711+00		<b>Field Station#</b>	10698+00	
<b>Pic 3 Desc.</b>	ROW is stabilized with natural vegetation.		<b>Pic 4 Desc.</b>	Sensitive resource buffer in place at stream S-G32.

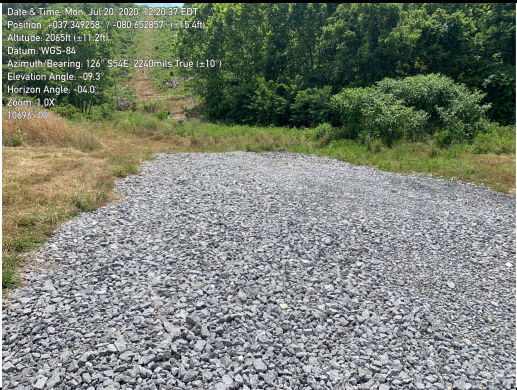
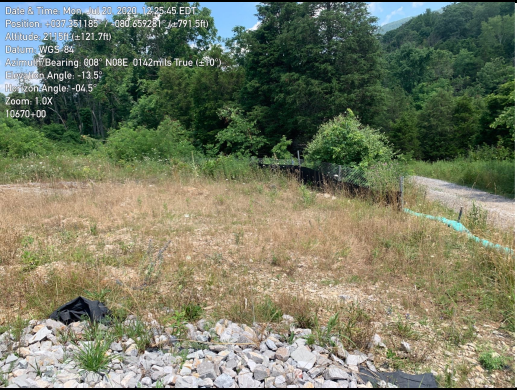
<b>GPS Location</b>	See photo for GPS location.		<b>GPS Location</b>	See photo for GPS location.	
<b>Field Station#</b>	10696+00		<b>Field Station#</b>	10670+00	
<b>Pic 5 Desc.</b>	RCE in place at Buffalo Anklets Road.		<b>Pic 6 Desc.</b>	Reinforced super silt fence in place along LOD.

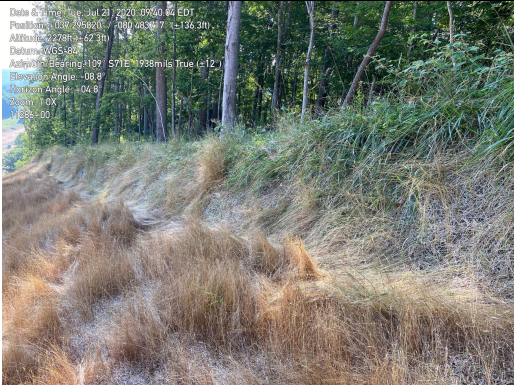
<b>GPS Location</b>	1	<b>GPS Location</b>	2		
<b>Field Station#</b>	11286+00	<b>Field Station#</b>	11292+80		
<b>Pic 1 Desc.</b>	Clear water diversion berm and temporary vegetation.	<b>Pic 2 Desc.</b>	S-MM18 and controls.

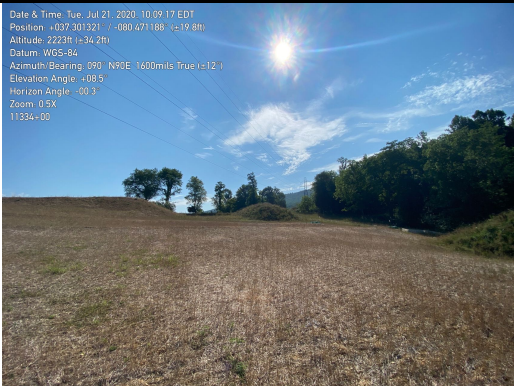
<b>GPS Location</b>	5	<b>GPS Location</b>	6		
<b>Field Station#</b>	11334+00	<b>Field Station#</b>	11352+97		
<b>Pic 5 Desc.</b>	Section of RoW showing conditions and controls.	<b>Pic 6 Desc.</b>	S-NN11 and controls.

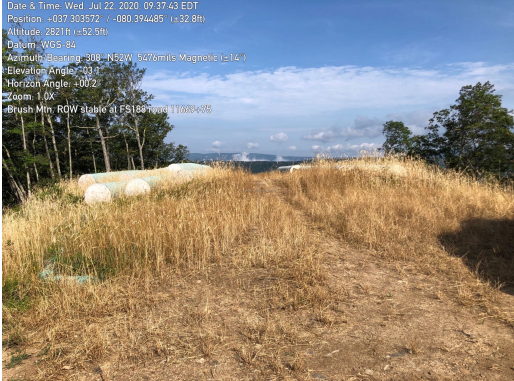
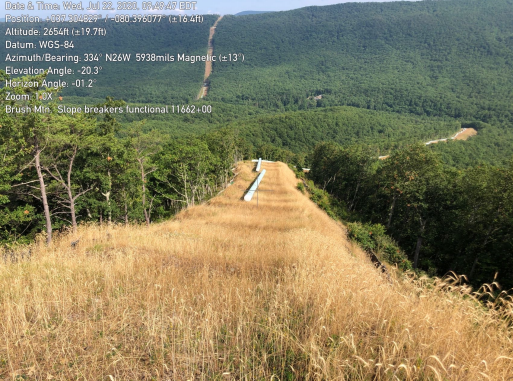
<b>GPS Location</b>	On photo	<b>GPS Location</b>	On photo		
<b>Field Station#</b>	11669+75	<b>Field Station#</b>	11662+00		
<b>Pic 1 Desc.</b>	ROW stable at top of Brush Mountain	<b>Pic 2 Desc.</b>	Slope breakers in place and functional

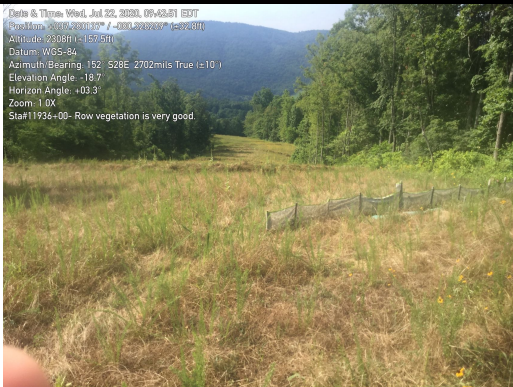
<p>Date &amp; Time: Wed, Jul 22, 2020, 09:47:20 EDT Position: +037.279132 / -080.327836 (+98.4ft) Altitude: +2304ft (+701.0m) Datum: WGS-84 Azimuth/Bearing: 139° 55SW 4178mils True ±10° Elevation Angle: -68° Horizon Angle: +07.0° Zoom: 1.0X Sta#11942+00- Silt fence perimeter controls damaged</p>

GPS Location	See photo GPS	GPS Location	See photo GPS		
Field Station#	11936+00	Field Station#	11941+00		
Pic 3 Desc.	Row vegetation is very good.	Pic 4 Desc.	Silt fence perimeter controls damaged.		
<p>Date &amp; Time: Wed, Jul 22, 2020, 09:58:26 EDT Position: +037.226012 / -080.326190 (+32.8ft) Altitude: +1957ft (+59.4m) Datum: WGS-84 Azimuth/Bearing: 215.555W 3822mils True ±10° Elevation Angle: -22.1° Horizon Angle: +07.0° Zoom: 1.0X Sta#11955+00- Level spreader vegetation</p>

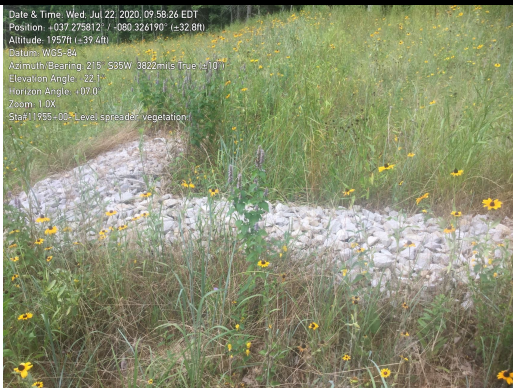
<p>Date &amp; Time: Wed, Jul 22, 2020, 10:14:45 EDT Position: +037.226012 / -080.322678 (+32.8ft) Altitude: +1951ft (+59.2m) Datum: WGS-84 Azimuth/Bearing: 307° N83W 3133mils True ±10° Elevation Angle: -16.5° Horizon Angle: +00.4° Zoom: 1.0X Sta#11979+00- Karst ECD's protection</p>

GPS Location	See photo GPS	GPS Location	See photo GPS		
Field Station#	11955+00	Field Station#	11979+00		
Pic 5 Desc.	Level spreader and row vegetation.	Pic 6 Desc.	Karst ECD's protection.

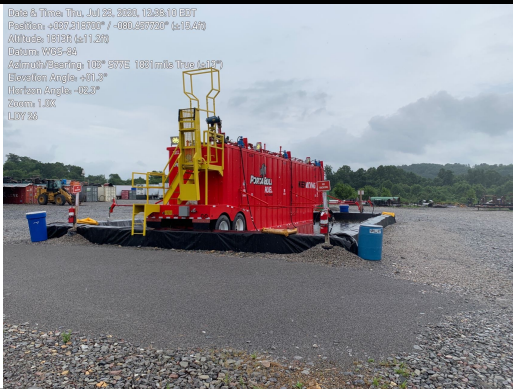
GPS Location		See photo for GPS location.		GPS Location	
Field Station#		12005+00		Field Station#	
Pic 3 Desc.		Secondary containment in place under fuel.		Pic 4 Desc.

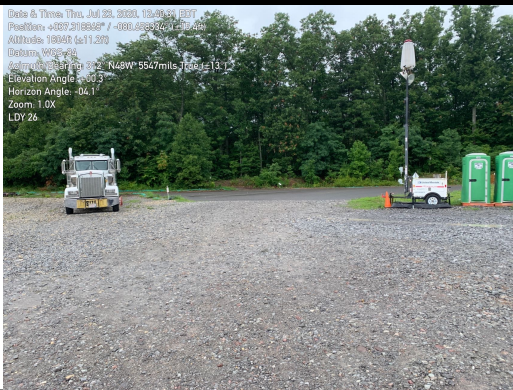
GPS Location		See photo for GPS location.		GPS Location	
Field Station#		12005+00		Field Station#	
Pic 5 Desc.		RCE in place at Lay Down Yard 26 entrance.		Pic 6 Desc.

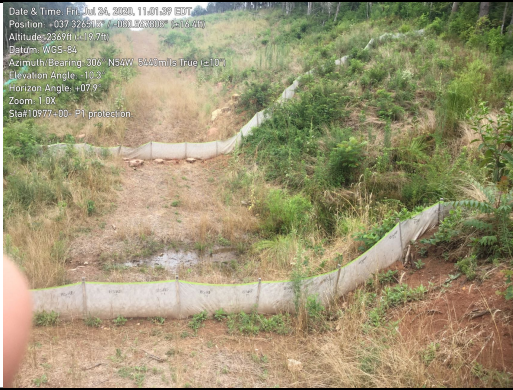
<p>Date &amp; Time: Fri, Jul 24, 2020, 11:01:39 EDT Position: +037.325811° / -080.565000° (+32.40ft) Altitude: 2369ft (+39.4ft) Datum: WGS-84 Azimuth/Bearing: 306° N42W 5403mils True (+10°) Elevation Angle: -11.3° Horizon Angle: +07.9° Zoom: 1.0X Silt fence protection for off row water source crossing row.</p>
