Visual Site Inspection Report

Project Name	H-600 Pipeline Spread G	AFE	124300137	Spread	H-600 Pipeline Spread G
Contractor	Precision			Report #	12458
Inspector	Len Kruizenga			Date/Time	7/6/2020 8:29 AM
Permit #	TBD	Inspection Type	VA SWPP	Station Begin	11788+52
State	VA	Inspection Area	Full	Station End	12005+00
County	Giles	Ground	Dry	Temperature (°F)	85.00
Municipality	N/A	Weather	Sunny	Rain Gauge (in)	0.00
				Rain Accumulation Time (days)	1.00

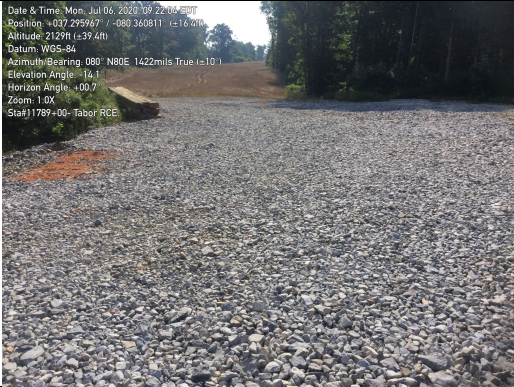
GPS Location	See photo GPS		GPS Location	See photo GPS	
Field Station#	11788+00		Field Station#	11828+00	
Pic 1 Desc.	Tabor RCE		Pic 2 Desc.	Row vegetation, level spreaders

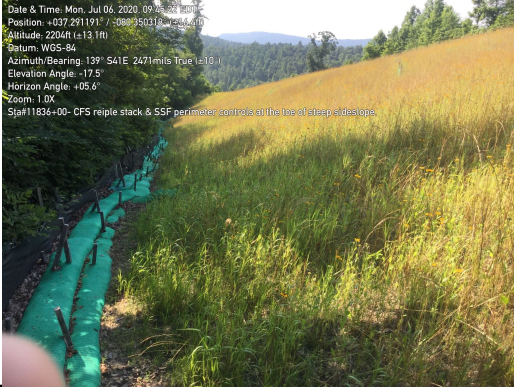
GPS Location	See photo GPS		GPS Location	See photo GPS	
Field Station#	11836+00		Field Station#	11900+00	
Pic 3 Desc.	CFS triple stack and SSF perimeter controls		Pic 4 Desc.	AR-266.03- Access road and CFS checks in bar ditch.

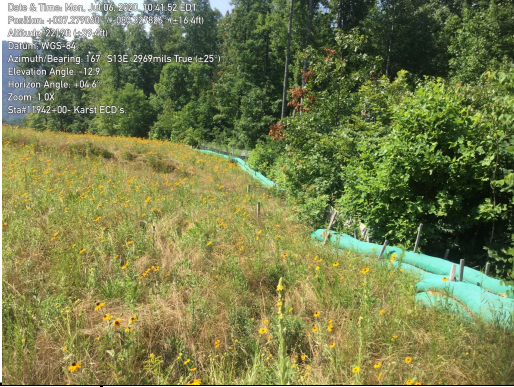
GPS Location	See photo GPS		GPS Location	See	
Field Station#	12942+00		Field Station#	11947+00	
Pic 5 Desc.	Karst ECD's		Pic 6 Desc.	Broad view of the row.

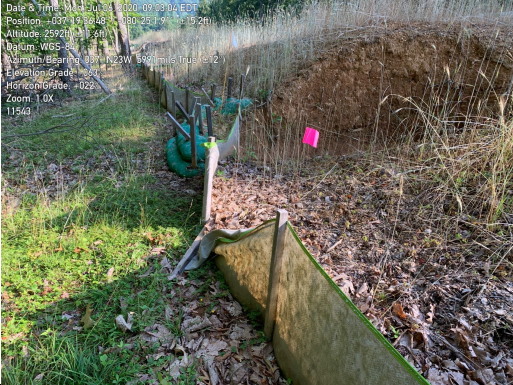
GPS Location	See picture above for GPS coordinates		GPS Location	See picture above for GPS coordinates	
Field Station#	11530+00		Field Station#	11543+00	
Pic 1 Desc.	ECD's and row conditions		Pic 2 Desc.	Damaged P1

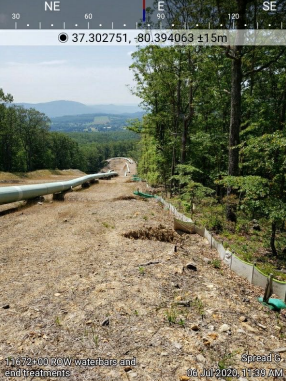
GPS Location	See photo for GPS location.		GPS Location	See photo for GPS location.	
Field Station#	11672+00		Field Station#	11693+50	
Pic 1 Desc.	ROW stabilized with mulch. Priority one silt fence in place along LOD. Waterbar and end treatments in place.		Pic 2 Desc.	Priority one silt fence in place along LOD.

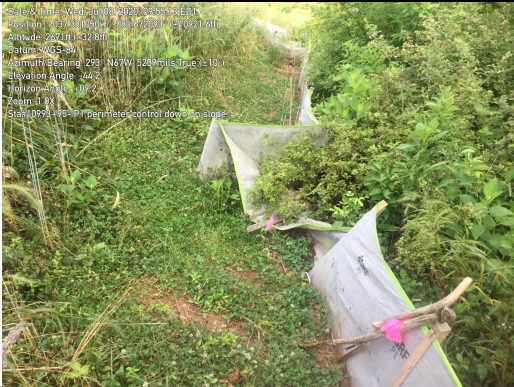
GPS Location	See photo GPS	GPS Location	See photo GPS
Field Station#	10993+95	Field Station#	10986+00
Pic 3 Desc.	Damaged silt fence perimeter controls, issue repaired same day.	Pic 4 Desc.	Stream S- E25 equipment bridge and ECD's.

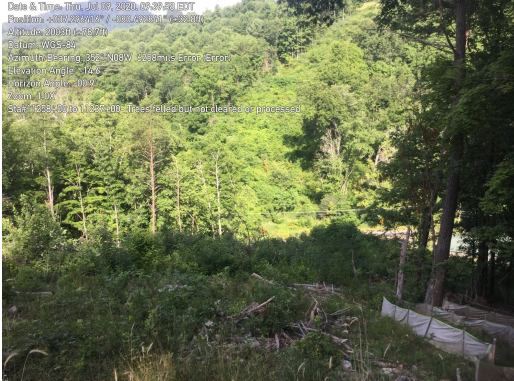
GPS Location	See photo GPS	GPS Location	See photo GPS		
Field Station#	11258+00	Field Station#	11262+00		
Pic 1 Desc.	Sta#11258+00 to 11237+00- Trees felled but not cleared or processed.	Pic 2 Desc.	Sta#11262+00 to 11258+00- Slope drains, water bars, end treatments, perimeter controls.

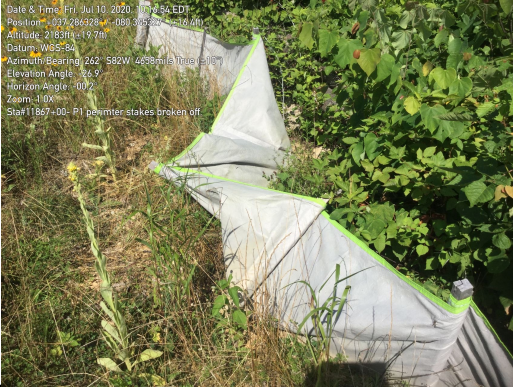
GPS Location	See photo GPS		GPS Location	See photo GPS	
Field Station#	11857+00		Field Station#	11867+00	
Pic 3 Desc.	Level spreaders,ECD's, row vegetation on slope.		Pic 4 Desc.	Silt fence perimeter control stakes broken off, contractor has been informed, issue added to the punch list.

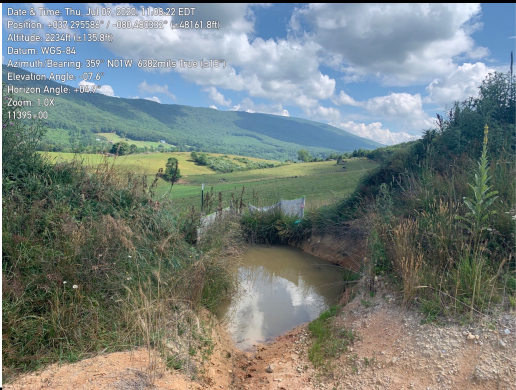
GPS Location	See photo for GPS location.
				GPS Location	See photo for GPS location.
	Field Station#	11395+00		Field Station#	11371+00
Pic 5 Desc.	Hole in priority one silt fence end treatment.		Pic 6 Desc.	Clean water diversion pipe and clean water diversion berm in place.
