Visual Site Inspection Report

Project Name	H-600 Pipeline Spread G	AFE	124300137	Spread	H-600 Pipeline Spread G
Contractor	Precision			Report #	13199
Inspector	Jared Saunders			Date/Time	8/2/2020 1:54 PM
Permit #	TBD	Inspection Type	VA SWPP	Station Begin	11353+00
State	VA	Inspection Area	Partial	Station End	11471+00
County	Giles	Ground	Wet	Temperature (°F)	85.00
Municipality	N/A	Weather	Sunny	Rain Gauge (in)	0.30
				Rain Accumulation Time (days)	1.00

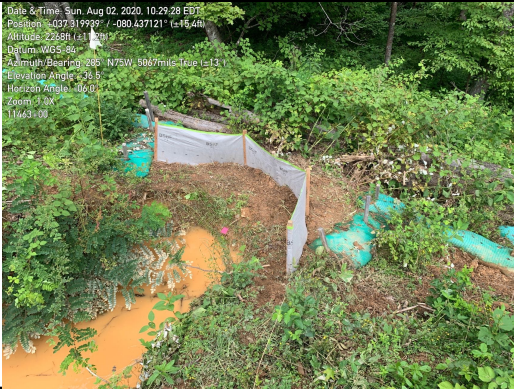
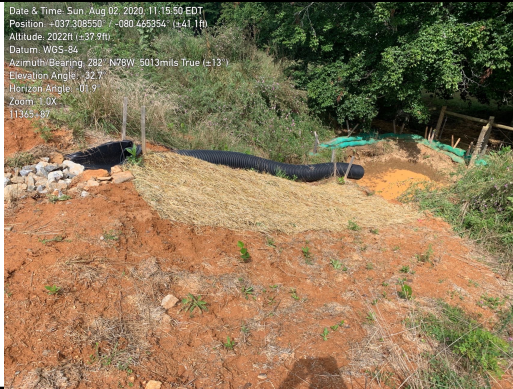
GPS Location	See photo for GPS location.		GPS Location	See photo for GPS location.	
Field Station#	11463+00		Field Station#	11365+87	
Pic 3 Desc.	Priority one silt fence end treatment repaired.		Pic 4 Desc.	Slope drain, fill slope erosion, and triple stack CFS end treatment repaired.

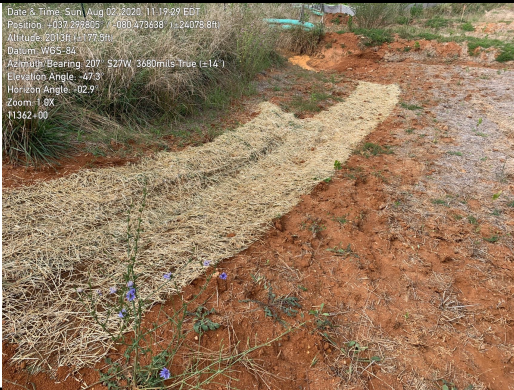
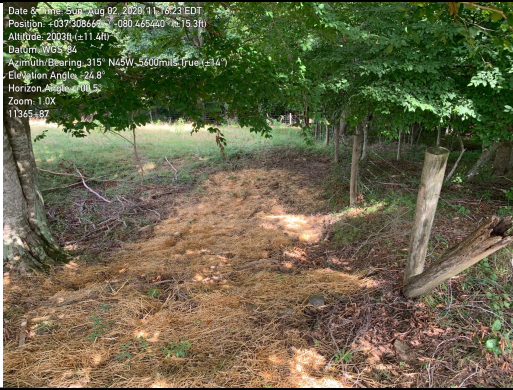
GPS Location	See photo for GPS location.		GPS Location	See photo for GPS location.	
Field Station#	11362+00		Field Station#	11365+87	
Pic 5 Desc.	Rilling raked out and area stabilized with ECB.		Pic 6 Desc.	Off ROW sediment recovered. Area disturbed during sediment retrieval stabilized with seed and mulch.

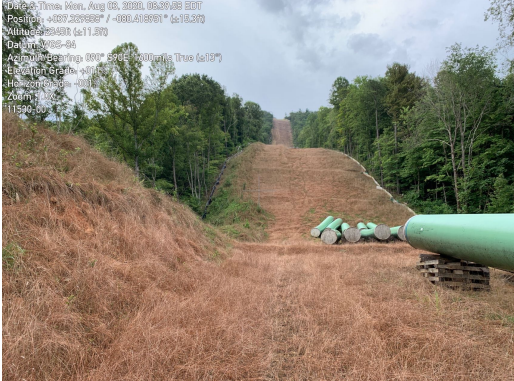
GPS Location	See picture above for GPS coordinates		GPS Location	See picture above for GPS coordinates	
Field Station#	1153+00		Field Station#	11547+00	
Pic 1 Desc.	ECD's and row conditions		Pic 2 Desc.	Damaged P1

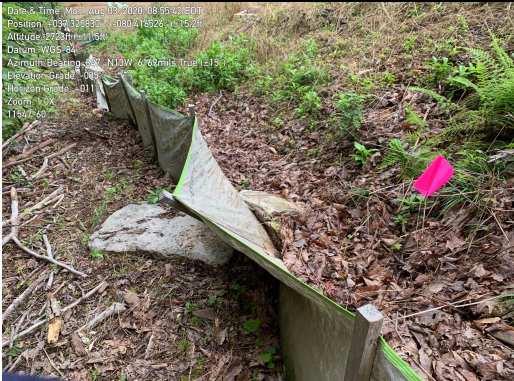
GPS Location	See picture above for GPS coordinates		GPS Location	See picture above for GPS coordinates	
Field Station#	11547+60		Field Station#	11568+50	
Pic 3 Desc.	Damaged P1		Pic 4 Desc.	Damaged P1

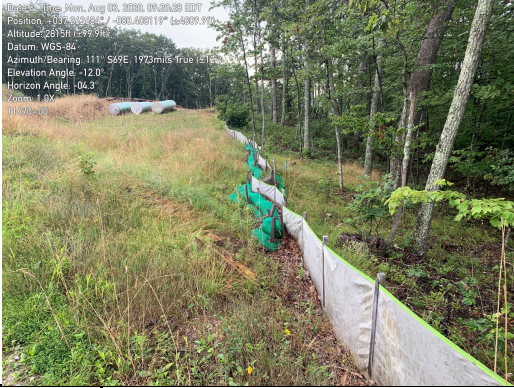
GPS Location		See photo for GPS location.		GPS Location	
Field Station#		11670+00		Field Station#	
Pic 1 Desc.		Triple stack CFS and priority one silt fence in place along LOD.		Pic 2 Desc.

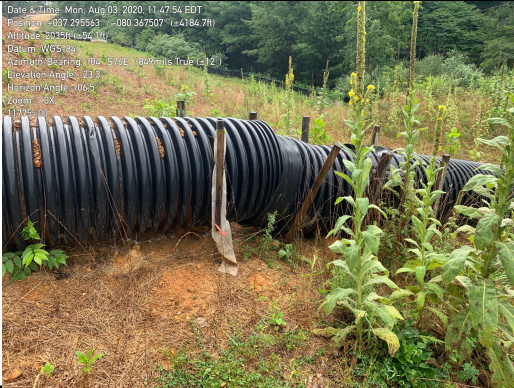
GPS Location		See photo for GPS location.		GPS Location	
Field Station#		11775+00		Field Station#	
Pic 5 Desc.		Clean water diversion pipe disconnected. Item added to punchlist.		Pic 6 Desc.

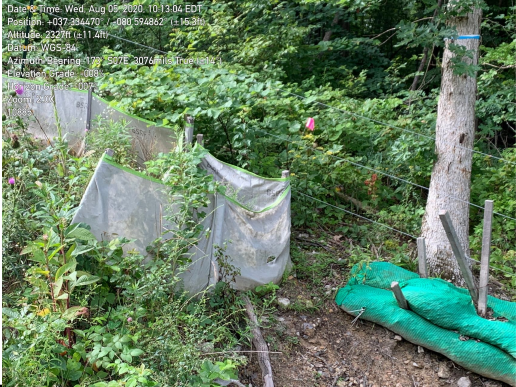
GPS Location		See picture above for GPS coordinates		GPS Location	
Field Station#		10885+00		Field Station#	
Pic 3 Desc.		Damaged P1		Pic 4 Desc.

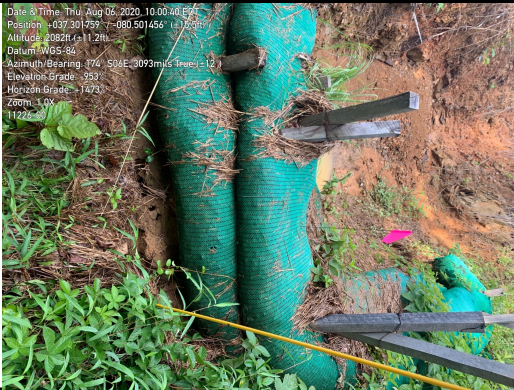
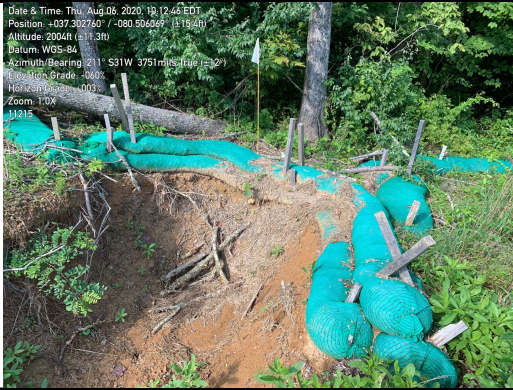
GPS Location	See picture above for GPS coordinates		GPS Location	See picture above for GPS coordinates	
Field Station#	11226+00		Field Station#	11215+00	
Pic 5 Desc.	Build up on CFS end treatment		Pic 6 Desc.	Build up on CFS end treatment
