Visual Site Inspection Report

Project Name	H-600 Pipeline Spread H	AFE	124300138	Spread	H-600 Pipeline Spread H
Contractor	Precision			Report #	11460
Inspector	Dustin Lyons			Date/Time	6/1/2020 4:08 PM
Permit #	TBD	Inspection Type	VA SWPP	Station Begin	12005+00
State	VA	Inspection Area	Partial	Station End	12119+17
County	Montgomery	Ground	Damp	Temperature (°F)	74.00
Municipality	N/A	Weather	Sunny	Rain Gauge (in)	0.00
				Rain Accumulation Time (days)	3.00

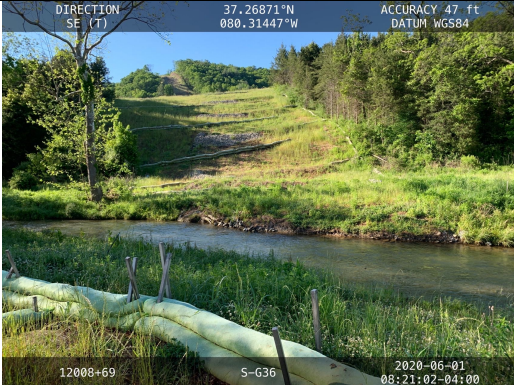
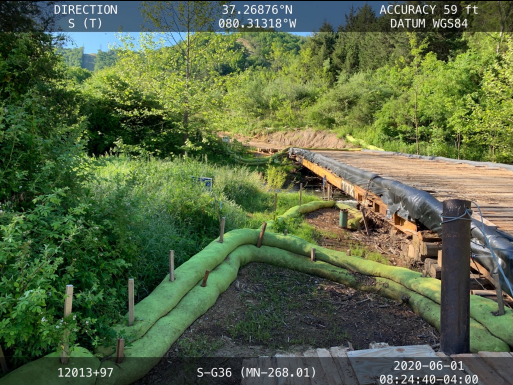
GPS Location	See photo for gps location data.		GPS Location	See photo for gps location data.	
Field Station#	12008+69		Field Station#	12013+97	
Pic 1 Desc.	Photo shows the ROW condition from about 12008+69 to about 12011+00 and stream S-G36.		Pic 2 Desc.	Photo shows the bridge over stream S-G36 on access road MN-268.01.

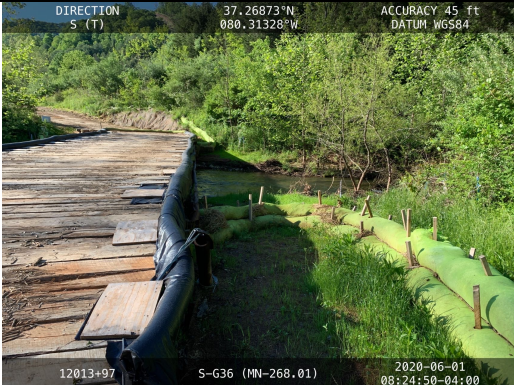
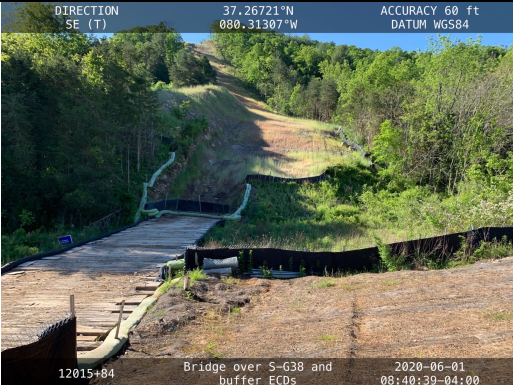
GPS Location	See photo for gps location data.		GPS Location	See photo for gps location data.	
Field Station#	12013+97		Field Station#	12015+84	
Pic 3 Desc.	Photo shows the bridge over stream S-G36 on access road MN-268.01.		Pic 4 Desc.	Photo shows the bridge over stream S-G38 and buffer ECDs.

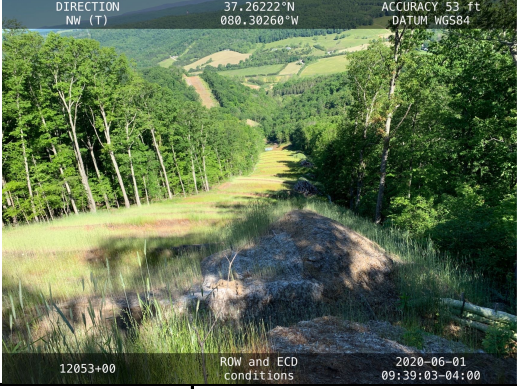
<p>DIRECTION W (T) 37.26451°N 080.30655°W ACCURACY 15 ft DATUM WGS84</p> <p>12037+75 Clean water outlet structure 2020-06-01 09:09:59-04:00</p>

GPS Location	See photo for gps location data.		GPS Location	See photo for gps location data.	
Field Station#	12037+75		Field Station#	12053+00	
Pic 9 Desc.	Photo shows the clean water outlet structure.		Pic 10 Desc.	Photo shows the ROW and ECD conditions from about 12048+00 to 12053+00.

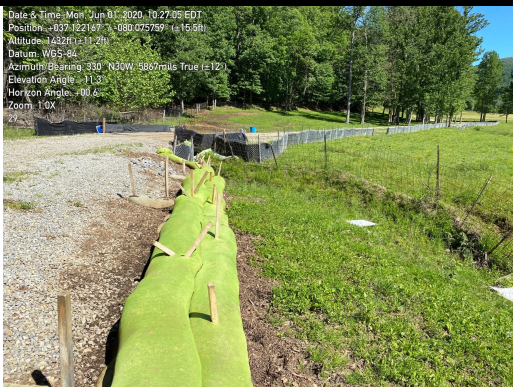
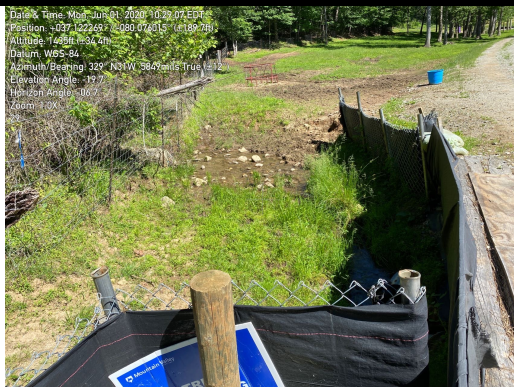
GPS Location	See photo for coordinates.		GPS Location	See photo for coordinates.	
Field Station#	13190+00		Field Station#	13190+00	
Pic 3 Desc.	MVP-AR-29, S-D10, downstream, cattle disturbance noted, no ECD failures.		Pic 4 Desc.	MVP-AR-29, S-D10, upstream, cattle disturbance noted, no ECD failures.

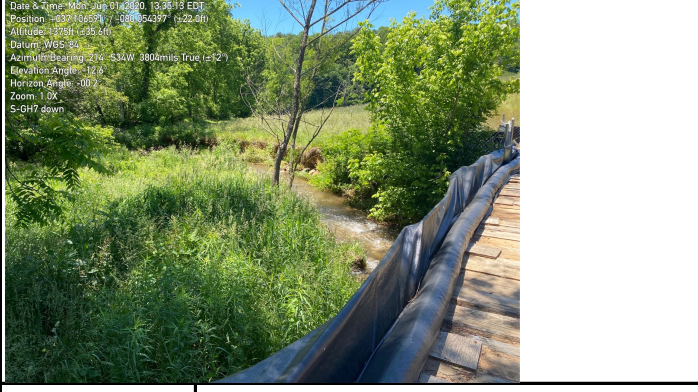
GPS Location	See photo for coordinates.	GPS Location	See photo for coordinates.		
Field Station#	13309+09	Field Station#	13309+09		
Pic 11 Desc.	CIS S-GH7, ECDs functioning acceptably.	Pic 12 Desc.	S-GH7, downstream, bridge in acceptable condition.

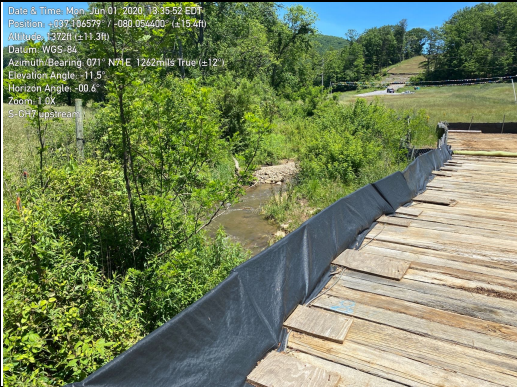
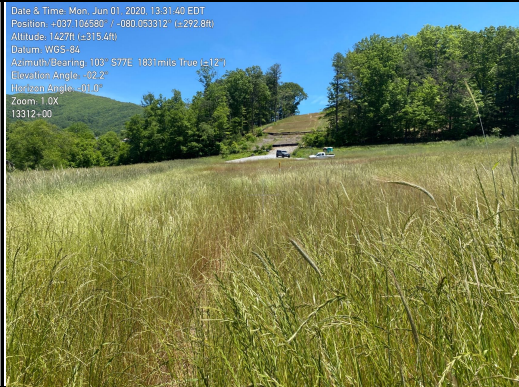
GPS Location	See photo for coordinates.		GPS Location	See photo for coordinates.	
Field Station#	13309+09		Field Station#	13312+00	
Pic 13 Desc.	S-GH7, upstream, ECDs functioning acceptably.		Pic 14 Desc.	LOD stable with good vegetative cover.

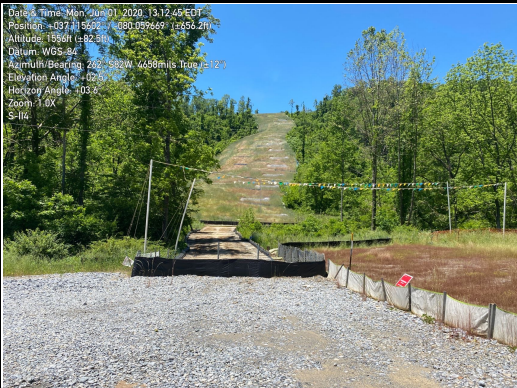
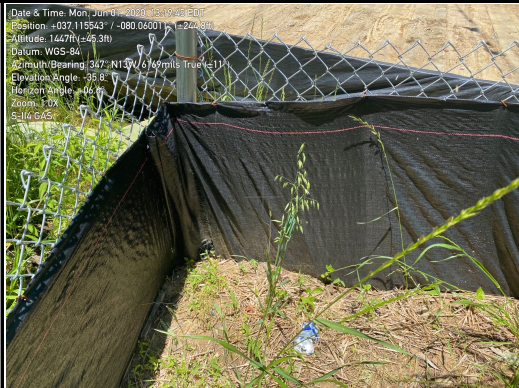
GPS Location	See photo for coordinates.		GPS Location	See photo for coordinates.	
Field Station#	13262+00		Field Station#	13260+85	
Pic 15 Desc.	S-II4, no ECD failures, ROW stable with moderate to good vegetative cover.		Pic 16 Desc.	GAS S-II4, hole in bottom of SSF, punch list item.	
Insert image here		Insert image here			
GPS Location	See photo for coordinates.		GPS Location	See photo for coordinates.	
Field Station#			Field Station#		
Pic 17 Desc.			Pic 18 Desc.

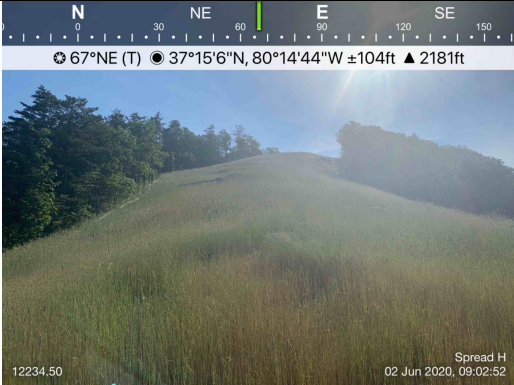
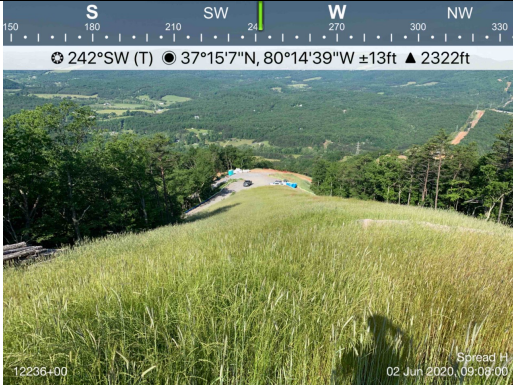
GPS Location	See Photo		GPS Location	See Photo	
Field Station#	12234+50		Field Station#	12236+00	
Pic 1 Desc.	ROW is well vegetated and in acceptable condition.		Pic 2 Desc.	ROW is well vegetated and in acceptable condition.

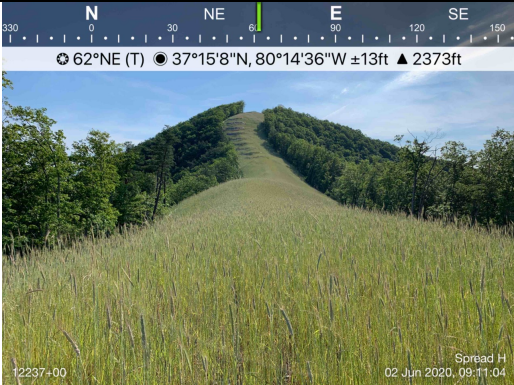
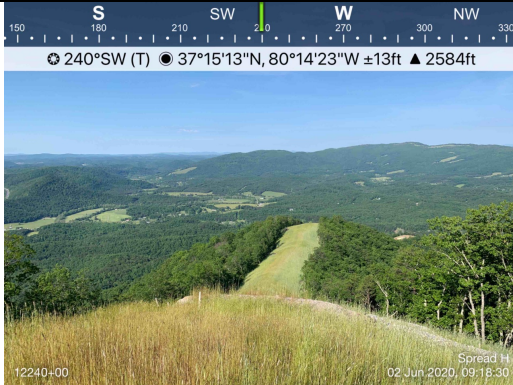
GPS Location	See Photo		GPS Location	See Photo	
Field Station#	12237+00		Field Station#	12240+00	
Pic 3 Desc.	ROW is well vegetated and in acceptable condition.		Pic 4 Desc.	ROW is well vegetated and in acceptable condition.

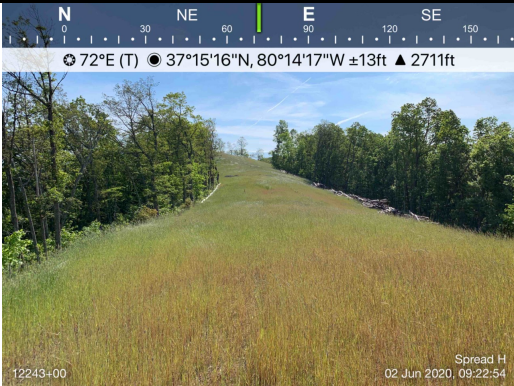
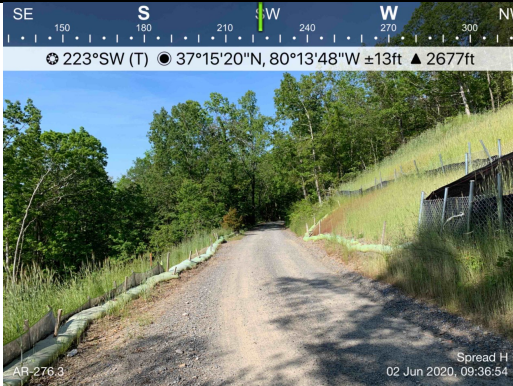
GPS Location	See Photo		GPS Location	See Photo	
Field Station#	12243+00		Field Station#	276+03	
Pic 5 Desc.	ROW is well vegetated and in acceptable condition.		Pic 6 Desc.	AR-276.03 is in acceptable condition.

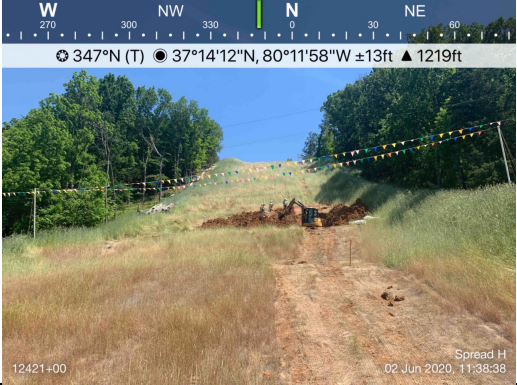
GPS Location	See Photo		GPS Location	See Photo	
Field Station#	12411+00		Field Station#	12421+00	
Pic 15 Desc.	Precision staff were restacking a spoil pile to improve its stability at the time of the inspection.		Pic 16 Desc.	Precision staff were repairing a waterbar during the inspection.

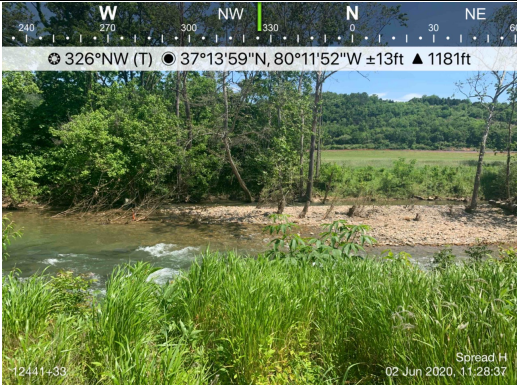
GPS Location	See Photo		GPS Location	See Photo	
Field Station#	12441+39		Field Station#	12442+00	
Pic 17 Desc.	The banks of the Roanoke river are stable and well vegetated.		Pic 18 Desc.	The ROW is well vegetated and in acceptable condition.

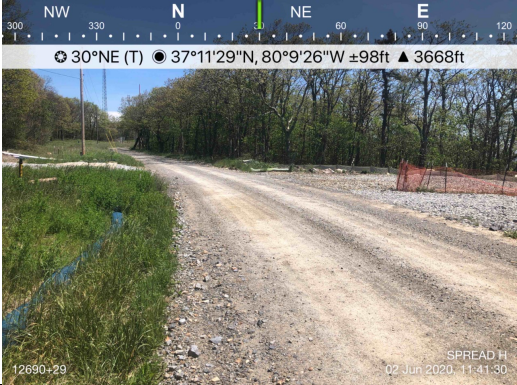
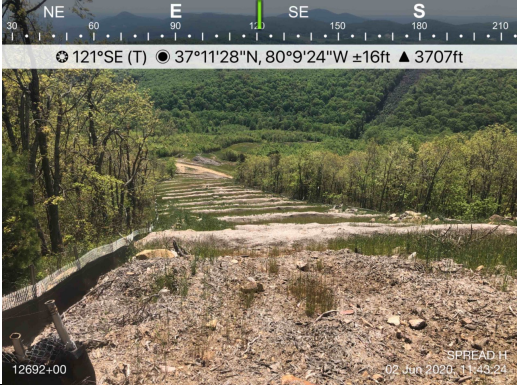
GPS Location	see photo		GPS Location	see photo	
Field Station#	12690+29		Field Station#	12692+00	
Pic 7 Desc.	CE's at the Honeysuckle Rd. crossing are in good condition.		Pic 8 Desc.	GAS of Honeysuckle Rd. in good condition. Controls in place and functioning on this slope.

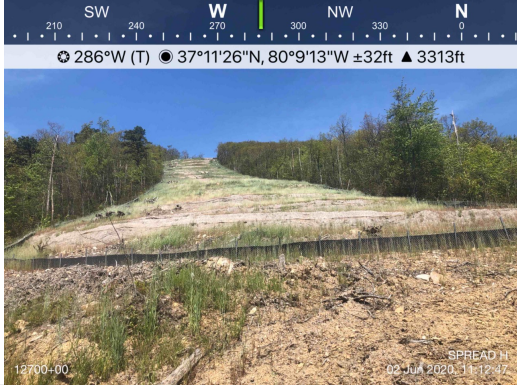
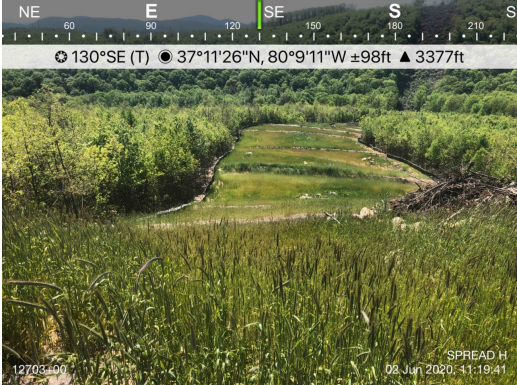
GPS Location	see photo		GPS Location	see photo	
Field Station#	12700+00		Field Station#	12703+00	
Pic 9 Desc.	Additional controls at this location are in good condition and functioning.		Pic 10 Desc.	Vegetation has filled in on the GAS slope of AR-280. Controls are in place and functioning.

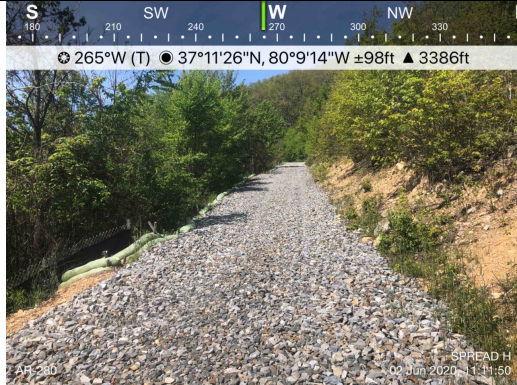
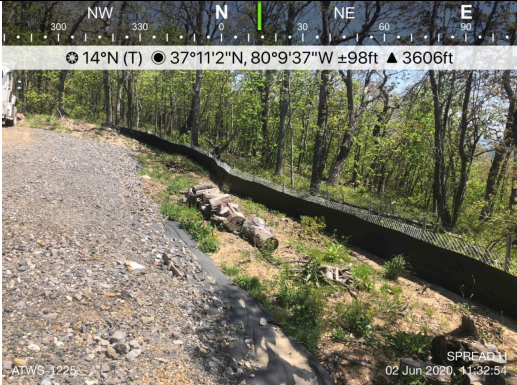
GPS Location	see photo		GPS Location	see photo	
Field Station#	280+00		Field Station#	1225+00	
Pic 11 Desc.	AR-280 in good condition with stone and CFS in place.		Pic 12 Desc.	ATWS-1225 remains dormant with controls in place.

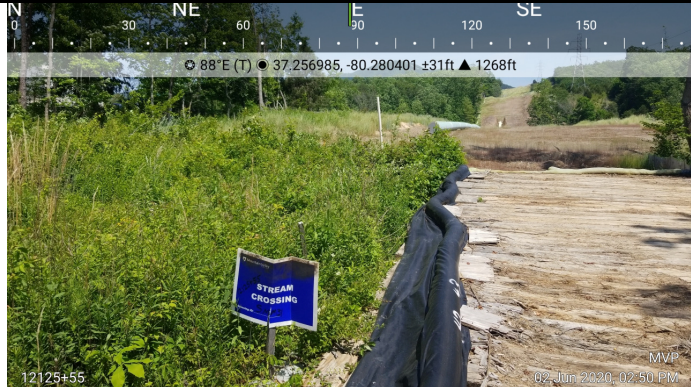
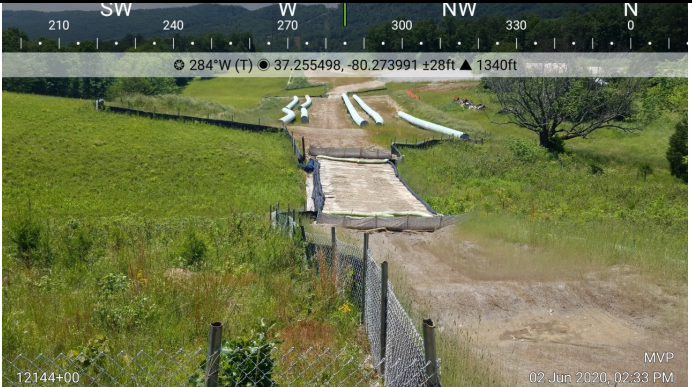
GPS Location	See Above	GPS Location	See Above		
Field Station#	12125+55	Field Station#	12144+00		
Pic 1 Desc.	Stream S-MM31, Looking East. ECDs are functional.	Pic 2 Desc.	Wetland W-C5, Looking West. ECDs are functional.

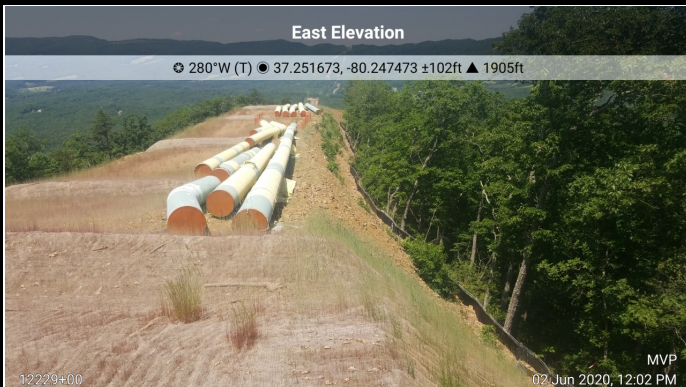
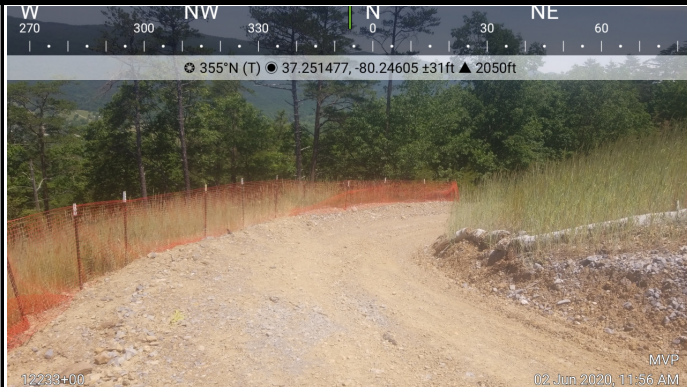
GPS Location	See Above		GPS Location	See Above	
Field Station#	12229+00		Field Station#	12233+00	
Pic 17 Desc.	Temporary vegetation remains stable and ECDs are functional. Looking West.		Pic 18 Desc.	Logging crews not associated with the MVP project have damaged some MVP project ECDs. Looking North.

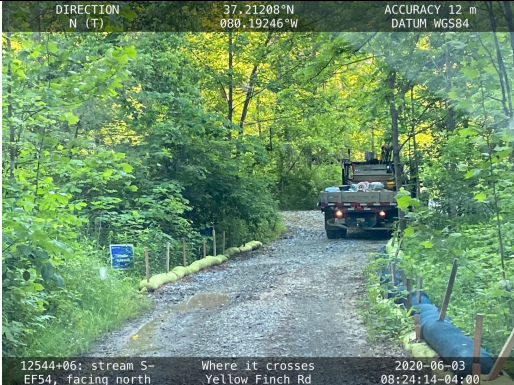
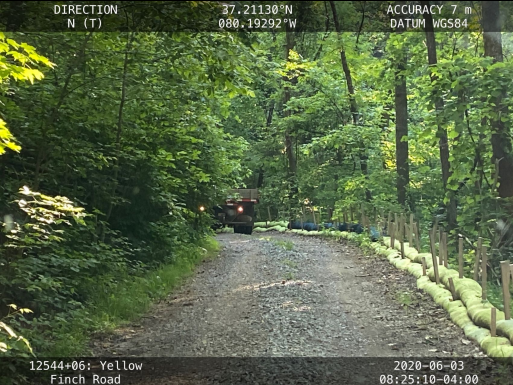
GPS Location	See photo		GPS Location	See photo	
Field Station#	12544+06		Field Station#	12544+06	
Pic 1 Desc.	Stream S-EF54, facing north, where it crosses Yellow Finch Road.		Pic 2 Desc.	Yellow Finch Road

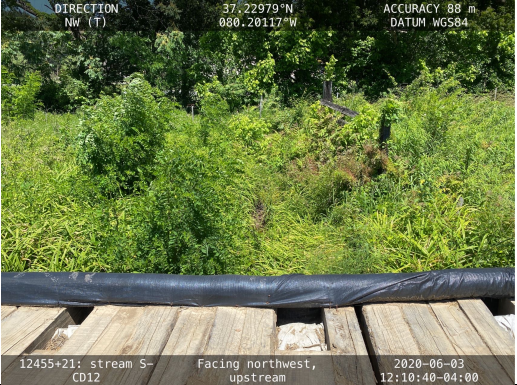
GPS Location	See photo		GPS Location	See photo	
Field Station#	12496+00		Field Station#	12455+21	
Pic 13 Desc.	Vegetative cover minimal, but sufficient cover provided by blanket and straw much.		Pic 14 Desc.	Stream S-CD12, facing northwest, downstream

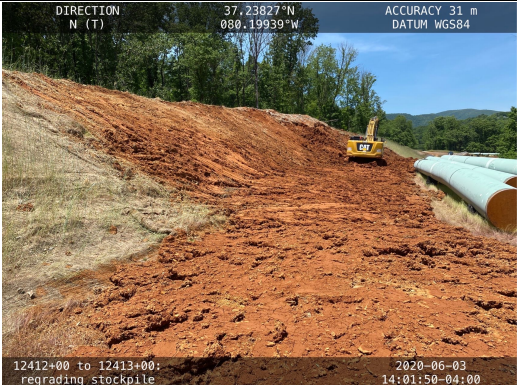
GPS Location	See photo		GPS Location	See photo	
Field Station#	12420+00		Field Station#	12413+00	
Pic 17 Desc.	A subsurface drain was installed where a waterbar had sloughed in an effort to prevent a recurrence.		Pic 18 Desc.	A track hoe was used to reshape this stockpile that had begun to slough.

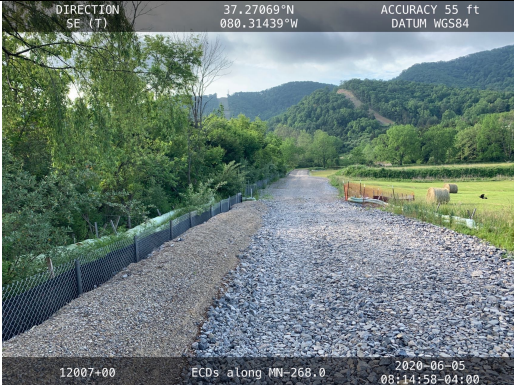
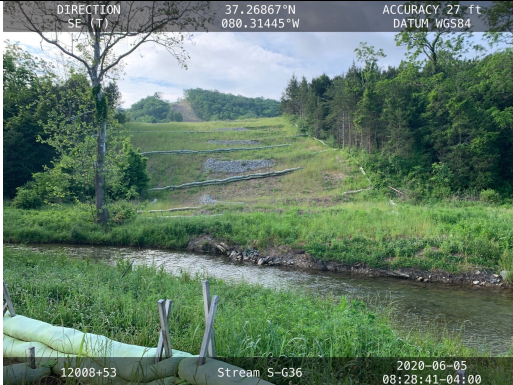
GPS Location	See photo for gps location data.		GPS Location	See photo for gps location data.	
Field Station#	12007+00		Field Station#	12008+53	
Pic 1 Desc.	Photo shows the ECDs along access road MN-268.0.		Pic 2 Desc.	Photo shows stream S-G36 and ROW conditions from 12008+53 to 12010+00.

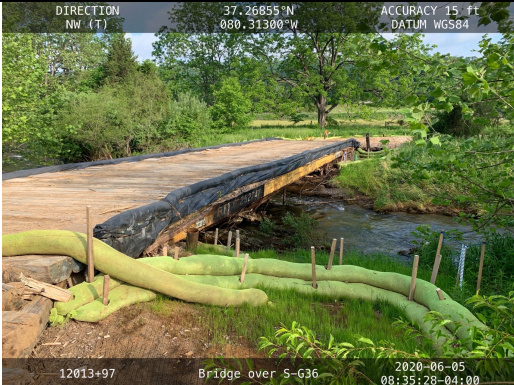
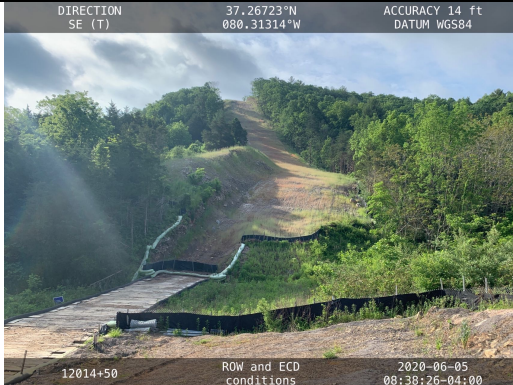
GPS Location	See photo for gps location data.		GPS Location	See photo for gps location data.	
Field Station#	12013+97		Field Station#	12014+50	
Pic 3 Desc.	Photo shows the ECDs along the bridge over S-G36.		Pic 4 Desc.	Photo shows the bridge over stream S-G38 and ROW conditions from about 12014+50 to 12025+00.

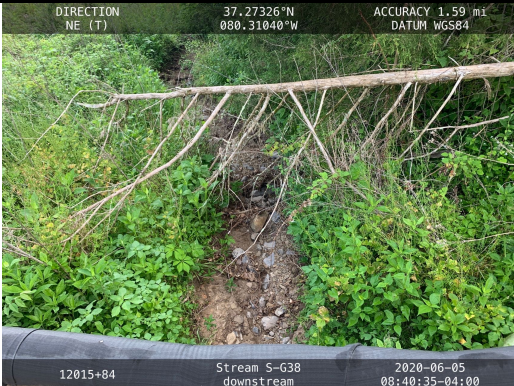
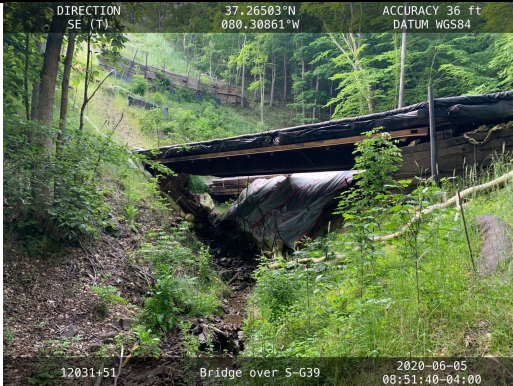
GPS Location	See photo for gps location data.		GPS Location	See photo for gps location data.	
Field Station#	12015+84		Field Station#	12031+51	
Pic 5 Desc.	Photo shows stream S-G38 downstream from the ROW crossing.		Pic 6 Desc.	Photo shows the bridge over stream S-G39 and buffer ECDs.

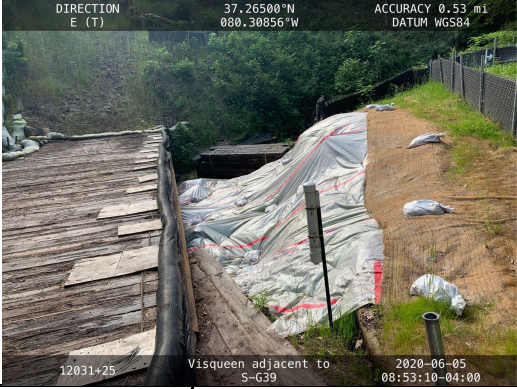
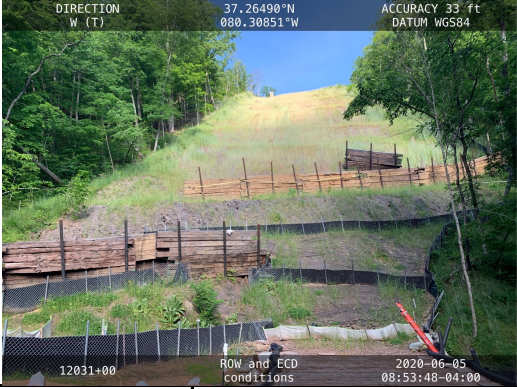
GPS Location	See photo for gps location data.		GPS Location	See photo for gps location data.	
Field Station#	12031+25		Field Station#	12031+00	
Pic 7 Desc.	Photo shows the slope stabilization near S-G39.		Pic 8 Desc.	Photo shows the ROW conditions from about 12028+00 to 12031+00.

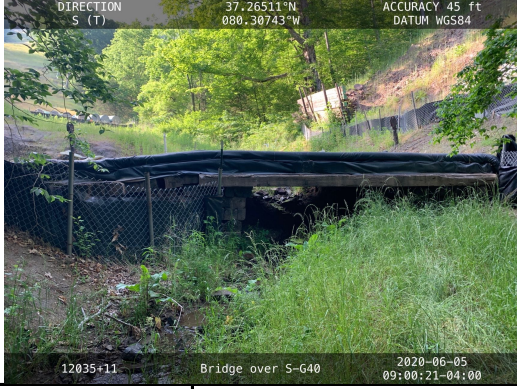
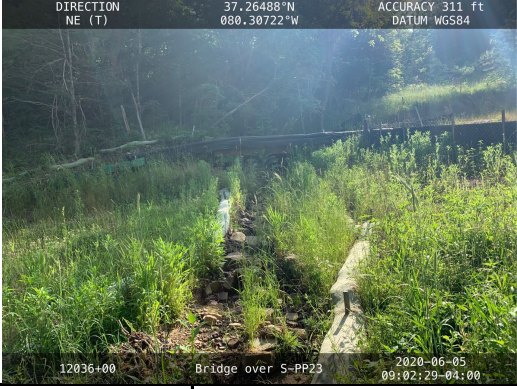
GPS Location	See photo for gps location data.		GPS Location	See photo for gps location data.	
Field Station#	12035+11		Field Station#	12036+00	
Pic 9 Desc.	Photo shows the bridge over stream S-G40.		Pic 10 Desc.	Photo shows the bridge over stream S-PP23.

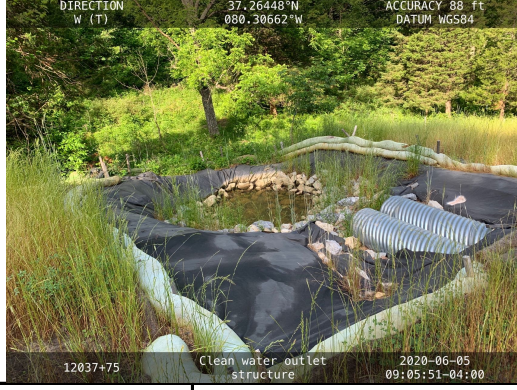
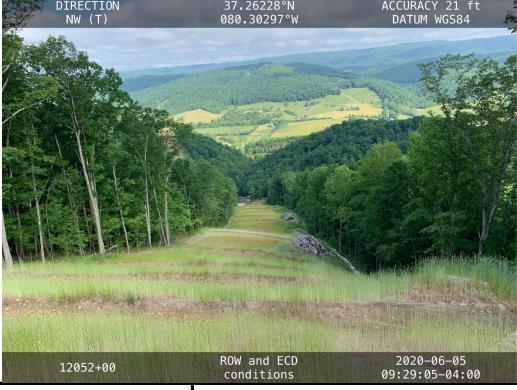
GPS Location	See photo for gps location data.		GPS Location	See photo for gps location data.	
Field Station#	12037+75		Field Station#	12052+00	
Pic 11 Desc.	Photo shows the clean water outlet structure.		Pic 12 Desc.	Photo shows the ROW condition from about 12042+00 to 12052+00.

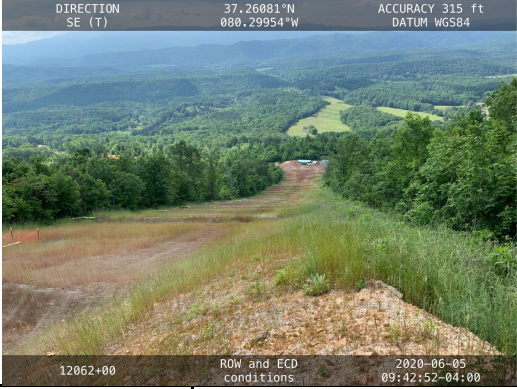
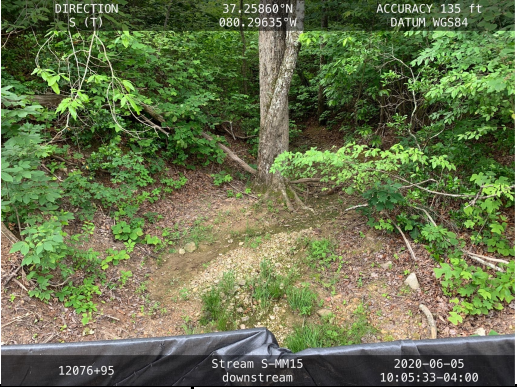
GPS Location	See photo for gps location data.		GPS Location	See photo for gps location data.	
Field Station#	12062+00		Field Station#	12076+95	
Pic 13 Desc.	Photo shows the ROW condition from about 12062+00 to 12072+00.		Pic 14 Desc.	Photo shows stream S-MM15 downstream from the ROW crossing.

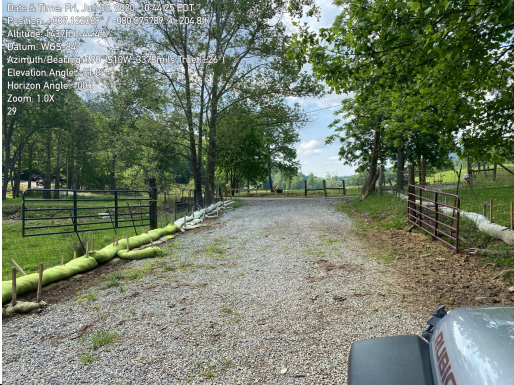
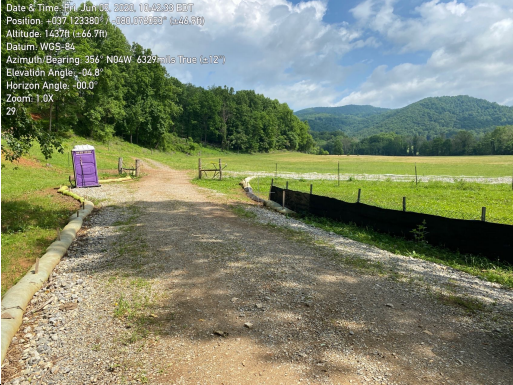
GPS Location	See photo for coordinates.		GPS Location	See photo for coordinates.	
Field Station#	13190+00		Field Station#	13190+00	
Pic 1 Desc.	MVP-AR-29, ECDs in acceptable condition along access road.		Pic 2 Desc.	MVP-AR-29, ECDs in acceptable condition along access road.

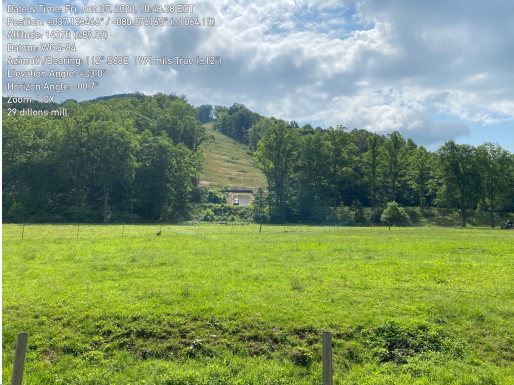
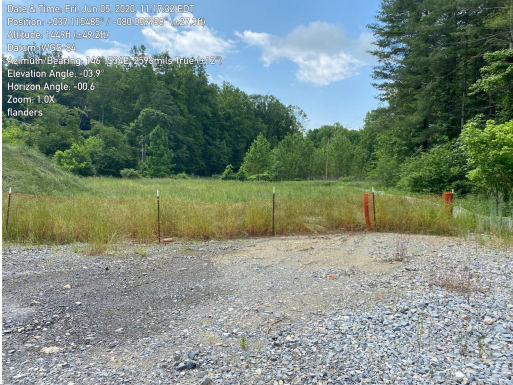
GPS Location	See photo for coordinates.		GPS Location	See photo for coordinates.	
Field Station#	13191+00		Field Station#	13261+00	
Pic 3 Desc.	Looking towards Dillons Mill, ROW temporarily stabilized.		Pic 4 Desc.	ATWS-1055, restored, good vegetative cover.

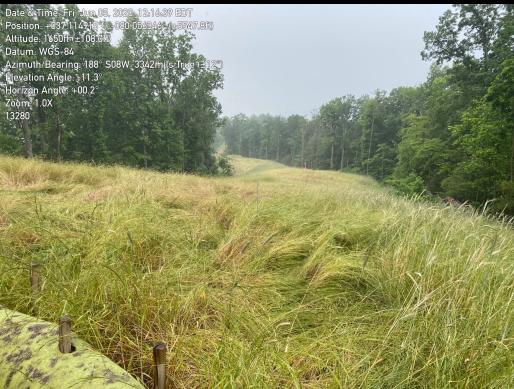
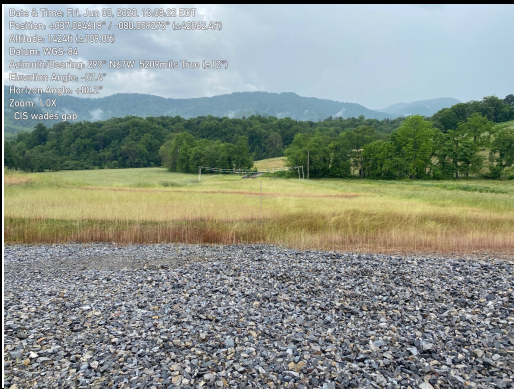
GPS Location		See photo for coordinates.						GPS Location		See photo for coordinates.	
Field Station#		13280+00						Field Station#		13314+00	
Pic 13 Desc.		Restored ROW stable with good vegetative cover.						Pic 14 Desc.		RCE in acceptable condition, temporary waterbars functioning acceptably.

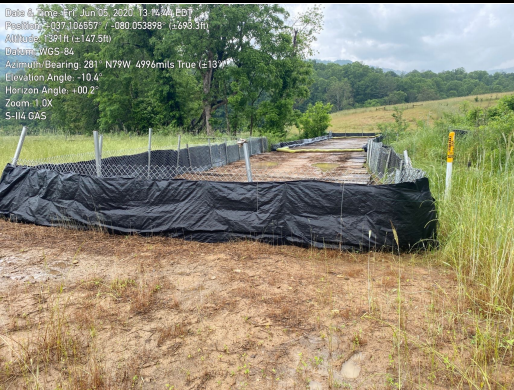
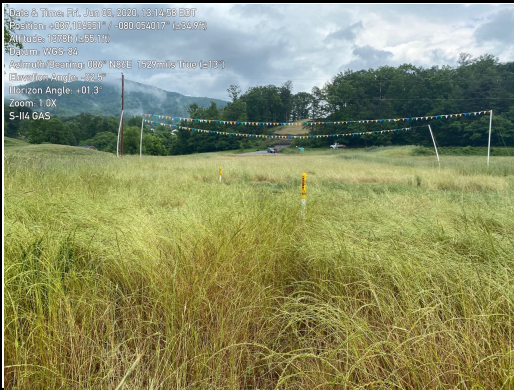
GPS Location		See photo for coordinates.						GPS Location		See photo for coordinates.	
Field Station#		13310+00						Field Station#		13310+50	
Pic 15 Desc.		S-GH7, GAS, ECDs functioning acceptably.						Pic 16 Desc.		Good vegetative cover noted across LOD.

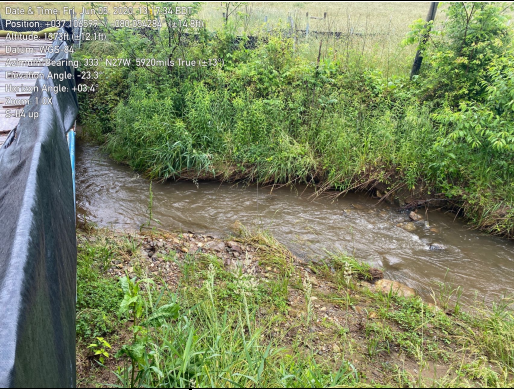
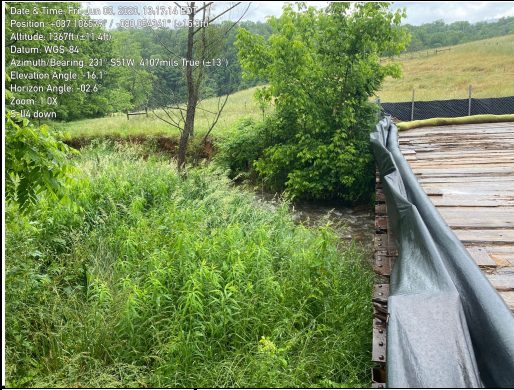
GPS Location		See photo for coordinates.						GPS Location		See photo for coordinates.	
Field Station#		13309+09						Field Station#		13309+09	
Pic 17 Desc.		S-GH7, upstream, no environmental issues noted, additional erosion noted on right descending bank from last high water event.						Pic 18 Desc.		S-GH7, downstream, bridge in acceptable condition, no environmental issues noted.
