Visual Site Inspection Report

Project Name	H-600 Pipeline Spread H	AFE	124300138	Spread	H-600 Pipeline Spread H
Contractor	Precision			Report #	11635
Inspector	Pat Davis			Date/Time	6/8/2020 4:00 PM
Permit #	TBD	Inspection Type	VA SWPP	Station Begin	+0
State	VA	Inspection Area	Partial	Station End	+0
County	Montgomery	Ground	Damp	Temperature (°F)	84.00
Municipality	N/A	Weather	Sunny	Rain Gauge (in)	0.20
				Rain Accumulation Time (days)	0.00

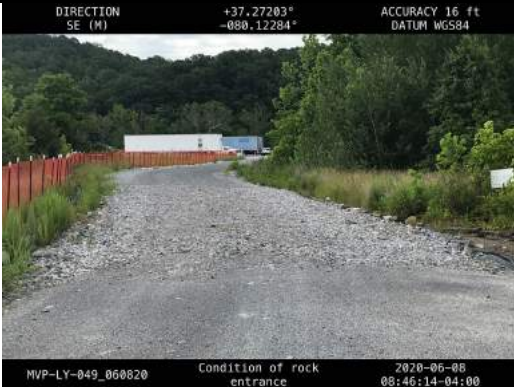
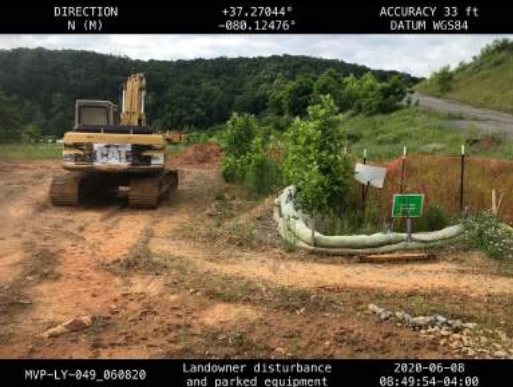
GPS Location	MVP-LY-049 See photo for gps data		GPS Location	MVP-LY-049 See photo for gps data	
Field Station#	+0		Field Station#	+0	
Pic 1 Desc.	Condition of rock entrance on center drive. No sediment on stone. Looking SE.		Pic 2 Desc.	Landowner disturbance and equipment parked next to compost filter sock and feature. No impact. Looking S.

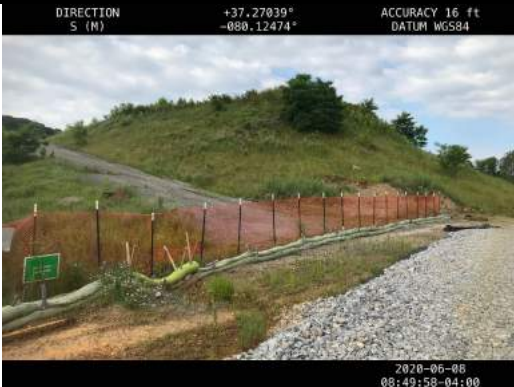
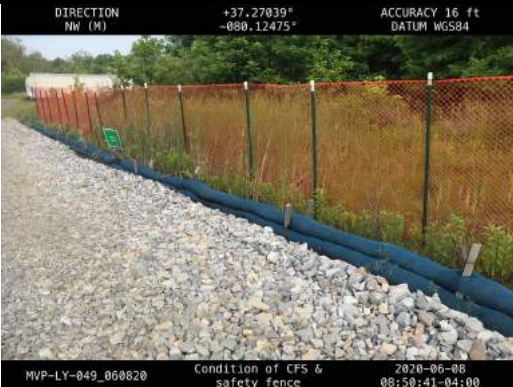
GPS Location	MVP-LY-049 See photo for gps data		GPS Location	MVP-LY-049 See photo for gps data	
Field Station#	+0		Field Station#	+0	
Pic 3 Desc.	Landowner disturbance within 100 feet of feature. No impacts. Looking S.		Pic 4 Desc.	Condition of compost filter sock and safety fence along feature. Looking NW.

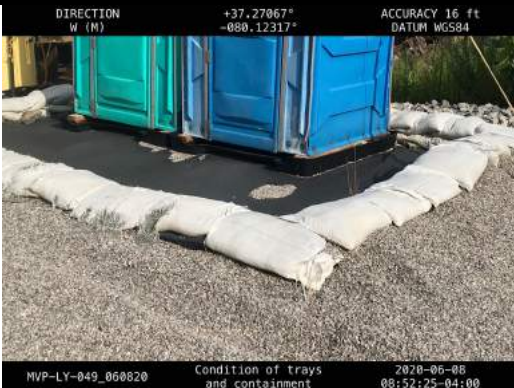
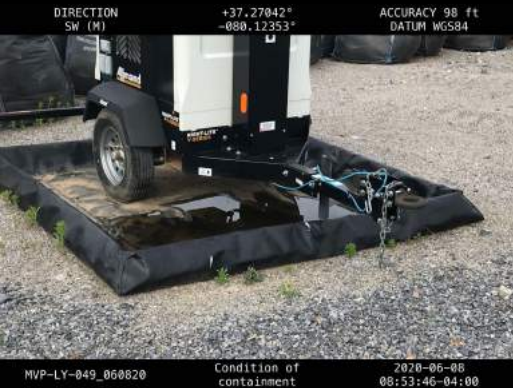
GPS Location	MVP-LY-049 See photo for gps data		GPS Location	MVP-LY-049 See photo for gps data	
Field Station#	+0		Field Station#	+0	
Pic 5 Desc.	Condition of trays and containment under toilets. Looking W.		Pic 6 Desc.	Condition of containment under light plant. Holding some stormwater. Looking SW.

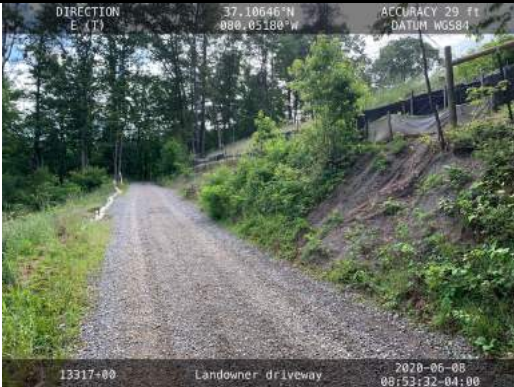
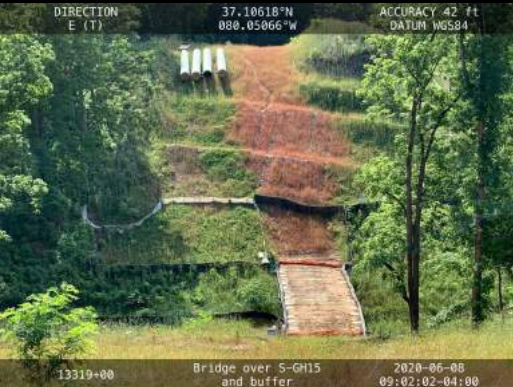
GPS Location	See photo for gps location data.		GPS Location	See photo for gps location data.	
Field Station#	13317+00		Field Station#	13319+00	
Pic 1 Desc.	Photo shows the landowner driveway near Wades Gap Road.		Pic 2 Desc.	Photo shows the bridge over stream S-GH15 and buffer ECDs.

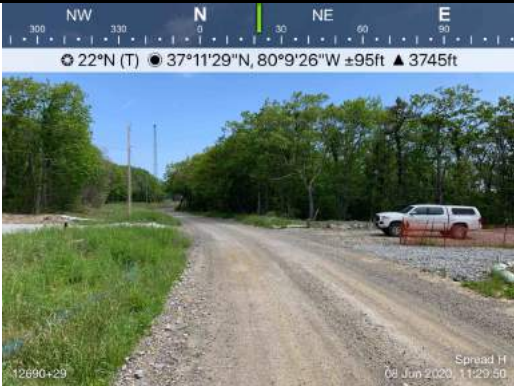
GPS Location	see photo		GPS Location	see photo	
Field Station#	12690+29		Field Station#	12701+37	
Pic 5 Desc.	Construction entrances are in acceptable condition.		Pic 6 Desc.	SSF is in place and functional.

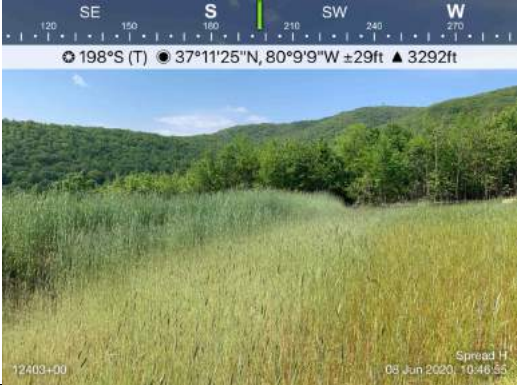
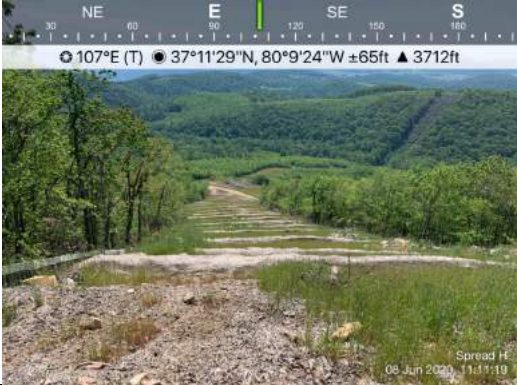
GPS Location	See photo		GPS Location	See Photo	
Field Station#	12703+00		Field Station#	12691+00	
Pic 7 Desc.	Vegetation is well estblished.		Pic 8 Desc.	Waterbars are in acceptable condition.

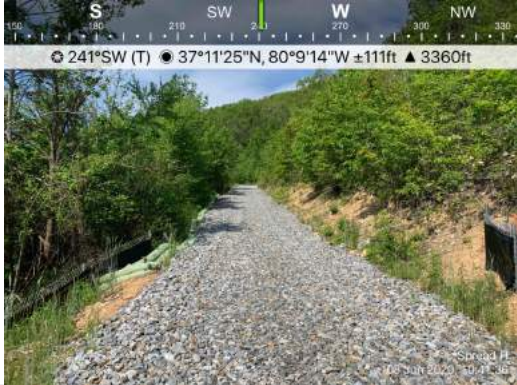
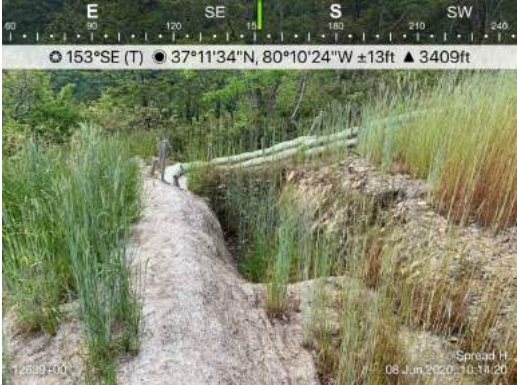
GPS Location	See photo		GPS Location	See Photo	
Field Station#	280+00		Field Station#	12629+00	
Pic 9 Desc.	AR-280 is in acceptable condition.		Pic 10 Desc.	End treatments are in acceptable condition.

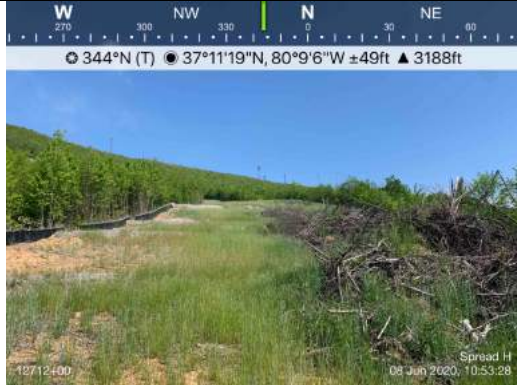
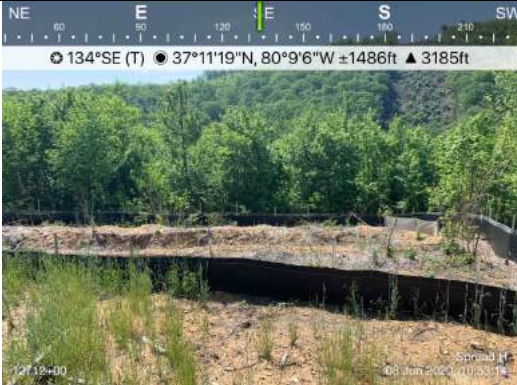
GPS Location	see photo		GPS Location	see photo	
Field Station#	12712+00		Field Station#	12712+00	
Pic 11 Desc.	The ROW vegetation is well established.		Pic 12 Desc.	SSF is in acceptable condition.

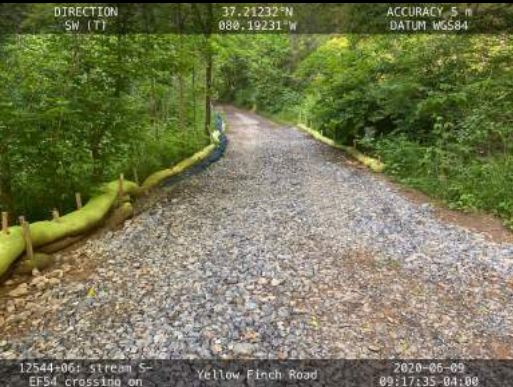
GPS Location	See photo		GPS Location	See photo	
Field Station#	12447+00		Field Station#	12544+06	
Pic 1 Desc.	Operator regraded parking area off Cove Hollow Road.		Pic 2 Desc.	Stream S-EF54 on Yellow Finch Road, facing southwest

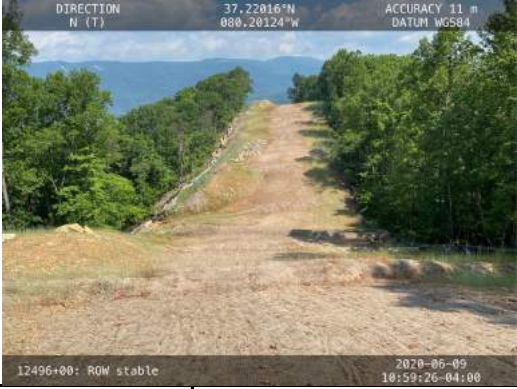
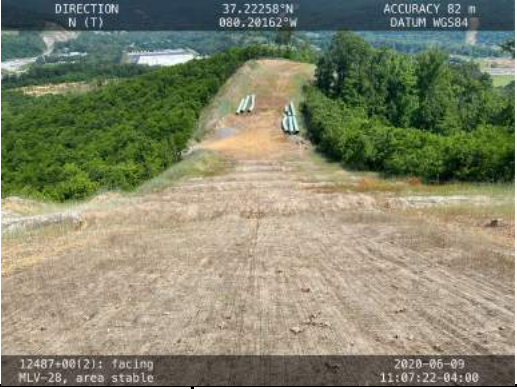
GPS Location	See photo		GPS Location	See photo	
Field Station#	12496+00		Field Station#	12487+00	
Pic 13 Desc.	ROW stable, ECDs in satisfactory condition.		Pic 14 Desc.	Facing MLV-28, ROW stable.

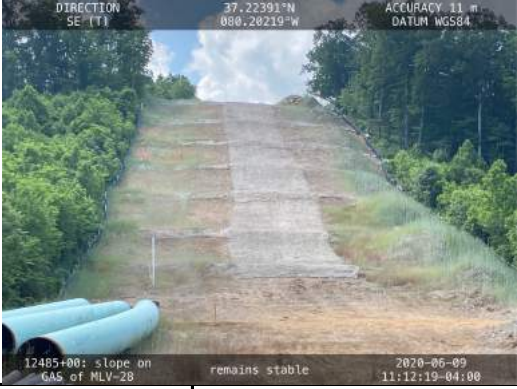
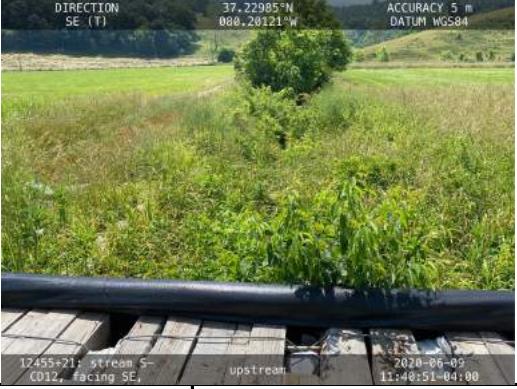
GPS Location	See photo		GPS Location	See photo	
Field Station#	12485+00		Field Station#	12455+21	
Pic 15 Desc.	Slope on GAS of MLV-28 stable, no indications of erosion.		Pic 16 Desc.	Stream S-CD12, facing southeast, upstream

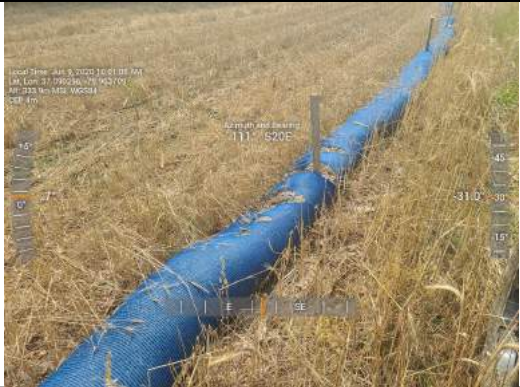
GPS Location	00000	GPS Location	0000		
Field Station#	13534+00	Field Station#	13640+98		
Pic 3 Desc.	Photo showing clover on areas of row	Pic 4 Desc.	Documented CFS that needs replaced and added to the punch list		
Insert image here			Insert image here		
GPS Location		GPS Location			
Field Station#		Field Station#			
Pic 5 Desc.		Pic 6 Desc.

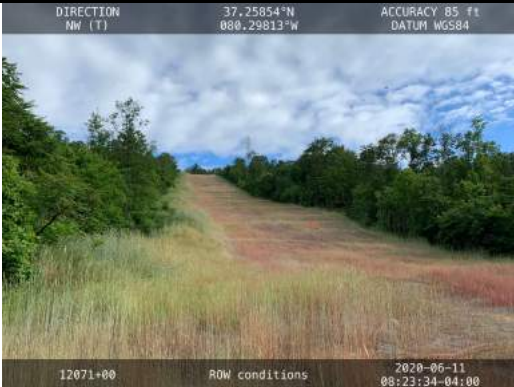
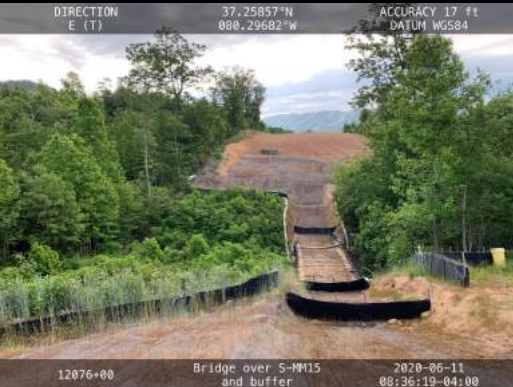
GPS Location	See photo for gps location data.		GPS Location	See photo for gps location data.	
Field Station#	12071+00		Field Station#	12076+00	
Pic 1 Desc.	Photo shows the ROW and ECD conditions from about 12062+00 to 12072+00.		Pic 2 Desc.	Photo shows bridge over stream S-MM15 and buffer ECDs.

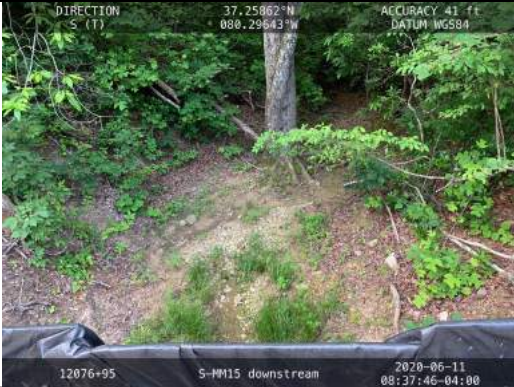
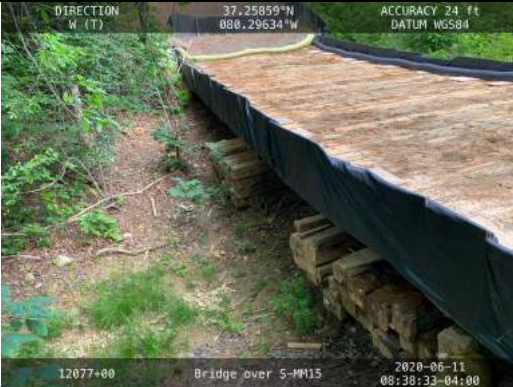
GPS Location	See photo for gps location data.		GPS Location	See photo for gps location data.	
Field Station#	12076+95		Field Station#	12077+00	
Pic 3 Desc.	Photo shows stream S-MM15 downstream from ROW crossing.		Pic 4 Desc.	Photo shows the bridge over stream S-MM5.

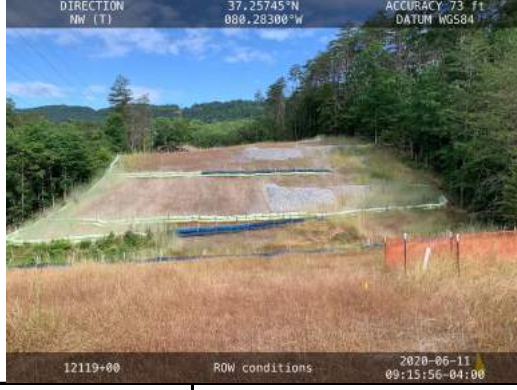
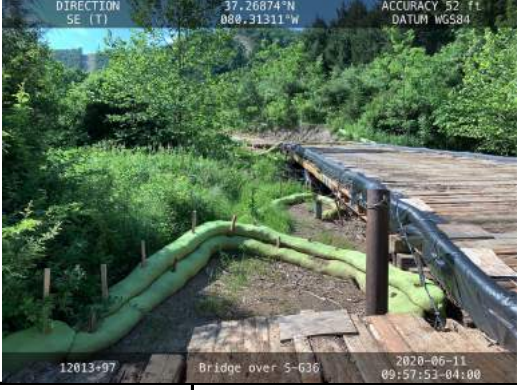
GPS Location	See photo for gps location data.		GPS Location	See photo for gps location data.	
Field Station#	12119+00		Field Station#	12013+97	
Pic 11 Desc.	Photo shows the ROW condition from about 12117+00 to 12119+00.		Pic 12 Desc.	Photo shows the ECDs along the bridge over stream S-G36 on access road MN-268.01.

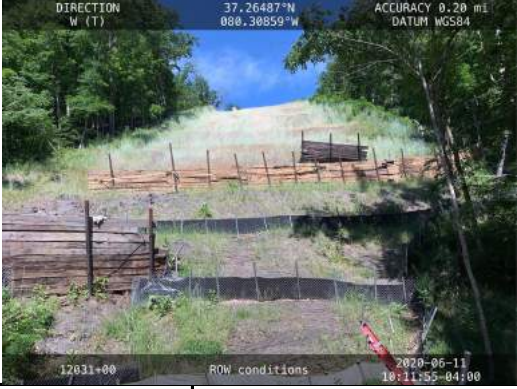
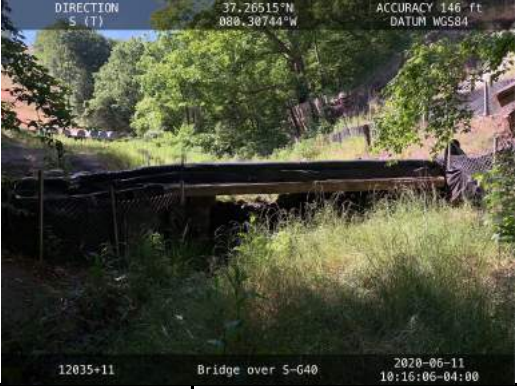
Field Station#	12031+00		Field Station#	12035+11	
Pic 15 Desc.	Photo shows the ROW condition from about 12028+00 to 12031+00.		Pic 16 Desc.	Photo shows the bridge over stream S-G40.

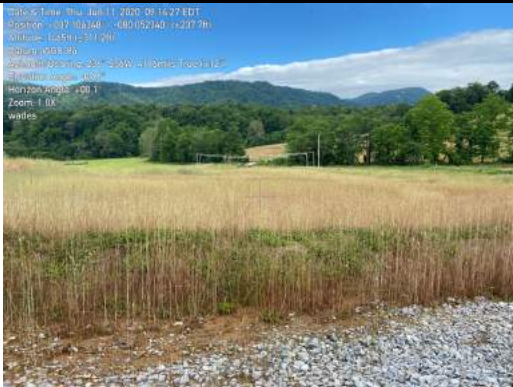
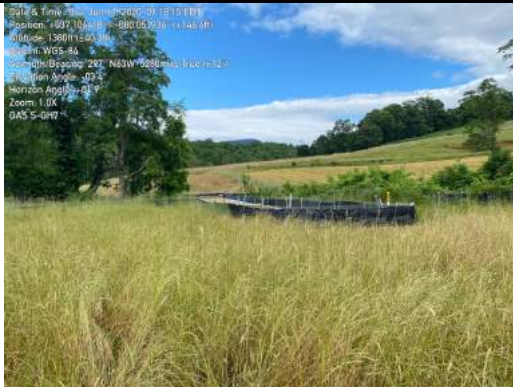
GPS Location		See photo for coordinates.		GPS Location	
Field Station#		13314+00		Field Station#	
Pic 1 Desc.		CIS Wades Gap, good vegetative cover across LOD.		Pic 2 Desc.

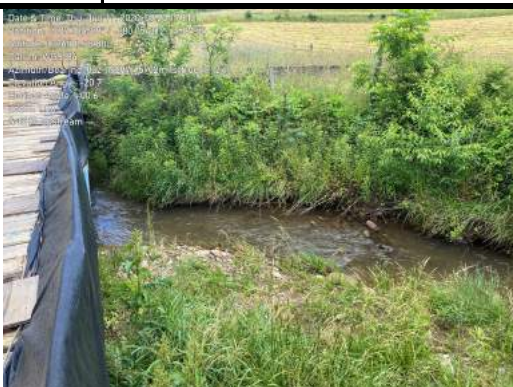
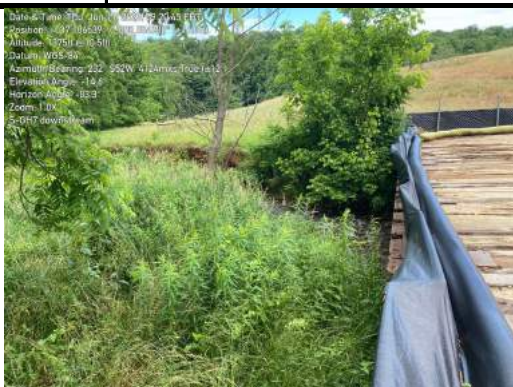
GPS Location		See photo for coordinates.		GPS Location	
Field Station#		13309+09		Field Station#	
Pic 5 Desc.		S_GH7, upstream, no environmental issues noted.		Pic 6 Desc.

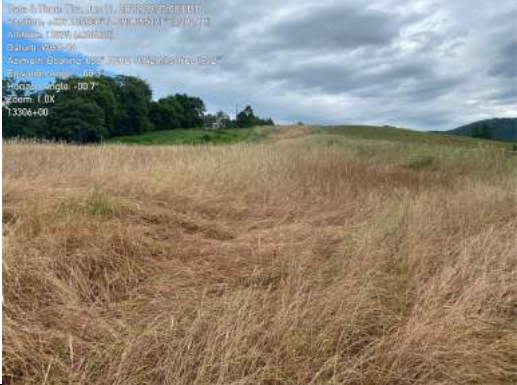
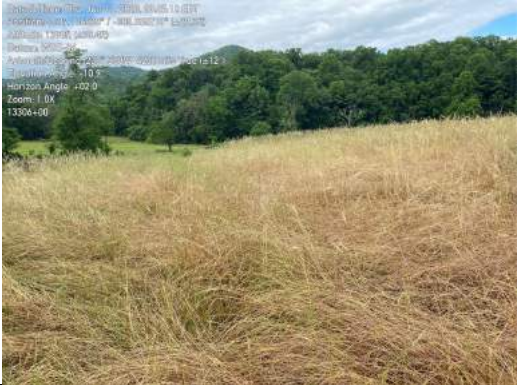
GPS Location	See photo for coordinates.		GPS Location	See photo for coordinates.	
Field Station#	13306+00		Field Station#	13306+00	
Pic 7 Desc.	Good vegetative cover across LOD in restored area, some vegetation matted down.		Pic 8 Desc.	Good vegetative cover across LOD in restored area, some vegetation matted down.

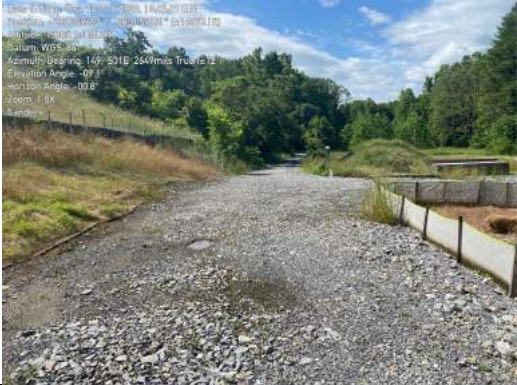
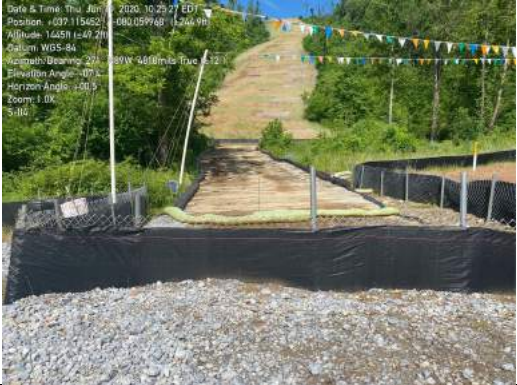
GPS Location	See photo for coordinates.		GPS Location	See photo for coordinates.	
Field Station#	13262+50		Field Station#	13261+00	
Pic 13 Desc.	MVP-FR-293.01, Flanders, access road, RCE, and perimeter controls in acceptable condition.		Pic 14 Desc.	GAS S-II4, ECDs functioning acceptably.

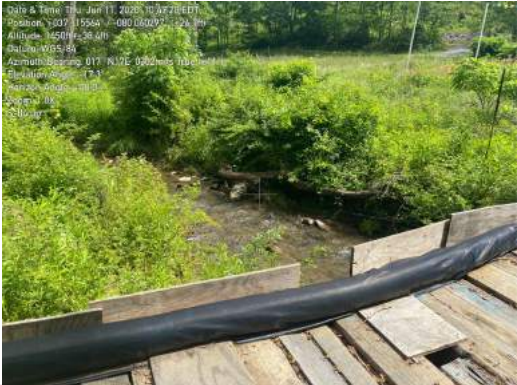
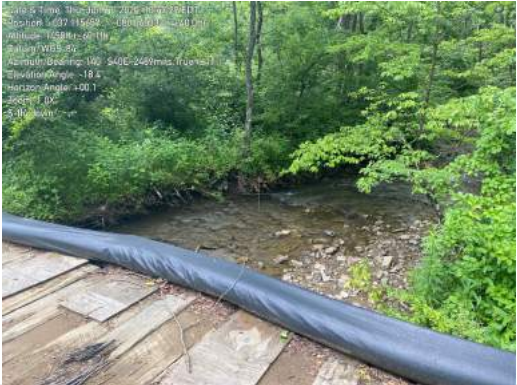
GPS Location	See photo for coordinates.		GPS Location	See photo for coordinates.	
Field Station#	13260+60		Field Station#	13260+60	
Pic 15 Desc.	S-II4, upstream, no environmental issues noted.		Pic 16 Desc.	S-II4, downstream, no environmental issues noted.

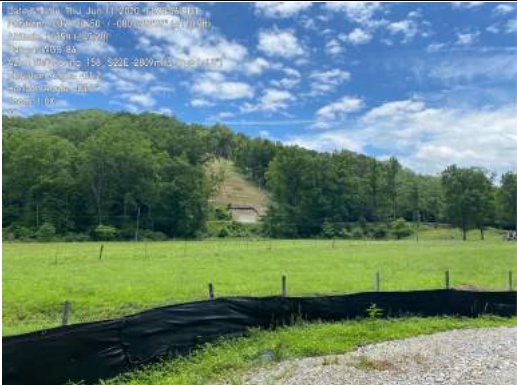
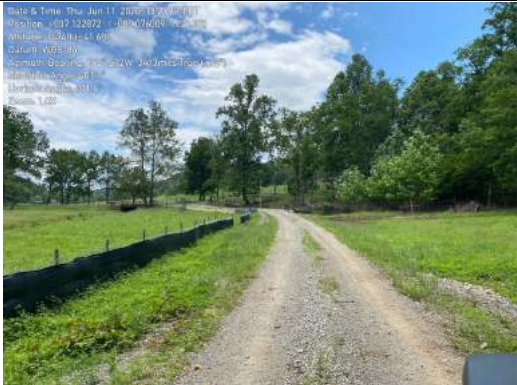
GPS Location	See photo for coordinates.		GPS Location	See photo for coordinates.	
Field Station#	13190+00		Field Station#	13190+00	
Pic 17 Desc.	MVP-AR-29, access road in acceptable condition, ROW GAS Dillons Mill stabilized.		Pic 18 Desc.	MVP-AR-29, ECDs functioning acceptably, landowner disturbance noted S-D10 adjacent to access road.

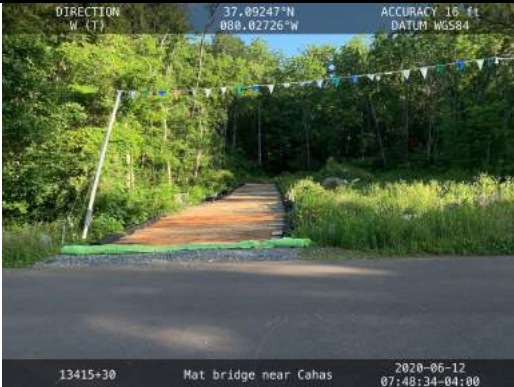
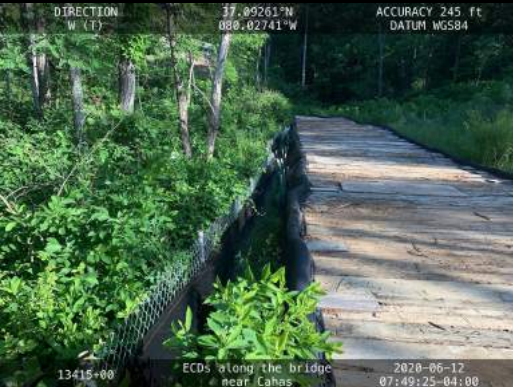
GPS Location	See photo for gps location data.		GPS Location	See photo for gps location data.	
Field Station#	13415+30		Field Station#	13415+00	
Pic 1 Desc.	Photo shows the mat bridge on the west side of Cahas Mountain Road.		Pic 2 Desc.	Photo shows the ECDs along the mat bridge near Cahas.

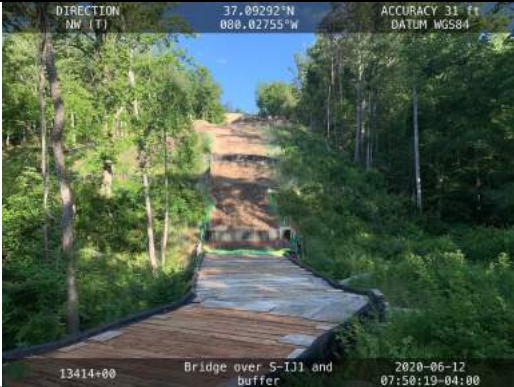
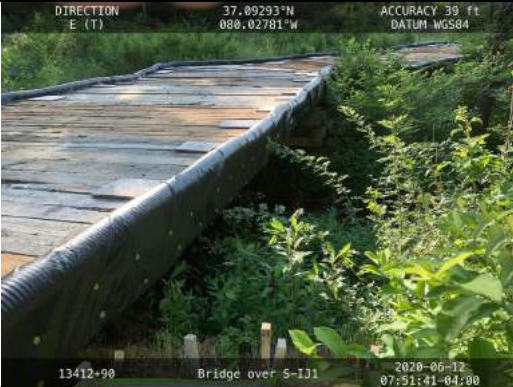
GPS Location	See photo for gps location data.		GPS Location	See photo for gps location data.	
Field Station#	13414+00		Field Station#	13412+90	
Pic 3 Desc.	Photo shows the bridge over stream S-IJ1 and ROW conditions from about 13410+00 to 13414+00.		Pic 4 Desc.	Photo shows the bridge over stream S-IJ1.

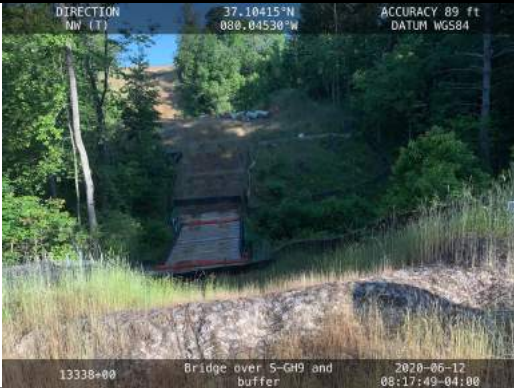
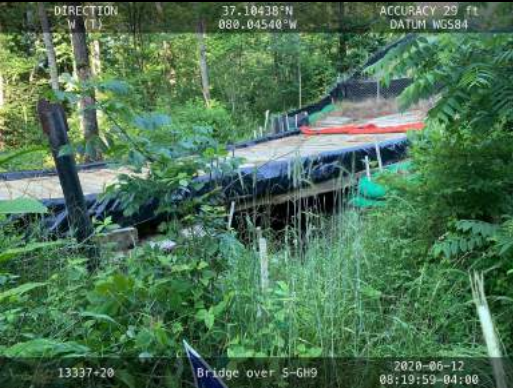
GPS Location	See photo for gps location data.		GPS Location	See photo for gps location data.	
Field Station#	13338+00		Field Station#	13337+20	
Pic 5 Desc.	Photo shows the bridge over stream S-GH9 and buffer ECDs.		Pic 6 Desc.	Photo shows the bridge over stream S-GH9.

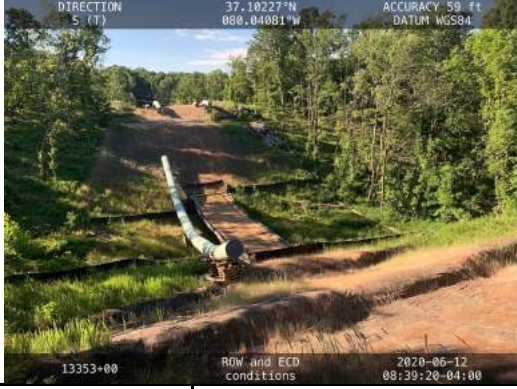
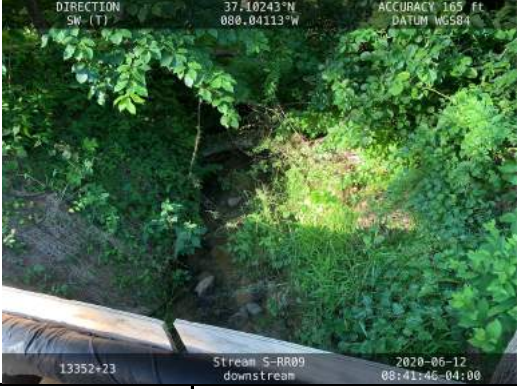
GPS Location	See photo for gps location data.		GPS Location	See photo for gps location data.	
Field Station#	13353+00		Field Station#	13352+23	
Pic 9 Desc.	Photo shows the ROW and ECD conditions from about 13353+00 to 13356+00.		Pic 10 Desc.	Photo shows stream S-RR09 downstream from the ROW crossing.

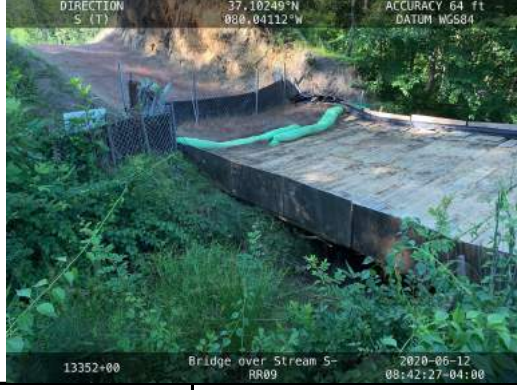
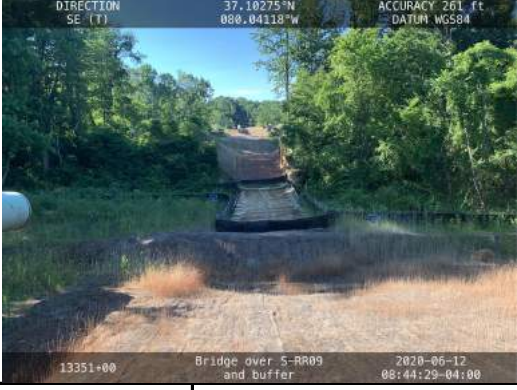
GPS Location	See photo for gps location data.		GPS Location	See photo for gps location data.	
Field Station#	13352+00		Field Station#	13351+00	
Pic 11 Desc.	Photo shows the bridge over stream S-RR09.		Pic 12 Desc.	Photo shows the bridge over stream S-RR09 and buffer ECDs.

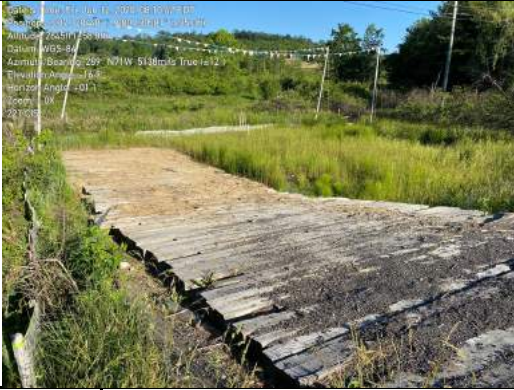
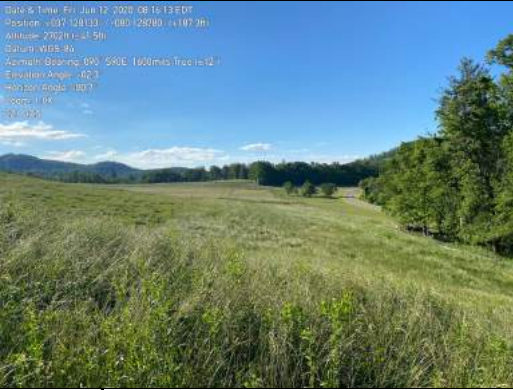
GPS Location	See photo for coordinates.		GPS Location	See photo for coordinates.	
Field Station#	12993+90		Field Station#	12999+30	
Pic 1 Desc.	CIS HWY221, no environmental issues noted.		Pic 2 Desc.	Good vegetative cover across LOD, perimeter ECDs functioning acceptably.

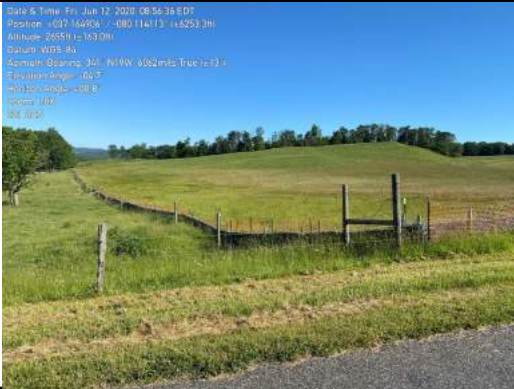
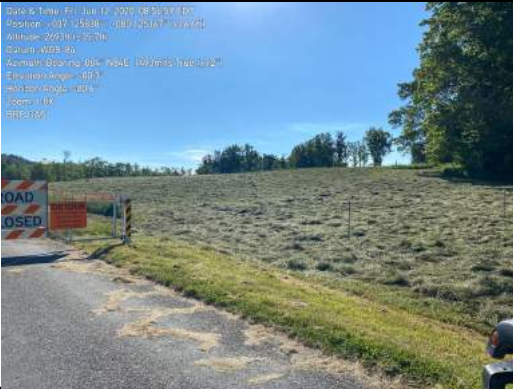
GPS Location	See photo for coordinates.		GPS Location	See photo for coordinates.	
Field Station#	13012+63		Field Station#	13012+63	
Pic 3 Desc.	CIS Blue Ridge Parkway crossing, ECDs functioning acceptably.		Pic 4 Desc.	GAS Blue Ridge Parkway crossing, recently cut.

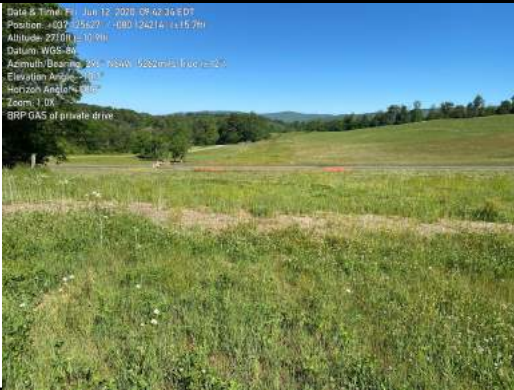
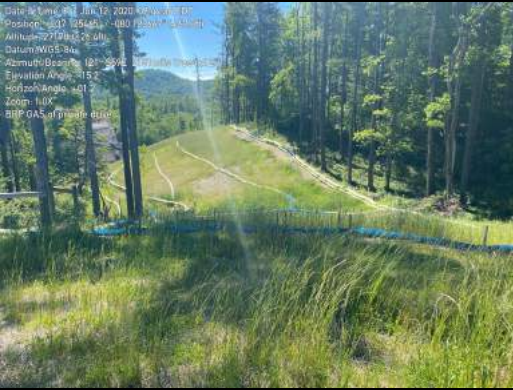
GPS Location	See photo for coordinates.		GPS Location	See photo for coordinates.	
Field Station#	13014+00		Field Station#	13020+00	
Pic 5 Desc.	GAS Blue Ridge Parkway.		Pic 6 Desc.	ECDs functioning acceptably, moderate to good vegetative cover noted across LOD.

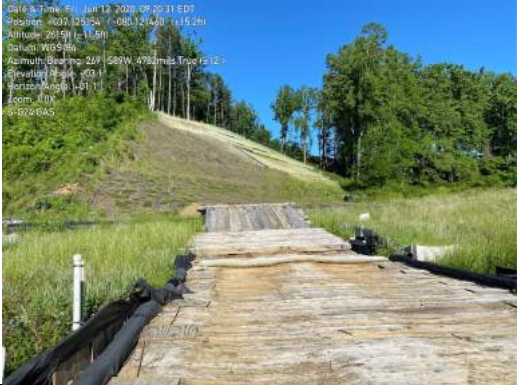
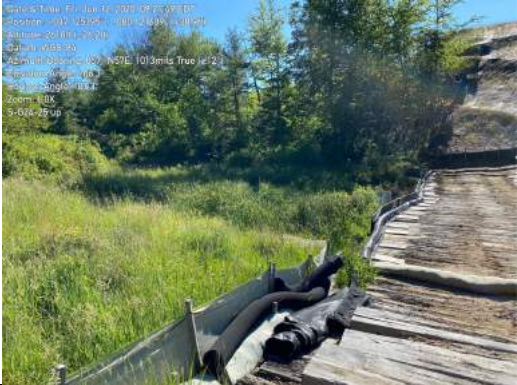
GPS Location	See photo for coordinates.		GPS Location	See photo for coordinates.	
Field Station#	13024+08		Field Station#	13024+08	
Pic 7 Desc.	ROW stabilized, clean water diversion pipe and plunge pool functioning acceptably.		Pic 8 Desc.	S-G24 and S-G25, upstream, bridge in acceptable condition, stream buffer well vegetated.

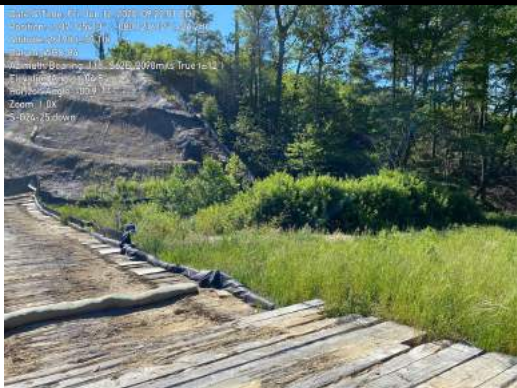
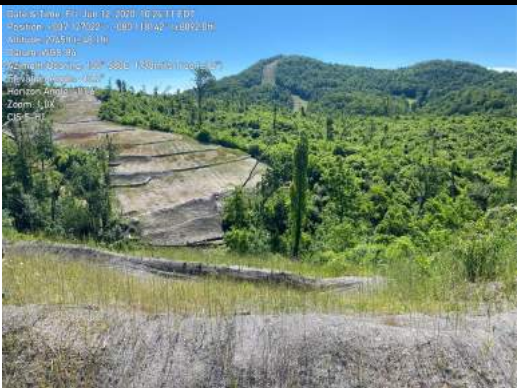
GPS Location	See photo for coordinates.		GPS Location	See photo for coordinates.	
Field Station#	13024+06		Field Station#	13041+50	
Pic 9 Desc.	S-G24 and S-G25, downstream, bridge in acceptable condition, stream buffer well vegetated.		Pic 10 Desc.	Sparse to moderate vegetation noted across LOD, temporary and permanently restored areas stable.

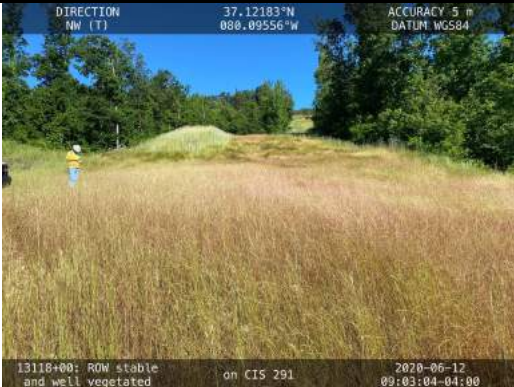
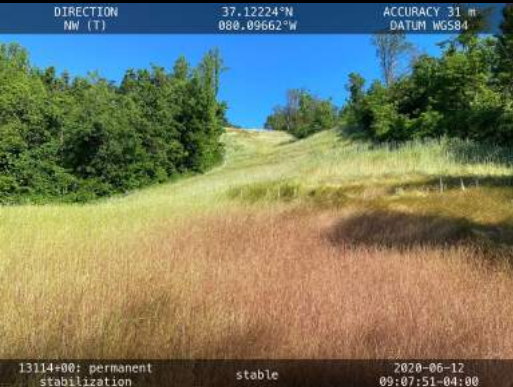
GPS Location	See photo		GPS Location	See photo	
Field Station#	13118+00		Field Station#	13114+00	
Pic 1 Desc.	Standing at MVP-FR-291 facing back towards MVP-FR-290, ROW very well vegetated and stable.		Pic 2 Desc.	Permanent restoration well vegetated and stable.

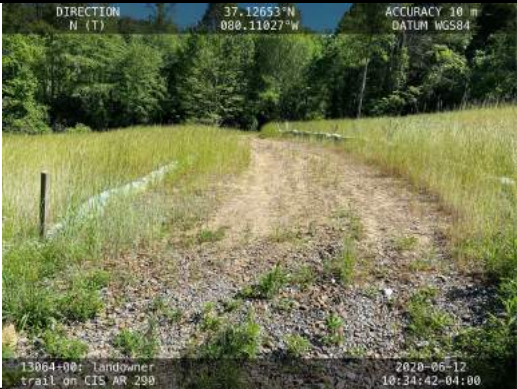
<p>DIRECTION N (T) 37.12653°N 088.11027°W ACCURACY 10 m DATUM WGS84</p> <p>13064+00: Landowner trail on CIS AR 290 2020-06-12 10:34:42-04:00</p>			
GPS Location	See photo		GPS Location	See photo	
Field Station#	13072+58		Field Station#	13064+00	
Pic 11 Desc.	ROW well vegetated and stable.		Pic 12 Desc.	Landowner trail across ROW on GAS of AR 290.
