Visual Site Inspection Report

Project Name	H-600 Pipeline Spread I	AFE	124300139	Spread	H-600 Pipeline Spread I
Contractor	Precision			Report #	11423
Inspector	Charles Head			Date/Time	6/2/2020 4:00 PM
Permit #	TBD	Inspection Type	VA SWPP	Station Begin	13784+35
State	VA	Inspection Area	Partial	Station End	14171+36
County	Franklin	Ground	Damp	Temperature (°F)	74.00
Municipality	N/A	Weather	Sunny	Rain Gauge (in)	1.25
				Rain Accumulation Time (days)	6.00

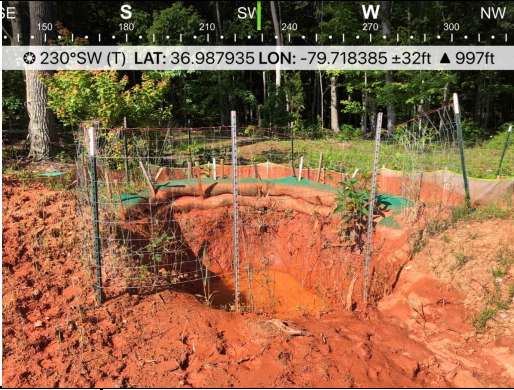
GPS Location	0	GPS Location	0		
Field Station#	14671+00	Field Station#	14673+10		
Pic 1 Desc.	Sump pit functioning as intended. Was recently cleaned due to heavy rainfall		Pic 2 Desc.	Equipment bridge clean and P1 silt fence holding up at stream S-H37

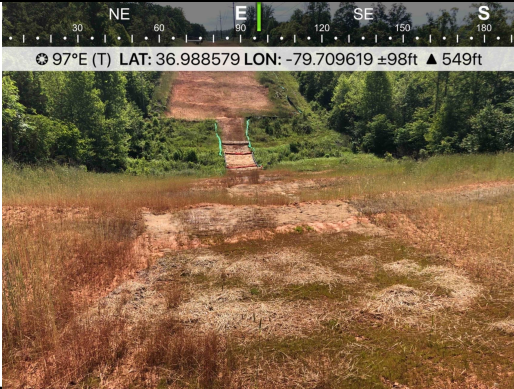
GPS Location	0	GPS Location	0		
Field Station#	14700+00	Field Station#	14712+33		
Pic 3 Desc.	Temporary stabilization on the GAS of Jacks Creek Road		Pic 4 Desc.	Rock check dams cleaned out after recent rain events at MVP-FR-321.01

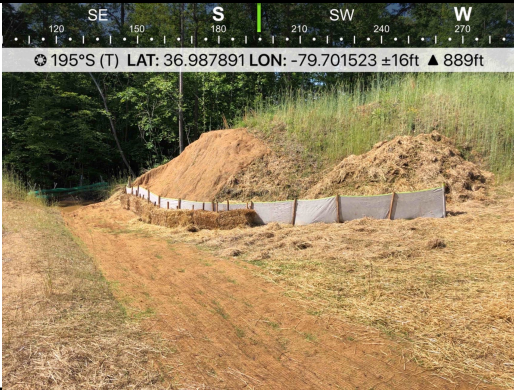
GPS Location	0	GPS Location	0		
Field Station#	14721+00	Field Station#	14753+00		
Pic 5 Desc.	Cut that was sloughing off is temporarily fixed until permitted and holding up		Pic 6 Desc.	water bar flow path needs erosion channel fixed and needs sediment removed

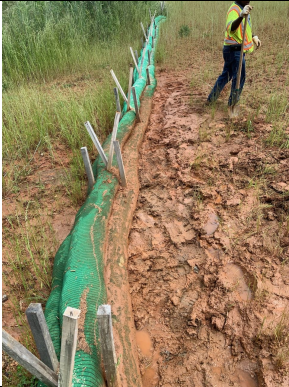
GPS Location	O	GPS Location	O		
Field Station#	15930+00	Field Station#	15930+00		
Pic 1 Desc.	Observing the Contractor repairing punch list items.	Pic 2 Desc.	Observing CFS that requires maintenance

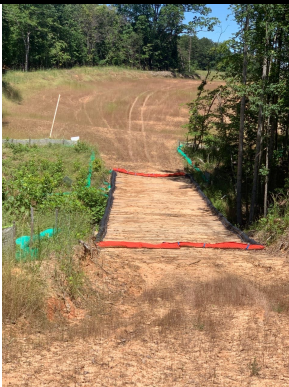
GPS Location	O	GPS Location	O		
Field Station#	15794+77	Field Station#	15807+00		
Pic 3 Desc.	Observing equipment crossing and ECD's performing as they should.	Pic 4 Desc.	Observing equipment crossing and ECD's performing as they should.		
Insert image here			Insert image here		
GPS Location		GPS Location			
Field Station#		Field Station#			
Pic 5 Desc.		Pic 6 Desc.

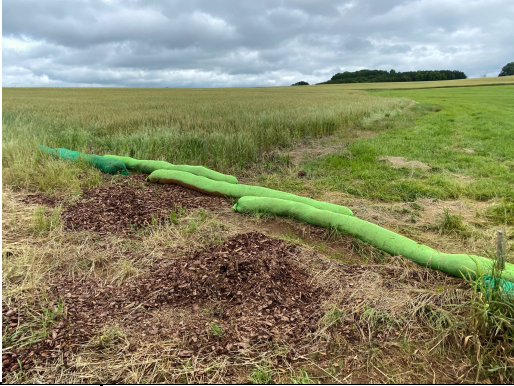
GPS Location	0	GPS Location	0		
Field Station#	15483+00	Field Station#	15485+00		
Pic 1 Desc.	Wattles installed along perimeter because landowner continues to drive equipment over CFS.		Pic 2 Desc.	Perimeter CFS damaged.

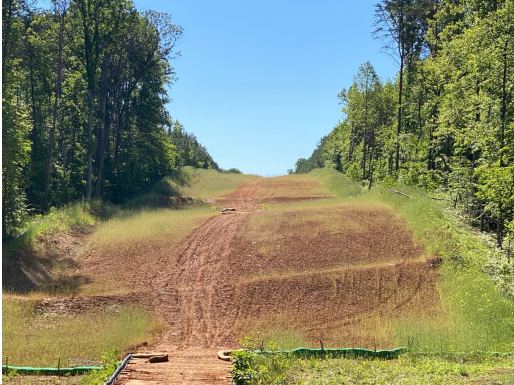
GPS Location	0	GPS Location	0		
Field Station#	15392+00	Field Station#	15485+00		
Pic 3 Desc.	Temporary vegetation is dying out along row.		Pic 4 Desc.	Replaced damaged CFS during maintenance process.

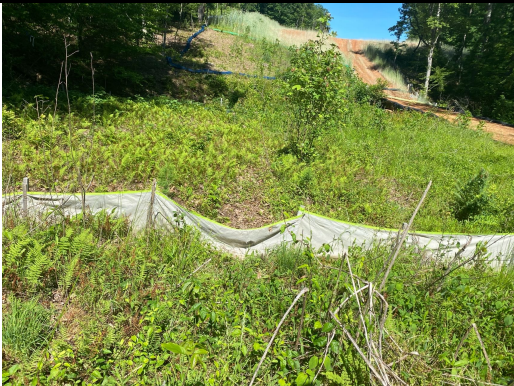
Insert image here			
GPS Location	0	GPS Location			
Field Station#	15427+50	Field Station#			
Pic 5 Desc.	Replace damaged P1 fence.		Pic 6 Desc.

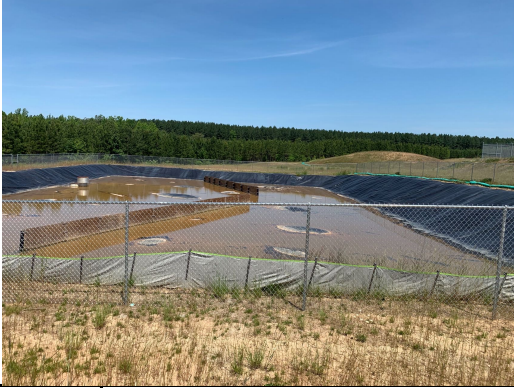
GPS Location	O	GPS Location	O		
Field Station#	00+00	Field Station#	00+00		
Pic 1 Desc.	Observing storm water pond.	Pic 2 Desc.	Observing outlet and outlet protection.

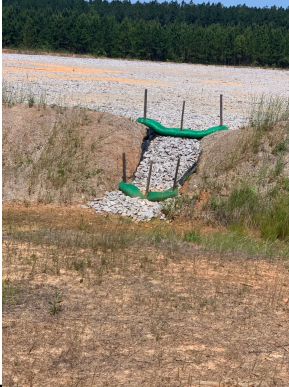
GPS Location	O	GPS Location	O		
Field Station#	00+00	Field Station#	00+00		
Pic 3 Desc.	Observing ECD's performing as they should.	Pic 4 Desc.	Observing sediment basin.		
<p style="text-align: center;">Insert image here</p>			<p style="text-align: center;">Insert image here</p>		
GPS Location		GPS Location			
Field Station#		Field Station#			
Pic 5 Desc.		Pic 6 Desc.
