# Visual Site Inspection Report

<b>Project Name</b>	H-600 Pipeline Spread I	<b>AFE</b>	124300139	<b>Spread</b>	H-600 Pipeline Spread I
<b>Contractor</b>	Precision			<b>Report #</b>	11931
<b>Inspector</b>	Logan Box			<b>Date/Time</b>	6/18/2020 4:42 PM
<b>Permit #</b>	TBD	<b>Inspection Type</b>	VA SWPP	<b>Station Begin</b>	13670+00
<b>State</b>	VA	<b>Inspection Area</b>	Partial	<b>Station End</b>	13784+35
<b>County</b>	Franklin	<b>Ground</b>	Wet	<b>Temperature (°F)</b>	76.00
<b>Municipality</b>	N/A	<b>Weather</b>	Light Rain	<b>Rain Gauge (in)</b>	5.80
				<b>Rain Accumulation Time (days)</b>	6.00

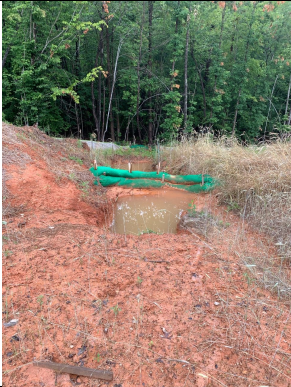
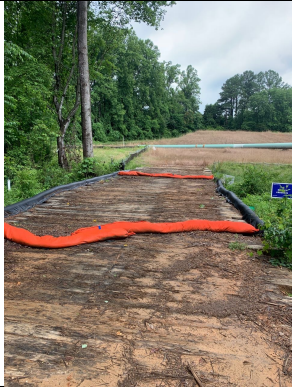
<b>GPS Location</b>	O	<b>GPS Location</b>	O		
<b>Field Station#</b>	15766+00	<b>Field Station#</b>	15763+80		
<b>Pic 1 Desc.</b>	Observing sump and end treatment performing as they should after the rain events.		<b>Pic 2 Desc.</b>	Observing equipment crossing and ECD's performing as they should after the rain events.

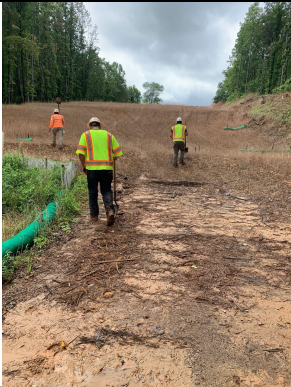
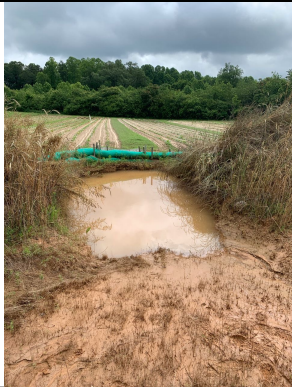
<b>GPS Location</b>	O	<b>GPS Location</b>	O		
<b>Field Station#</b>	15764+00	<b>Field Station#</b>	15776+00		
<b>Pic 3 Desc.</b>	Observing the Contractor repairing punch list items.		<b>Pic 4 Desc.</b>	Observing sump and end treatment performing as they should after the rain events.	
Insert image here			Insert image here		
<b>GPS Location</b>		<b>GPS Location</b>			
<b>Field Station#</b>		<b>Field Station#</b>			
<b>Pic 5 Desc.</b>			<b>Pic 6 Desc.</b>

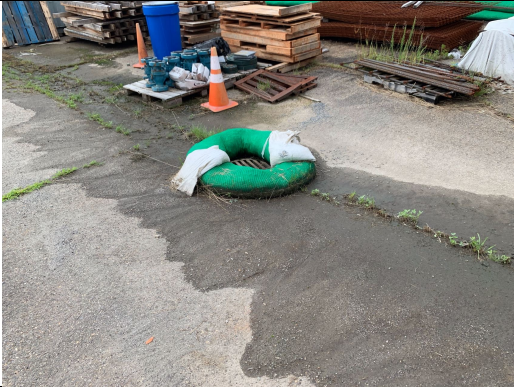
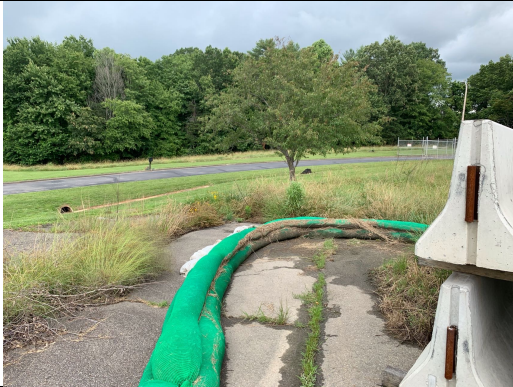
<b>GPS Location</b>	000000000000	<b>GPS Location</b>	000000000000		
<b>Field Station#</b>	0000+00	<b>Field Station#</b>	0000+00		
<b>Pic 1 Desc.</b>	Inlet protection for parking lot drain in the paved yard in good condition		<b>Pic 2 Desc.</b>	Perimeter ECD's on northwest corner of paved yard in acceptable condition.

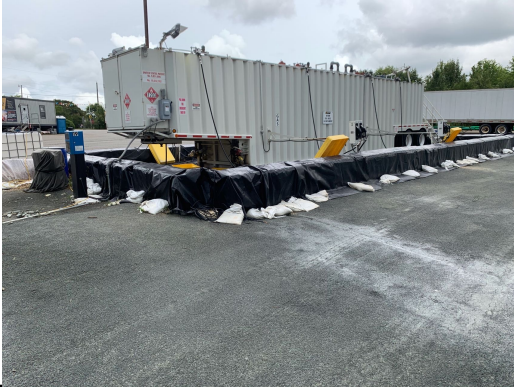
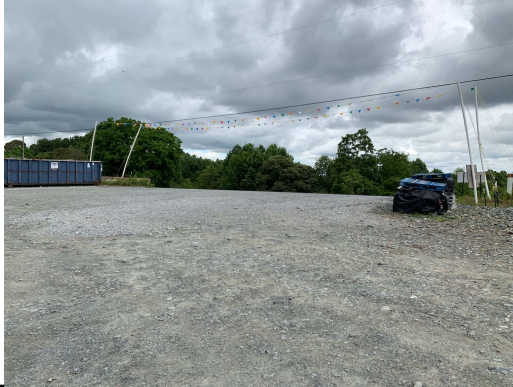
<b>GPS Location</b>	000000000000	<b>GPS Location</b>	000000000000		
<b>Field Station#</b>	0000+00	<b>Field Station#</b>	0000+00		
<b>Pic 3 Desc.</b>	Secondary containment structure for fuel cell in compliance at the time of inspection		<b>Pic 4 Desc.</b>	RCE at gravel yard in good condition

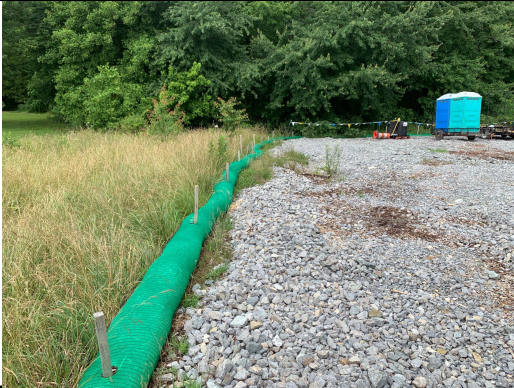
<b>Pic 5 Desc.</b>	Perimeter ECD's on south end of gravel yard		<b>Pic 6 Desc.</b>

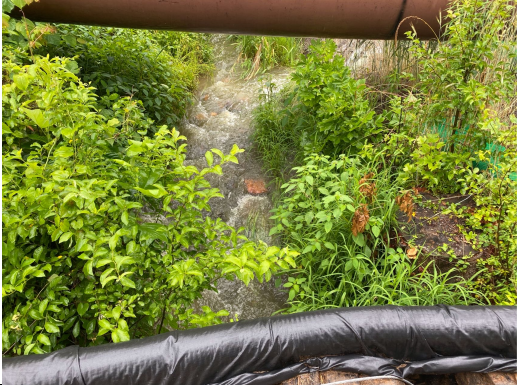
<p>Insert image here</p>			
<b>GPS Location</b>	0	<b>GPS Location</b>			
<b>Field Station#</b>	13998+15	<b>Field Station#</b>			
<b>Pic 7 Desc.</b>	Approximately 13998+15. Upstream view of stream S-KL36.		<b>Pic 8 Desc.</b>		
<p>Insert image here</p>		<p>Insert image here</p>			
<b>GPS Location</b>			<b>GPS Location</b>		
<b>Field Station#</b>			<b>Field Station#</b>		
<b>Pic 9 Desc.</b>			<b>Pic 10 Desc.</b>		
<p>Insert image here</p>		<p>Insert image here</p>			
<b>GPS Location</b>			<b>GPS Location</b>		
<b>Field Station#</b>			<b>Field Station#</b>		
<b>Pic 11 Desc.</b>			<b>Pic 12 Desc.</b>

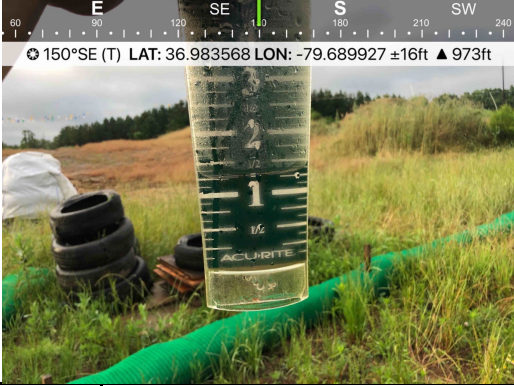
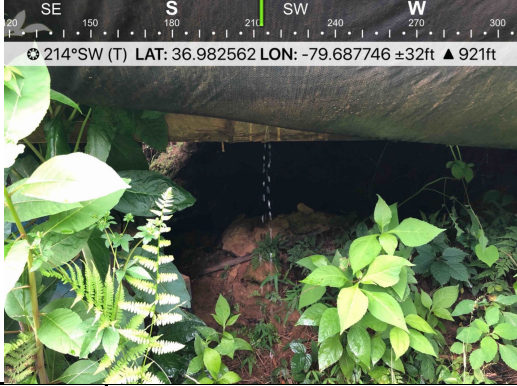
<b>GPS Location</b>	0	<b>GPS Location</b>	0		
<b>Field Station#</b>	14758+16	<b>Field Station#</b>	14766+11		
<b>Pic 1 Desc.</b>	Rain gauge at Indian Cave Road 1.25"	<b>Pic 2 Desc.</b>	Geotech under bridge at stream S-MM44 leaking and requires maintenance

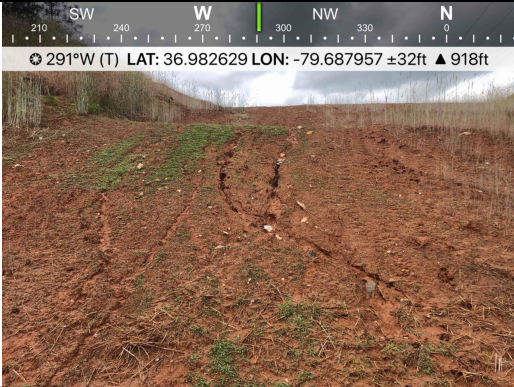
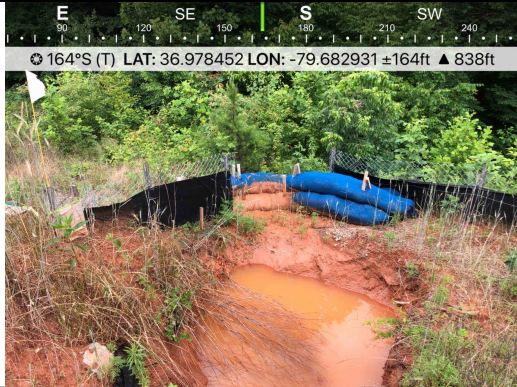
<b>GPS Location</b>	0	<b>GPS Location</b>	0		
<b>Field Station#</b>	14765+00	<b>Field Station#</b>	14780+00		
<b>Pic 3 Desc.</b>	Erosion along slope causing sediment to build up in water bar flow path	<b>Pic 4 Desc.</b>	CFS on end treatment needs cleaned off so that it filters properly

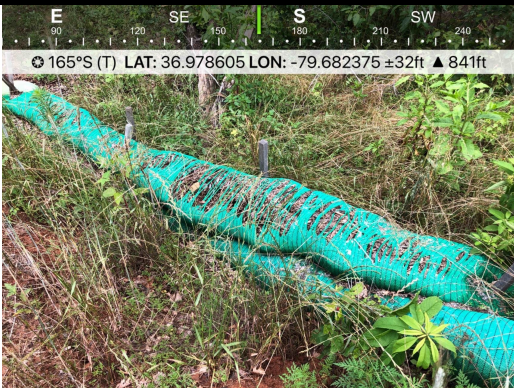
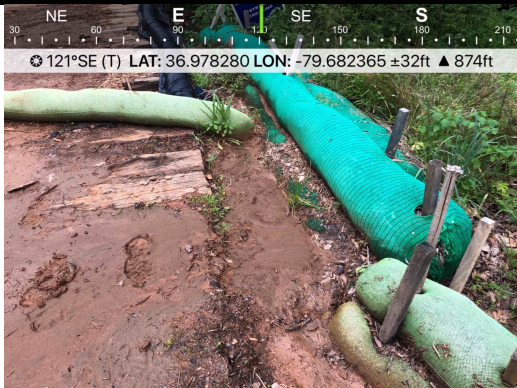
<b>GPS Location</b>	0	<b>GPS Location</b>	0		
<b>Field Station#</b>	14781+00	<b>Field Station#</b>	14788+77		
<b>Pic 5 Desc.</b>	Perimeter CFS needs to be replaced	<b>Pic 6 Desc.</b>	Sediment building up beside bridge at stream S-H25

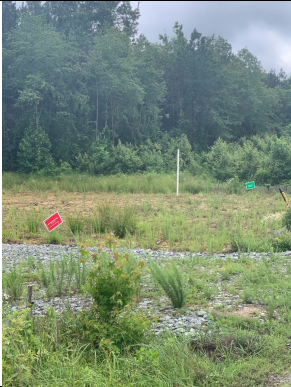
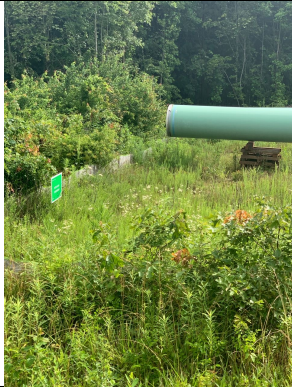
<b>GPS Location</b>	O	<b>GPS Location</b>	O		
<b>Field Station#</b>	15+50	<b>Field Station#</b>	17+55		
<b>Pic 1 Desc.</b>	Observing signage and ECD's performing as they should after the rain events.		<b>Pic 2 Desc.</b>	Observing signage and ECD's performing as they should after the rain events.

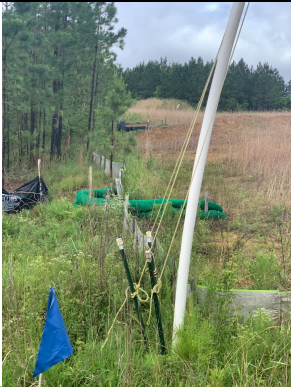
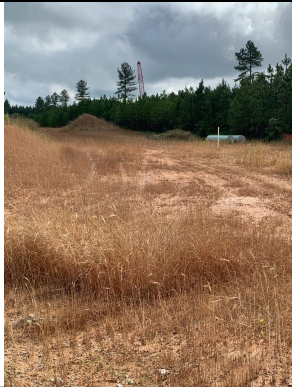
<b>GPS Location</b>	O	<b>GPS Location</b>	O		
<b>Field Station#</b>	12+80	<b>Field Station#</b>	4+00		
<b>Pic 3 Desc.</b>	Observing ECD's performing as they should after the rain events.		<b>Pic 4 Desc.</b>	Observing temporary vegetation.	
Insert image here			Insert image here		
<b>GPS Location</b>		<b>GPS Location</b>			
<b>Field Station#</b>		<b>Field Station#</b>			
<b>Pic 5 Desc.</b>		<b>Pic 6 Desc.</b>

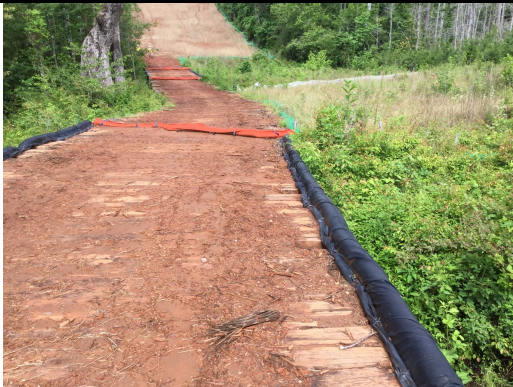
GPS Location	1	GPS Location	2		
Field Station#	15026+75	Field Station#	15026+00		
Pic 1 Desc.	Equipment bridge and surrounding ECD's at streams S-D3 and S-D4 in place and functional.		Pic 2 Desc.	Upstream view of S-D3 at ROW crossing. No issues observed.

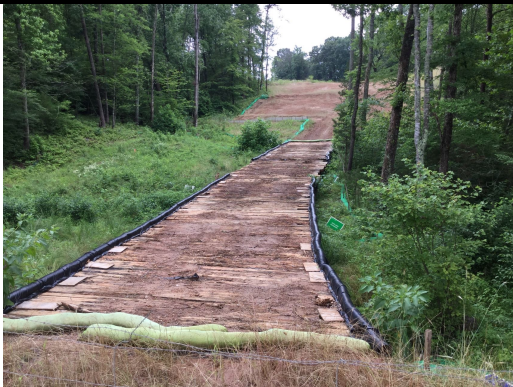
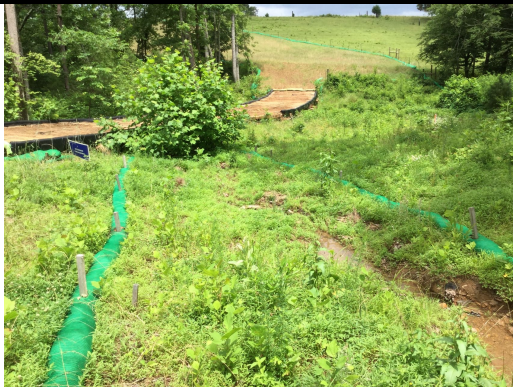
GPS Location	3	GPS Location	4		
Field Station#	15103+75	Field Station#	15104+28		
Pic 3 Desc.	Equipment bridge and surrounding ECD's at streams S-G8 and S-Q15 in place and functional.		Pic 4 Desc.	ECD's at S-Q15 in place and functional. Stream bed dry at ROW crossing.

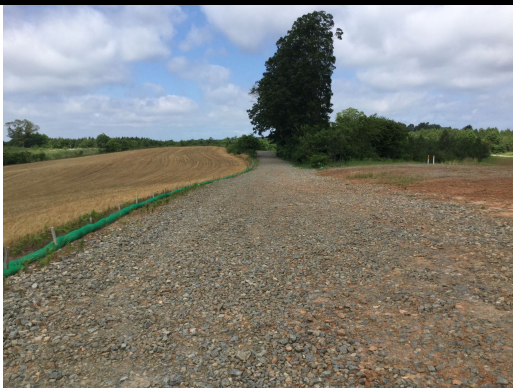
GPS Location	5	GPS Location	6		
Field Station#	15227+00	Field Station#	15063+85		
Pic 5 Desc.	RCE and access road at MVP-PI-328 in good condition.		Pic 6 Desc.	RCE at Armstrong Rd in good condition. Slight ponding of water along road at ROW crossing.

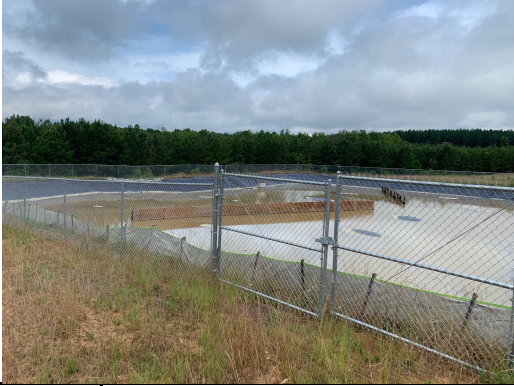
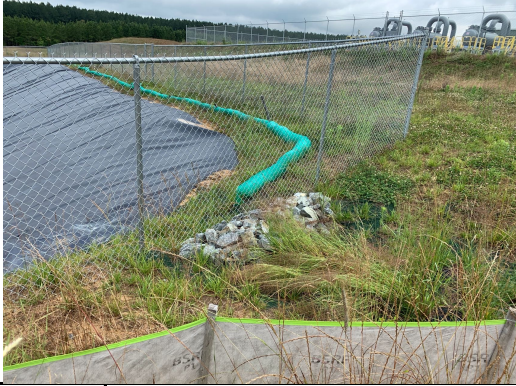
<b>GPS Location</b>	O	<b>GPS Location</b>	O		
<b>Field Station#</b>	00+00	<b>Field Station#</b>	00+00		
<b>Pic 1 Desc.</b>	Observing storm water pond and ECD's performing as they should after the rain events.		<b>Pic 2 Desc.</b>	Observing rock check dam and ECD's performing as they should after the rain events.

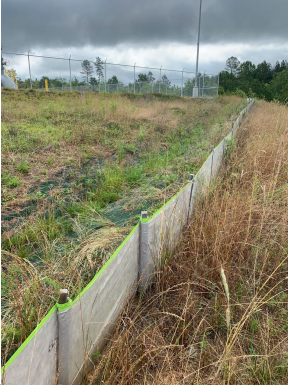
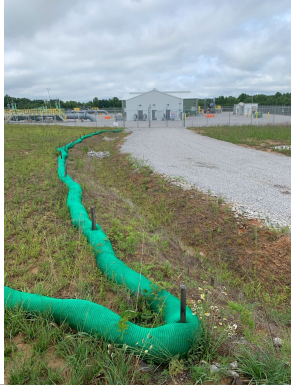
<b>GPS Location</b>	O	<b>GPS Location</b>	O		
<b>Field Station#</b>	00+00	<b>Field Station#</b>	00+00		
<b>Pic 3 Desc.</b>	Observing ECD's performing as they should after the rain events.		<b>Pic 4 Desc.</b>	Observing ECD's performing as they should after the rain events.	
Insert image here			Insert image here		
<b>GPS Location</b>		<b>GPS Location</b>			
<b>Field Station#</b>		<b>Field Station#</b>			
<b>Pic 5 Desc.</b>			<b>Pic 6 Desc.</b>
