Visual Site Inspection Report

Project Name	H-600 Pipeline Spread I	AFE	124300139	Spread	H-600 Pipeline Spread I
Contractor	Precision			Report #	12082
Inspector	Logan Box			Date/Time	6/24/2020 5:23 PM
Permit #	TBD	Inspection Type	VA SWPP	Station Begin	13670+00
State	VA	Inspection Area	Partial	Station End	13784+35
County	Franklin	Ground	Wet	Temperature (°F)	85.00
Municipality	N/A	Weather	Sunny	Rain Gauge (in)	4.20
				Rain Accumulation Time (days)	6.00

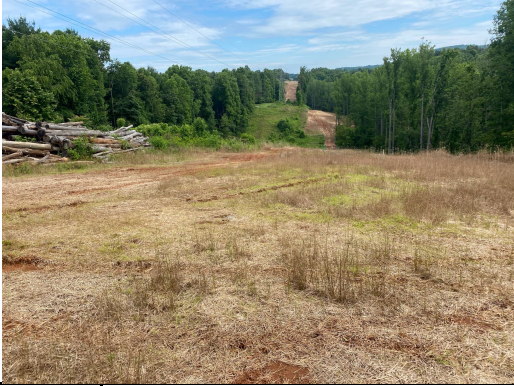
GPS Location	0	GPS Location	0		
Field Station#	13853+50	Field Station#	14141+62		
Pic 1 Desc.	Approximately 13853+50. Overview of ROW. ROW temporarily stabilized and has temporary vegetation growing.		Pic 2 Desc.	Approximately 14141+62. Overview of stream crossing, equipment bridge and ECDs at stream S-C8.

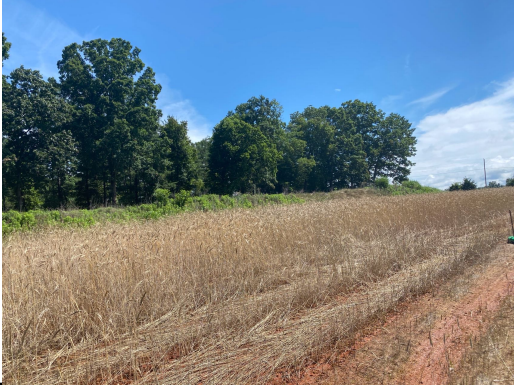
GPS Location	0	GPS Location	0		
Field Station#	13954+00	Field Station#	13888+63		
Pic 3 Desc.	Approximately 13954+00. Overview of MVP-ATWS-1299A. Area has been temporarily stabilized and has temporary vegetation growing.		Pic 4 Desc.	Approximately 13888+63. Overview of wetland, equipment bridge and ECDs at wetland W-CD5.

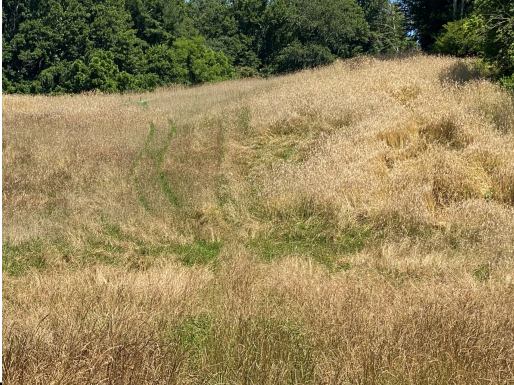
GPS Location	0	GPS Location	0		
Field Station#	13907+00	Field Station#	13923+00		
Pic 5 Desc.	Approximately 13907+00. Overview of ROW. ROW temporarily stabilized and has temporary vegetation growing.		Pic 6 Desc.	Approximately 13923+00. Over of ROW. ROW temporarily stabilized and has temporary vegetation growing.

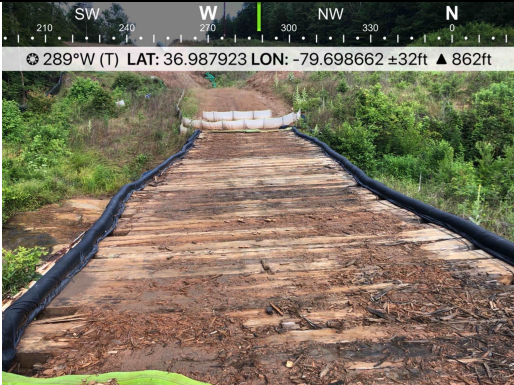
GPS Location	0	GPS Location	0		
Field Station#	14729+19	Field Station#	14752+00		
Pic 3 Desc.	Equipment bridge clean at stream S-A20	Pic 4 Desc.	Sump pit functioning as intended

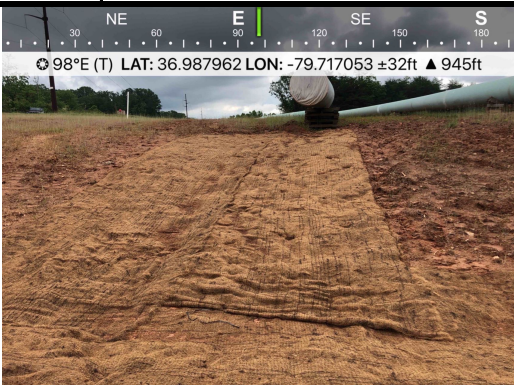
GPS Location	0	GPS Location	0		
Field Station#	14675+00	Field Station#	14680+37		
Pic 5 Desc.	Curlex functioning as intended	Pic 6 Desc.	Equipment bridge clean at stream S-H36

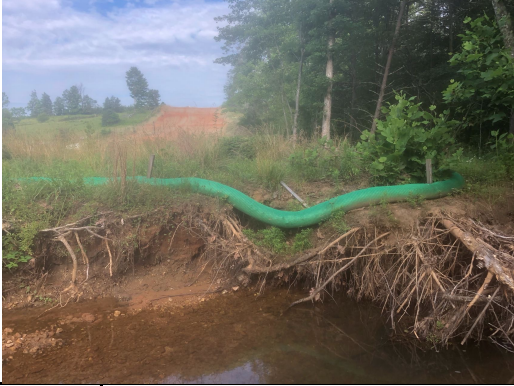
GPS Location	1	GPS Location	2		
Field Station#	15044+75	Field Station#	15044+75		
Pic 1 Desc.	Perimeter CFS around resource buffer at S-D2 falling into stream after bank washed out.		Pic 2 Desc.	Contractor repositioned and staked down CFS per punch list item.

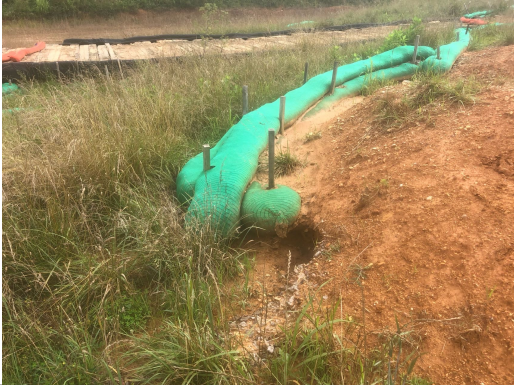
GPS Location	3	GPS Location	4		
Field Station#	14939+00	Field Station#	14939+00		
Pic 3 Desc.	Area at corner of CFS triple stack eroding away leading into natural drainage area.		Pic 4 Desc.	Contractor repaired erosion and installed erosion control blanket to prevent the issue from reoccurring.

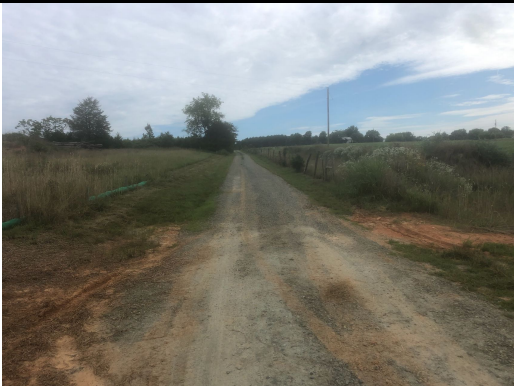
GPS Location	5	GPS Location	6		
Field Station#	15080+64	Field Station#	15217+50		
Pic 5 Desc.	View of ROW crossing at MVP-PI-325. Access road in good condition. No issues observed.		Pic 6 Desc.	View of final cleanup area between Star Land Dr and Grassland Dr. Permanent vegetation is growing and permanent ECD's are in place and functional. No issues observed.

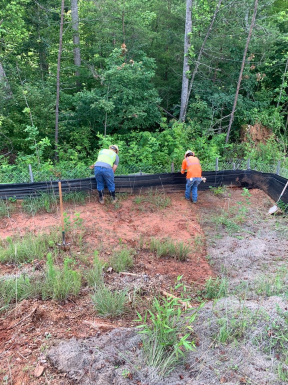
<p style="text-align: center;">Insert image here</p>			
GPS Location	O	GPS Location			
Field Station#	15707+00	Field Station#			
Pic 5 Desc.	Observing the Contractor performing ECD maintenance.	Pic 6 Desc.

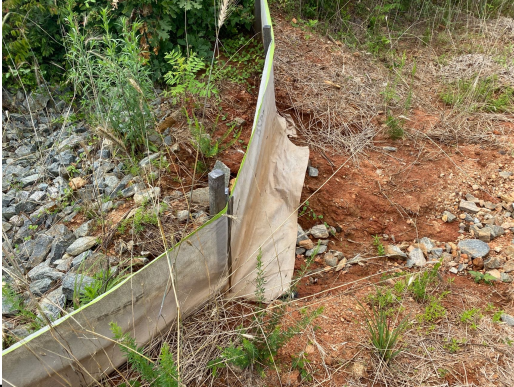
GPS Location	0	GPS Location	0		
Field Station#	15584+00	Field Station#	15584+00		
Pic 3 Desc.	Repair erosion issue and replace P1 fence.	Pic 4 Desc.	Erosion repaired and P1 fence installed during maintenance process.

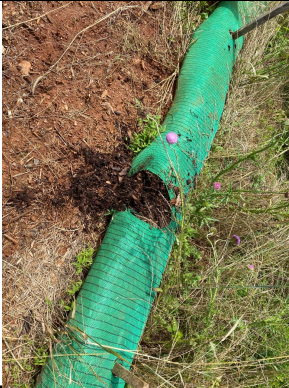
GPS Location	0	GPS Location	0		
Field Station#	15346+50	Field Station#	15346+50		
Pic 5 Desc.	Replace damaged CFS.	Pic 6 Desc.	CFS replaced during maintenance process.
