Visual Site Inspection Report

Project Name	H-600 Pipeline Spread I	AFE	124300139	Spread	H-600 Pipeline Spread I
Contractor	Precision			Report #	12288
Inspector	Justin Burch			Date/Time	6/30/2020 7:53 AM
Permit #	TBD	Inspection Type	VA SWPP	Station Begin	14171+36
State	VA	Inspection Area	Full	Station End	14546+75
County	Franklin	Ground	Damp	Temperature (°F)	84.00
Municipality	N/A	Weather	Sunny	Rain Gauge (in)	0.00
				Rain Accumulation Time (days)	6.00

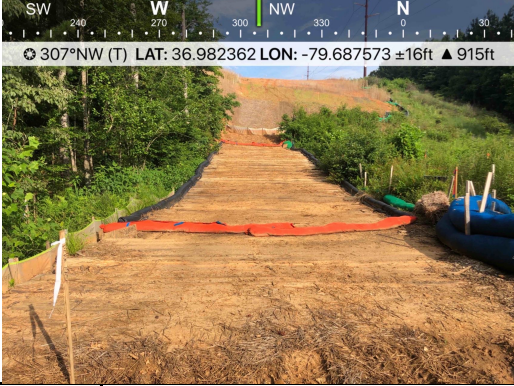
GPS Location	0	GPS Location	0		
Field Station#	14766+11	Field Station#	14770+00		
Pic 1 Desc.	Equipment bridge clean at stream S-MM44	Pic 2 Desc.	Sump pit functioning as intended

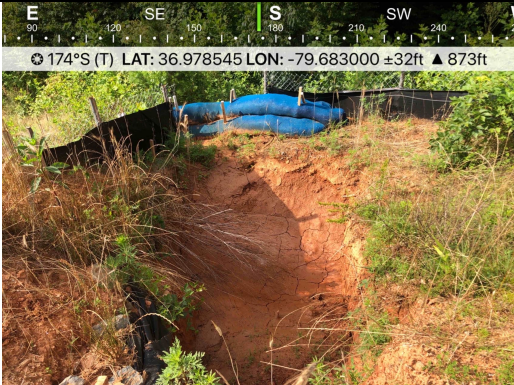
GPS Location	0	GPS Location	0		
Field Station#	14788+00	Field Station#	14788+77		
Pic 3 Desc.	Sump pit functioning as intended	Pic 4 Desc.	Equipment bridge clean at stream S-H25

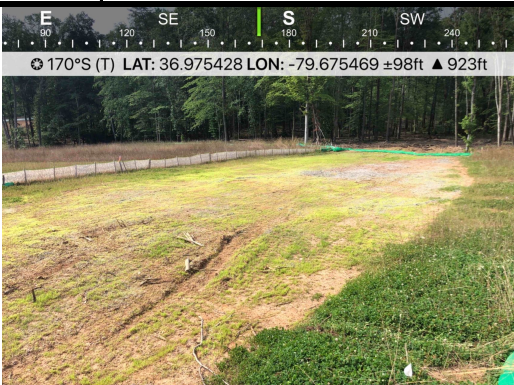
GPS Location	0	GPS Location	0		
Field Station#	14812+00	Field Station#	14830+00		
Pic 5 Desc.	Restoration where the third party logging company crossed the right of way	Pic 6 Desc.	Plunge pool functioning as intended

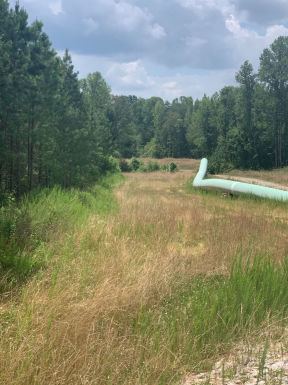
GPS Location	O	GPS Location	O		
Field Station#	8+00	Field Station#	11+50		
Pic 1 Desc.	Observing temporary vegetation.	Pic 2 Desc.	Observing signage.

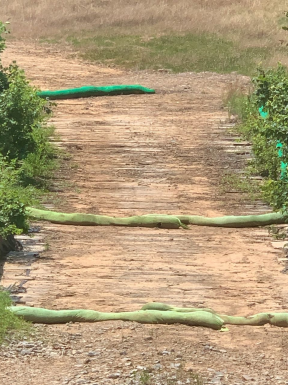
GPS Location	O	GPS Location	O		
Field Station#	12+65	Field Station#	12+00		
Pic 3 Desc.	Observing equipment crossing and ECD's performing as they should.	Pic 4 Desc.	Observing ECD's performing as they should.		
Insert image here			Insert image here		
GPS Location		GPS Location			
Field Station#		Field Station#			
Pic 5 Desc.		Pic 6 Desc.

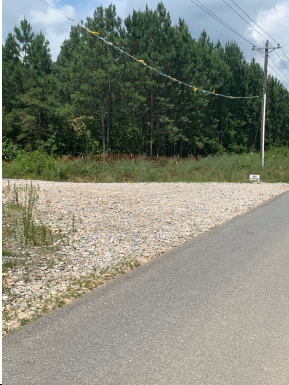
GPS Location	O	GPS Location	O		
Field Station#	00+00	Field Station#	00+00		
Pic 1 Desc.	Observing RCE.	Pic 2 Desc.	Observing access road and ECD's performing as they should.

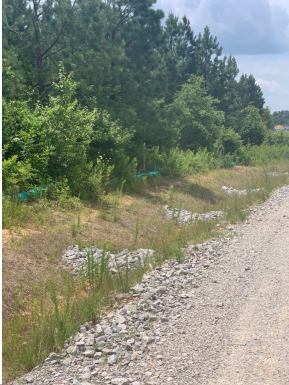
GPS Location	O	GPS Location	O		
Field Station#	00+00	Field Station#	00+00		
Pic 3 Desc.	Observing rock check dams and ECD's performing as they should.	Pic 4 Desc.	Observing storm water pond and ECD's performing as they should.		
Insert image here			Insert image here		
GPS Location		GPS Location			
Field Station#		Field Station#			
Pic 5 Desc.		Pic 6 Desc.

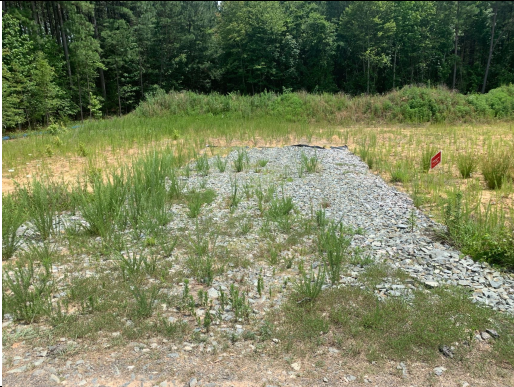
GPS Location	O	GPS Location	O		
Field Station#	14+00	Field Station#	15+73		
Pic 1 Desc.	Observing RCE.	Pic 2 Desc.	Observing ECD's performing as they should.

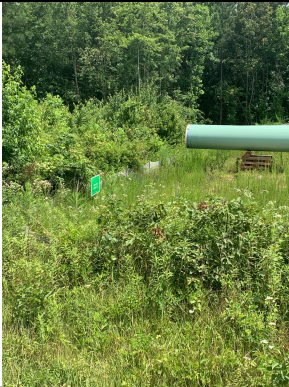
GPS Location	O	GPS Location	O		
Field Station#	17+55	Field Station#	13+00		
Pic 3 Desc.	Observing signage and ECD's performing as they should.	Pic 4 Desc.	Observing ECD's performing as they should.		
Insert image here			Insert image here		
GPS Location		GPS Location			
Field Station#		Field Station#			
Pic 5 Desc.		Pic 6 Desc.

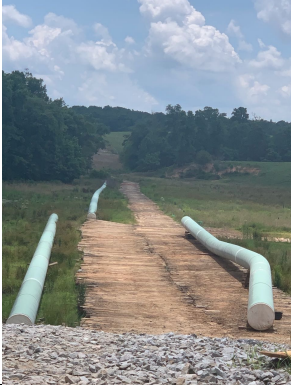
GPS Location	O	GPS Location	O		
Field Station#	15952+00	Field Station#	15945+00		
Pic 1 Desc.	Observing equipment crossing.	Pic 2 Desc.	Observing ECD's performing as they should.

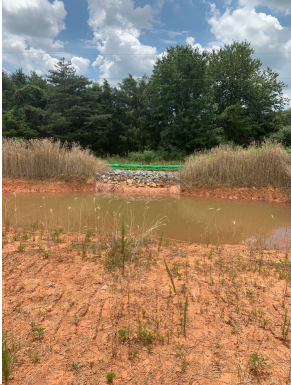
GPS Location	O	GPS Location	O		
Field Station#	15740+00	Field Station#	15735+00		
Pic 3 Desc.	Observing sump and end treatment performing as they should.	Pic 4 Desc.	Observing CWD outlet performing as it should.		
Insert image here			Insert image here		
GPS Location		GPS Location			
Field Station#		Field Station#			
Pic 5 Desc.		Pic 6 Desc.

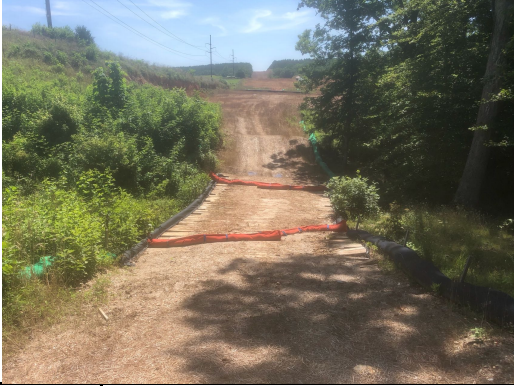
GPS Location	1	GPS Location	2		
Field Station#	14932+89	Field Station#	14932+89		
Pic 1 Desc.	View of equipment bridge crossing and surrounding ECD's at S-G15 and resource buffer. All ECD's in place and functional.		Pic 2 Desc.	Downstream view of S-G15. No issues observed.

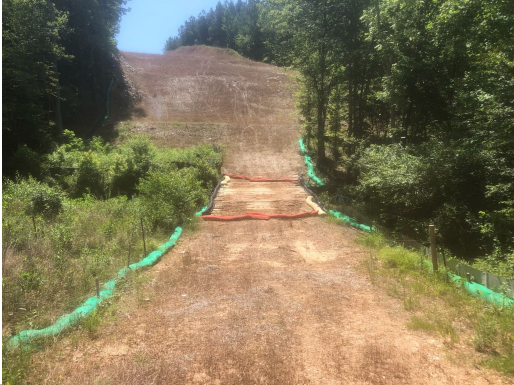
GPS Location	3	GPS Location	4		
Field Station#	14950+47	Field Station#	14950+47		
Pic 3 Desc.	View of equipment bridge crossing and surrounding ECD's at S-G13 and resource buffer. All ECD's in place and functional.		Pic 4 Desc.	Downstream view of S-G13. No issues observed.

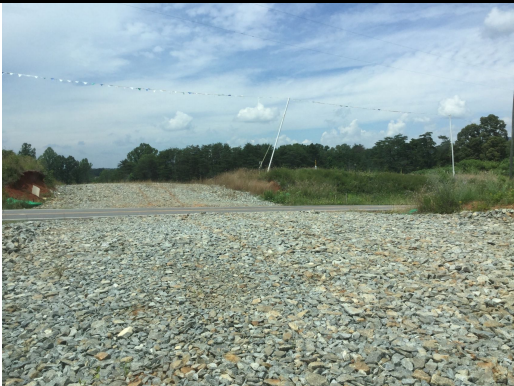
GPS Location	5	GPS Location	6		
Field Station#	15113+00	Field Station#	15234+00		
Pic 5 Desc.	RCE at Museville Rd in good condition. No issues observed.		Pic 6 Desc.	View of ROW between MVP-PI-328 and HDD exit site. Noticeable wear along travel lane from landowner use.

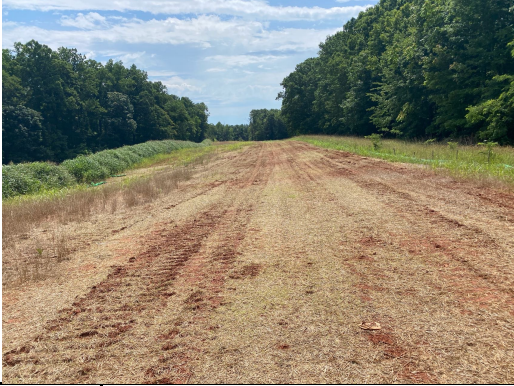
GPS Location	0	GPS Location	0		
Field Station#	14086+00	Field Station#	14072+00		
Pic 1 Desc.	Approximately 14086+00. Overview of ROW. ROW temporarily stabilized and has temporary vegetation growing.		Pic 2 Desc.	Approximately 14072+00. Overview of CWD piping and plunge pool. CWD piping and plunge pool appears to be installed and functioning correctly at time of inspection.

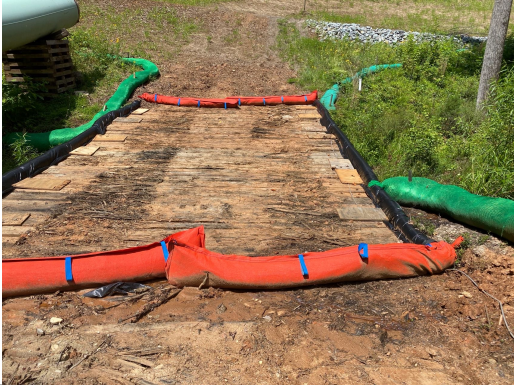
GPS Location	0	GPS Location	0		
Field Station#	14066+77	Field Station#	14012+50		
Pic 3 Desc.	Approximately 14066+77. Overview of stream crossing, equipment bridge and ECDs at stream S-EF48.		Pic 4 Desc.	Approximately 14012+50. Overview of ROW. ROW temporarily stabilized and has temporary vegetation growing.

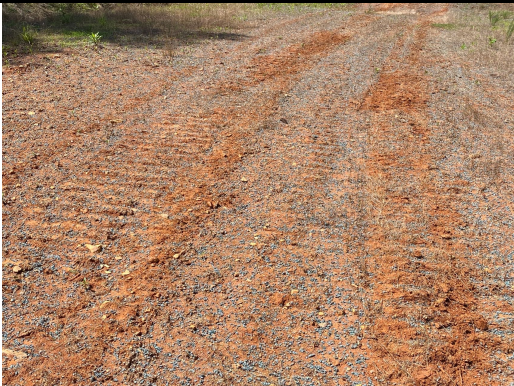
GPS Location	0	GPS Location	0		
Field Station#	14040+00	Field Station#	14062+00		
Pic 5 Desc.	Approximately 14040+00. Overview of ROW. ROW temporarily seeded and stabilized in this area.		Pic 6 Desc.	Approximately 14062+00. Overview of RCE. RCE appears to be installed and functioning correctly.

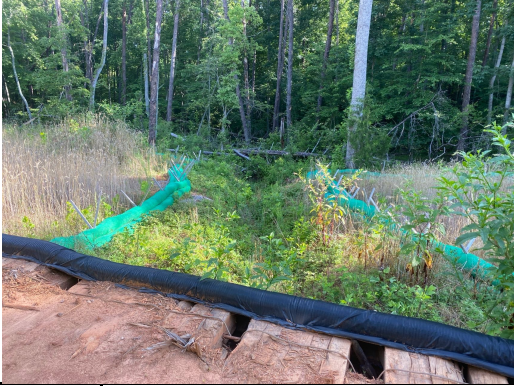
GPS Location	0	GPS Location	0		
Field Station#	15393+00	Field Station#	15488+00		
Pic 1 Desc.	All ECDs are functioning properly at natural drainage feature.		Pic 2 Desc.	CFS damaged by landowner.

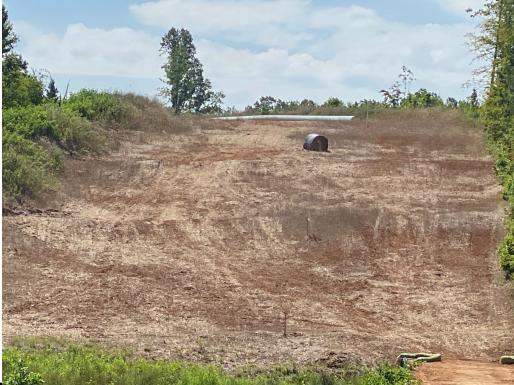
GPS Location	0	GPS Location	0		
Field Station#	15545+00	Field Station#	15562+50		
Pic 3 Desc.	No vegetation present along row.		Pic 4 Desc.	Landowner continues to run over bridge wattles causing damage.	
Insert image here			Insert image here		
GPS Location		GPS Location			
Field Station#		Field Station#			
Pic 5 Desc.		Pic 6 Desc.
